# Did They Get It Wrong?

by Tom Endy

## The clutch release shaft:

## The service bulletin:

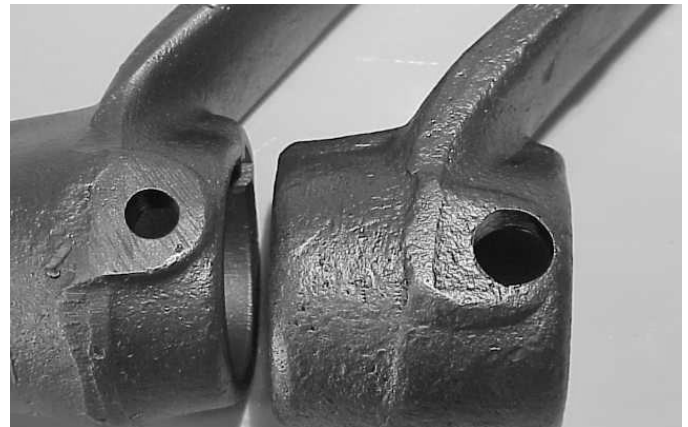
However, there is not ample material to allow the arm to be drilled out to accommodate the larger pin.

If the pin hole in the arm is enlarged the outer circumference of the new hole is almost to the edge of the arm and would certainly be prone to a crack at that point.

Perhaps the engineer writing the service bulletin got the two parts confused and reversed the instructions for the two parts. I would think after 70 plus years someone would have caught it by now. Maybe this is the reason why you hear about clutch release arms breaking occasionally.

The above photo shows two A7511-B arms. The arm on the left has the original 3/16" hole. The arm on the right has been drilled out to 5/16". Note how close to the edge the new hole is.

I certainly would never drill out an old A7511-B release arm to accommodate a 5/16" locking pin, as it would be an invitation to failure of the arm. ☺

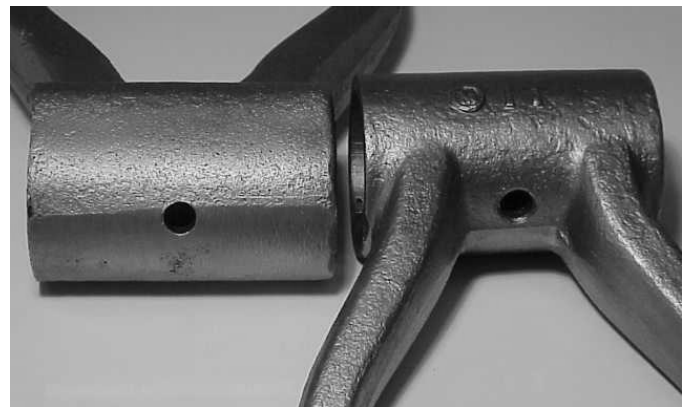
If you examine the old fork you will notice that there is ample material to accommodate a larger hole to allow use of the larger diameter pin.

The above photo shows two A7515-B forks with the original 3/16" holes. Note there is ample material to drill the holes out to 5/16".
