A Hidden Repo Fault

by Tom Endy

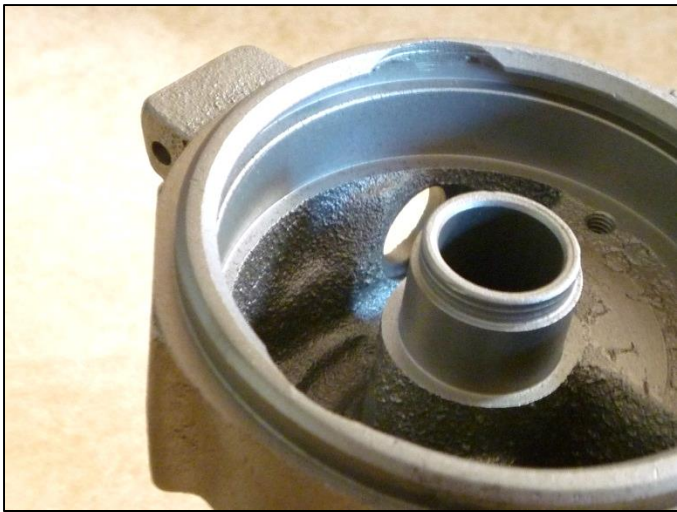
After much inspection and analyzing I came to the conclusion that when the condenser was installed it pushed the tab on the lower plate forward and it contacted a protrusion on the inside of the casting on the left side of the window where the tab and fiber washer locate. The protrusion appeared more pronounced on this particular casting.

The length of the new condenser was measured and it was found to be slightly longer in overall length than several of the old condensers removed from several of the cores. The extra length was about 3/32". My conclusion is that the extra length pushed the tab on the lower plate forward enough to contact the protrusion on the inside of the casting.

One must consider that this distributor housing had been in service for 86 years with more than likely numerous different condenser replacements. Therefore the problem lies with the new condenser being slightly too long to operate with some castings.

The 1931 casting is more robust. Note the protrusion on the left side of the window where the lower plate tab and the fiber washer at the end of the condenser reside. This is where the tab on the lower plate can short out with an extra-long condenser.

The problem was remedied by using a Dremel to grind off some of the protrusion material on the inside of this distributor housing. This resolved the problem. The condenser that is slightly longer than the originals then installed without shorting out the points.

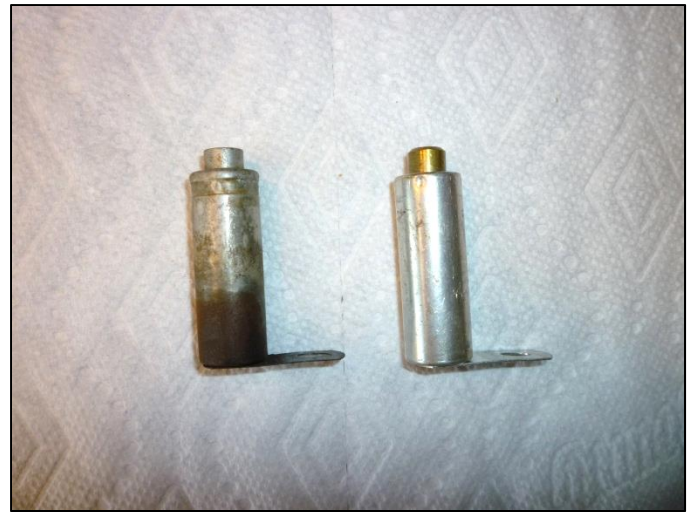
An earlier condenser on the left removed from a distributor core measures 2 $\frac{1}{32}$ " in overall length. The condenser on the right recently purchased measures 2 $\frac{1}{8}$ in overall length.

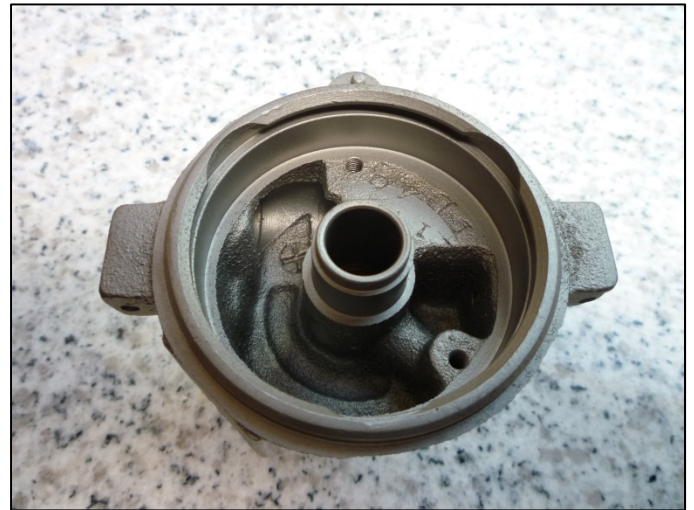
A common problem found with many distributor cores is that the attach points for the cap clamps is broken off. This damage does not usually occur when the distributor is in service on the car. It occurs when removed and someone drops it on the ground. Bridging the clamp attachment added extra strength.
