1928 Differential Rebuild, May 2016

by Tom Endy

This 1928 rear axle assembly was removed from a 1929 roadster pick up for rebuild; the owner is a member of the Santa Anita A's. A complete disassembly took place while the owner was present.

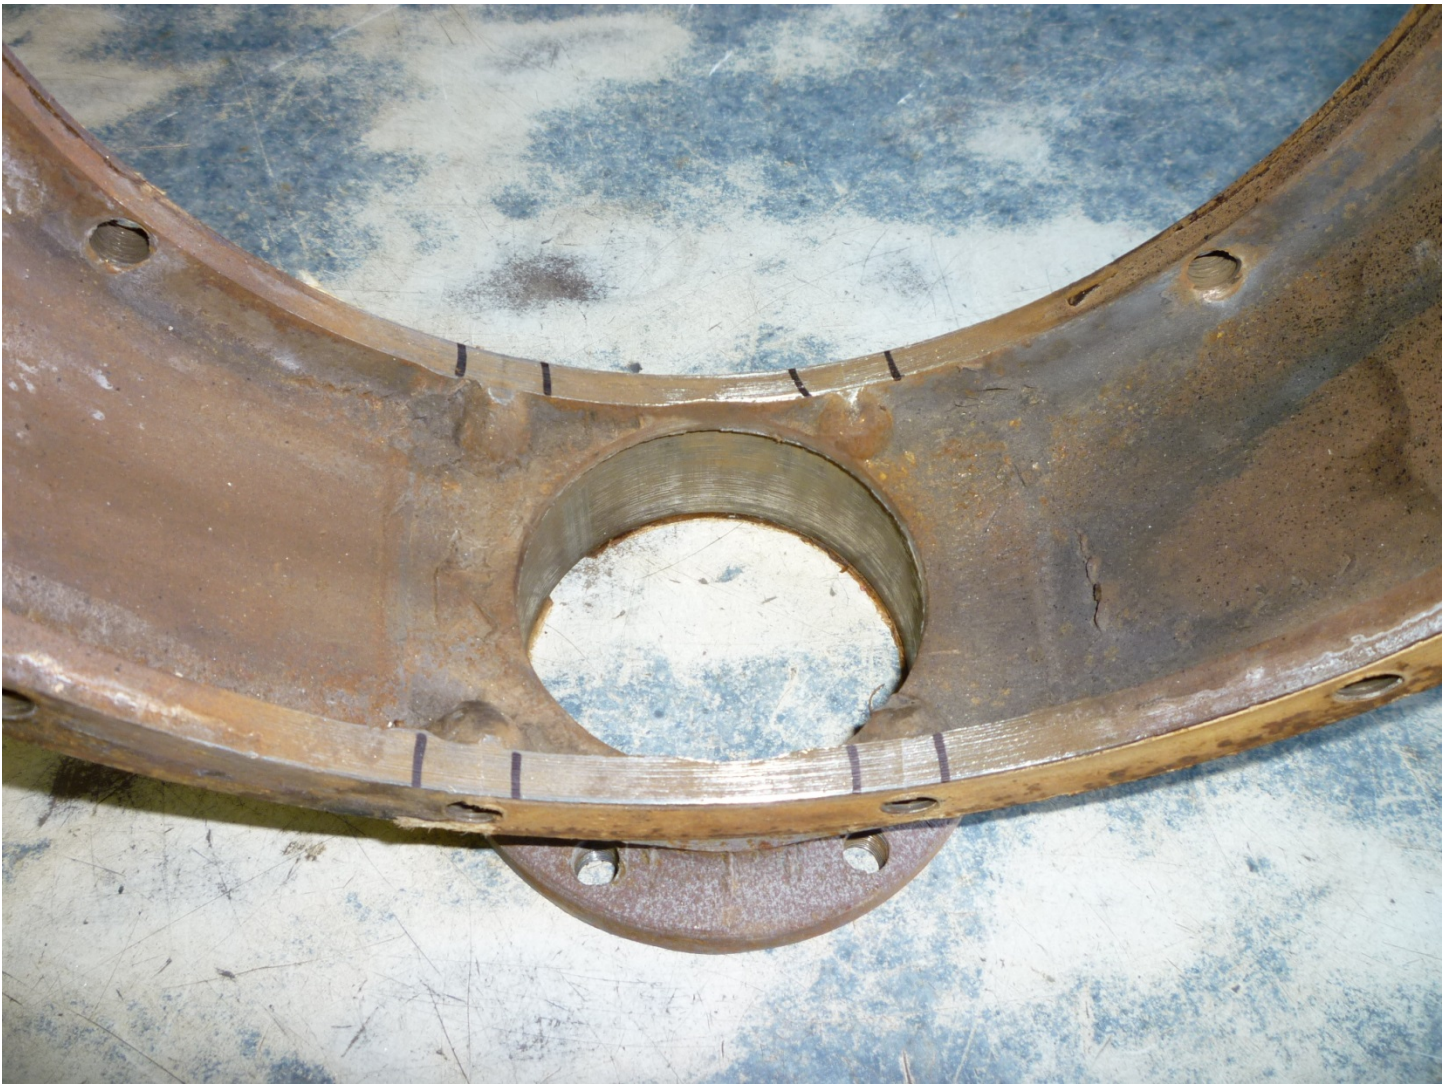
The original banjo was a 1928 without support gussets. These early banjos are prone to crack at the four bolt holes nearest the torque tube flange, which was the case with this banjo. It is prudent to replace these early banjos with a 29-30 banjo unless the car is being restored for blue ribbon judging.

Note the four cracks across the rails at each of the four bolt holes closest to the torque tube flange. The banjo has been replaced with a 1928-1930 banjo that has support gussets

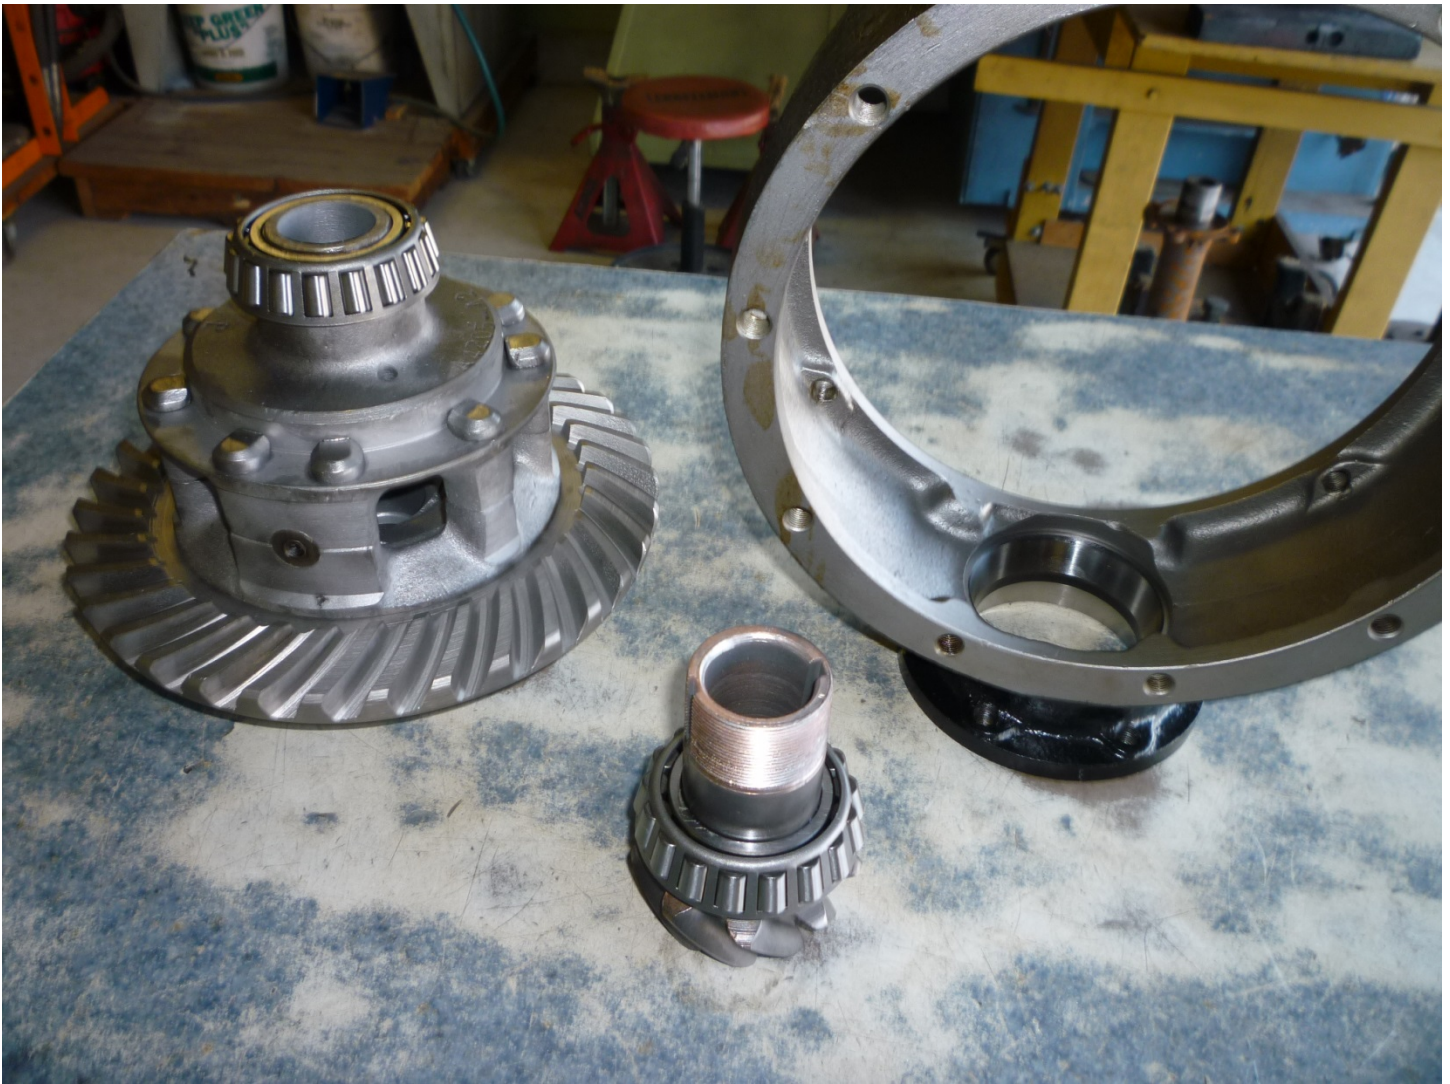
The carrier assembly with the ring gear installed. Both bearings are installed and the pre-load tool is inside the carrier. The pinion gear has a new rear bearing installed. A replacement banjo has a new double race installed.

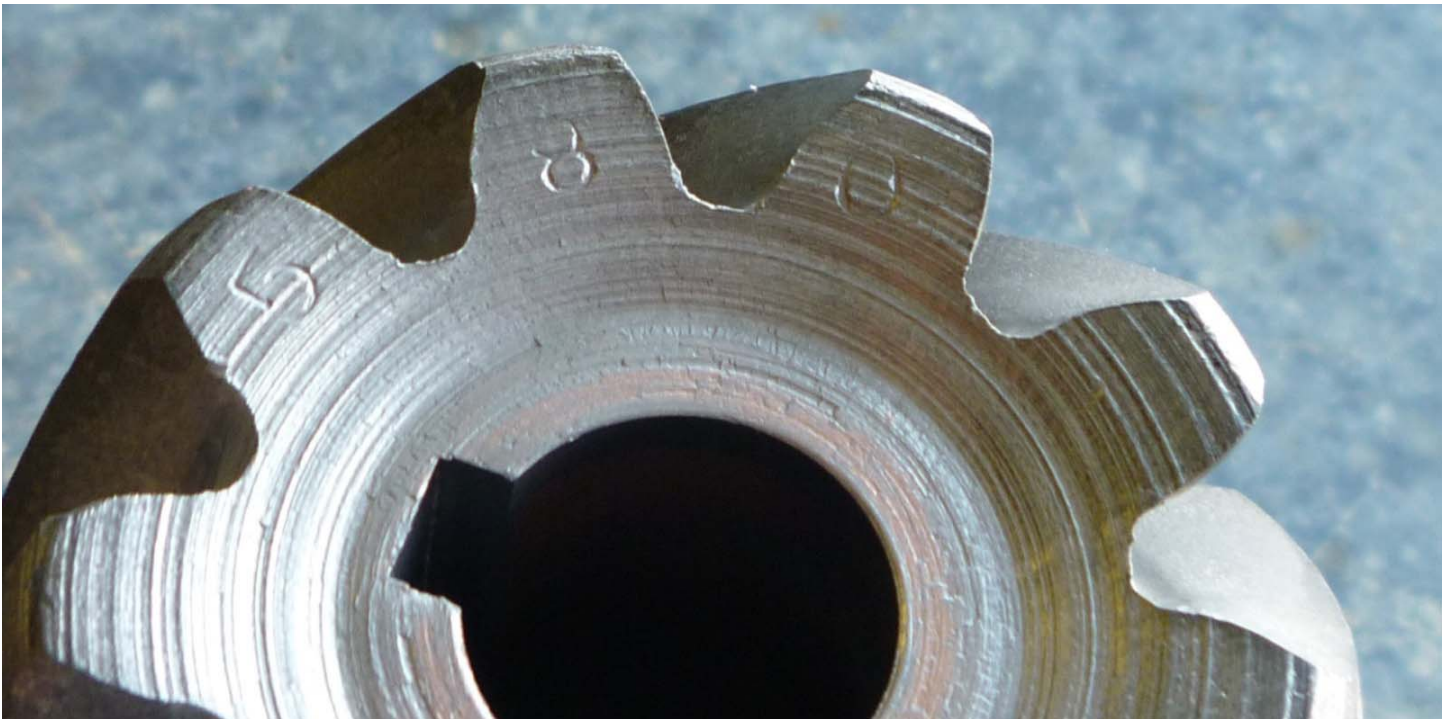
The 378 ring & pinion found in this rear axle assembly was an original, but did not have matching numbers. The ring gear number is 878; the pinion gear number is 580. It was common practice at the Ford factory to pull a numbered pinion gear from stock and write this number with a vibrator tool on the back side of a ring gear pulled from stock. After a few hundred miles the gears would have lapped themselves into a matched set.

Apparently sometime in the history of the car the ring or the pinion was replaced, for whatever reason, with a part from another car. Since this assembly came from a running car the gears should have lapped themselves into a matched set during the time it was driven and should be perfectly serviceable.

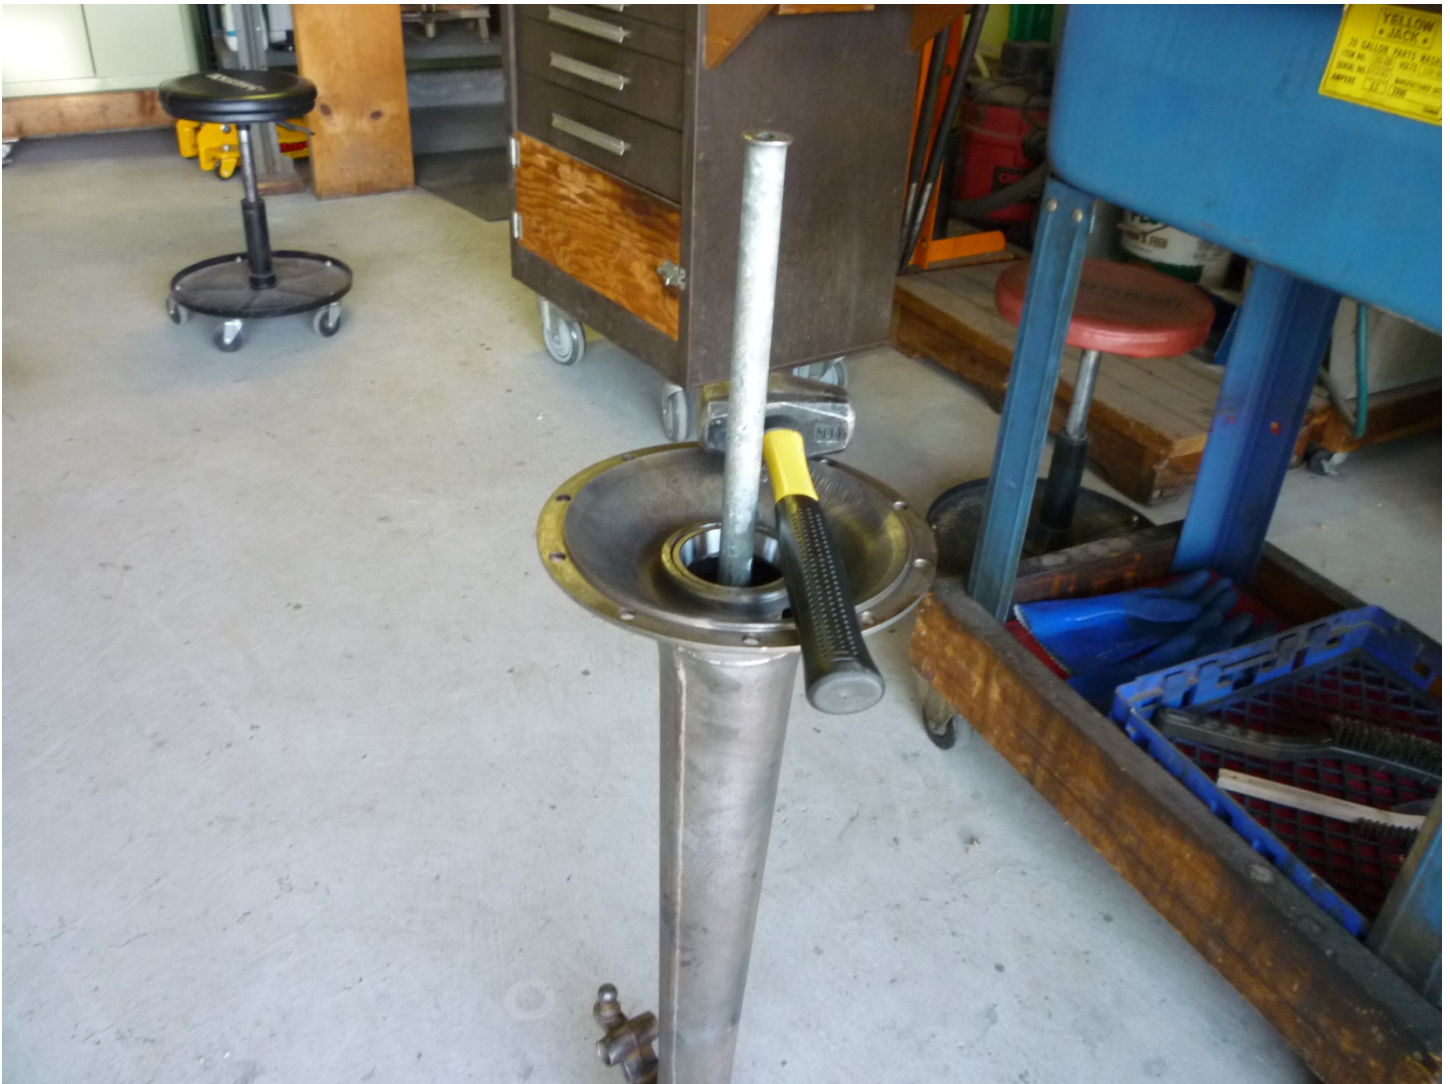
A new axle housing grease seal is driven into place using an insertion tool and a hammer. The original Ford leather seals installed at the factory were found inside each axle housing and in the torque tube. The leather was totally deteriorated. Original seals will have the letters CR stamped on them. It stands for Chicago Rawhide.

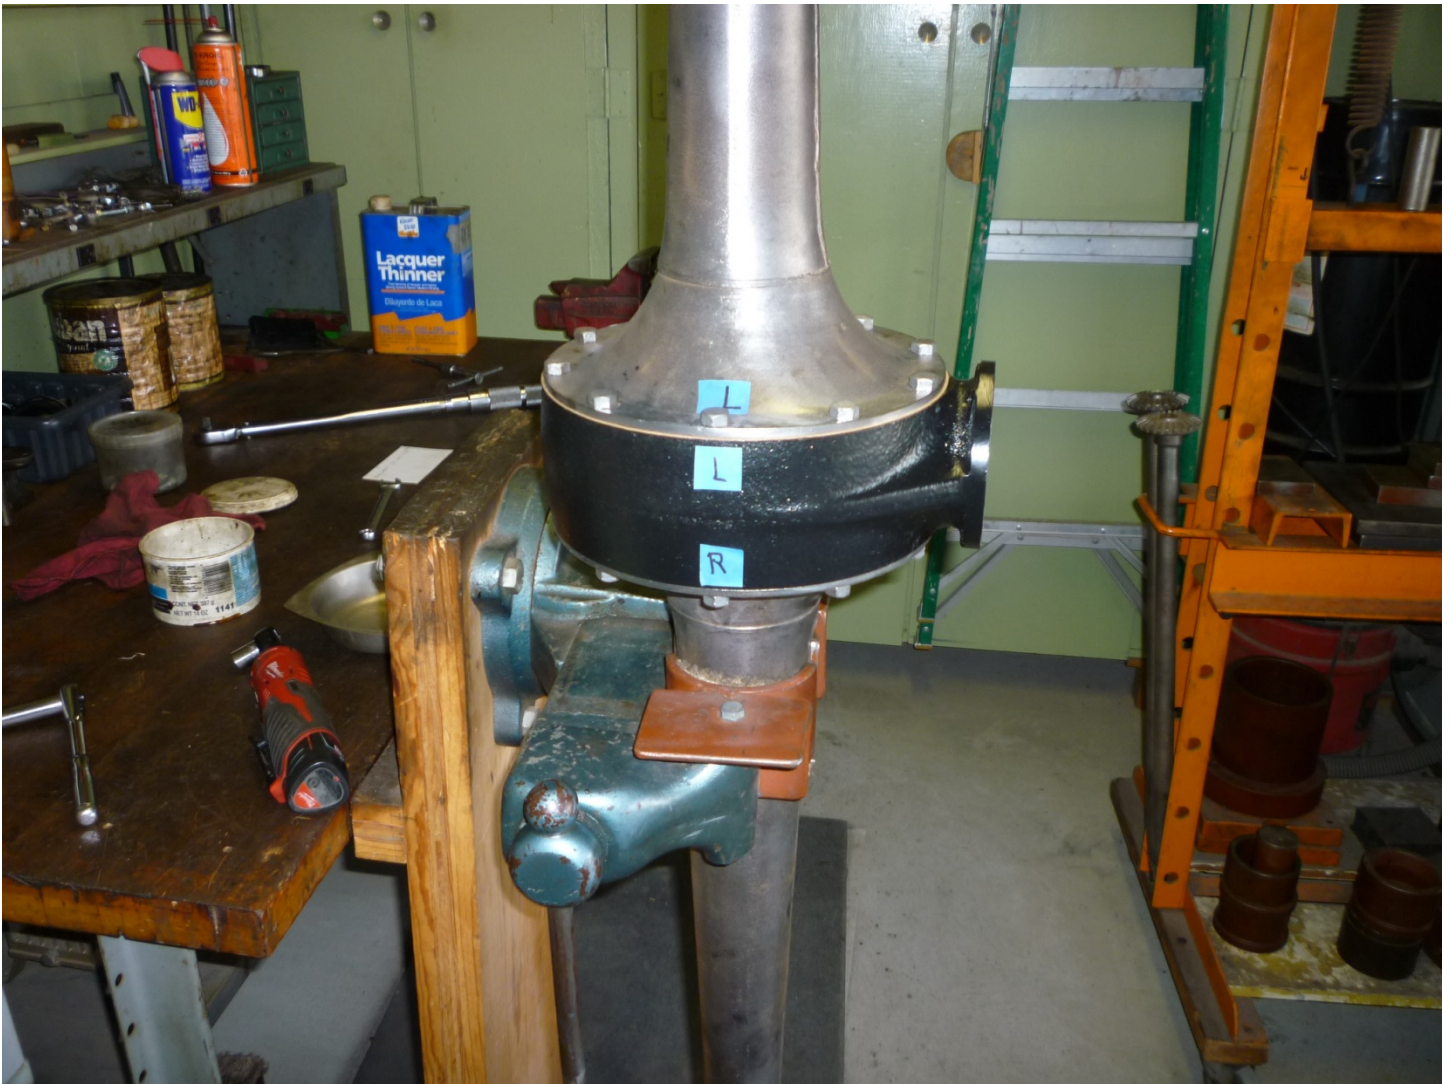
After a number of trial and error attempts the pre-load was set and was determined to require three .010 banjo gaskets to establish pre-load which in this case came to 14-16 in. lbs. pre-load. The three gaskets will be installed on both the left and the right side of the banjo during final assembly. Their individual placement left and right will determine backlash.

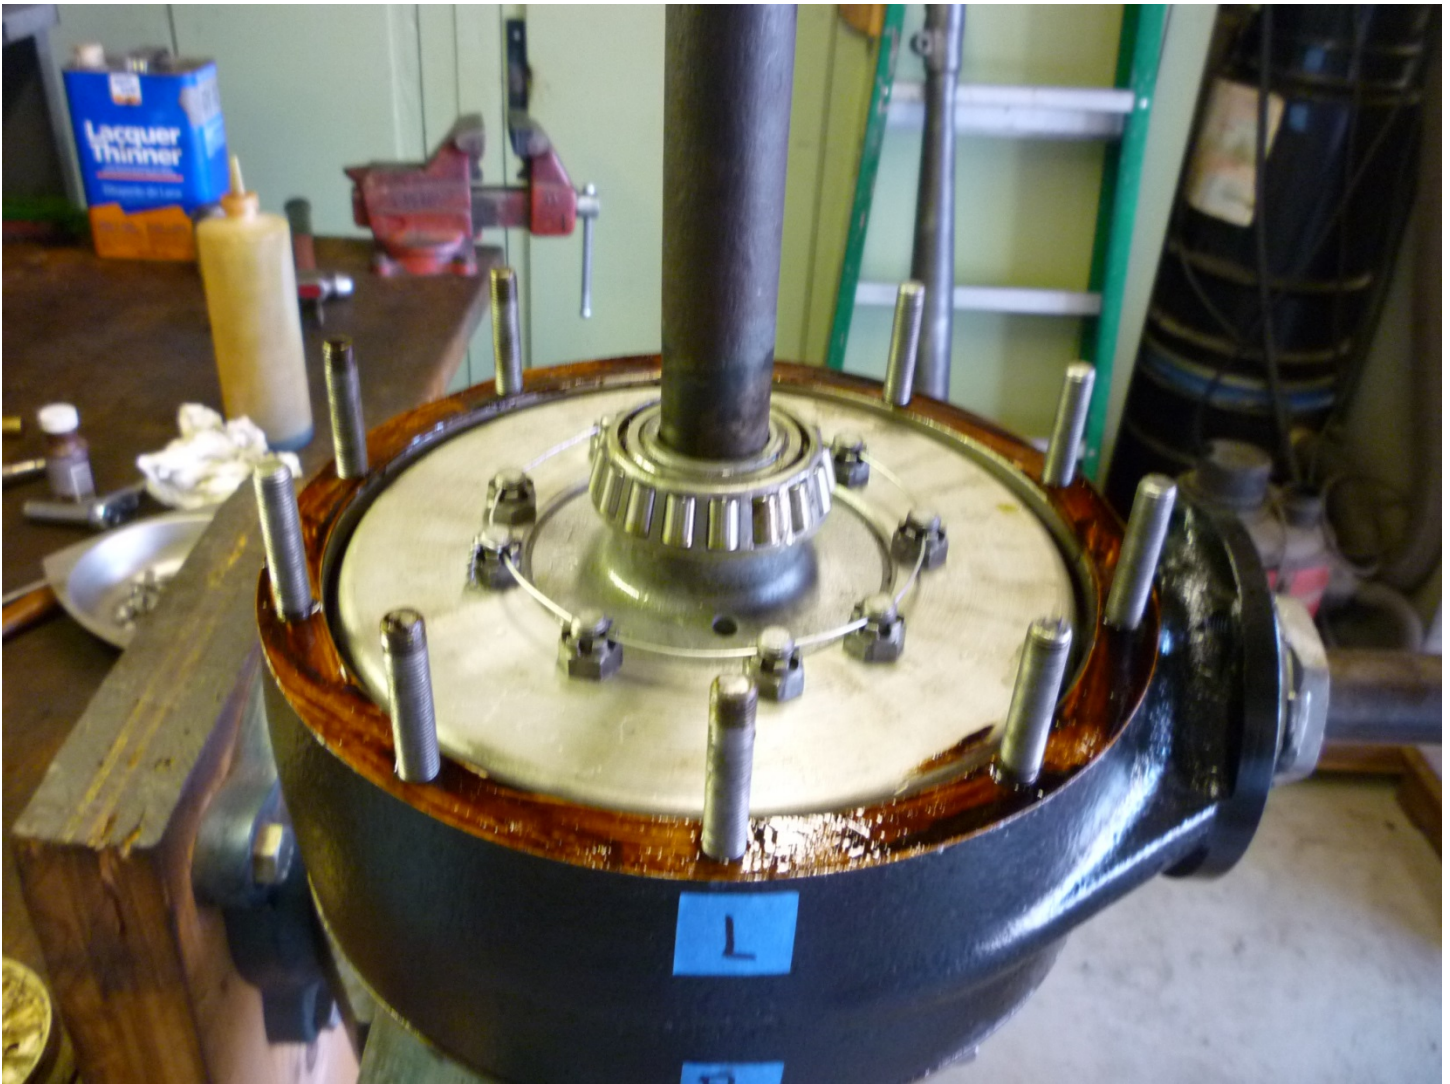
The backlash has been set. It was determined that two of the .010 gaskets are installed on the right side of the banjo. A single .010 gasket is installed on the left side of the banjo. The three .010 gaskets were previously determined to set the carrier pre-load. The final assembly is taking place with gasket sealer applied to both sides of the three gaskets.

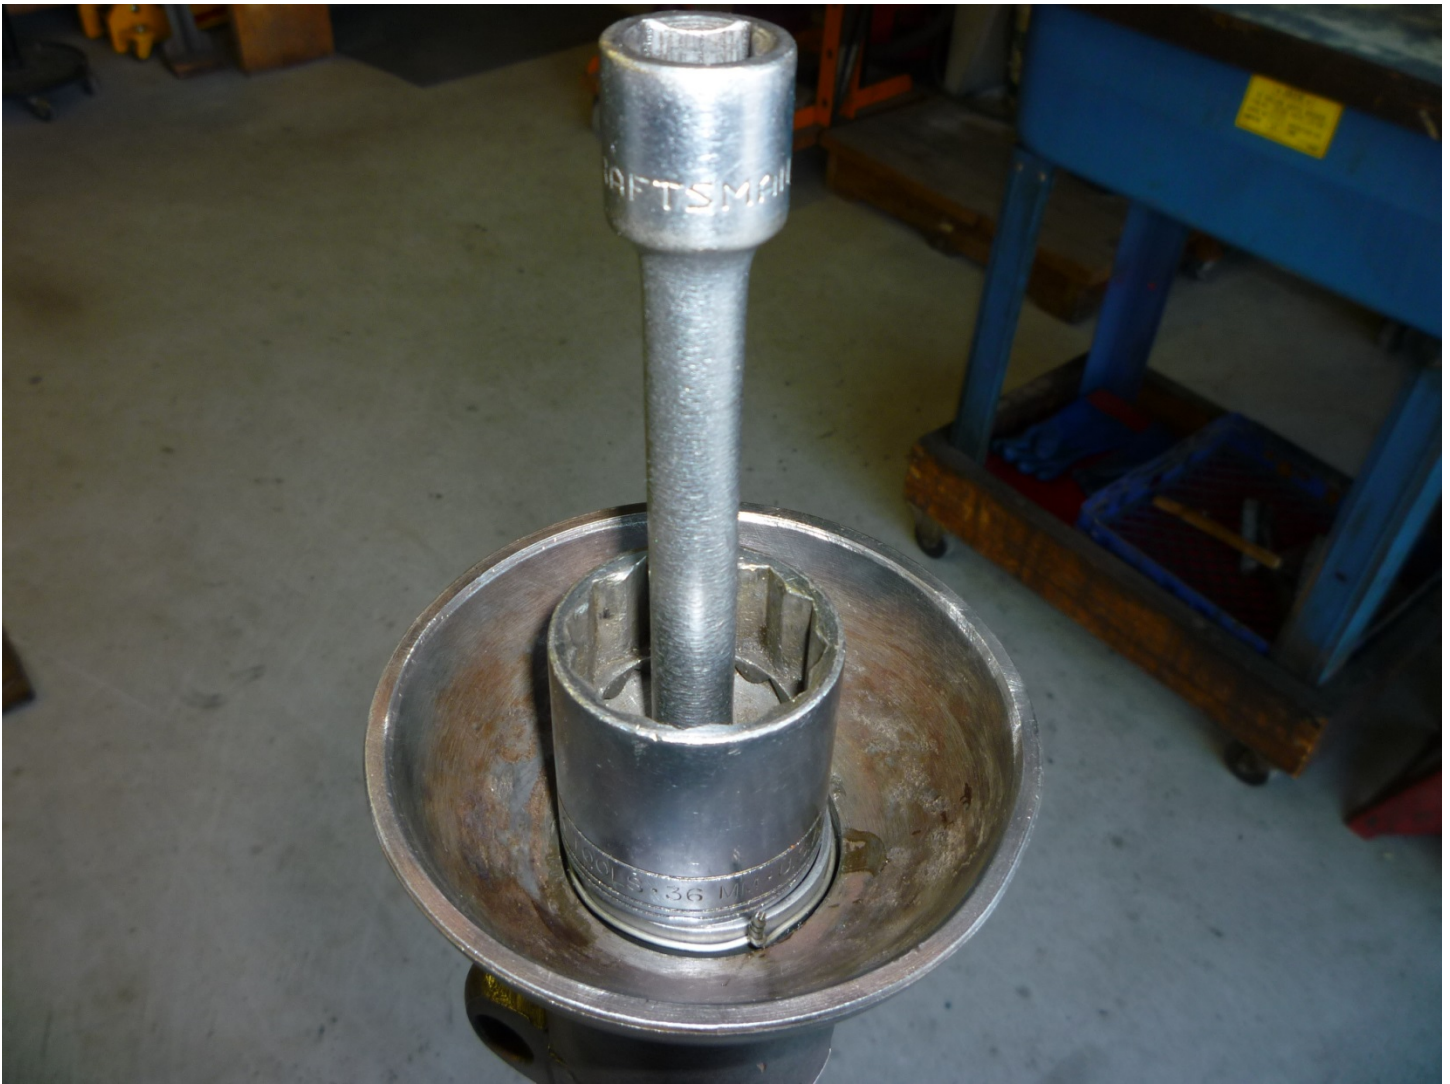
The roller bearing race sleeve is driven into place with the flat side of a 36mm socket. It is important that the race seat around the inner circumference of the torque tube with the dimple in the recess. The race must fit into place properly or the bearing and drive shaft will not be able to install. The safety wire will exit as the sleeve is seated.
