# Oil Pump Change

by Tom Endy

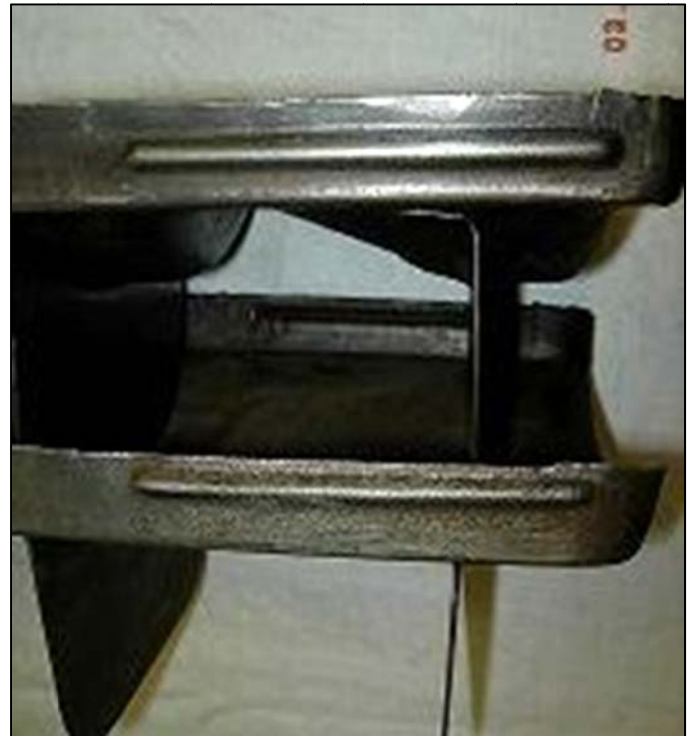
The bottom dipper tray is the modified one with the bead raised 1\8” along the edge of the tray to lower it in the pan. The dipper tray at top is the original with the bead in the center.

Common wisdom has it that if you are going to use the oil pump shield you must use the corresponding modified dipper tray.

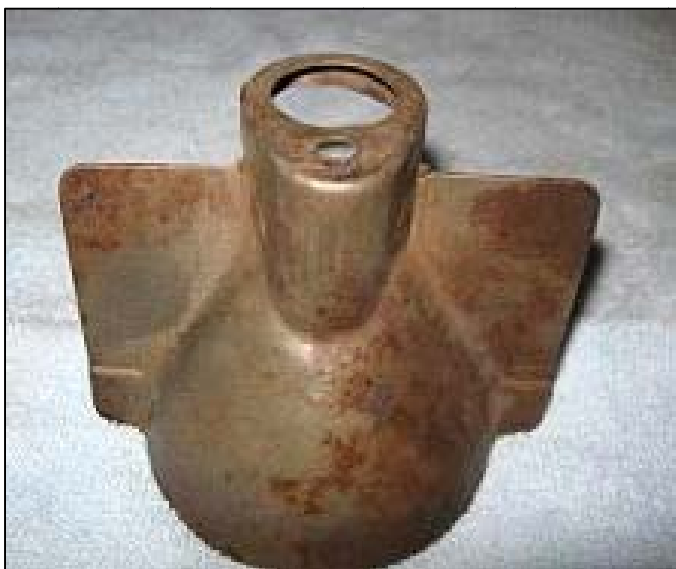
The shield that fits around the oil pump

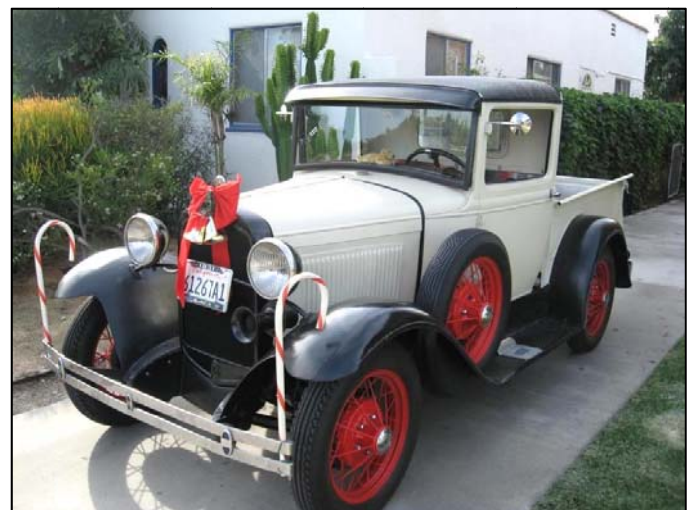
The engine in this 1931 wide bed pick-up was found to have the oil pump shield installed, but not a modified dipper tray. The shield was removed from the pump.
