# Rear Axle Assembly Rebuild Pictorial 2015

by Tom Endy

The following series of photos were taken during the rebuild of a Model A rear axle assembly.

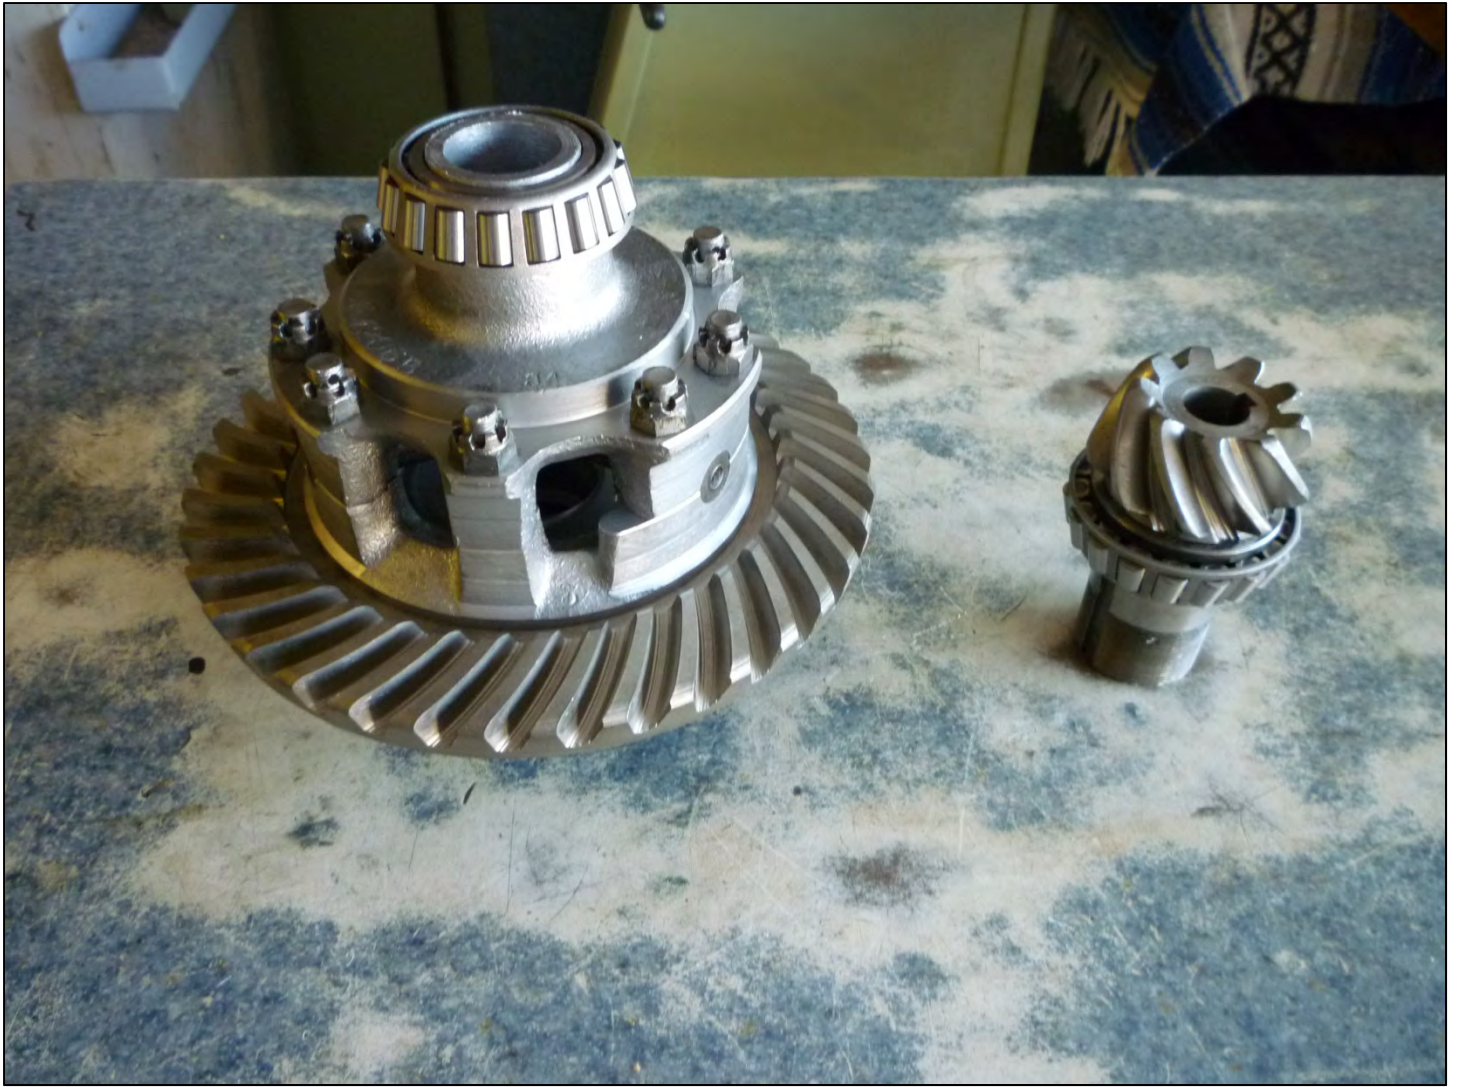
**The carrier has been cleaned and bead blasted and inspected for any signs of wear. A 411 ring and pinion gear set will be part of this rebuild. The two carrier halves along with the ring gear have been bolted together with a modified spider gear yoke inside to facilitate the pre-load adjustment of the carrier bearings. Two new bearings have been pressed onto the carrier. The two bearings must press on with an interference press fit. The pinion gear has a new rear bearing pressed on.**

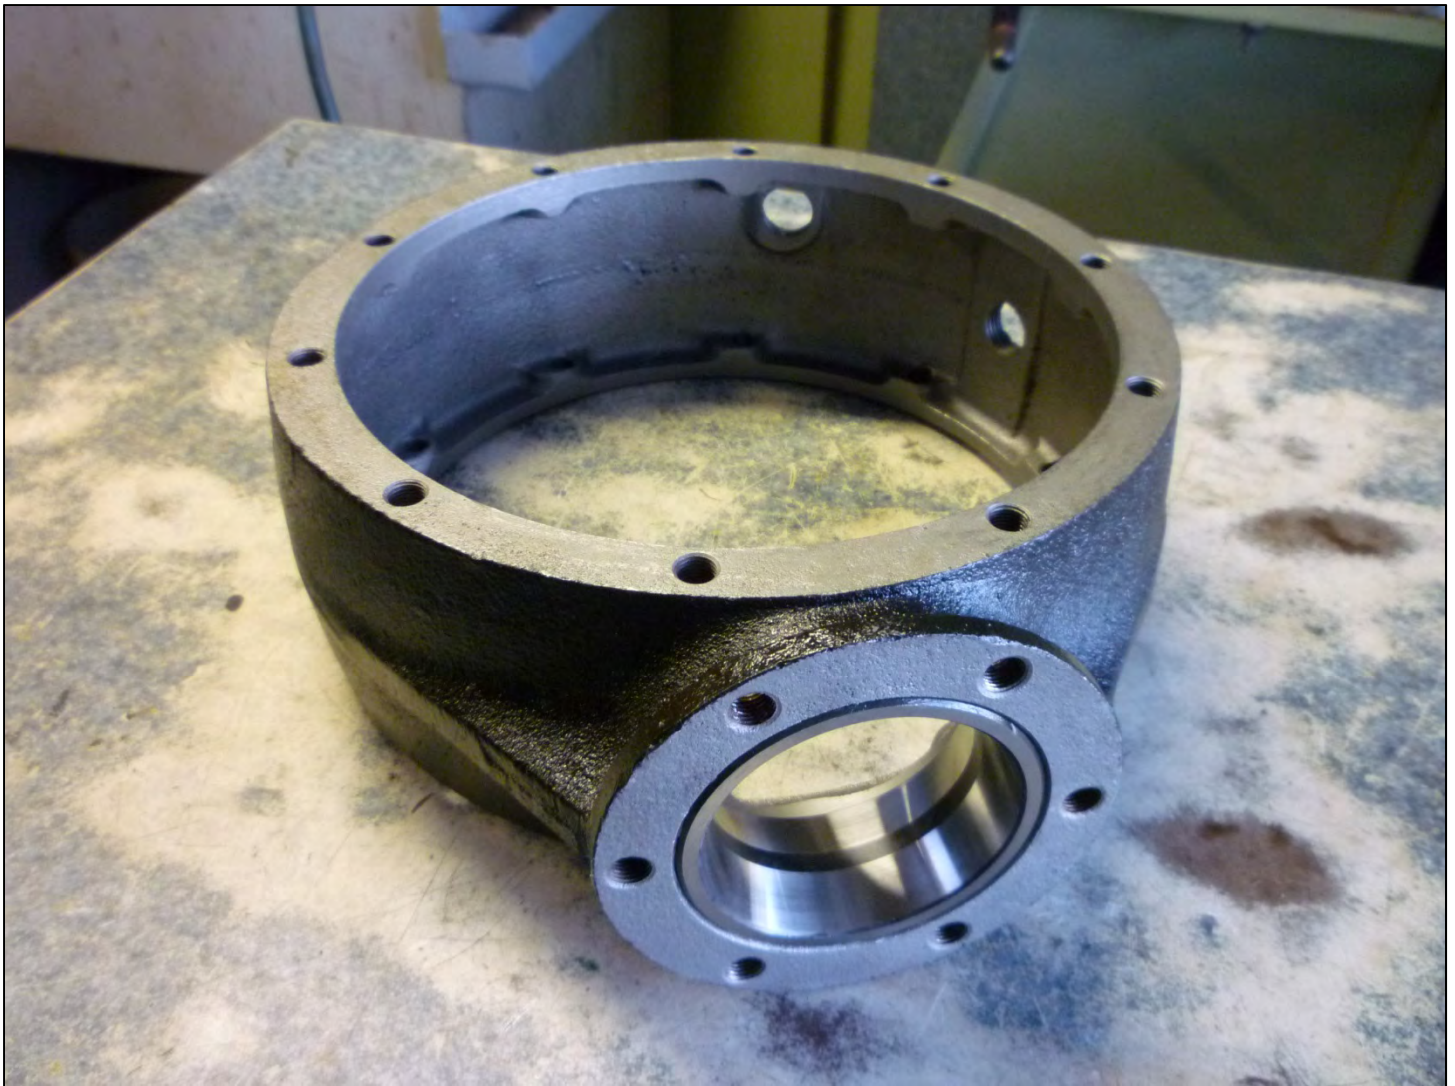
**The banjo has been cleaned, bead blasted, inspected, and painted. All the thread holes have been inspected and cleaned with a small wire brush mounted in a drill motor. A new double bearing race has been pressed into place.**

**Care should be taken when installing this race. Do not set the back side of the banjo on a press platform as it will likely distort the shape of the banjo as the race is pressed in. Support the inside of the banjo where the race stop is by hanging it over a rail on the press platform and placing the old removed race under for support.**

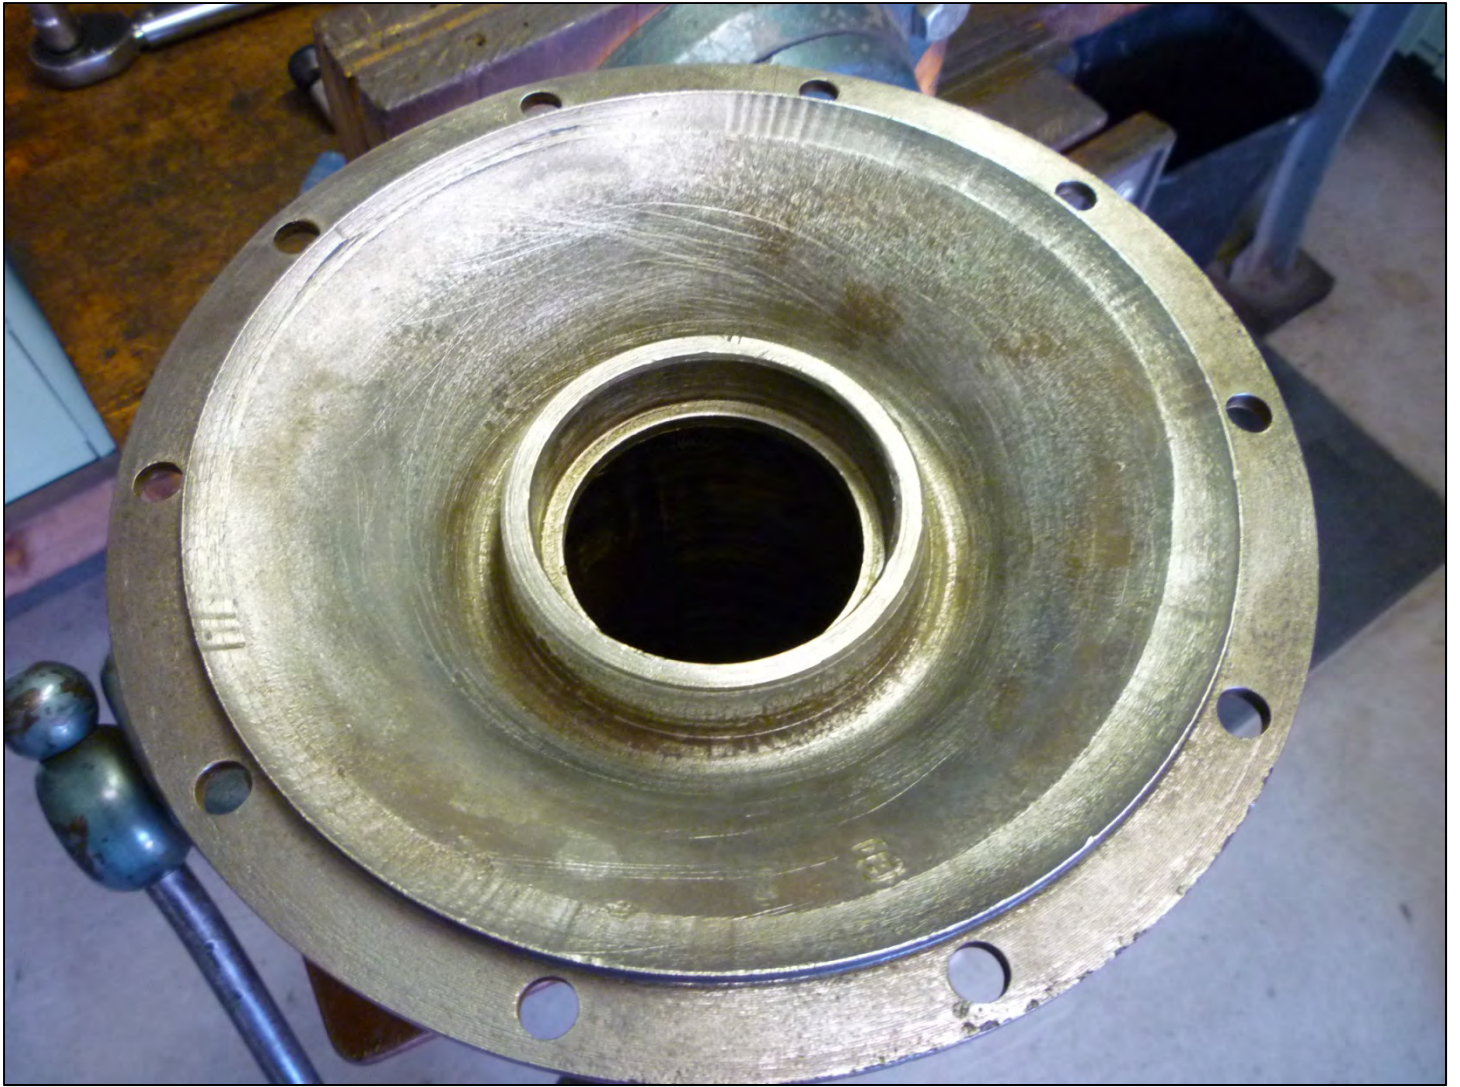
**Both axle housings have been cleaned, wire wheeled, and the exterior sanded. The old bearing race has been removed and is ready for the installation of a new race.**

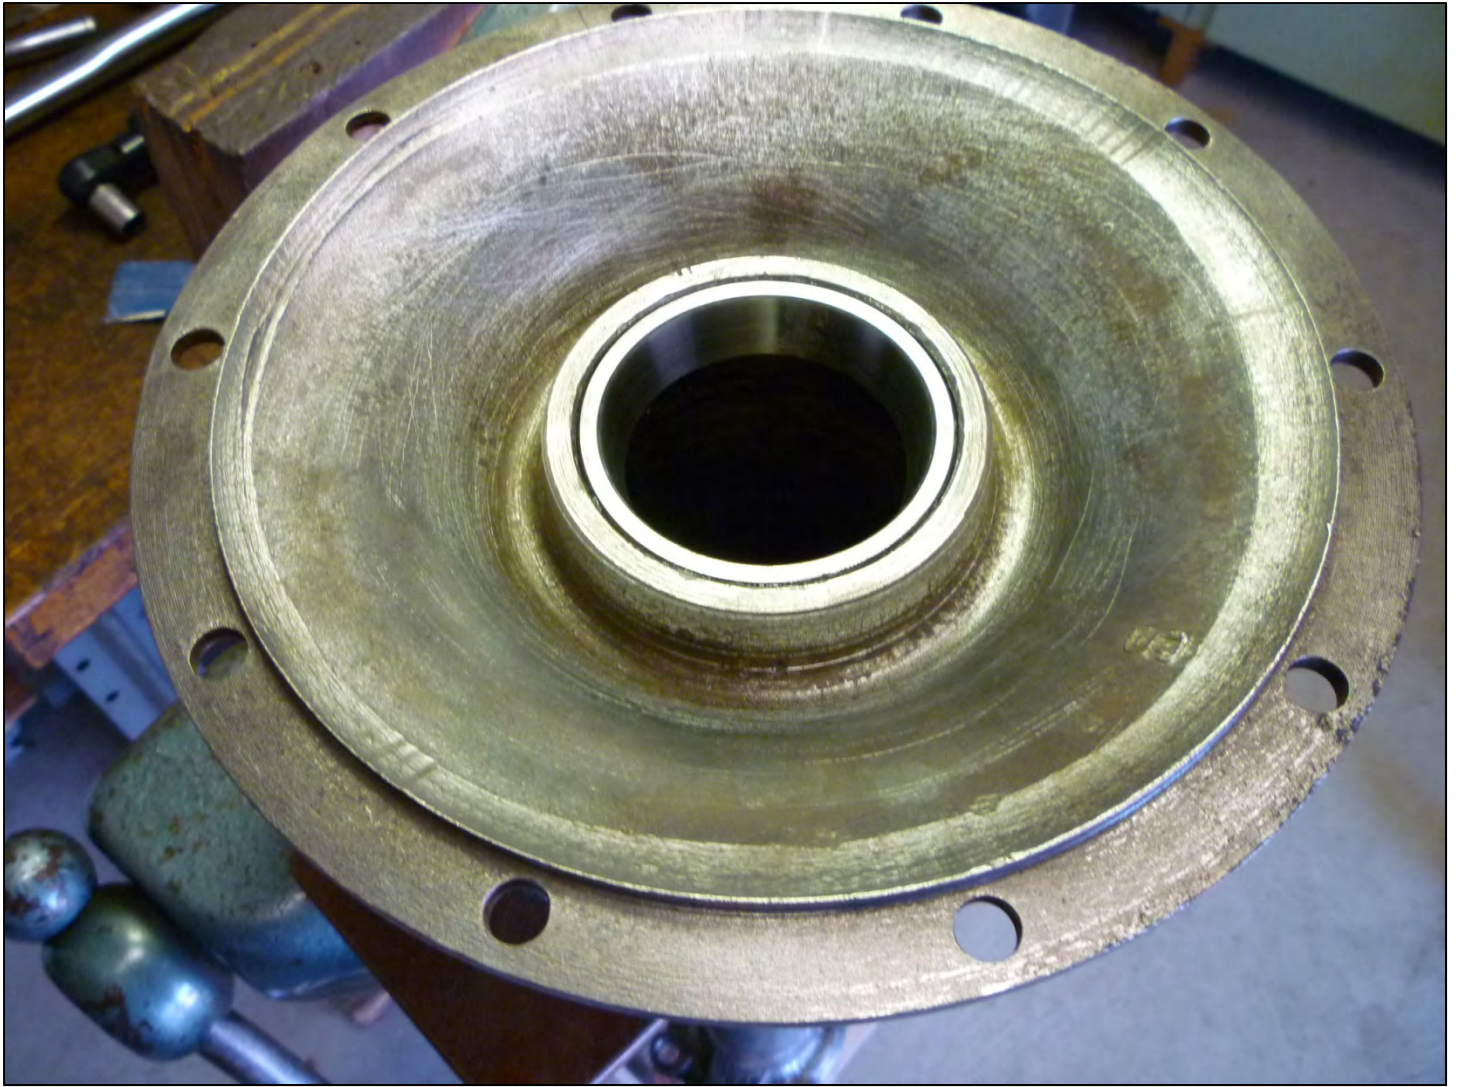
**A new bearing race has been pressed into place. It is important that the race is seated properly. A small mirror should be used to determine that the race is firmly seated against the stop all the way around. The new race may be installed using a shop press or a K. R. Wilson tool.**

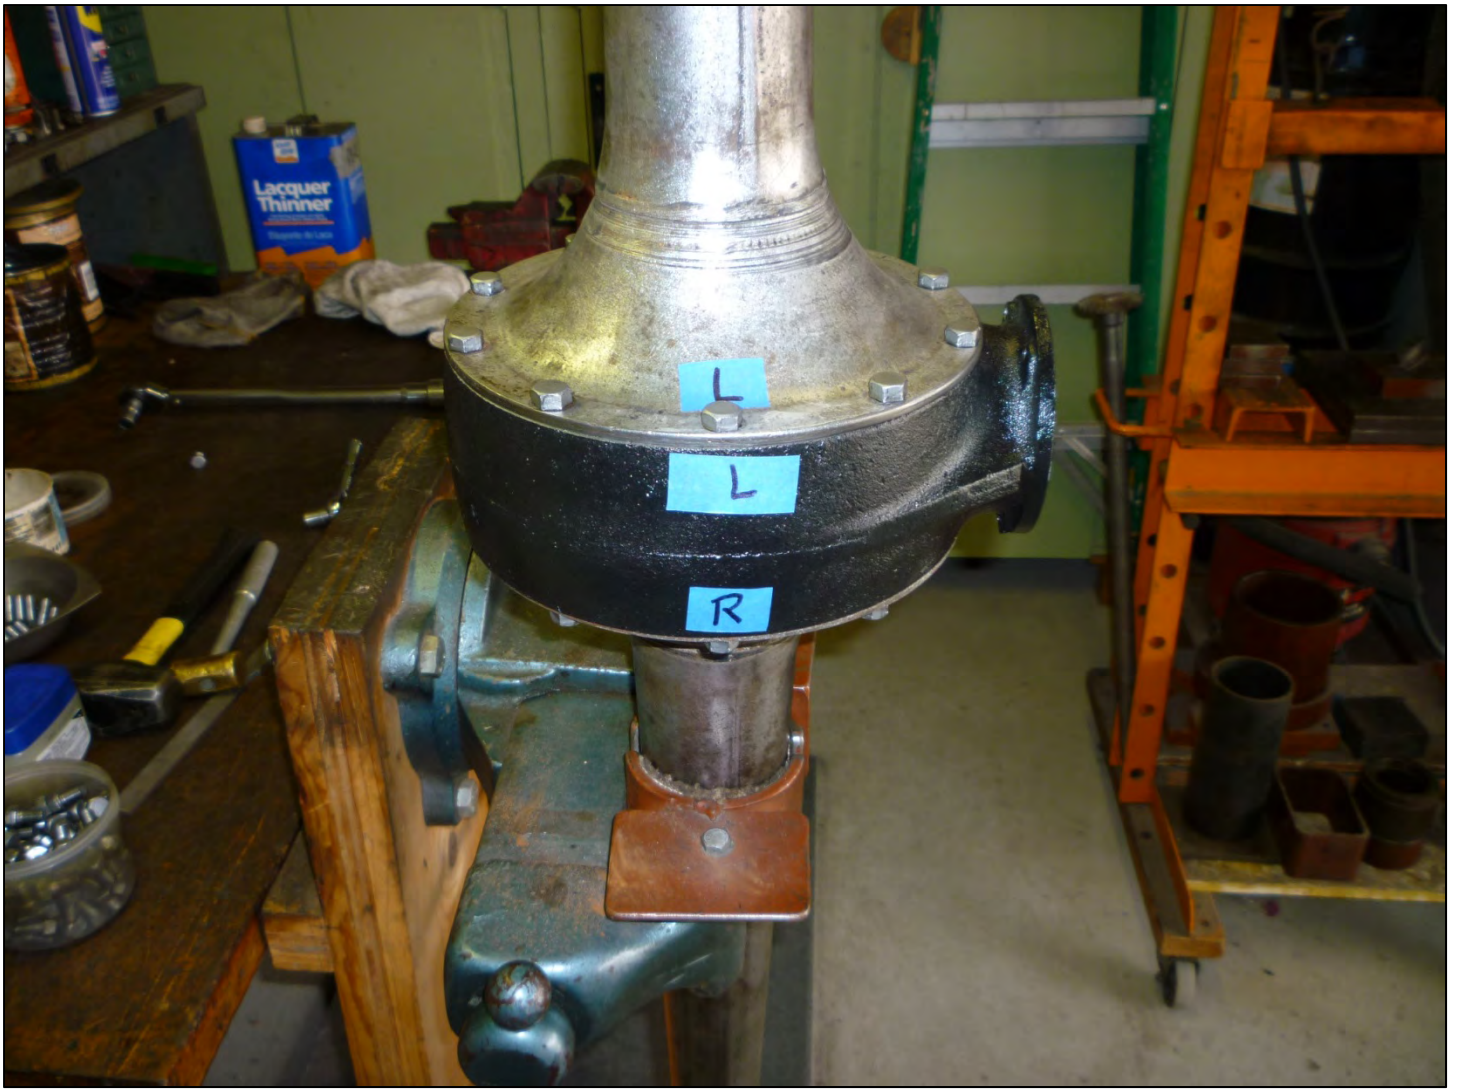
**The left axle housing is installed and the ten banjo bolts were pulled down snug while turning the ring gear by finger until the ring gear locked up. On this particular rebuild the ring gear did lock up when all the bolts were torqued down.**

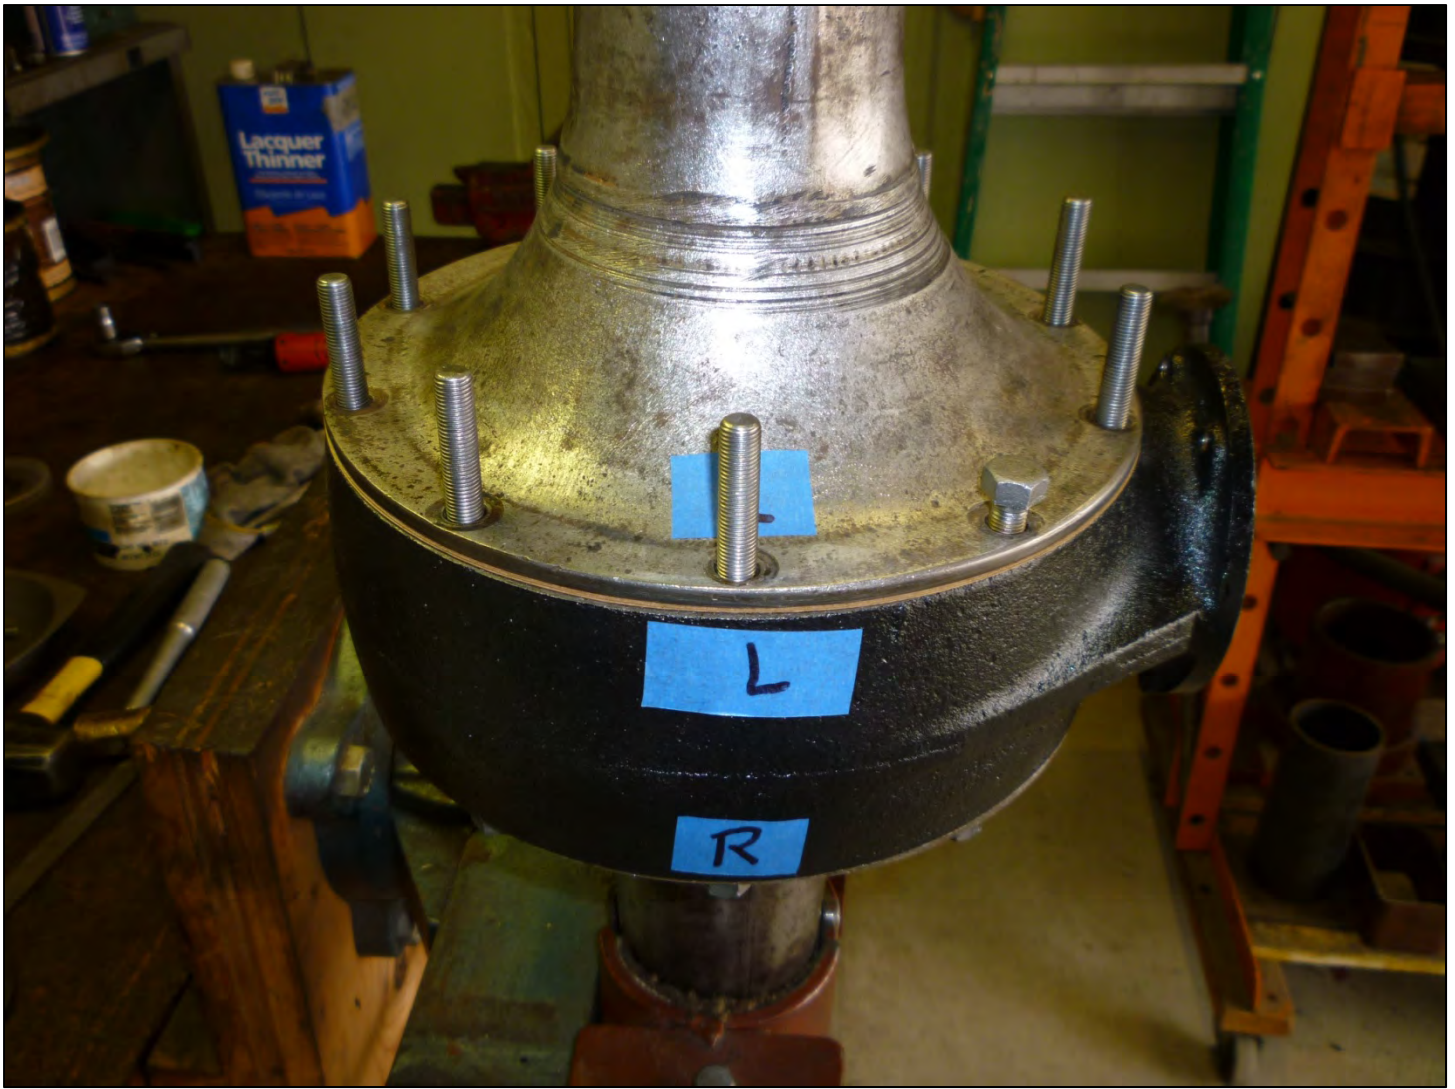
**The left axle housing is re-installed and the threaded studs are replaced with banjo bolts one at a time. When the ten bolts were installed and torqued down the ring gear could be freely turned through the pinion assembly opening. This is an indication that a pre-load adjustment cannot be achieved. The left axle housing had to once again be removed and both bearings on the carrier had to be removed and shims installed under each.**

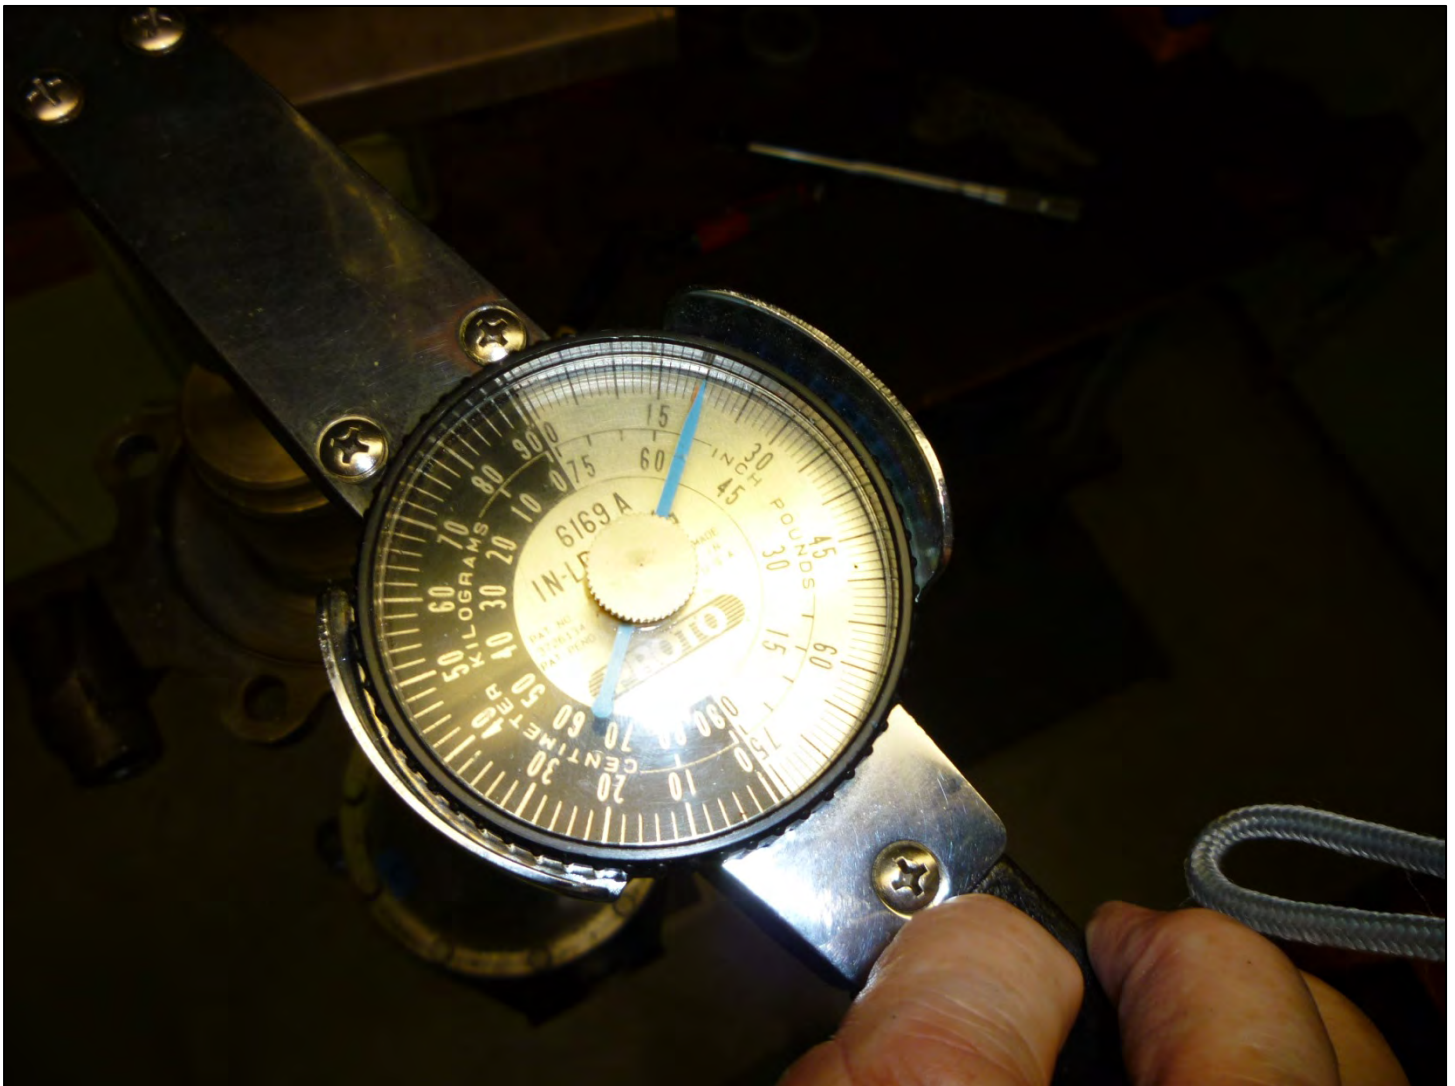
**The reading was almost dead on 20 in. lbs. The reading should be taken as the wrench is slowly rotated. When the rotation is first initiated the bearings have to overcome inertia so the reading will be initially high. As the wrench is slowly rotated the reading will drop and settle and indicate the true pre-load. There will be some amount of slight fluxuation. A reading from 16 to 22 in lbs. is acceptable.**

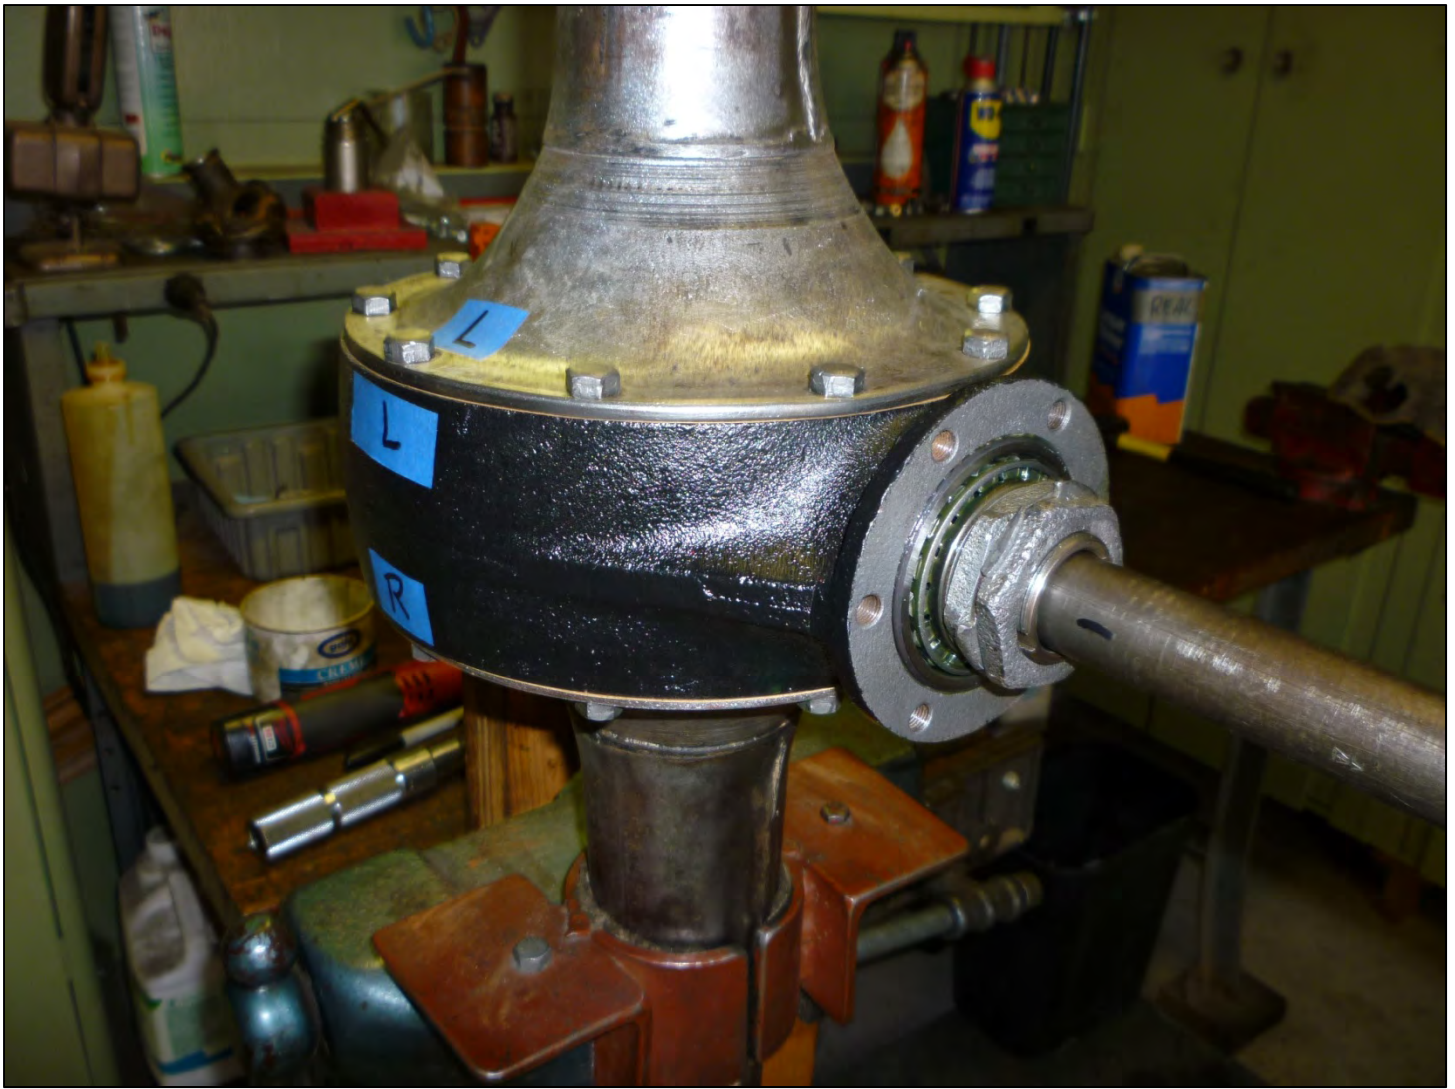
**With the quantity of the selected gaskets installed on both sides of the banjo for a trial and error effort, and all 20 banjo bolts torqued down to 35 ft. lbs., the backlash can be detected. Grasp the drive shaft by hand and very slowly rotate it in both directions to feel the distance where a pinion tooth contacts one side of a ring gear tooth and then the other side. It should be very small, only a few thousandths. It is important to have some amount of backlash, but not too much. How much is too much? I don't know, it depends on who is telling the story. I would think more than .010 may be too much.**

**In the case of this rebuild, if there was too little backlash, the .006 gasket would be moved from the right side of the banjo to the left side, which would increase the backlash. However, in this case the backlash was very little, only a few thousandths.**

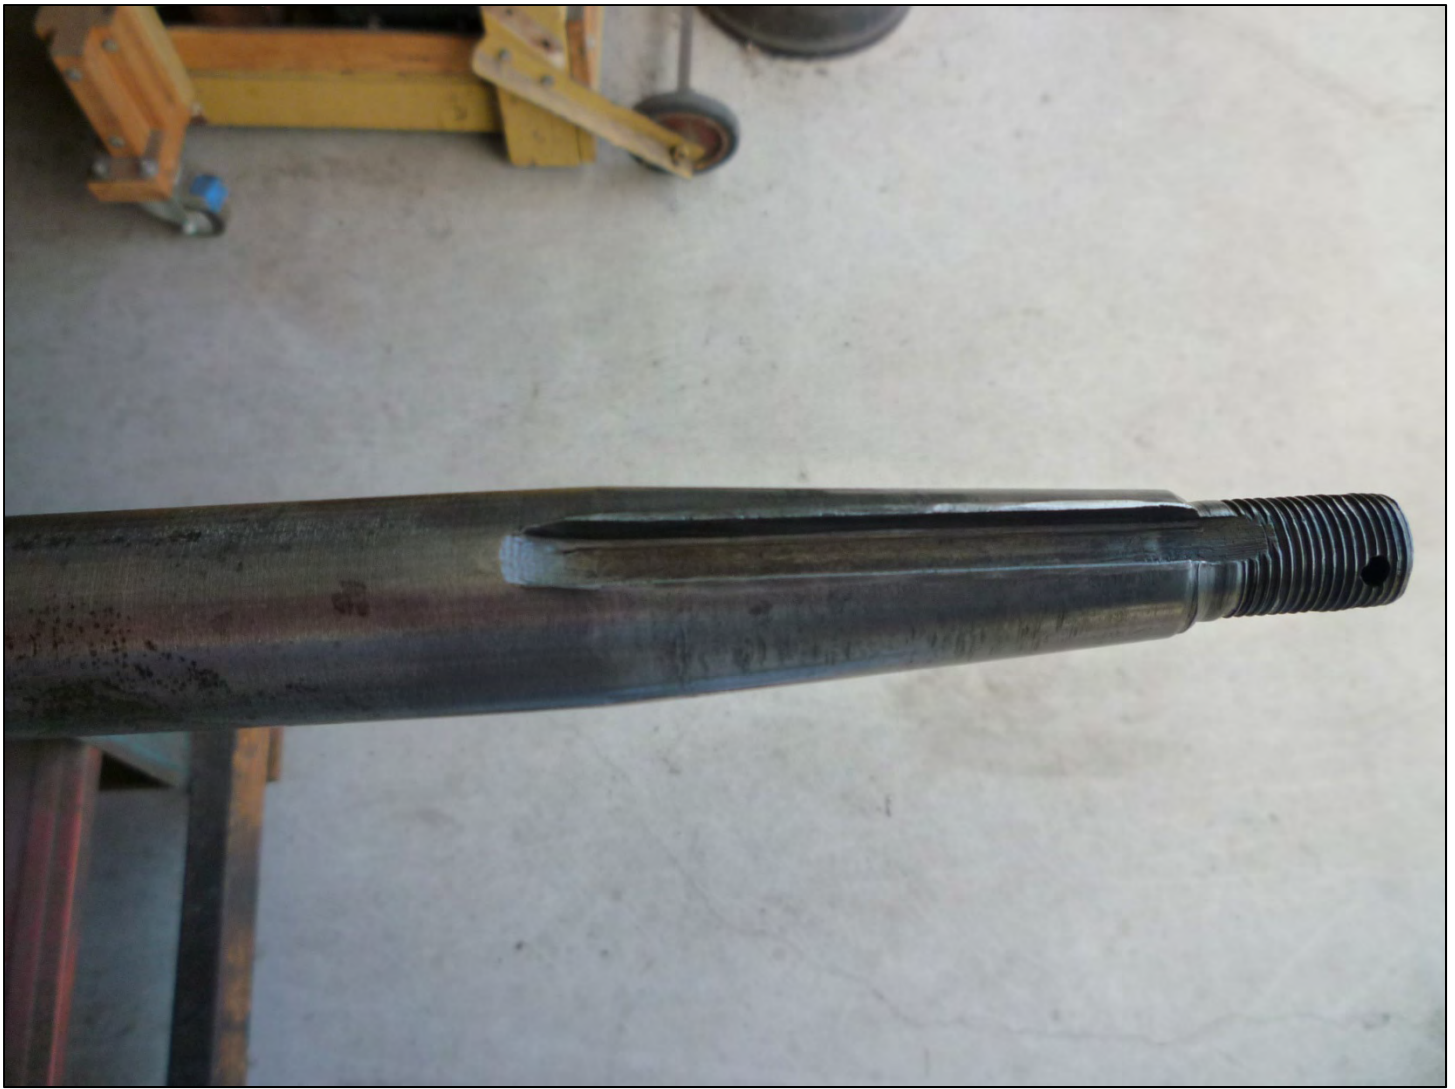
**The key slot should be inspected for a crack at the inboard end. A crack will usually start in this area and eventually work its way around the circumference of the axle shaft, and then break off. The key slot should also be inspected for wallowing. This is caused when the axle nut was not torqued down to a nominal 100 ft. lbs. This allows movement of the brake drum against the locking key and in time will wallow out the slot. Some repair can be made by placing the axle on an anvil and with a heavy hammer pound the edges of the key slot back. An axle shaft with an excessively wallowed key slot should be discarded in favor of a better one.**

**Check the threads carefully. If they appear somewhat compromised a dye can be run over them. However, excessively damaged threads are cause for rejection of the axle shaft.**

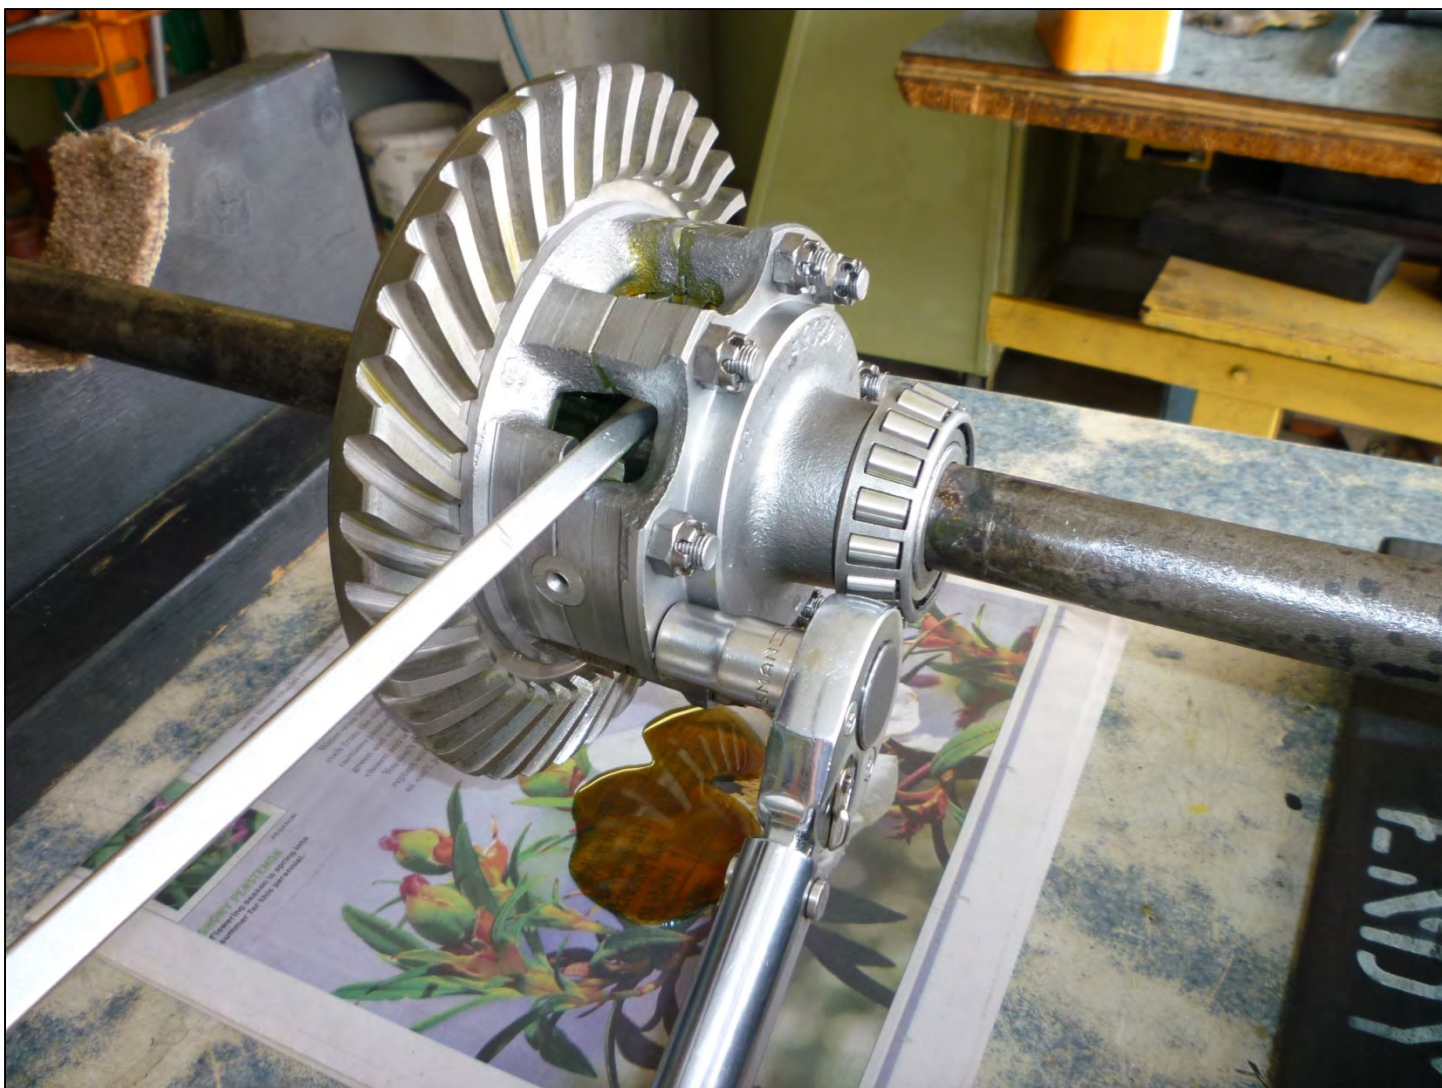
**A long screwdriver inserted into the openings of the carrier is used to hold the carrier from rotating while the nuts are torqued down.**

**After each nut is torqued note where the safety wire hole is located in each castle nut. If the hole is not in a window, tighten the nut more to bring it into a window.**

**Before applying the safety wire grasp each axle up close to the bearings and rotate the axles by hand in opposite directions. There should be no binding.**

**Some reproduction axle shafts are not made correctly and will bind the inside of the carrier. These should not be used.**

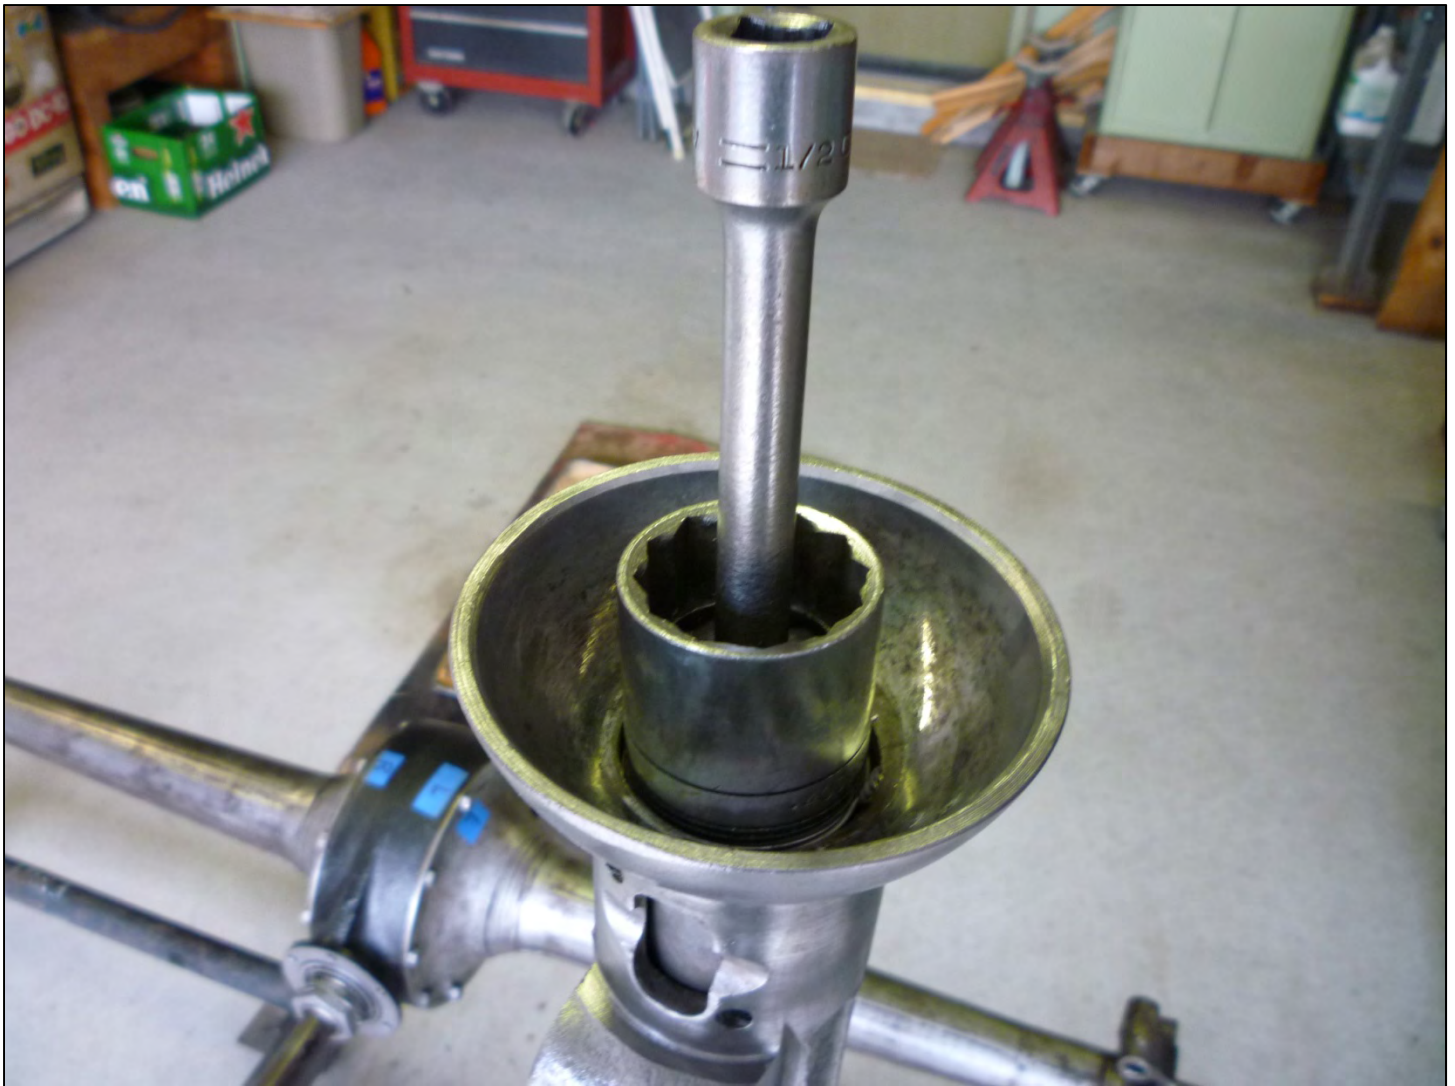
**The sleeve is driven into place with the flat side of a large socket (this one is a 36mm). As the sleeve is driven into place the wire wrap previously installed will exit the top of the sleeve and is removed.**

**It is important that the sleeve is properly seated or it will not be possible to install the roller bearing once the torque tube is installed. Examine the sleeve installation carefully. The sleeve should have expanded and be tight around the 360 degree circumference. If it is not, it is not fully seated. If it is only slightly hanging up at the dimple take a punch and insert it through the opening for the speedometer drive and place it in the dimple and give a sharp smack with a hammer.**

**If this does not properly seat it, it will have to be removed by driving the grease seal and the sleeve out together. The process will have to be started over again.**
