Zenith Carburetor Tip

by Tom Endy

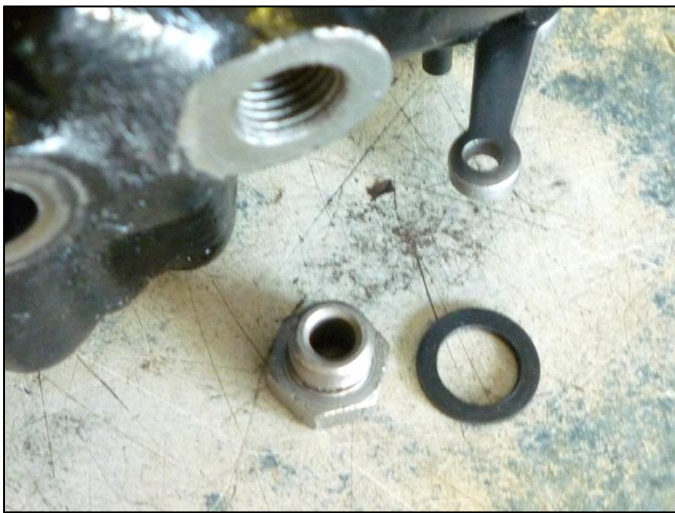
Quite often the drain boss threads on the bottom casting of a Zenith are found to be striped. This is caused by people over-tightening the drain plug. There is a reason why people do this. When the float valve does not hold sufficiently, the fuel level in the reservoir rises. At the same time the fuel level rises in the main jet and cap jet until it spills over the top. It then runs into the throat of the carburetor and out through the small drain hole in the bottom of the throat. From there it runs back to the hex plug on the drain boss and drips off of it leading people to believe there is a fuel leak at the drain boss; hence over-tightening.

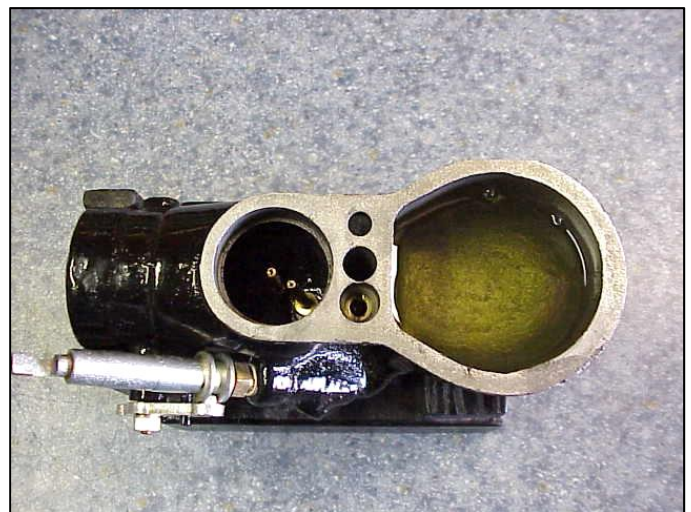
The fuel level in the main and cap jets is always at the same level as the fuel in the reservoir. If the float valve allows the fuel in the reservoir to climb it will also climb in the two jets until it spills over the top.
