Rear Axle Assembly Rebuild Pictorial 2015

by Tom Endy

The following series of photos were taken during the rebuild of a Model A rear axle assembly.

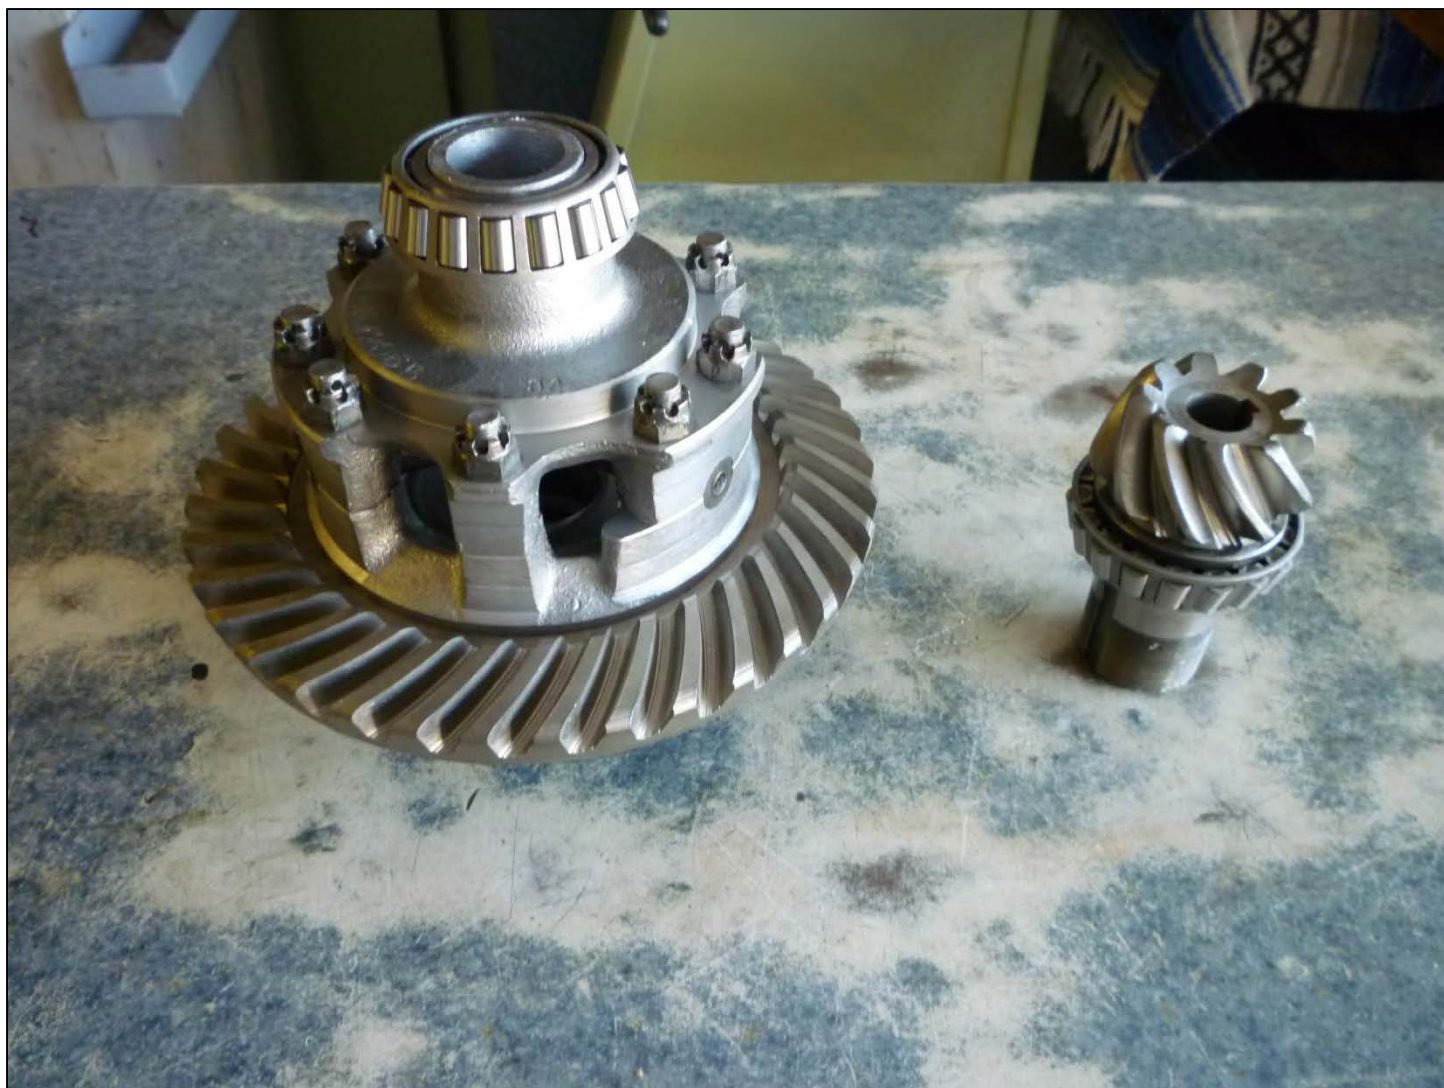
The carrier has been cleaned and bead blasted and inspected for any signs of wear. A 411 ring and pinion gear set will be part of this rebuild. The two carrier halves along with the ring gear have been bolted together with a modified spider gear yoke inside to facilitate the pre-load adjustment of the carrier bearings. Two new bearings have been pressed onto the carrier. The two bearings must press on with an interference press fit. The pinion gear has a new rear bearing pressed on.

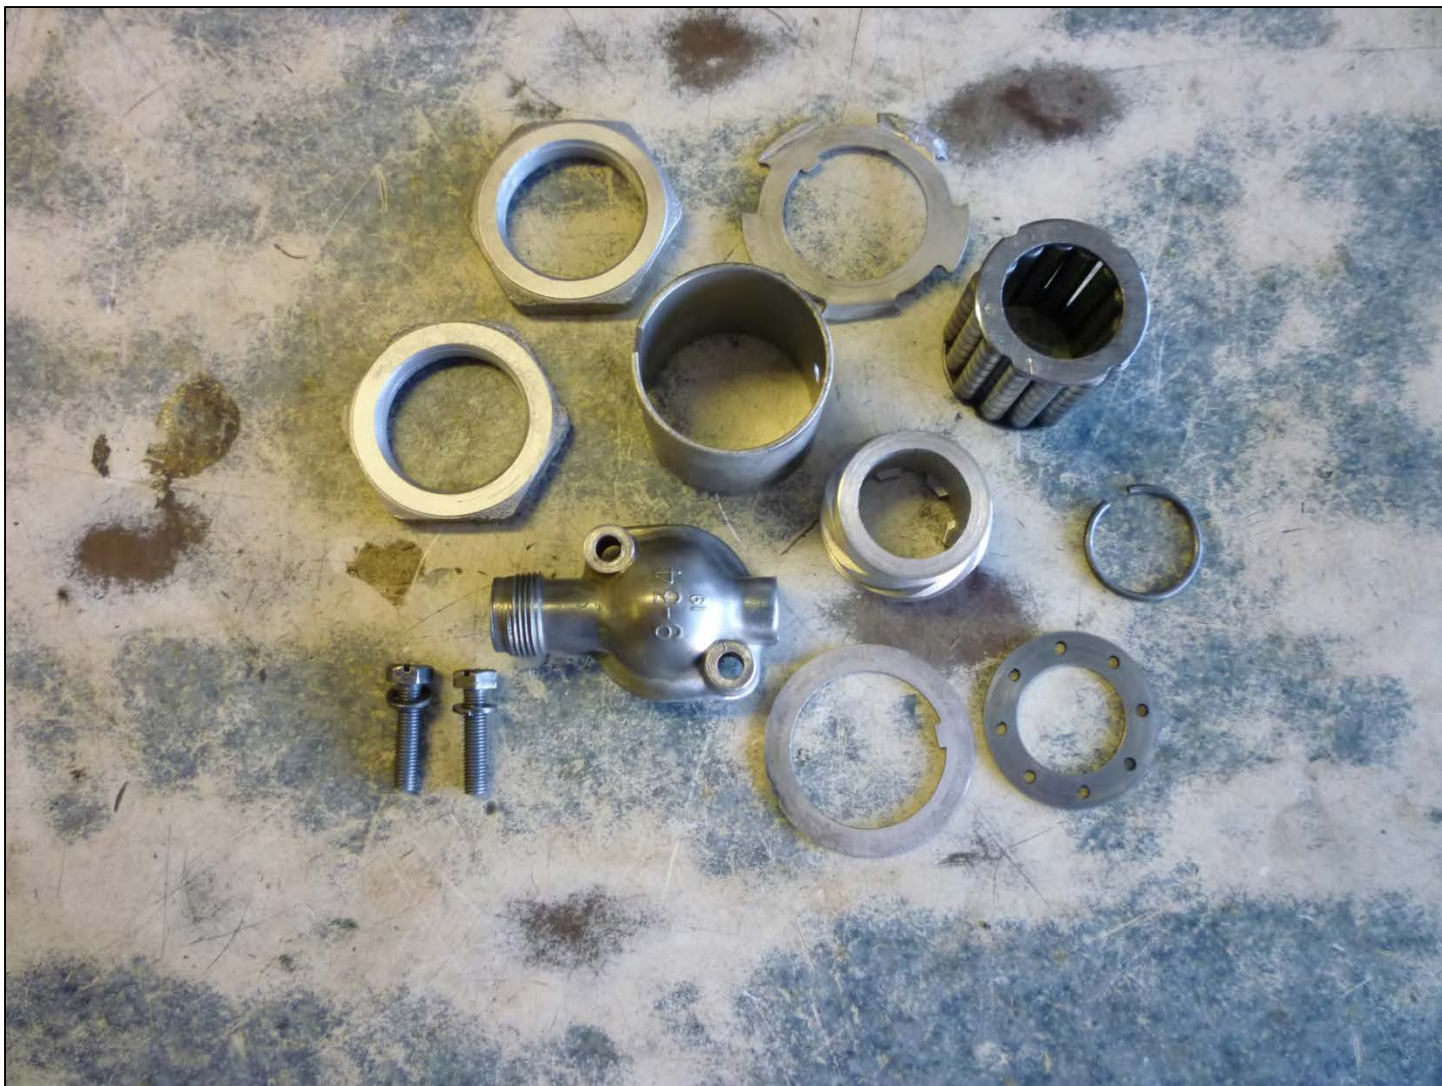
The miscellaneous hardware for the front of the torque tube has been cleaned and bead blasted along with the hardware for the pinion gear sleeve.

Note the flat thrust washer on the right with the holes around the circumference. This washer is positioned between the roller bearing and the speedo drive gear. The purpose is to allow grease pumped into the U-joint housing to reach the roller bearing.

A new grease seal will be installed in the neck of the torque tube just behind the roller bearing and race sleeve to prevent grease from migrating down the drive shaft.

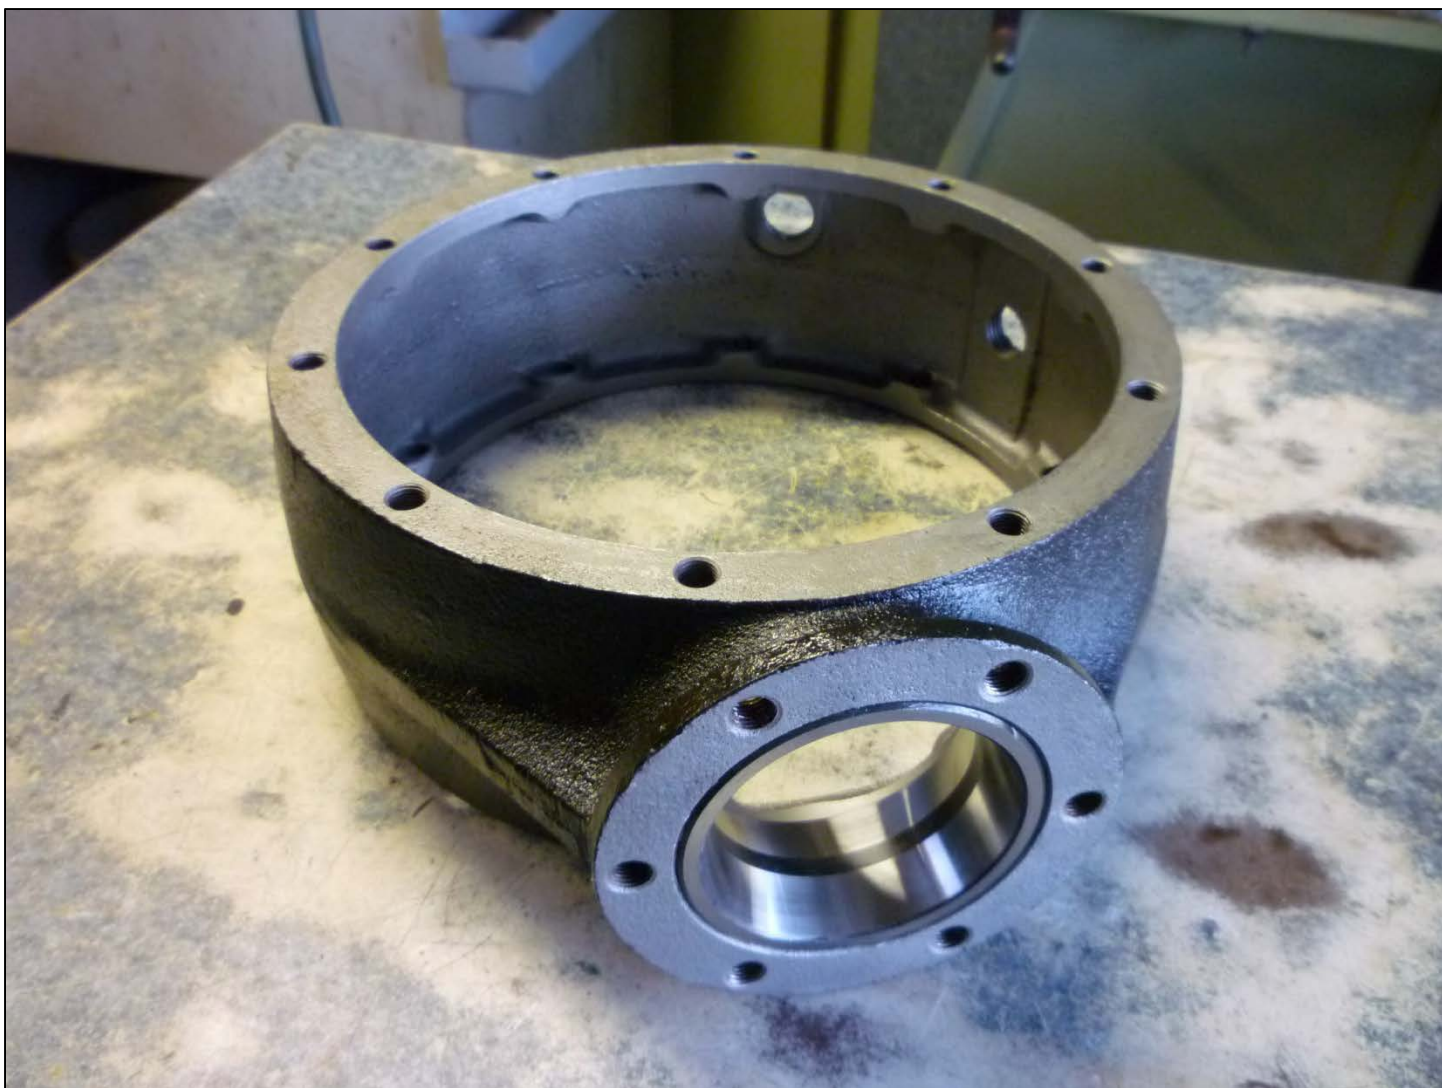
The banjo has been cleaned, bead blasted, inspected, and painted. All the thread holes have been inspected and cleaned with a small wire brush mounted in a drill motor. A new double bearing race has been pressed into place.

Care should be taken when installing this race. Do not set the back side of the banjo on a press platform as it will likely distort the shape of the banjo as the race is pressed in. Support the inside of the banjo where the race stop is by hanging it over a rail on the press platform and placing the old removed race under for support.

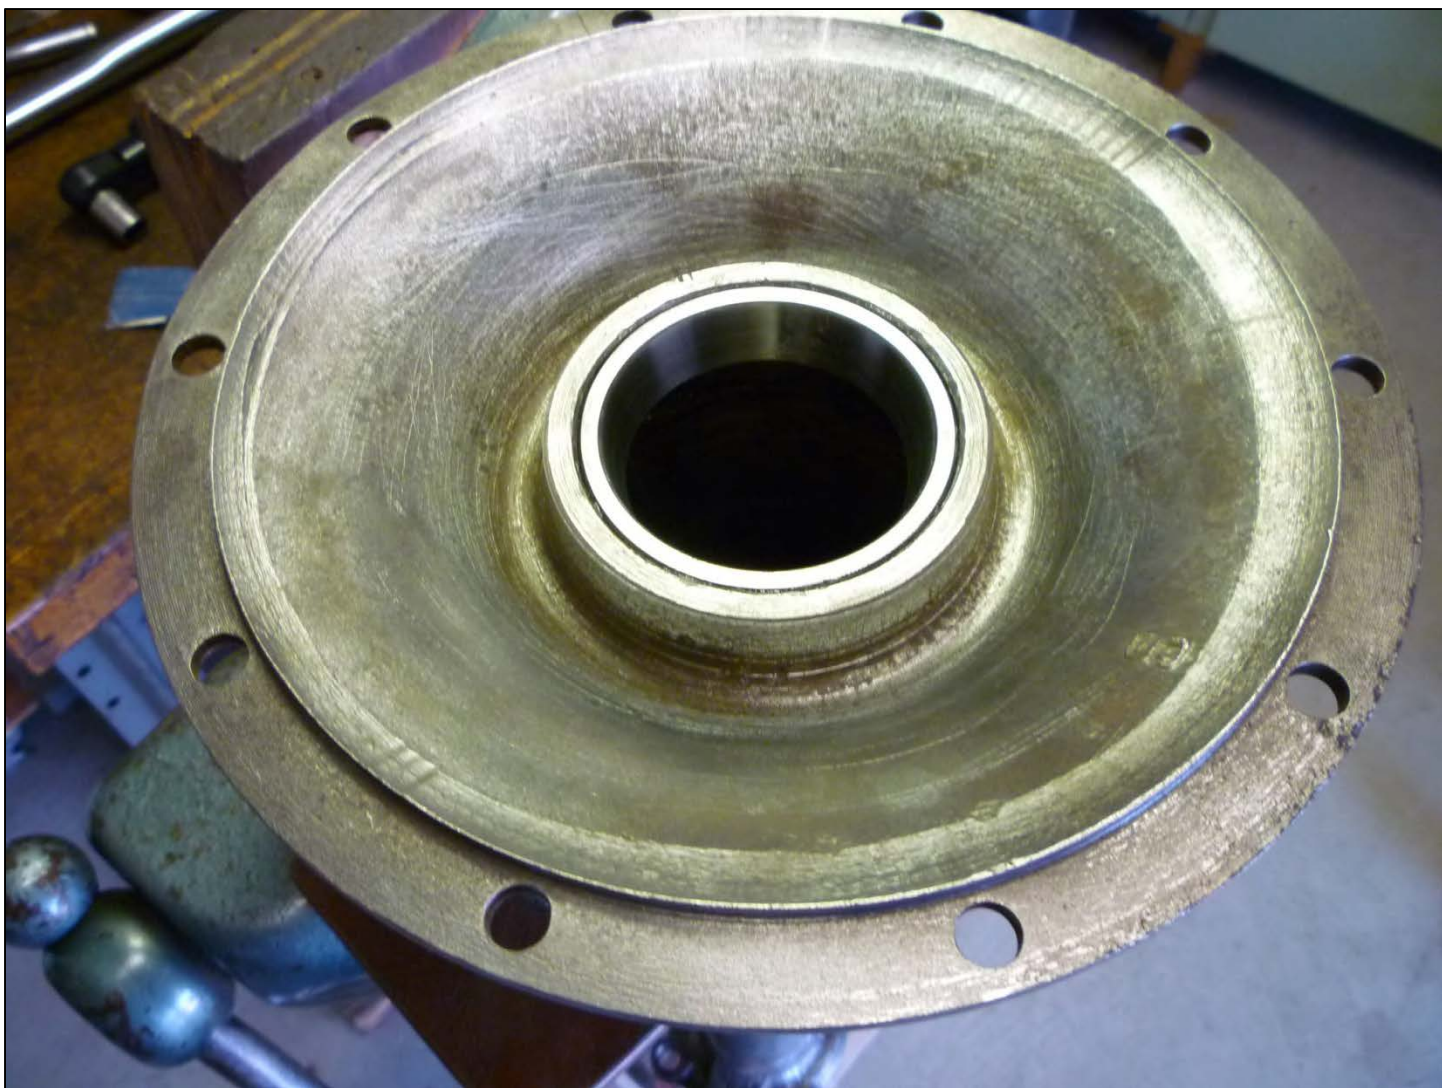
A new bearing race has been pressed into place. It is important that the race is seated properly. A small mirror should be used to determine that the race is firmly seated against the stop all the way around. The new race may be installed using a shop press or a K. R. Wilson tool.

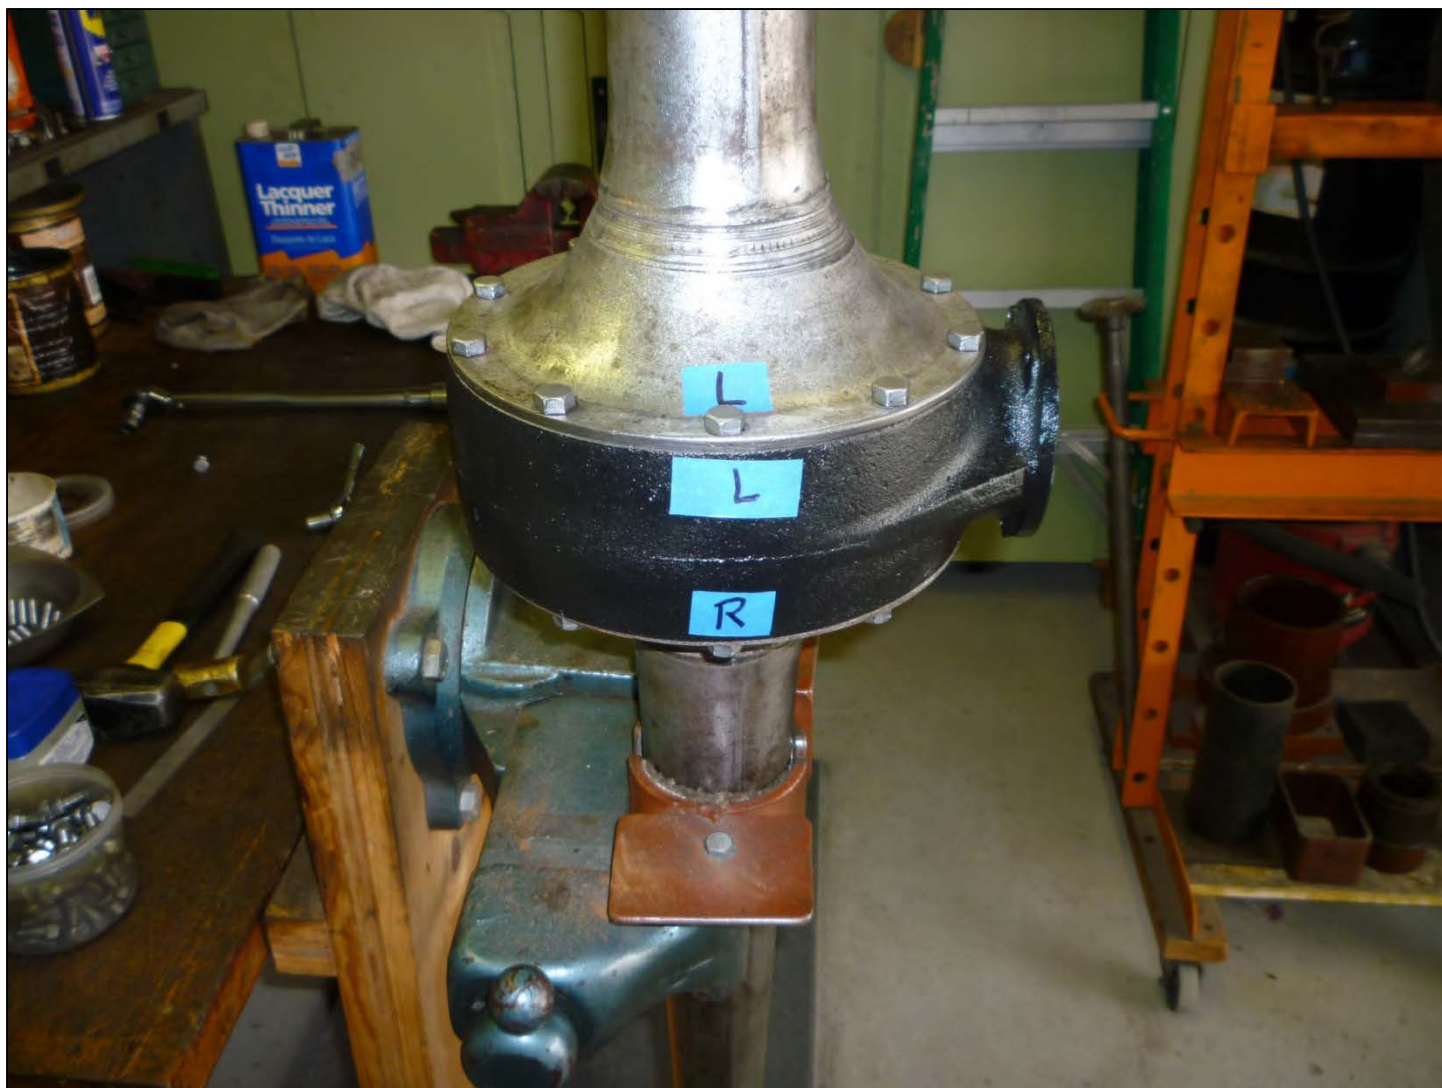
The left axle housing is installed and the ten banjo bolts were pulled down snug while turning the ring gear by finger until the ring gear locked up. On this particular rebuild the ring gear did lock up when all the bolts were torqued down.

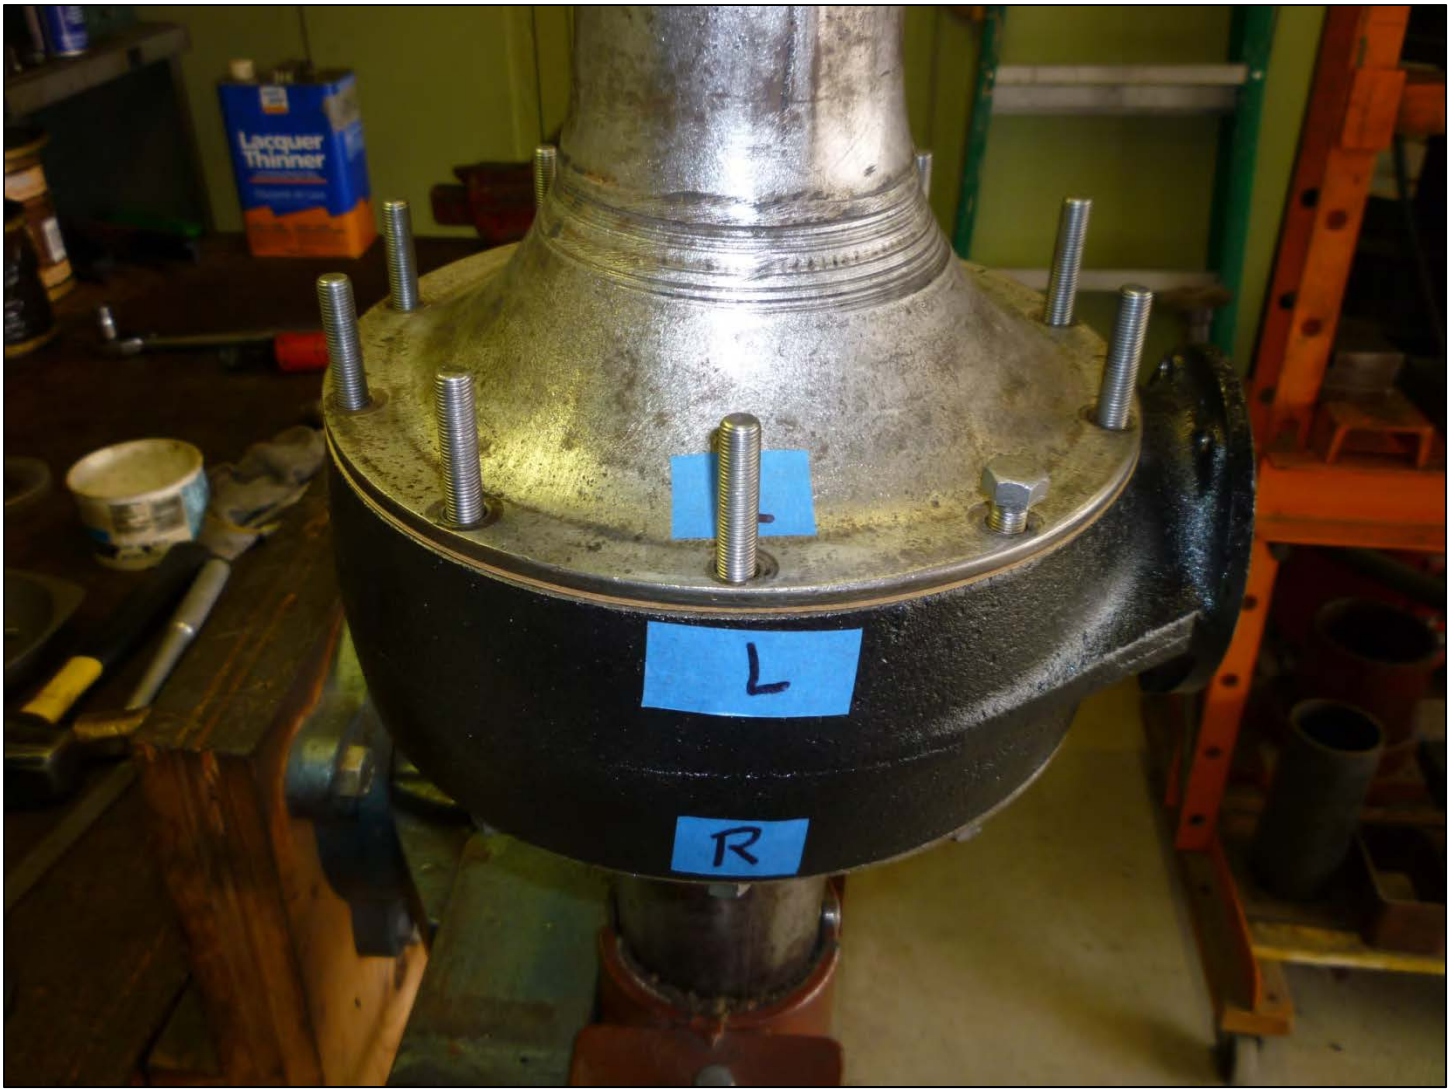
The left axle housing is re-installed and the threaded studs are replaced with banjo bolts one at a time. When the ten bolts were installed and torqued down the ring gear could be freely turned through the pinion assembly opening. This is an indication that a pre-load adjustment cannot be achieved. The left axle housing had to once again be removed and both bearings on the carrier had to be removed and shims installed under each.

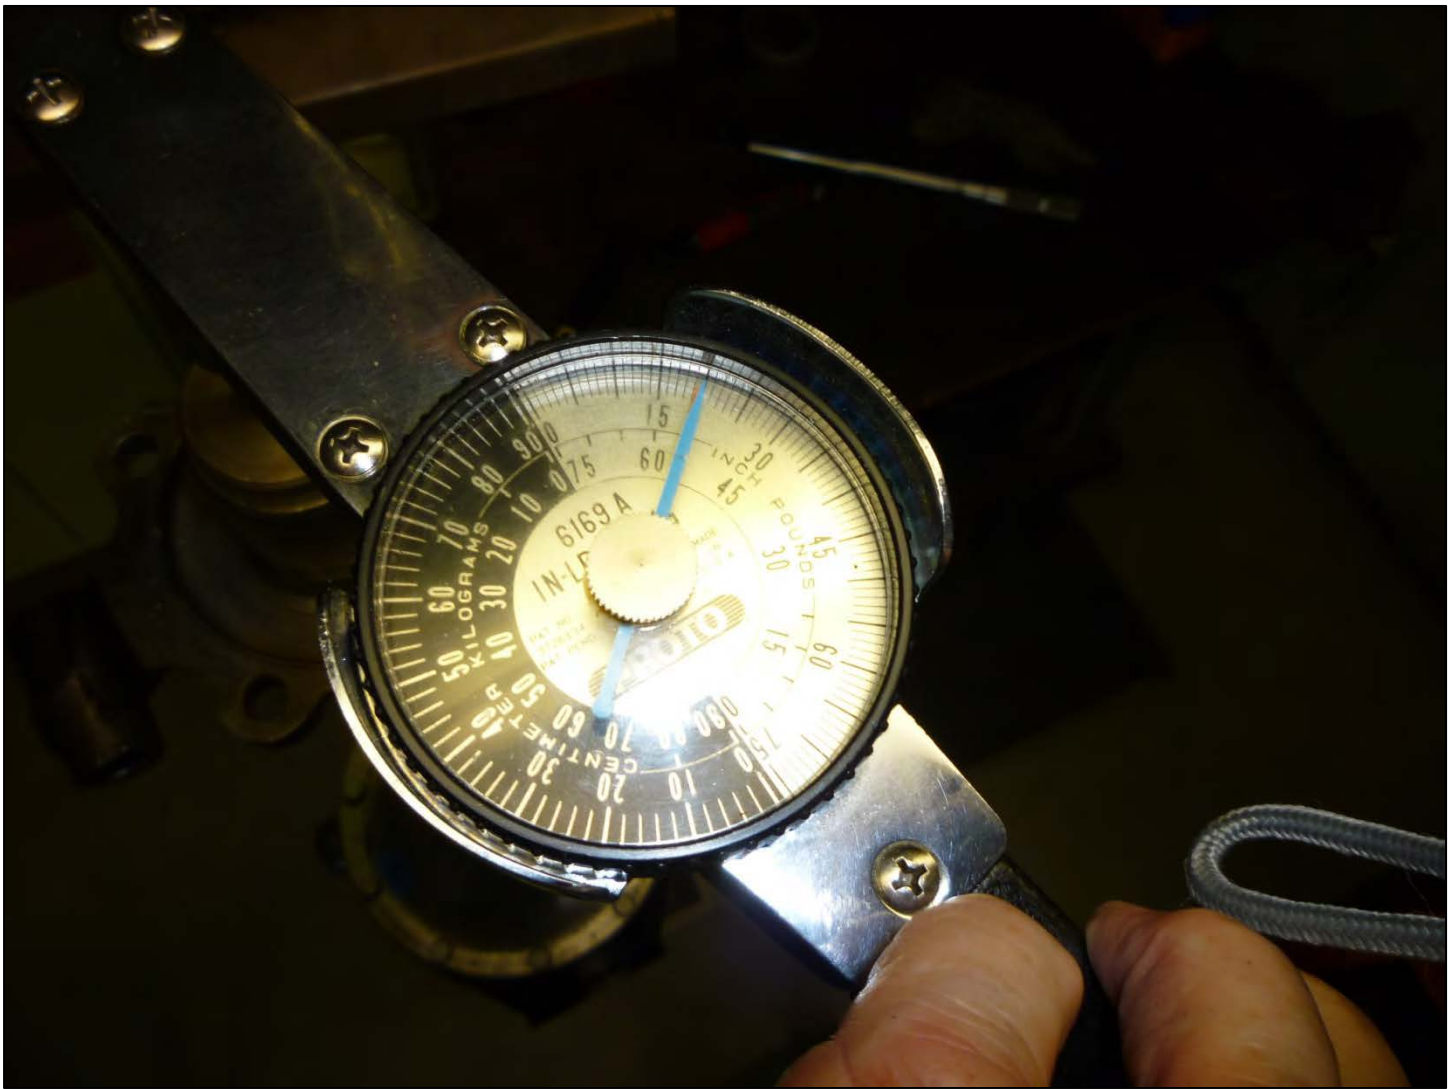
The reading was almost dead on 20 in. lbs. The reading should be taken as the wrench is slowly rotated. When the rotation is first initiated the bearings have to overcome inertia so the reading will be initially high. As the wrench is slowly rotated the reading will drop and settle and indicate the true pre-load. There will be some amount of slight fluxuation. A reading from 16 to 22 in lbs. is acceptable.

With an acceptable pre-load established the assembly is disassemble. Both axle housings are removed from the banjo and the carrier is set aside. The three banjo gaskets are also set aside. These gaskets will eventually be installed to both sides of the banjo during final assemble. The back lash on the ring and pinion gears will be determined by the number of gaskets on either side of the banjo. In this case only the .006 banjo gasket can me moved in order to maintain an oil seal. If the back lash cannot be established with the movement of this single gasket, the two shims under the carrier bearings may have to be moved to either side.

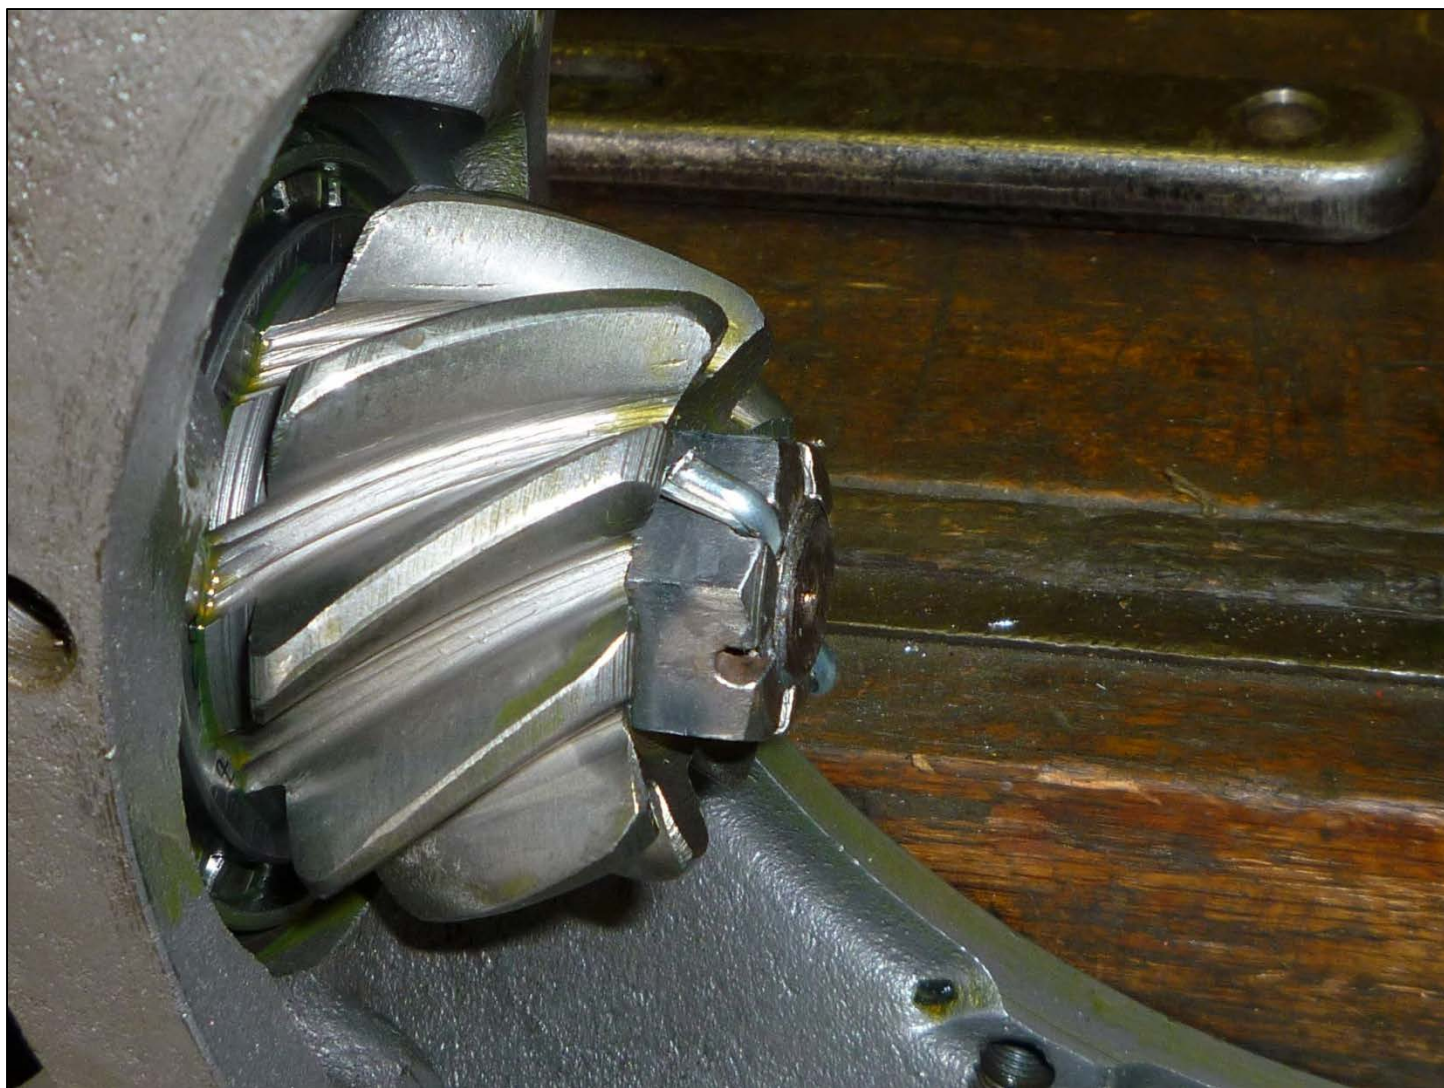
The nut on the end of the drive shaft is torqued to a nominal 100 ft. lbs. My procedure is to set the torque wrench to 90 ft. lbs., tighten and then look to see where the cotter pin hole is. I then tighten more until the hole is in a window of the castle nut. The end torque value will be between 90 and 120 ft. lbs.

Quite often the cotter pin cannot be inserted through the hole in the drive shaft because a mechanic of yester year hammered on the end of the dive shaft in an attempt to remove it and made the hole oblong. When encountering this situation I carefully run a drill bit of the proper size through the hole.

The cotter pin is installed as shown with the two cotter legs bent down alongside the nut. Do not bend it over the end of the drive shaft as it may contact the rotating carrier. Care should be taken when installing a cotter pin so that it has a low profile and does not interfere with the gears.

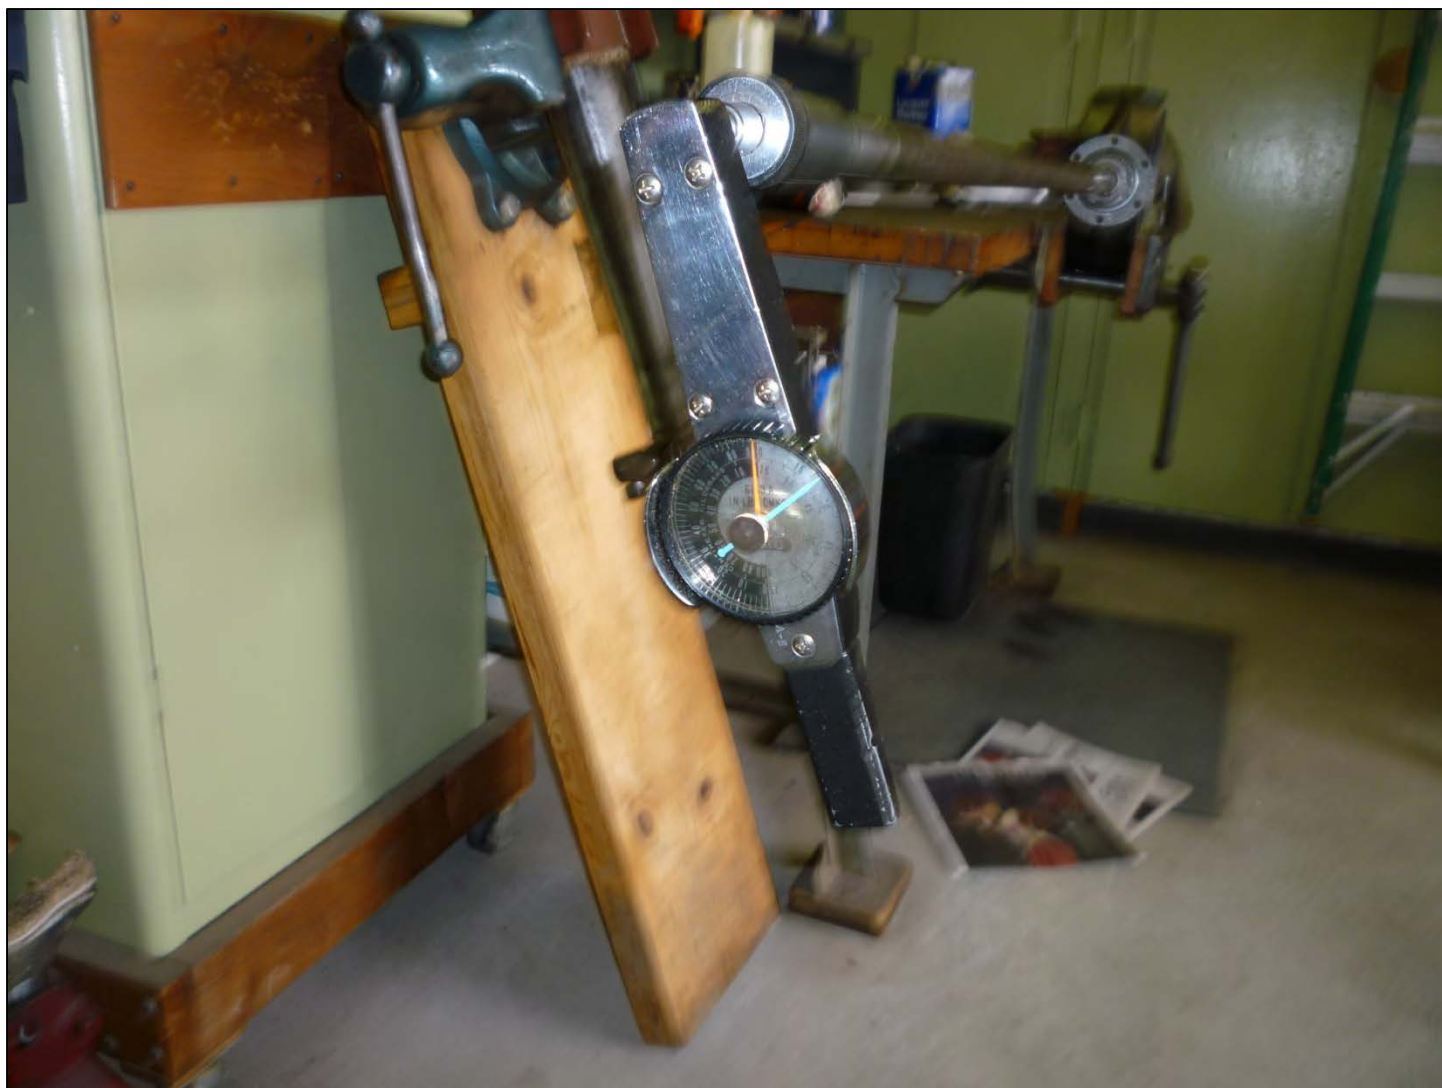
The pinion pre-load is read from a dial indicator inch pound torque wrench. A one and a sixteenth inch six point deep socket will fit directly onto the spline end of a Model A drive shaft. The photo shows the socket in place and being turned with the dial indicator torque wrench.

When making the pinion pre-load adjustment it is often necessary to loosen the two nuts and start over again. For this reason the back, or second pinion bearing, must have the ability to be repositioned with little effort. If it is on with a press fit it makes the task difficult if not impossible. This is the reason original pinion gear sleeves have two dimensions on the sleeve with a difference of .0015. Not all reproduction pinion gear sleeves are machined correctly. Some have the sleeve machined to one dimension (a press fit for both). These will definitely cause you grief.

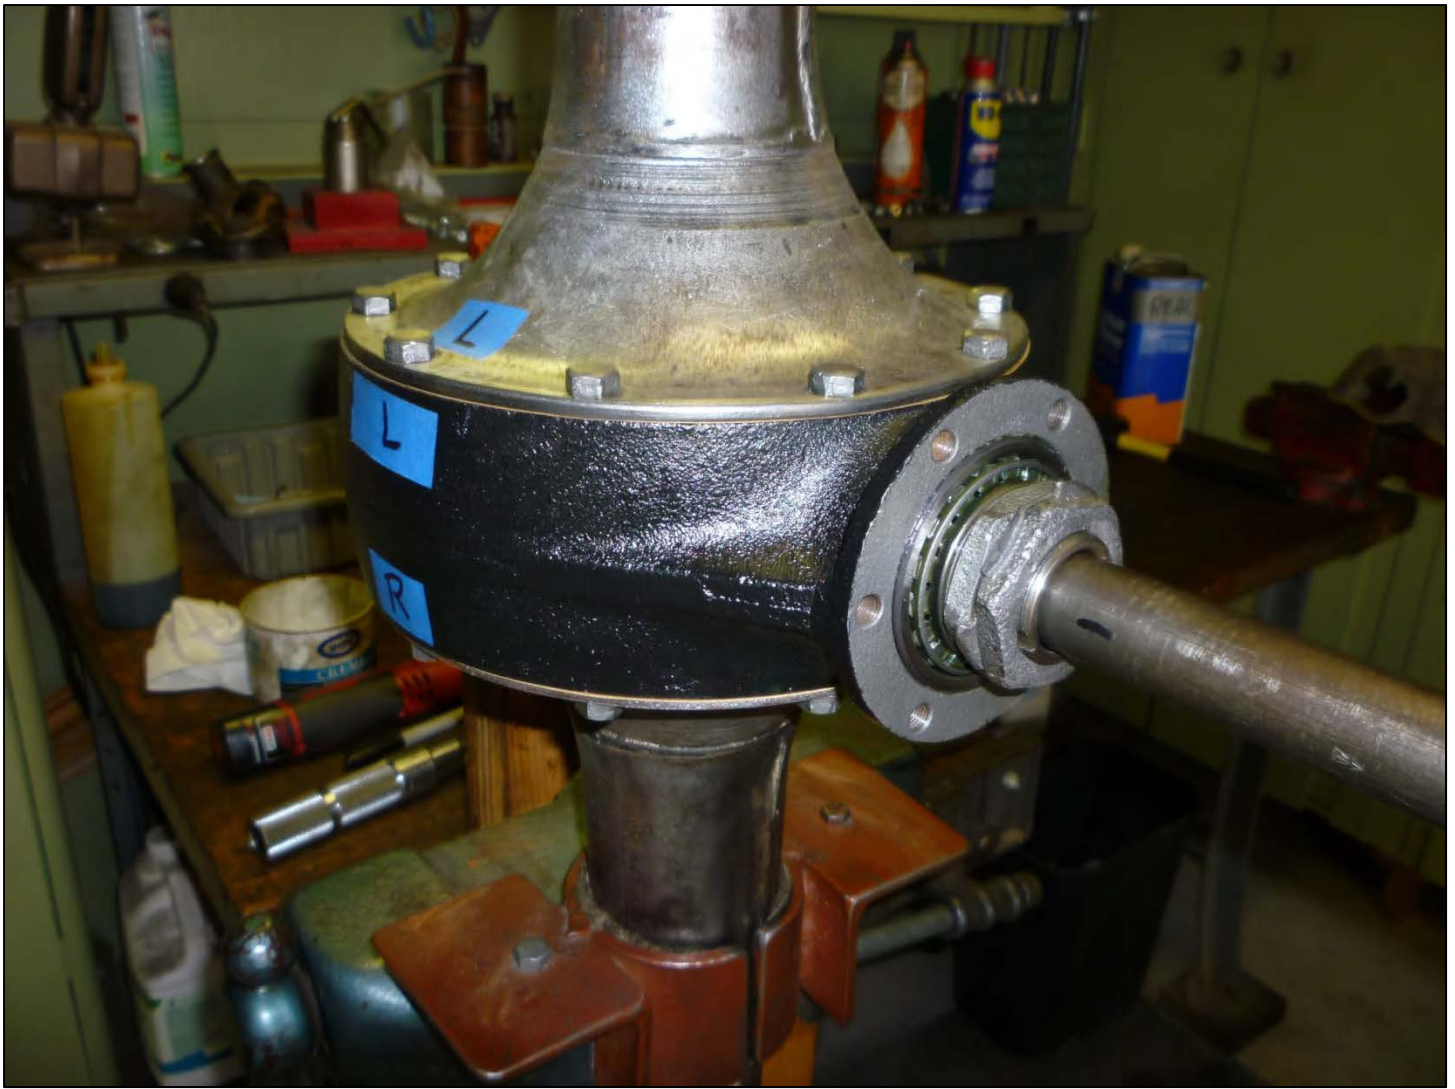
With the quantity of the selected gaskets installed on both sides of the banjo for a trial and error effort, and all 20 banjo bolts torqued down to 35 ft. lbs., the backlash can be detected. Grasp the drive shaft by hand and very slowly rotate it in both directions to feel the distance where a pinion tooth contacts one side of a ring gear tooth and then the other side. It should be very small, only a few thousandths. It is important to have some amount of backlash, but not too much. How much is too much? I don't know, it depends on who is telling the story. I would think more than .010 may be too much.

In the case of this rebuild, if there was too little backlash, the .006 gasket would be moved from the right side of the banjo to the left side, which would increase the backlash. However, in this case the backlash was very little, only a few thousandths.

The next step is to rotate the drive shaft to accomplish the 360 degree rotation of the ring gear, stopping periodically to check and ensure the backlash is consistent throughout the rotation and there is not binding. If there is any binding it has to be investigated.

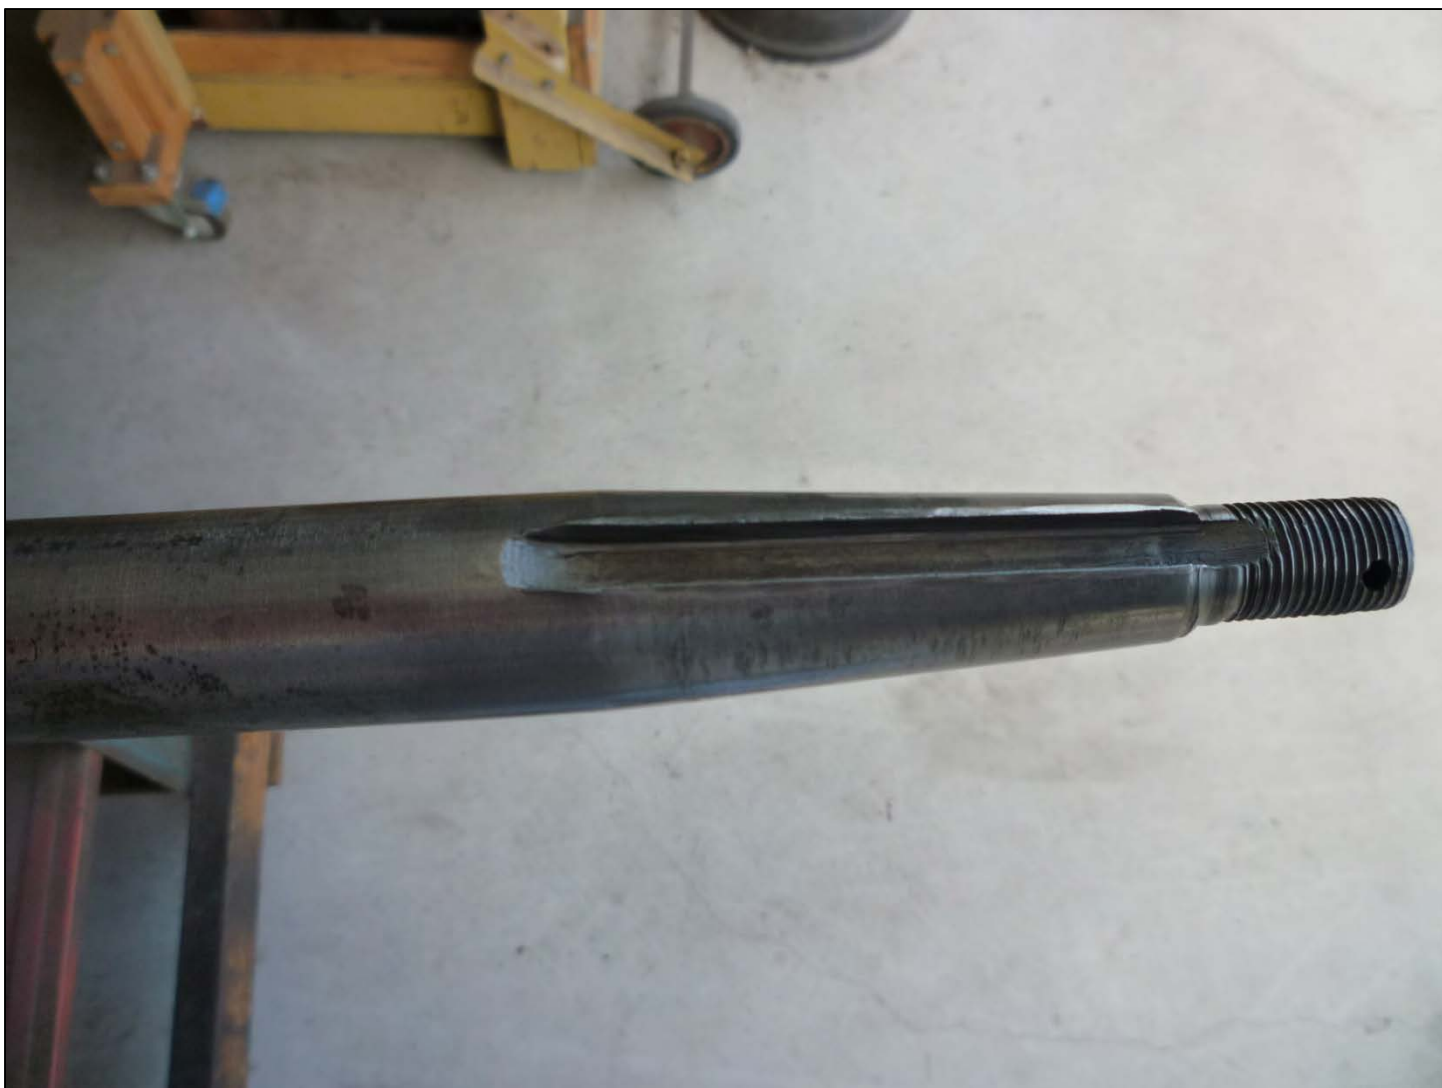
The key slot should be inspected for a crack at the inboard end. A crack will usually start in this area and eventually work its way around the circumference of the axle shaft, and then break off. The key slot should also be inspected for wallowing. This is caused when the axle nut was not torqued down to a nominal 100 ft. lbs. This allows movement of the brake drum against the locking key and in time will wallow out the slot. Some repair can be made by placing the axle on an anvil and with a heavy hammer pound the edges of the key slot back. An axle shaft with an excessively wallowed key slot should be discarded in favor of a better one.

Check the threads carefully. If they appear somewhat compromised a dye can be run over them. However, excessively damaged threads are cause for rejection of the axle shaft.

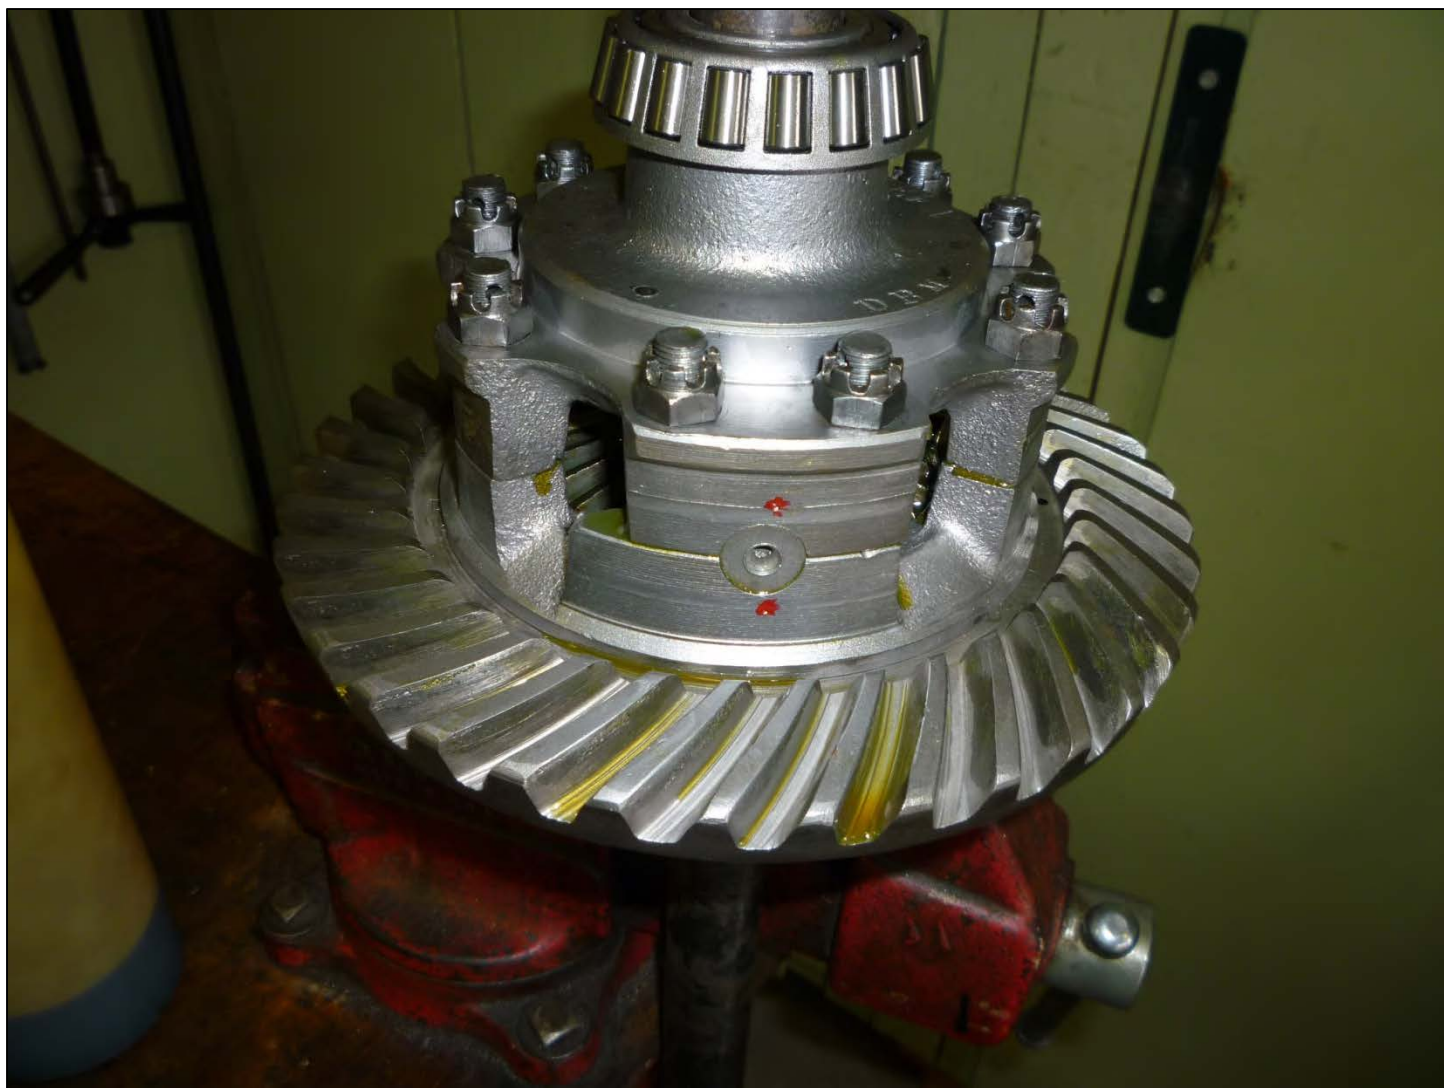
The right carrier half has been installed and the castle nuts installed and snugged down enough to hold the assembly together. Note the two carrier half assembly marks in red. These were placed there before disassembly. The back side of the three spider gears rides against the inside of the carrier and cause three wear patterns. It is best to line up the wear patterns as before. In some instances the wear patterns are severe and the carrier should be discarded in favor of a better one.

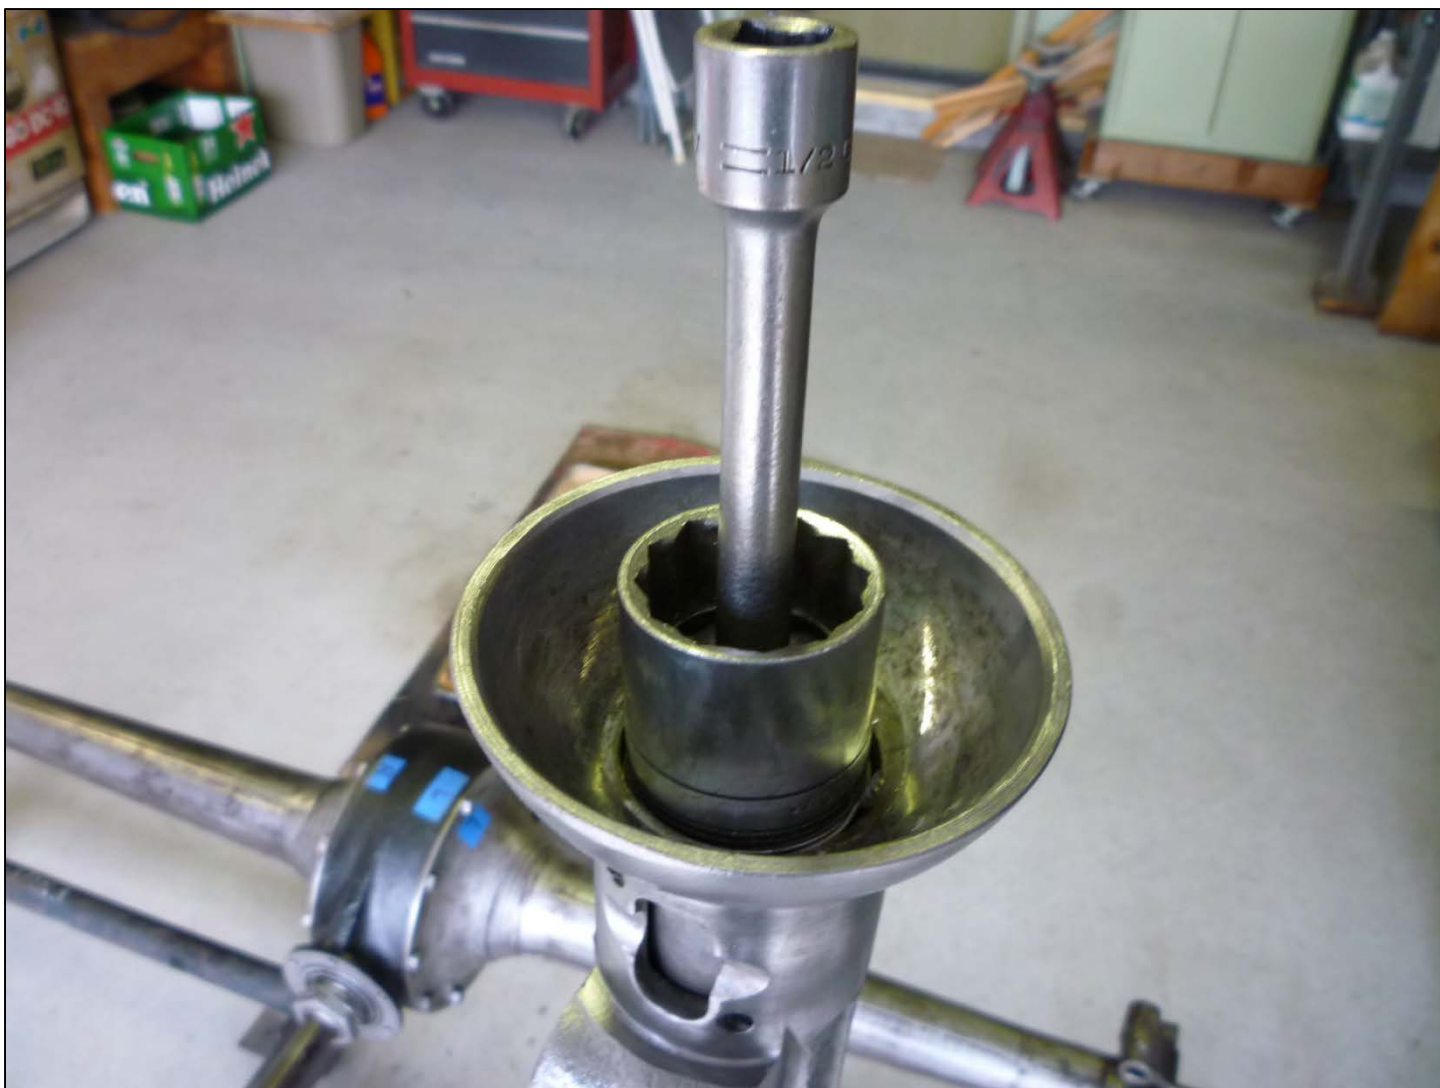
The sleeve is driven into place with the flat side of a large socket (this one is a 36mm). As the sleeve is driven into place the wire wrap previously installed will exit the top of the sleeve and is removed.

It is important that the sleeve is properly seated or it will not be possible to install the roller bearing once the torque tube is installed. Examine the sleeve installation carefully. The sleeve should have expanded and be tight around the 360 degree circumference. If it is not, it is not fully seated. If it is only slightly hanging up at the dimple take a punch and insert it through the opening for the speedometer drive and place it in the dimple and give a sharp smack with a hammer.

If this does not properly seat it, it will have to be removed by driving the grease seal and the sleeve out together. The process will have to be started over again.
