Differential failure 2018

by Tom Endy

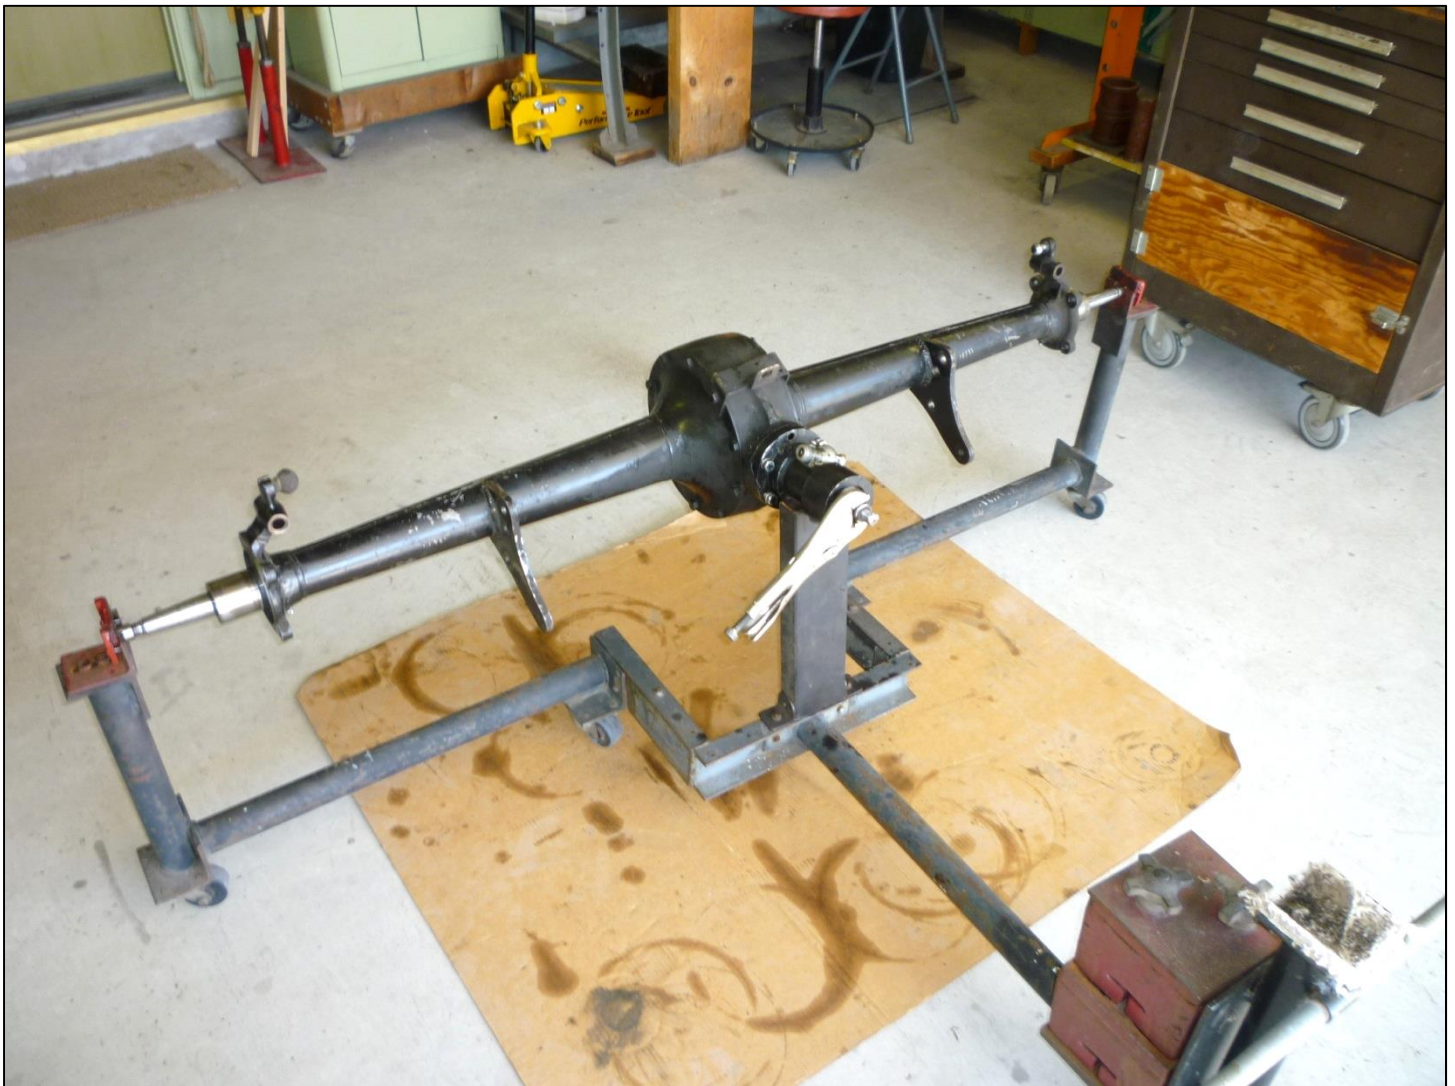
When the assembly was rotated with the vice grips both axles rotated in both directions giving an indication that all was well. Apparently there was enough friction at the axle shear to drive the left axle. Once the rear axle assembly was disassembled it was obvious that all was not well.

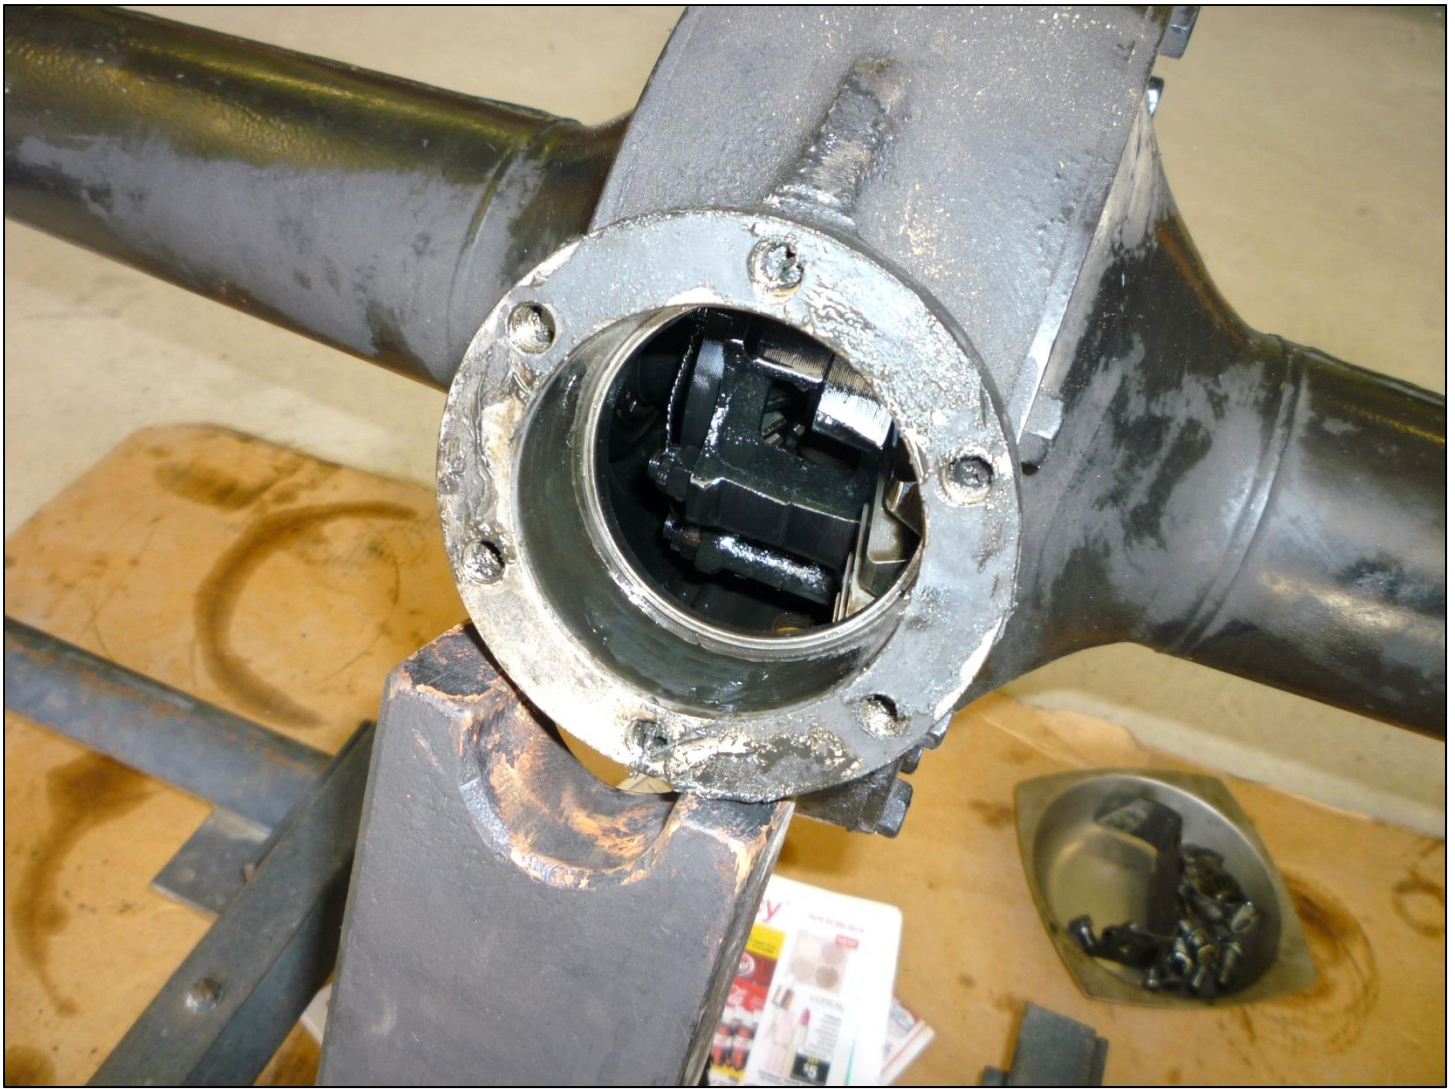
An additional failure mode was discovered: The double race that is part of the pinion gear assembly is supposed to mount inside the banjo flange opening with an interference press fit. This was not the case. The bearing assembly had spun the race in the banjo, machining metal away such that the assembly could easily be pulled out by hand. The race had about .005 slop in its fit. The banjo had to be replaced.

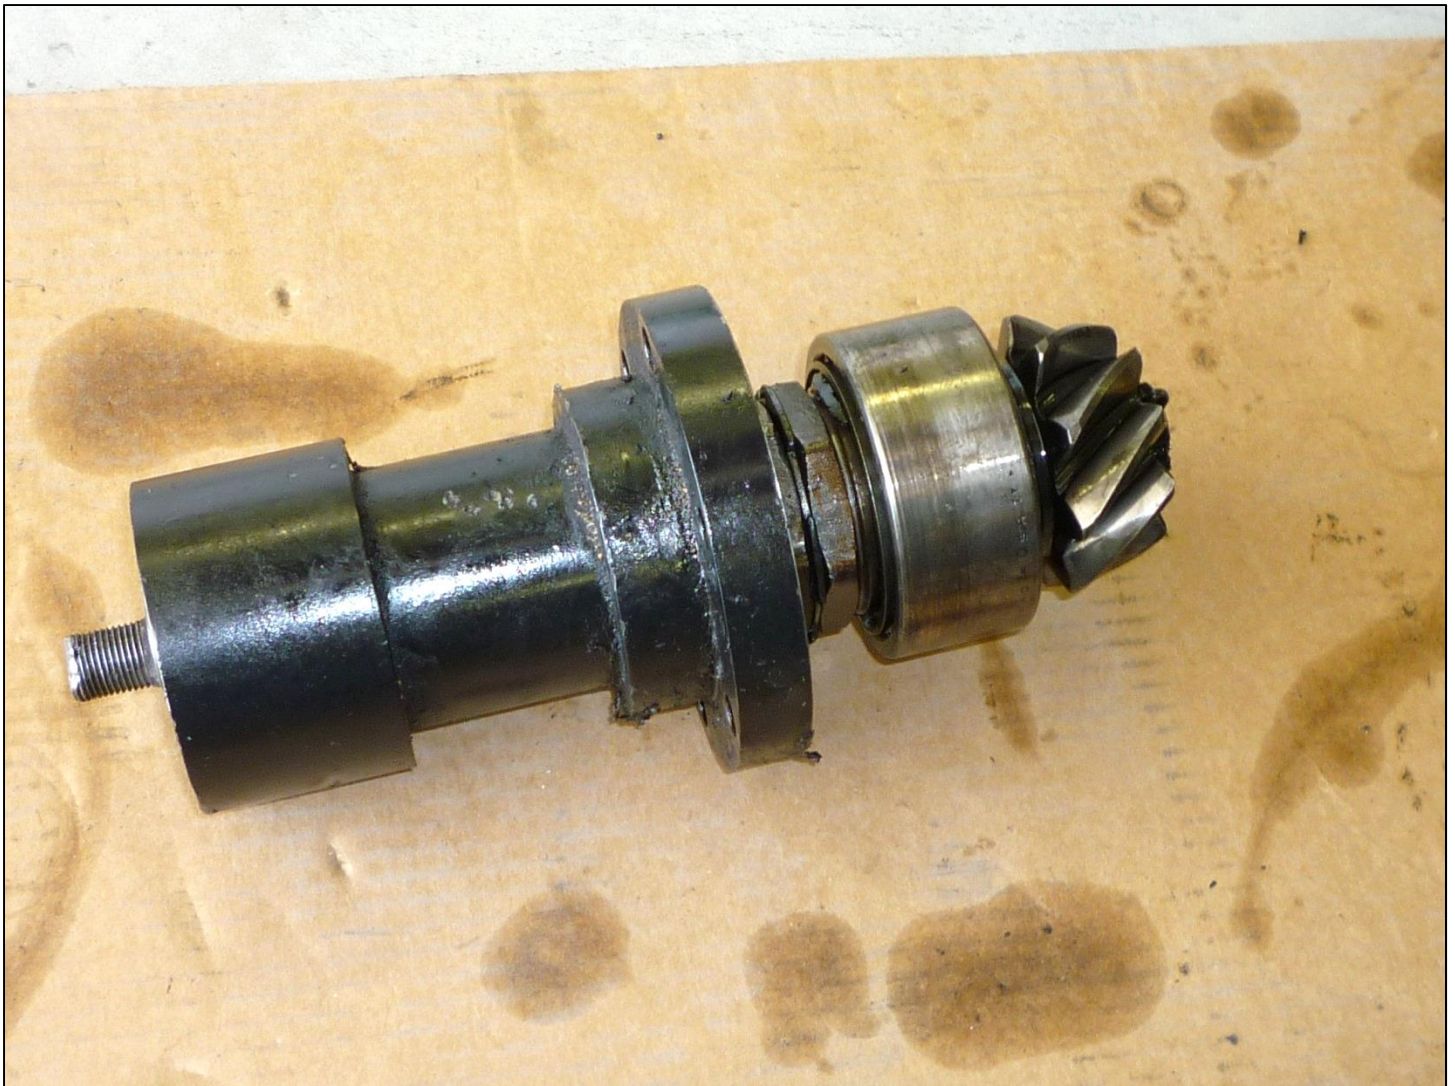
Another look at what suffices as a torque tube and drive shaft with the pinion assembly attached. This assembly was easily pulled out of the banjo. It should not have been the case. The bearing race is supposed to press into the banjo with an interference press fit. The race had apparently spun in its mount at some point.

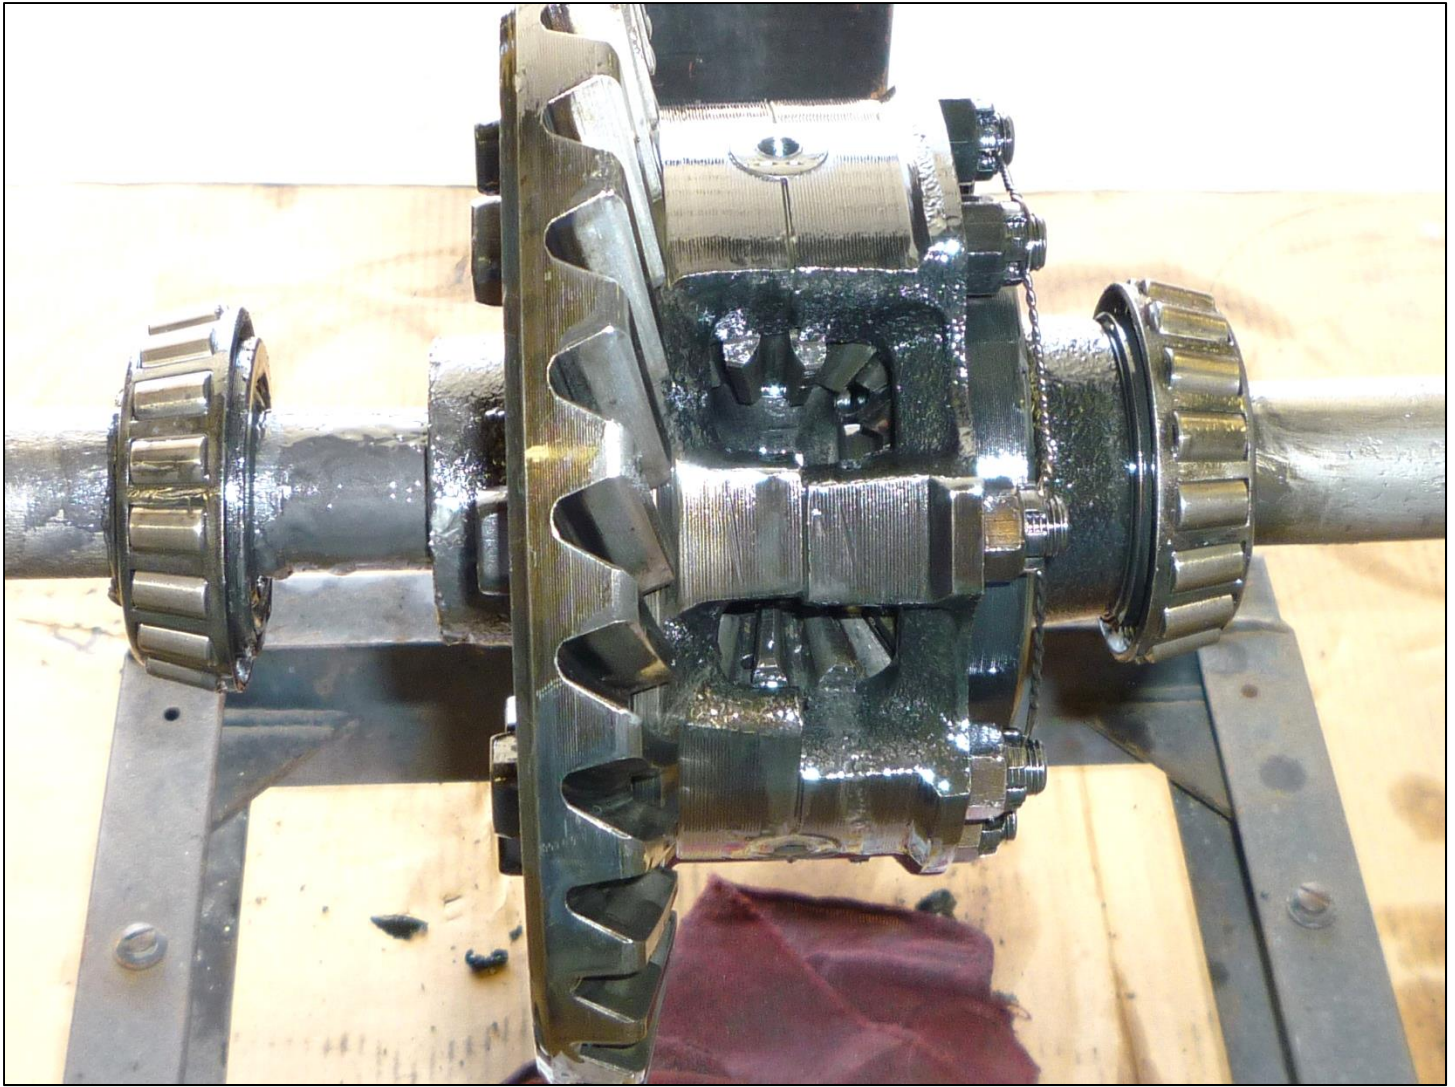
The first failure: The left carrier hub has sheared from the carrier. The bearing is still pressed onto the sheared section of the carrier. This failure is not a show stopper; a car can continue to operate in this condition. However it will generate an extreme amount of heat that will affect the left axle. This first failure of the carrier could have occurred months or years before the axle sheared,

The damage caused by both failures will require the replacement of the carrier, the left axle shaft, and the banjo. All the bearings, races, seals, and gaskets will also be replaced. Both axle housing will require a thorough cleaning as they were both full of metal particles.

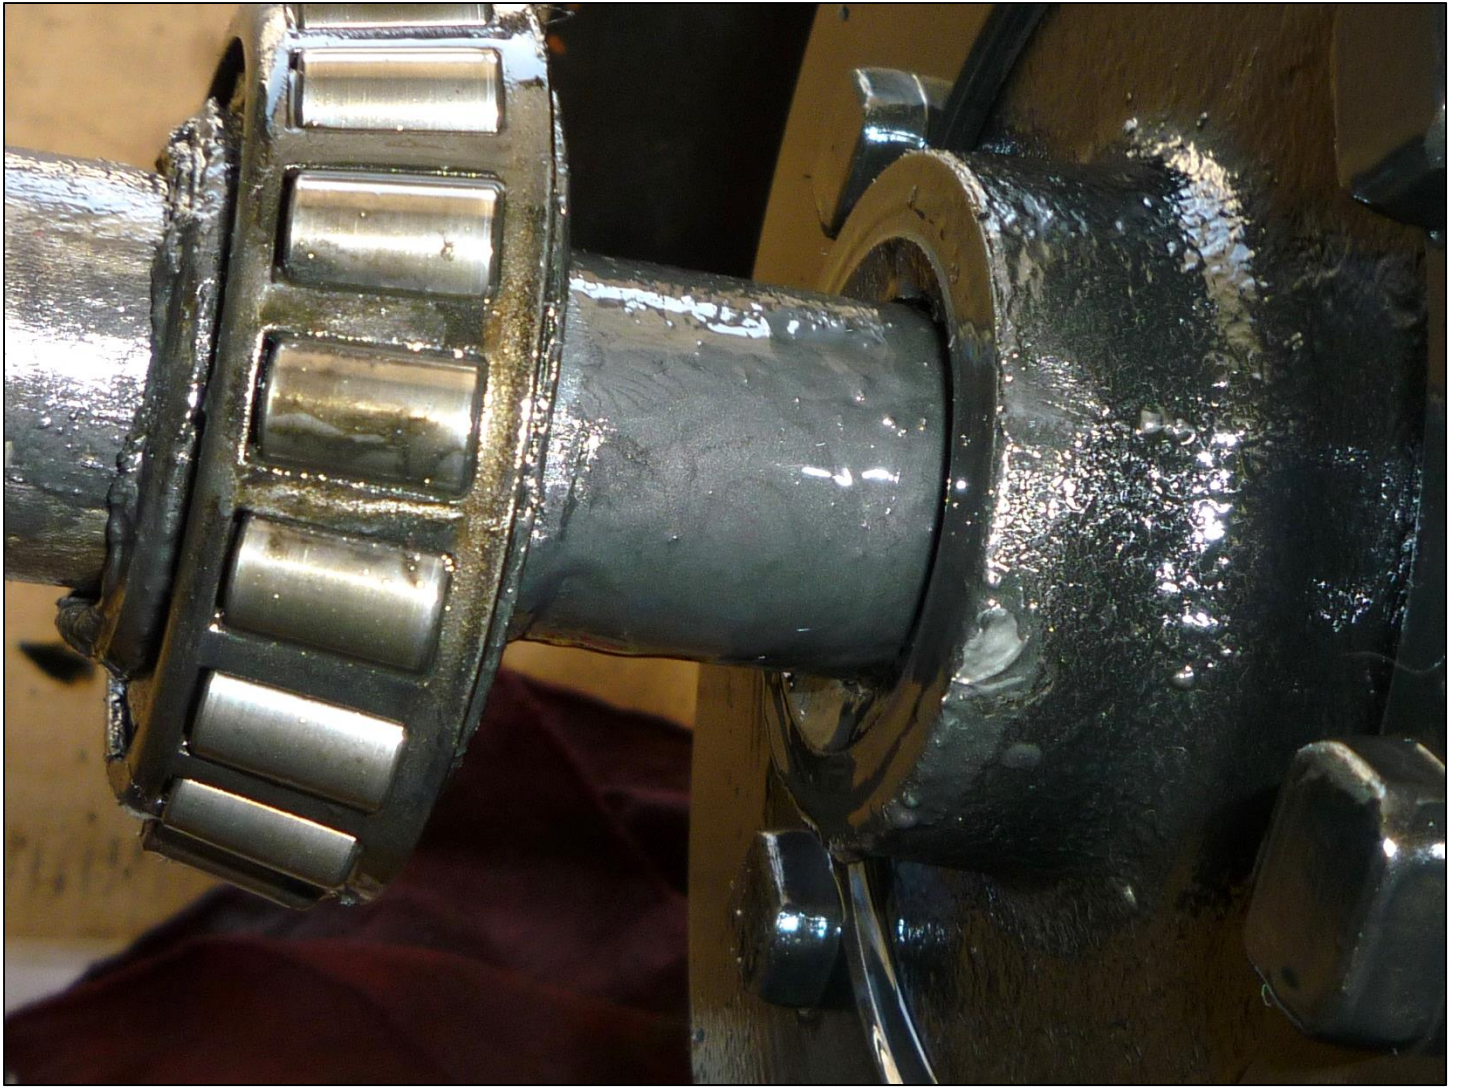
A close up look at the sheared area of the left carrier half:

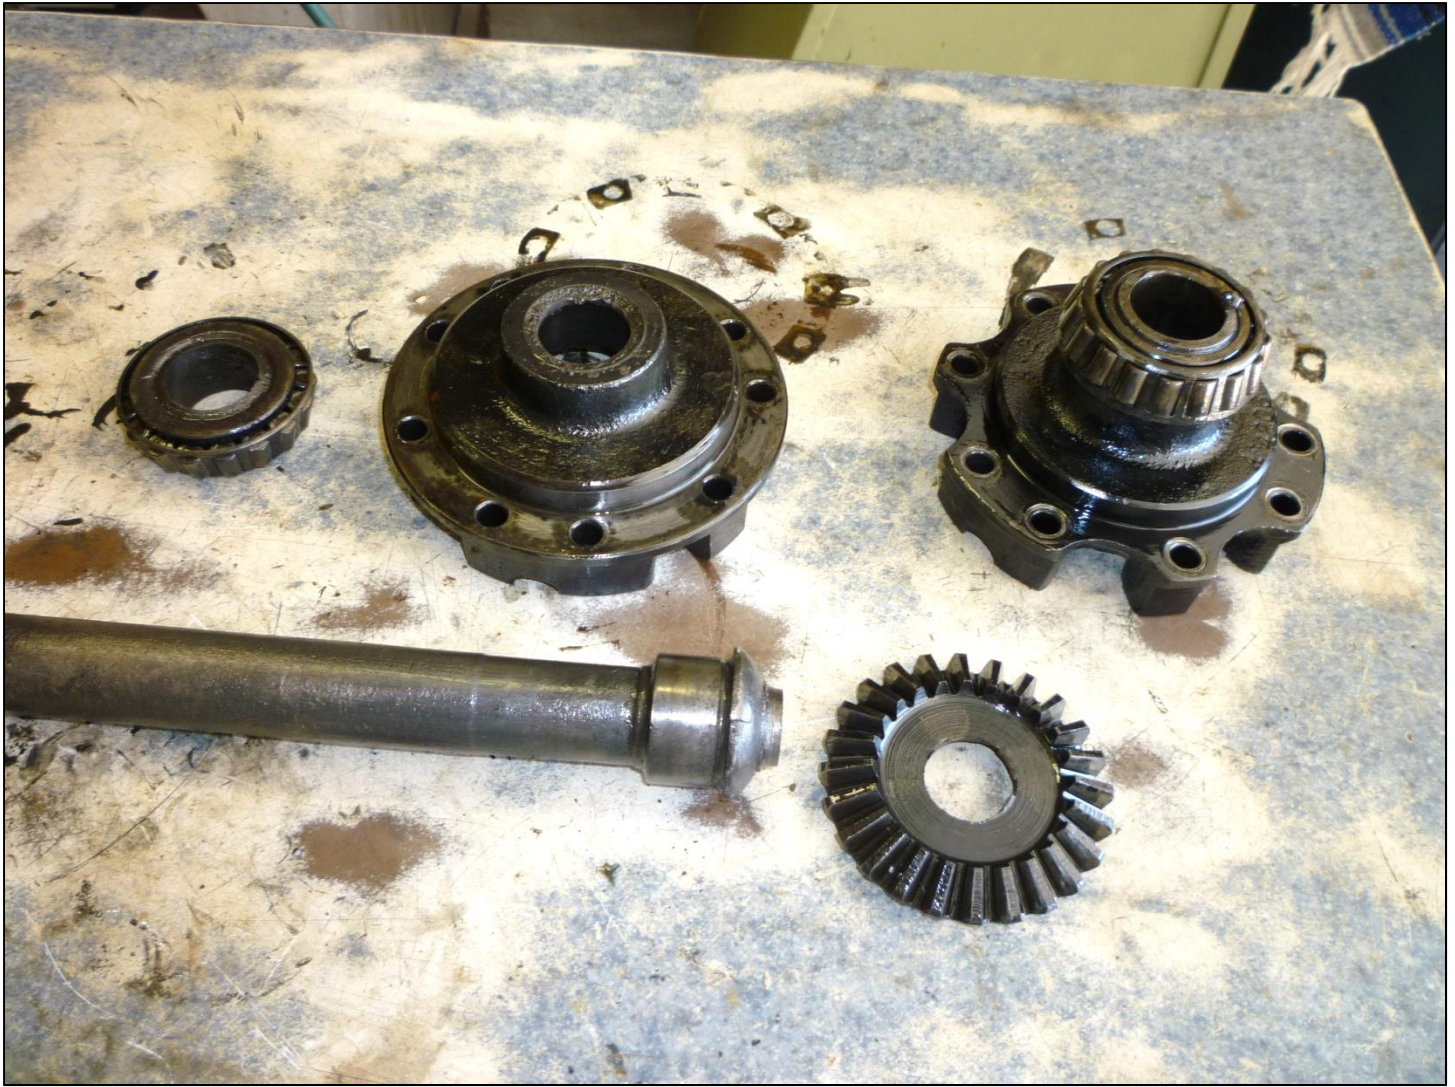
The second failure was the gear end of the left axle sheared off the shaft. That was the show stopper; the car would no longer run with a sheared axle. Shown above the sheared axle shaft are both sides of the carrier. The left side sheared, the right side remained intact. The left side is where the ring gear mounts.

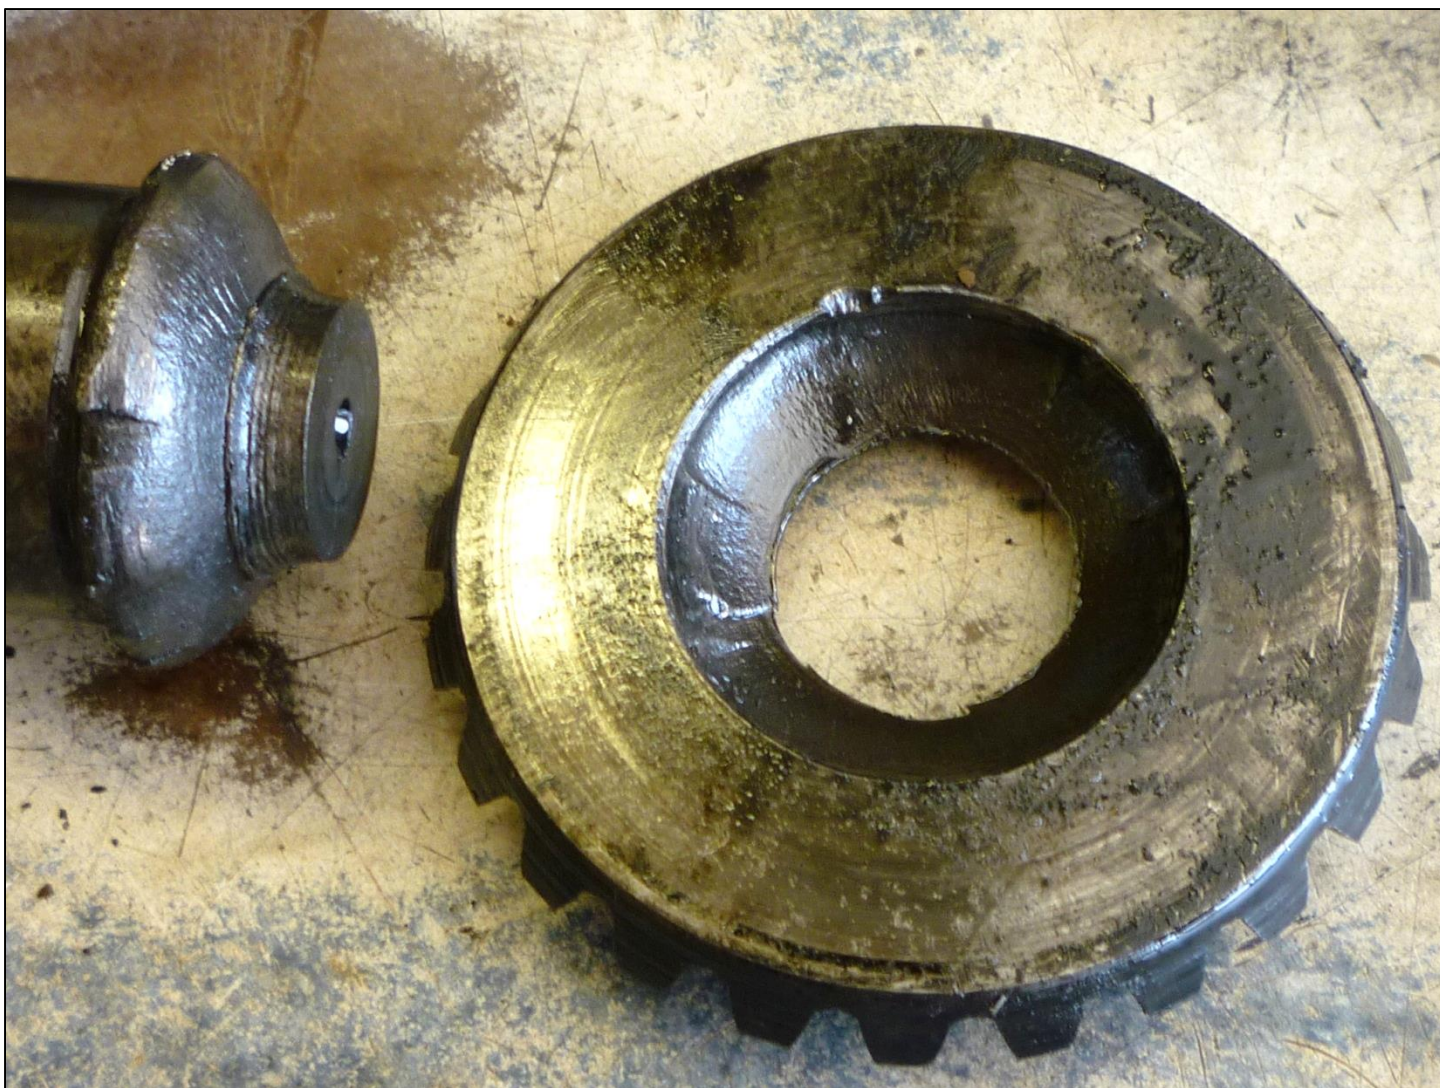
A close up look at the sheared left axle shaft: This is an original axle with the gear and the shaft being one piece. Reproduction axle shafts have the gear end welded to the shaft and there have been failures with the weld separating. This is not the case with this failure.

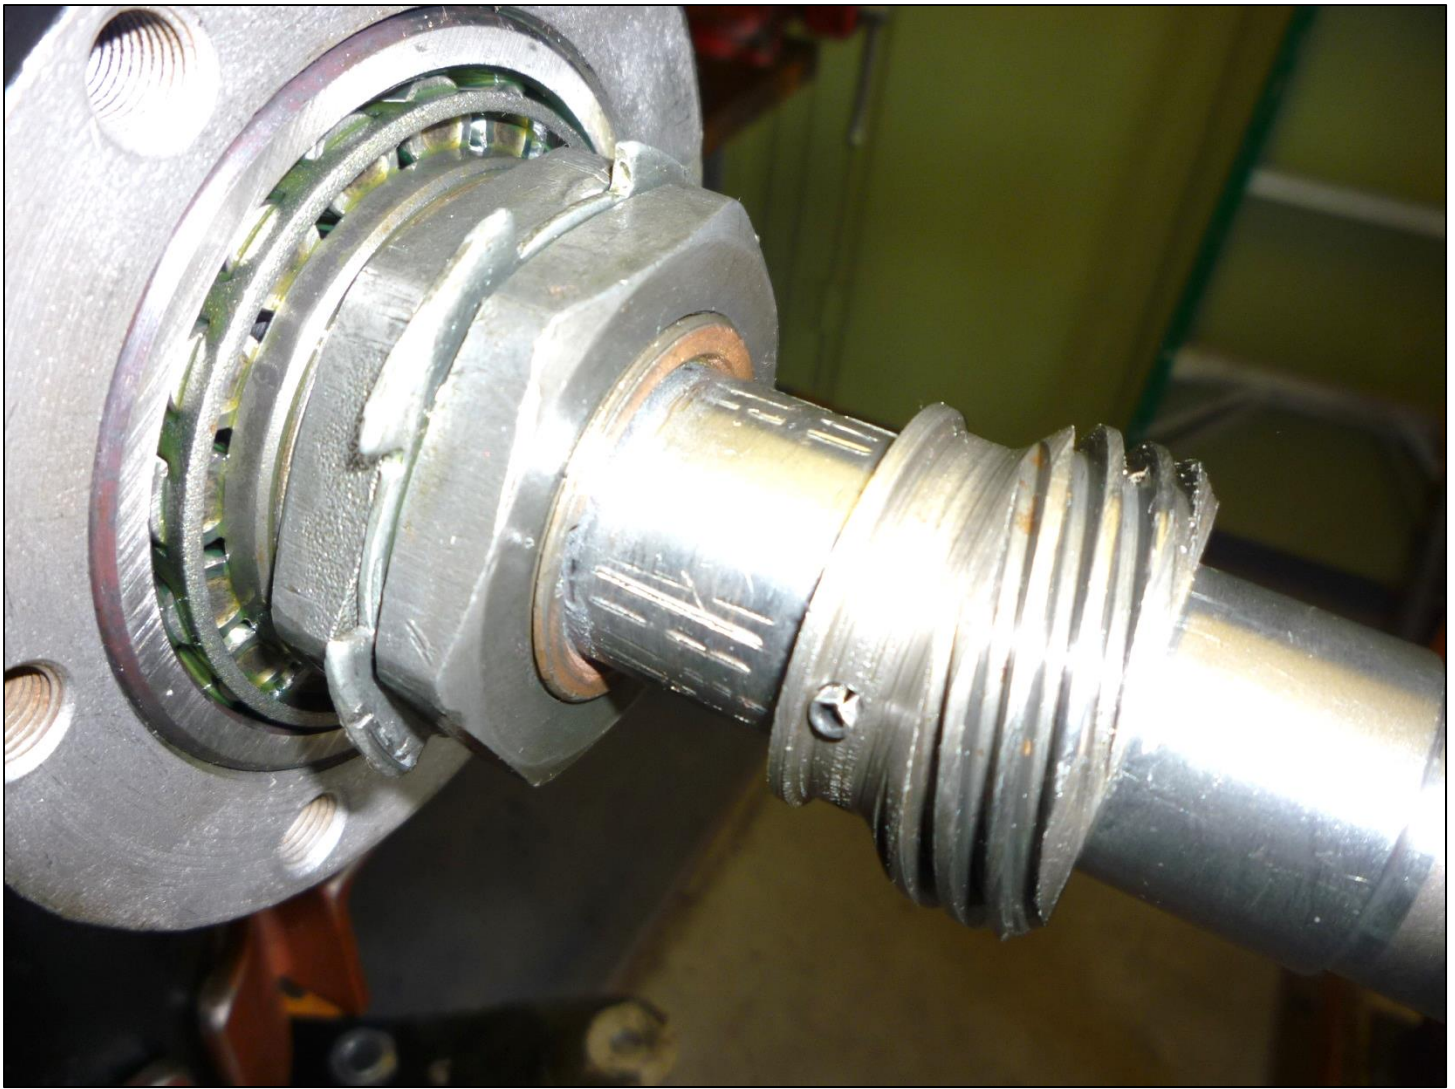
The task of tightening the pinion nut to 100 ft. lbs. and establishing the pre-load on the pinion bearings has been accomplished. Note the galling that has occurred to the stub shaft in the area between the speedo drive gear and the two large nuts. This cannot be avoided if the task is to be done correctly. The galling is of no consequence as this section of the shaft is not critical.
