Dramatic Differential failure 2018

by Tom Endy

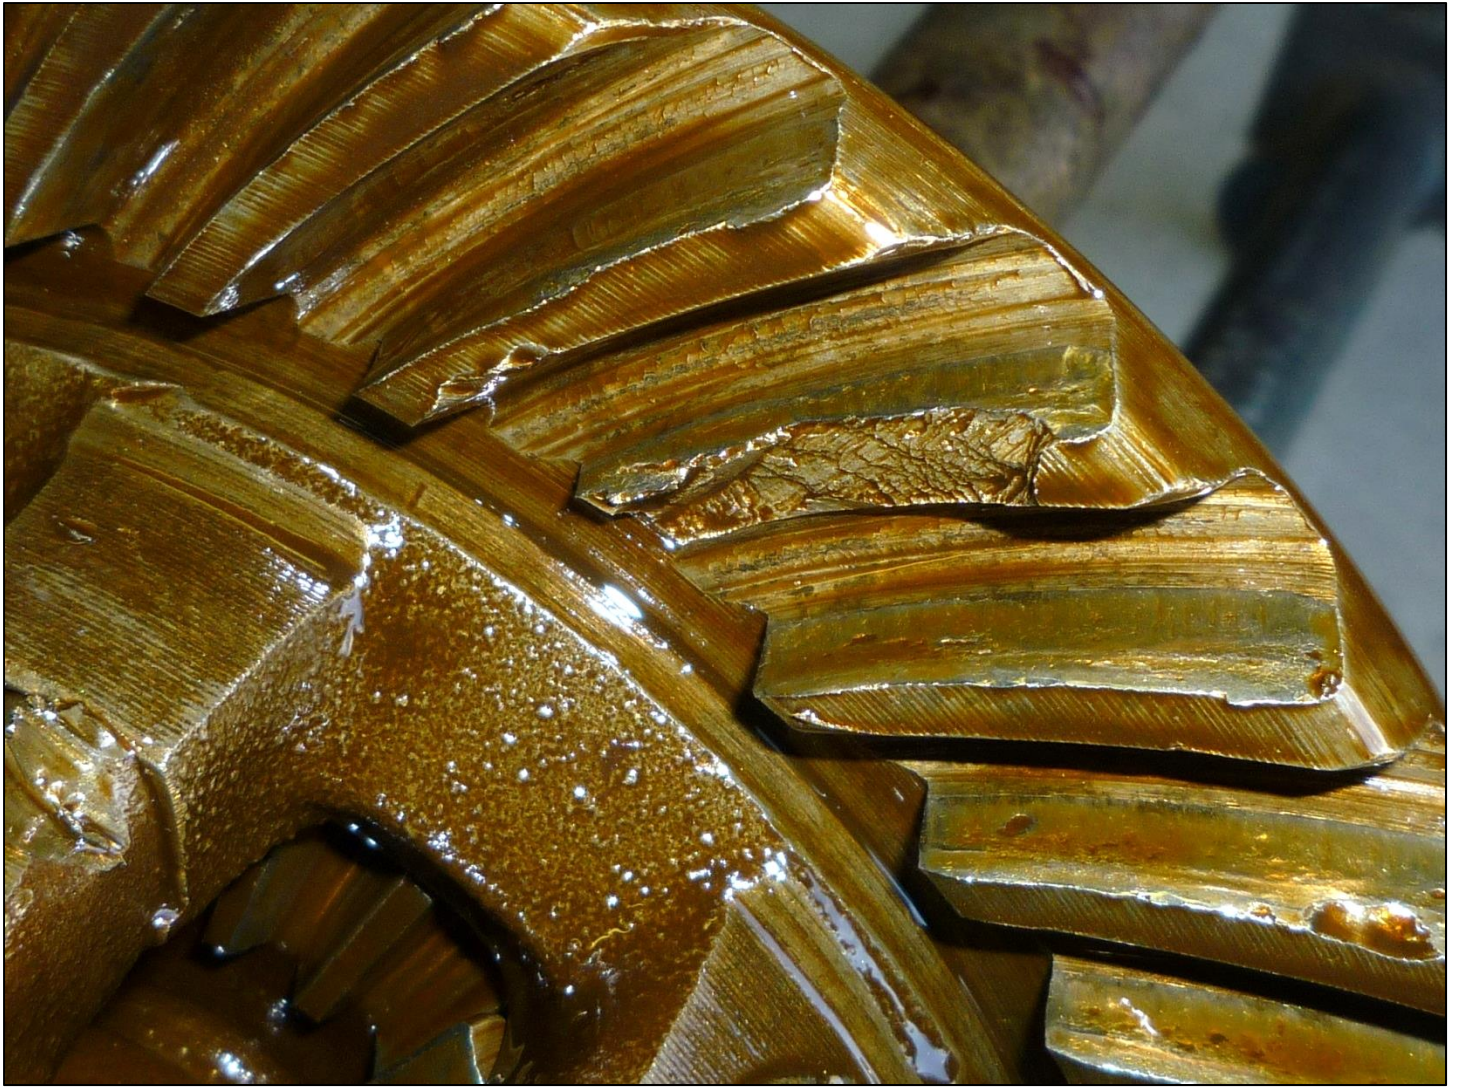
One tooth was knocked off the ring gear, along with damage to many others.

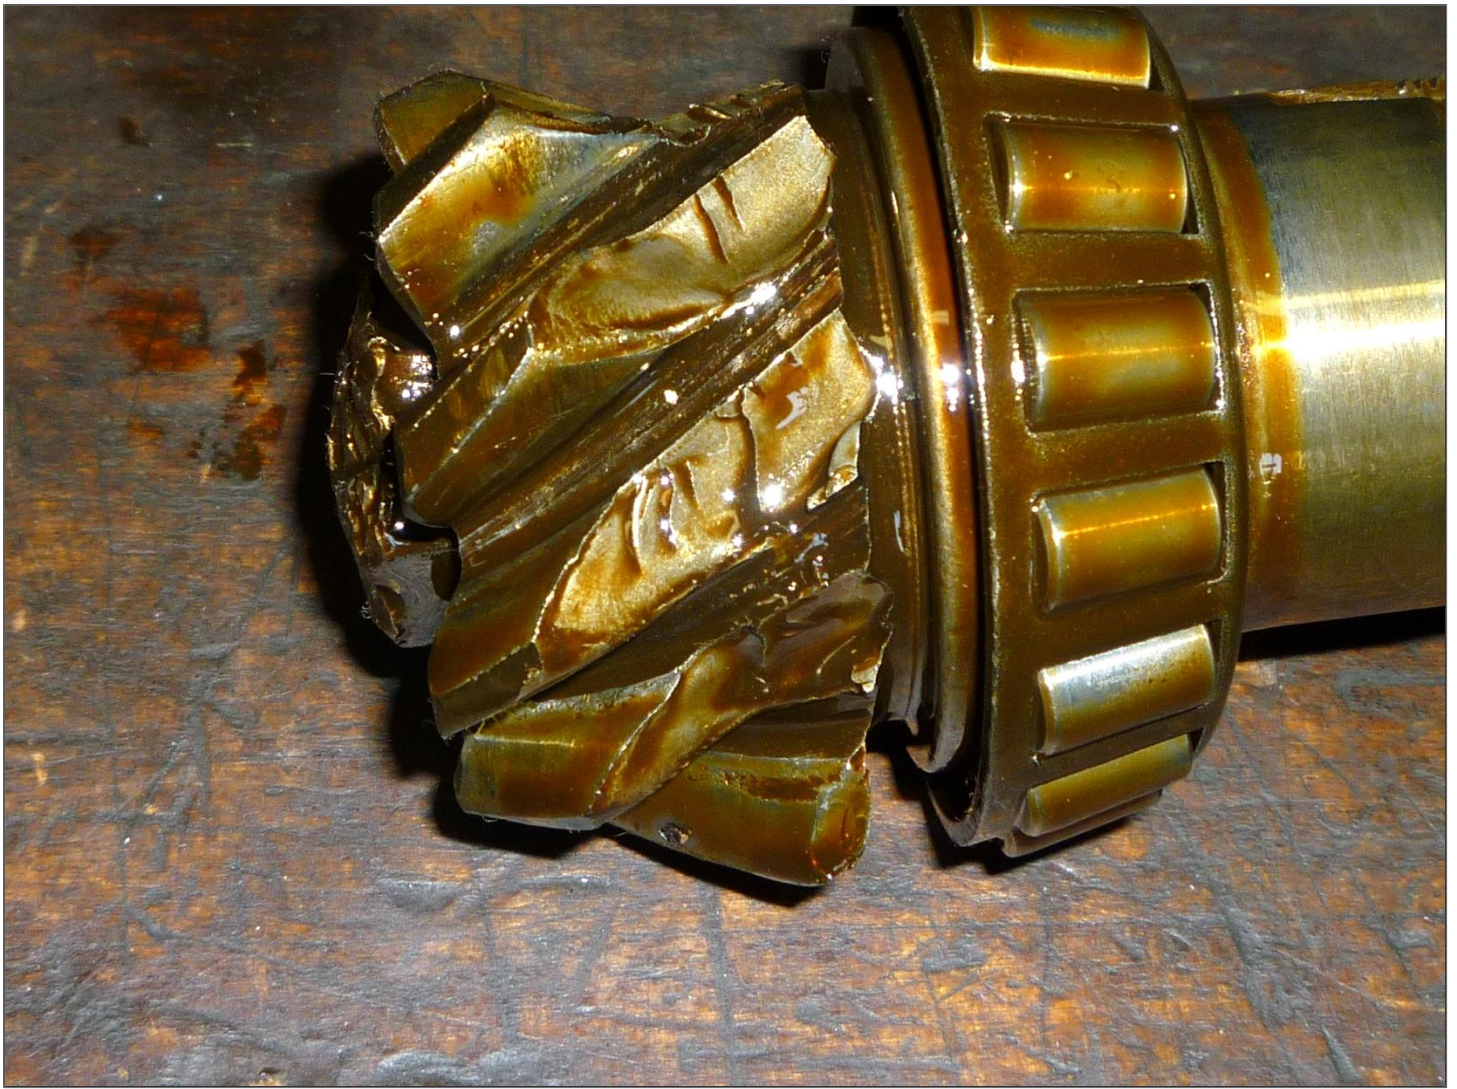
Multiple teeth were knocked of the pinion gear.

The failure of a pinion gear such as exhibited here can be caused by going over a speed bump, railroad tracks, or a rutted road at high speed. The transverse rear spring on the Model A can easily bounce the car such that the rear wheels will come off the pavement momentarily. If the driver keeps his foot on the gas the rear wheels can spin up to 10 times the speed the car is travelling. When the rear wheels reconnect with the pavement the rear wheels and the ring gear attempt to resume the speed of the car; the pinion gear takes the brunt of the process and damage will occur.

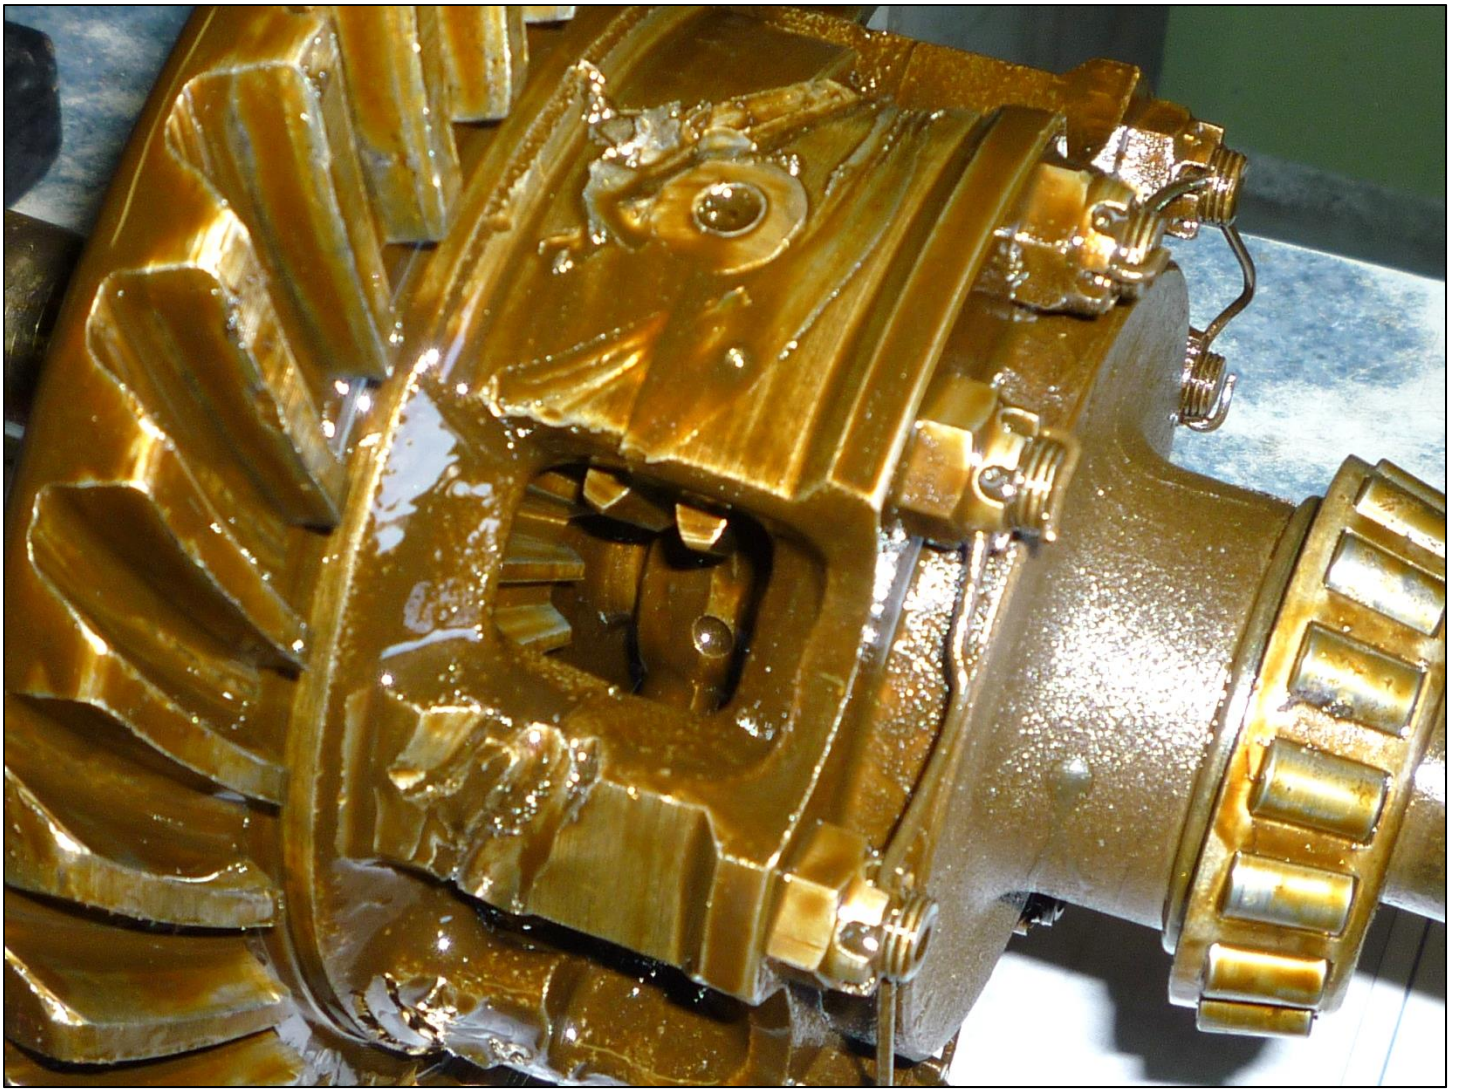
The left carrier bearing was found spun on its mount. In addition the carrier was badly battered by broken gear teeth adrift in the banjo. The bolt tunnels on the carrier halves were so hammered it was difficult to remove the bolts. The carrier will have to be replaced and is not salvageable due to the damage to the tunnels. The ring & pinion and the drive shaft will also have to be replaced. Both axle housings were found full of metal debris and will have to be thoroughly cleaned. The torque tube was also found full of metal debris.

The carrier was badly battered by flying debris. Note damage to bolt tunnel surfaces. This made it extremely difficult to remove the bolts. The carrier is not salvageable due to the damage to the bolt tunnels.

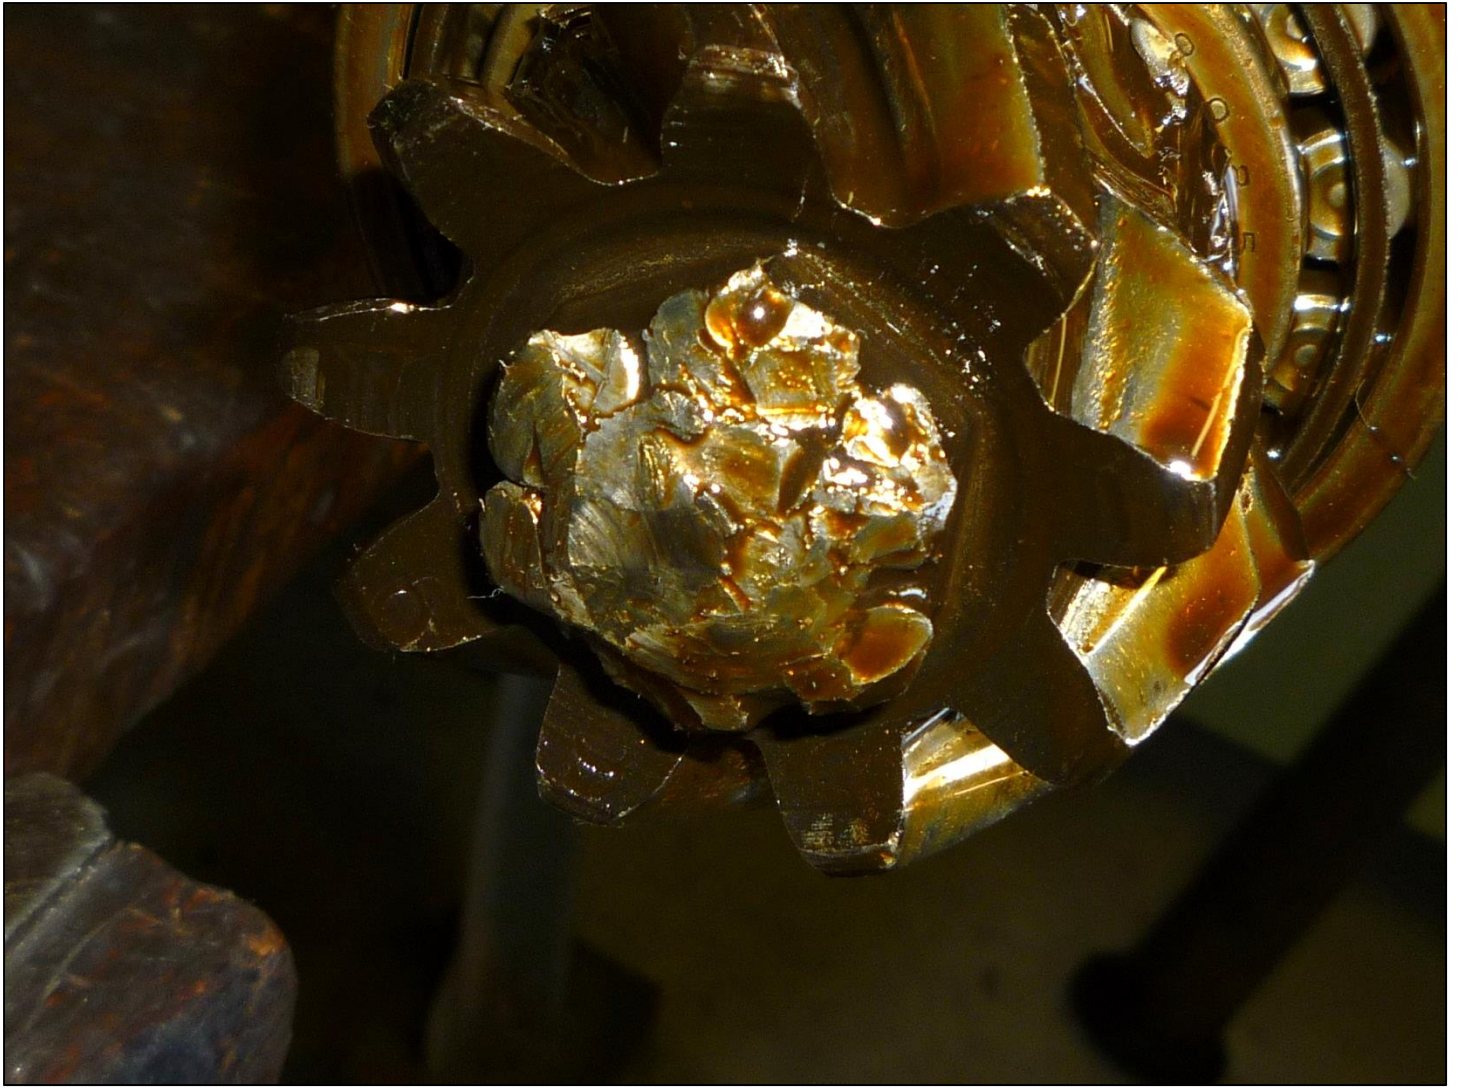
The nut on the end of the drive shaft is battered along with a number of threads on the drive shaft and the cotter pin hole.

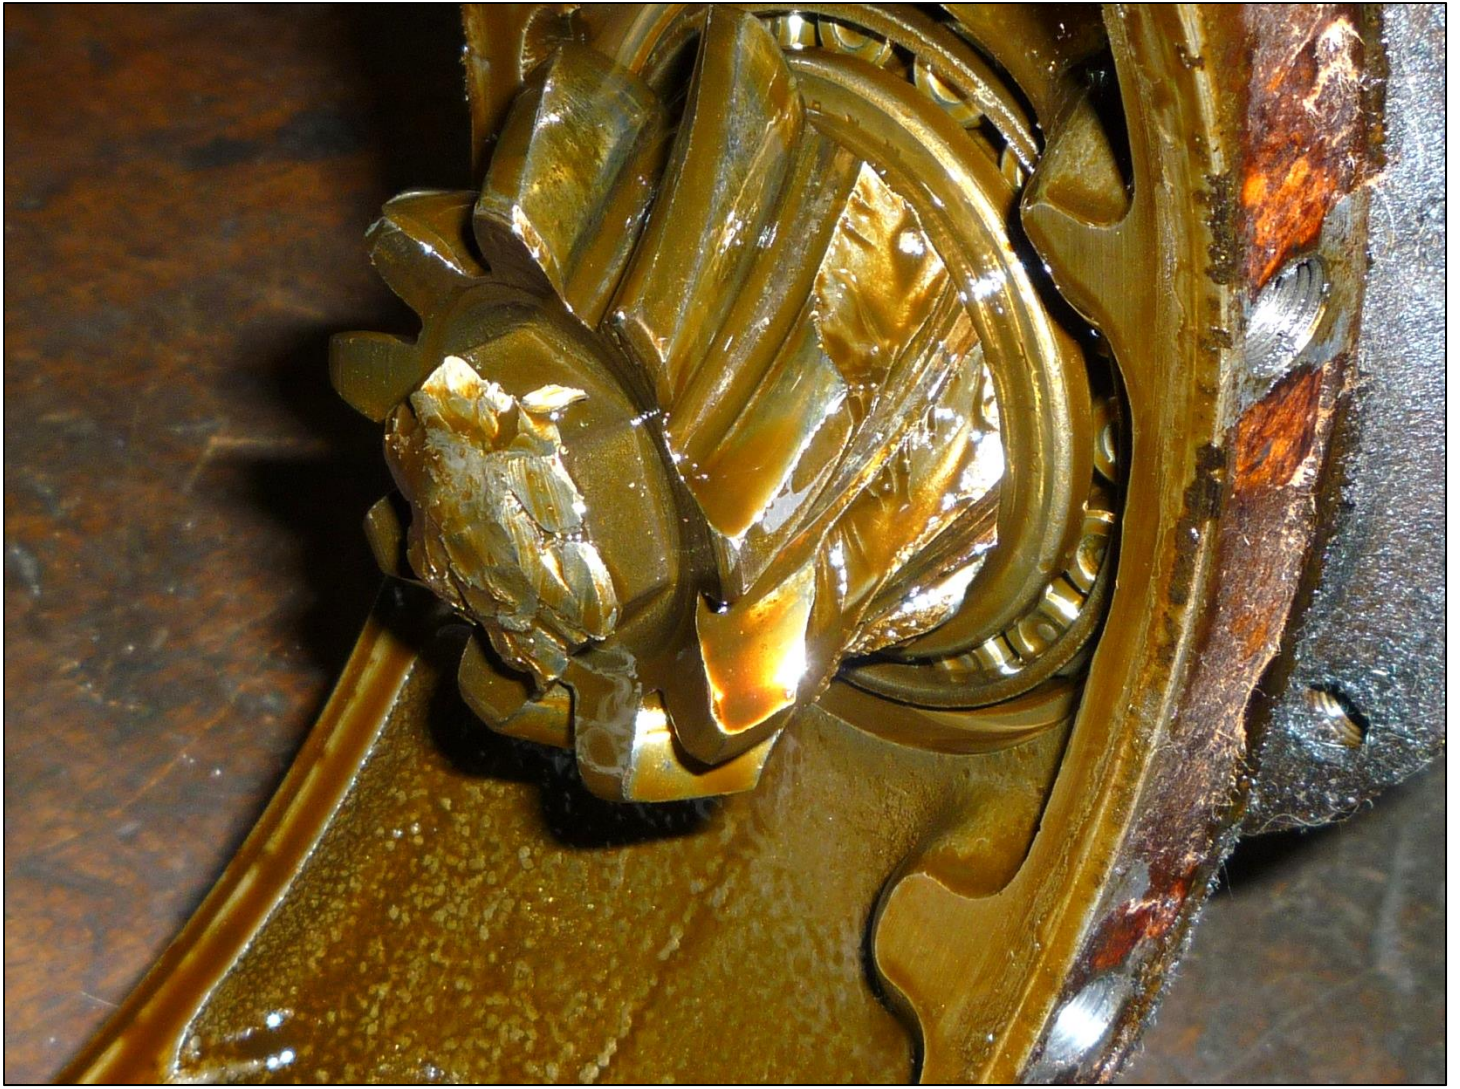
Another view of the pinion gear:

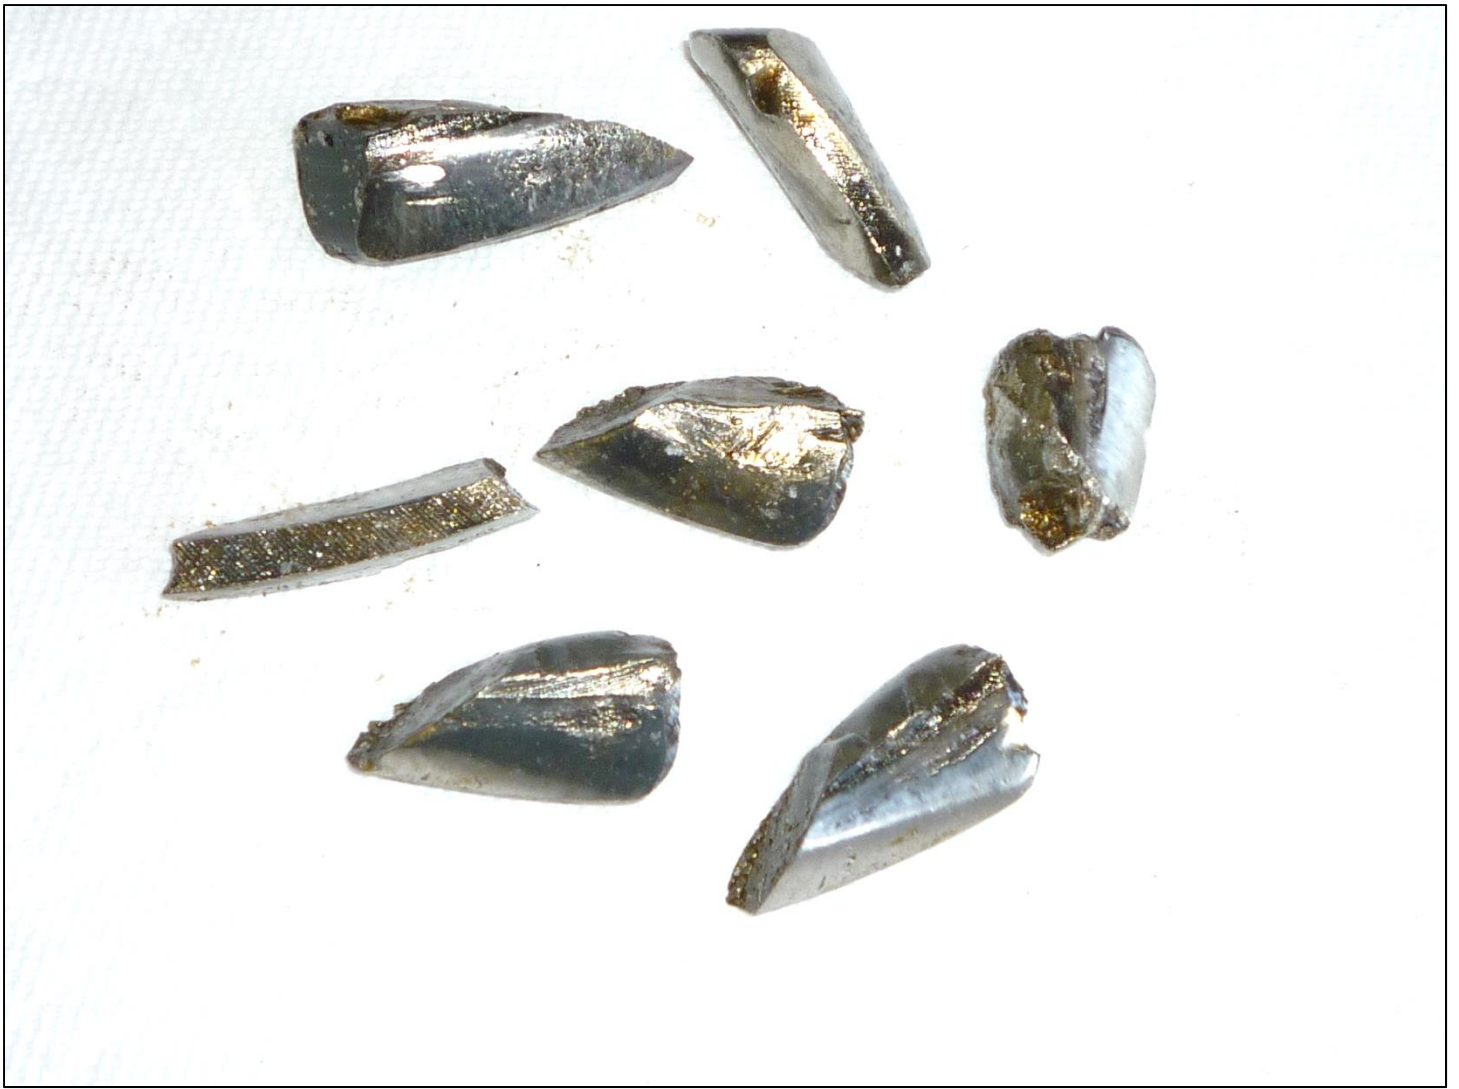
Teeth from both the ring and the pinion found lying in the bottom of the banjo.
