Model A Carrier Repair

by Tom Endy

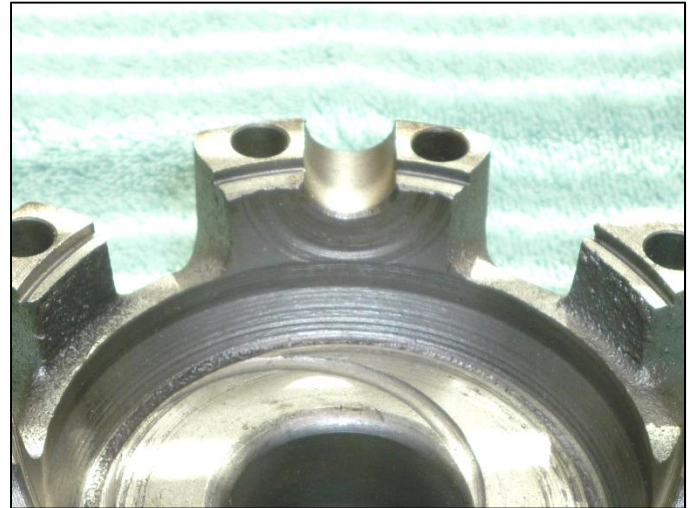
There are two different failure modes. One is caused by in-service wear. The inside area of the carrier can become worn from the backside of the three spider gears rubbing against it. The wear can cut an indentation as much as $1/16$ " deep. There is no repair for this that I am aware of. The only resolve is to discard the carrier and find a better one.

There is always some amount of wear in this area. That is why it is important to mark the carrier before you separate the two halves so it can go back together with the wear patterns lined up.

Service wear can be seen where the back side of a spider gear rotates against the carrier just below the two bolt holes at center.

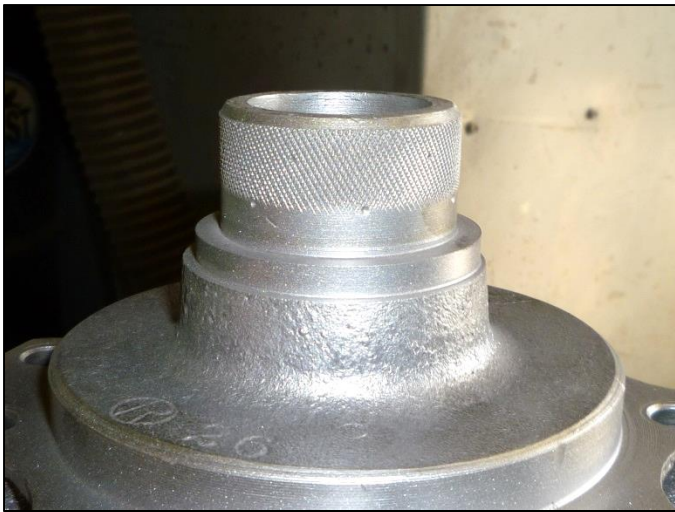
The second failure mode is self-induced. Generations of "mechanics" attempting to rebuild the differential with no knowledge of carrier bearing pre-load have put rear axle assemblies together with a single gasket on each side of the banjo instead of selecting quantity and thickness of gaskets to establish the pre-load. In many cases they ended up with the carrier bearings locked. Henry's forty horses will unlock them. However the unlocking process causes the bearings to spin on their mounts and the result is the rear is not riding on bearings 100% of the time. Metal is worn away on the hubs such that a replacement bearing will not press on with an interference press fit. This is the predominant failure mode. Around 80% of rear axle assemblies disassembled for overhaul exhibit one or both of the carrier bearings spun on their mounts.

The hub in the photo has been knurled. The bearing stop was also machined to true it up as it also had metal indiscriminately machined off. A .005 cut is made and will have to be replaced with a .005 shim. An additional cut was made below the stop that is a nominal 1/16" deep and 1/4" wide. The purpose of this cut is to provide more access under the bearing to install a bearing puller if the new bearing has to be removed to install additional shims. Note the three punch marks where some mechanic of yesteryear attempted to provide a form of knurling.

There is a repair for this failure. The hubs can be knurled to raise the metal so that the replacement bearings will press on with an interference press fit.

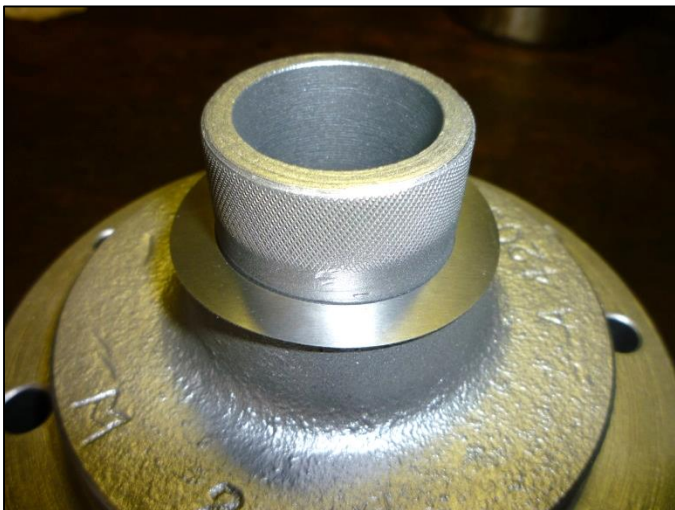
A .005 shim is installed before the new bearing is pressed on. Bratton's Antique Auto stocks the .005 shims.

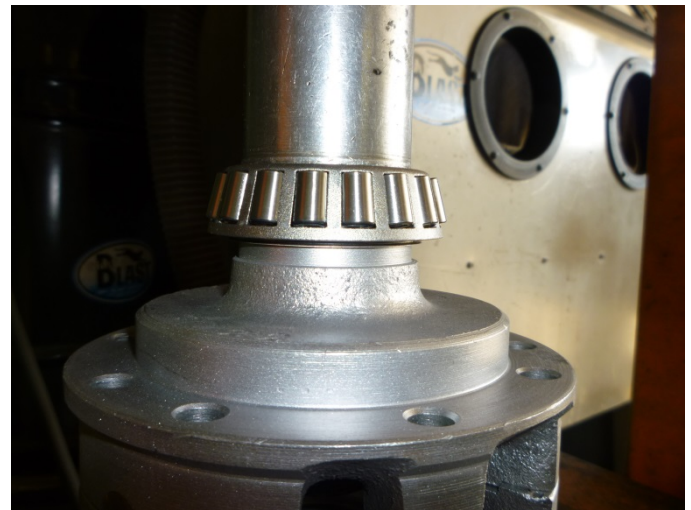
A new bearing is pressed on. The shim can be seen under the bearing. Note the second cut taken at the base of the hub will allow more room under the bearing for a bearing puller if additional shims are required.

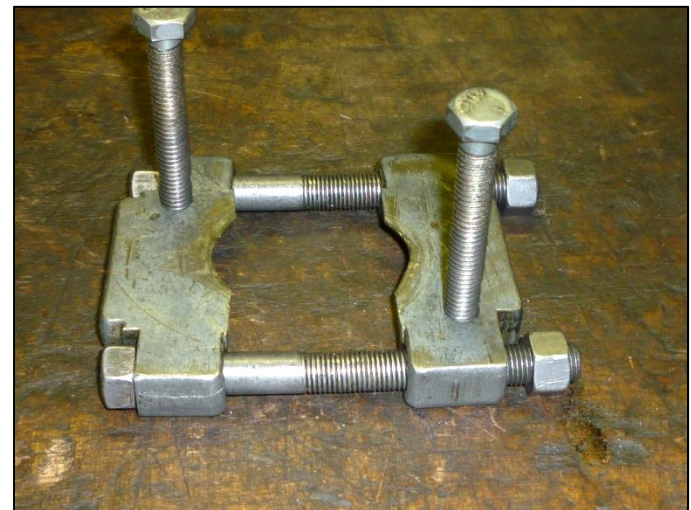
A bearing puller such as this is used to pull a bearing off of the hub without damaging the bearing. This is important if you are removing a new bearing that you intend to reinstall.
