Reproduction!

by Tom Endy

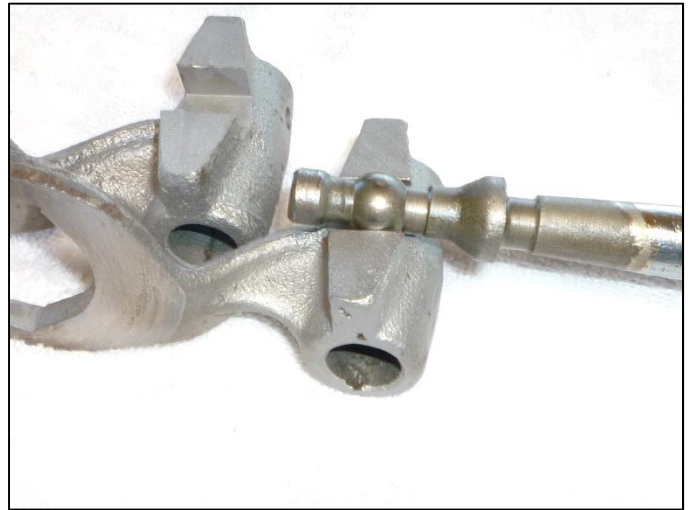
The ball of the end of the shifter is a nominal 1½” round diameter; the slot in the shift fork is also a nominal 1½” diameter; however, they can’t both be the same diameter as there has to be some clearance for the ball to be able to move around inside the slots.

The slots in the two reproduction forks are not wide enough to allow the ball on the end of the shifter to travel inside the slots without becoming jammed.

For years Model A hobbyist have been restoring transmission towers by welding up the worn ball on the end of the shifter and grinding it down to fit into the fork slot properly. The wear in the forks is also welded up and milled to fit the ball on the end of the shifter properly.

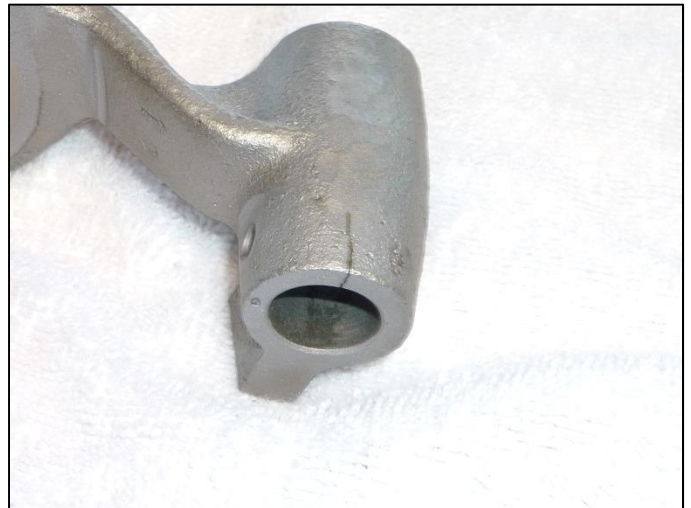
I discovered another problem while taking it apart. The tunnels bored through the shift forks are too small and both shaft rails were installed extremely tight, so much so that one cracked when someone tried to insert a shift rail through it. I had a difficult time getting them apart. Someone had even put a rail shaft locking pin in up-side-down and then somehow managed to peen it over on top. I had a difficult time removing it.

The tunnel drilled through the forks for the shift rails to insert through is not large enough and caused this one to crack.
