Differential Rebuild 1932 V8 Ford June 2, 2019

by Tom Endy

This job came into the shop for the purpose of having the ring & Pinion gear ratio changed from what ever found to a 354:1 ratio. The owner supplied a new gear set. The unit came out of a 1932 Tudor with a V8 engine. The early 1932's are similar to a Model A rear axle assembly; however, there are several differences. This will be a complete overhaul with new bearings, races, seals, and gaskets.

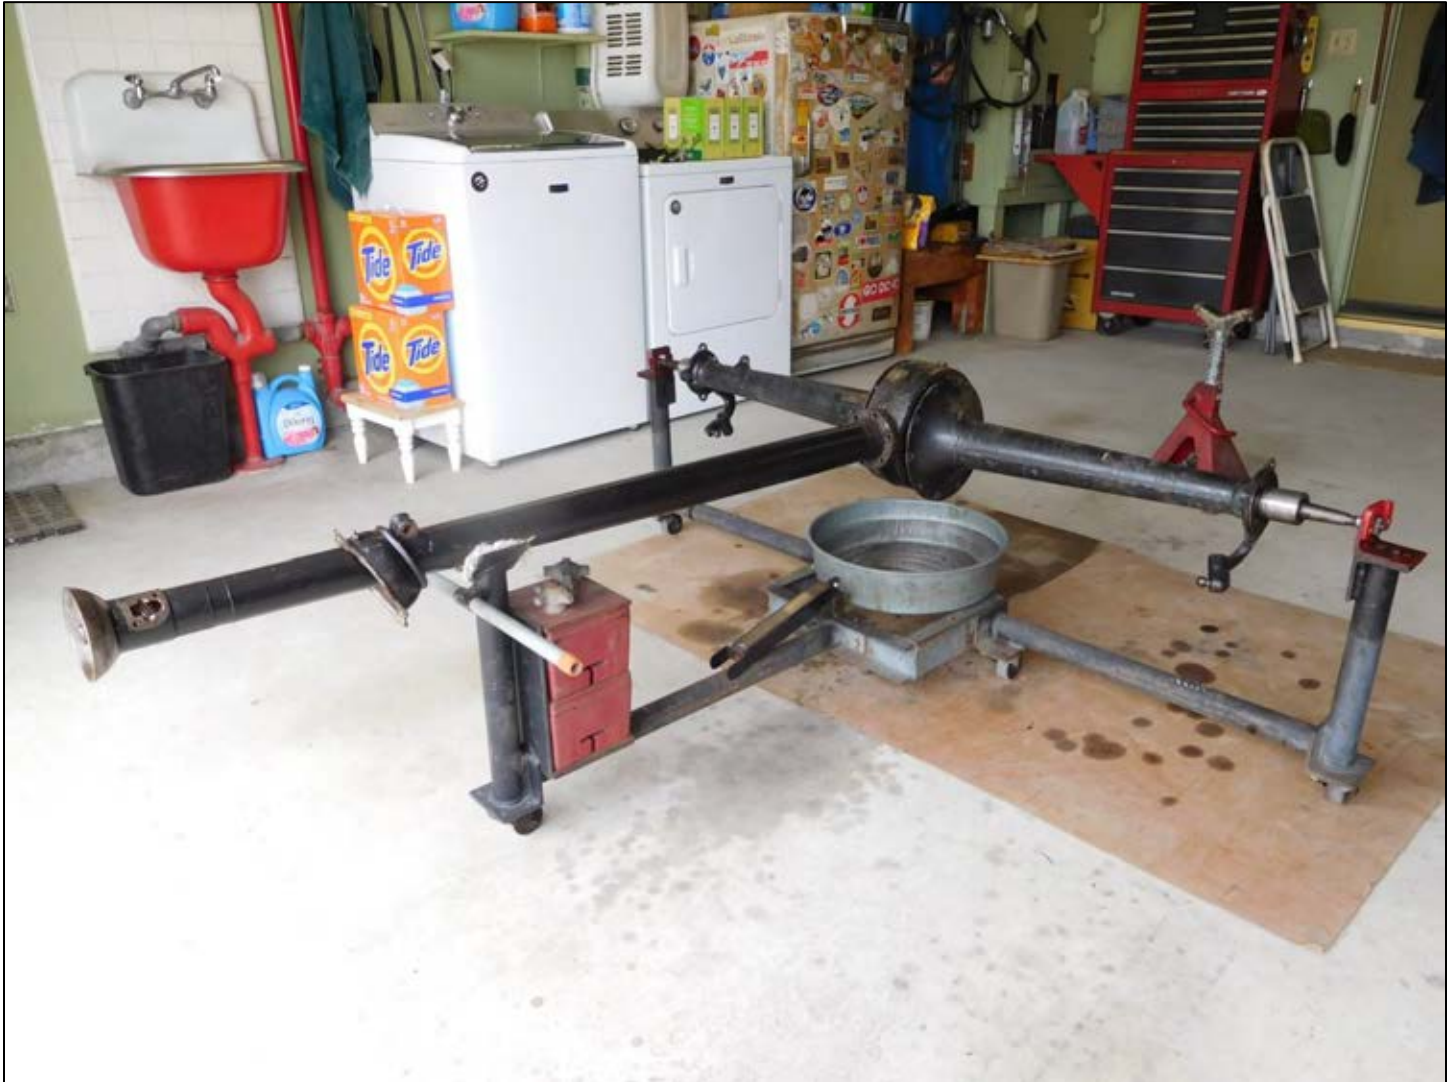
The rear axle assembly has had all the bolts removed from the torque tube and both sides of the banjo. Note some of the differences from a Model A.

The torque tube and drive shaft is longer to accommodate a longer wheel base on the 1932 Fords. The U-joint housing is one piece. It was installed before the bell end of the torque tube was welded on, so there is no removing it, The two spring perches are much larger,

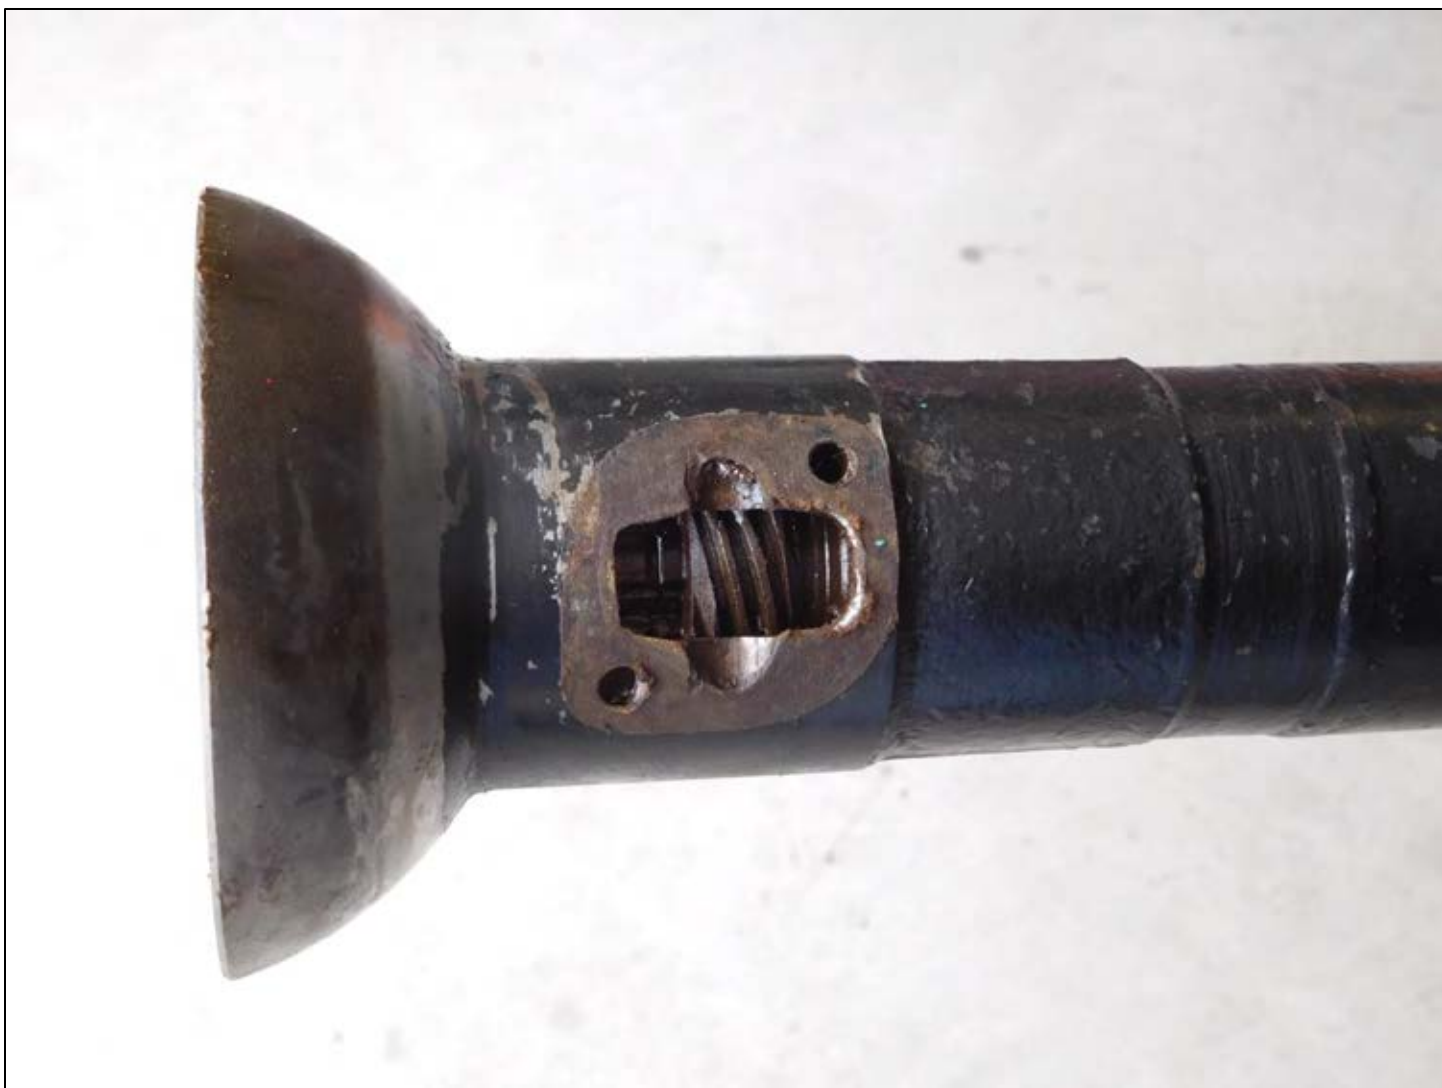
A show stopper:

Shown here is the speedo drive gear that slides onto the splined drive shaft at the front of the torque tube. Any that I have ever seen on a Model A just slide right off. This one does not, it is somehow jammed onto the drive shaft, probably rusted there as I did find water inside the banjo. A hammer and a chisel did not dislodge it. It will be a challenge getting it off.

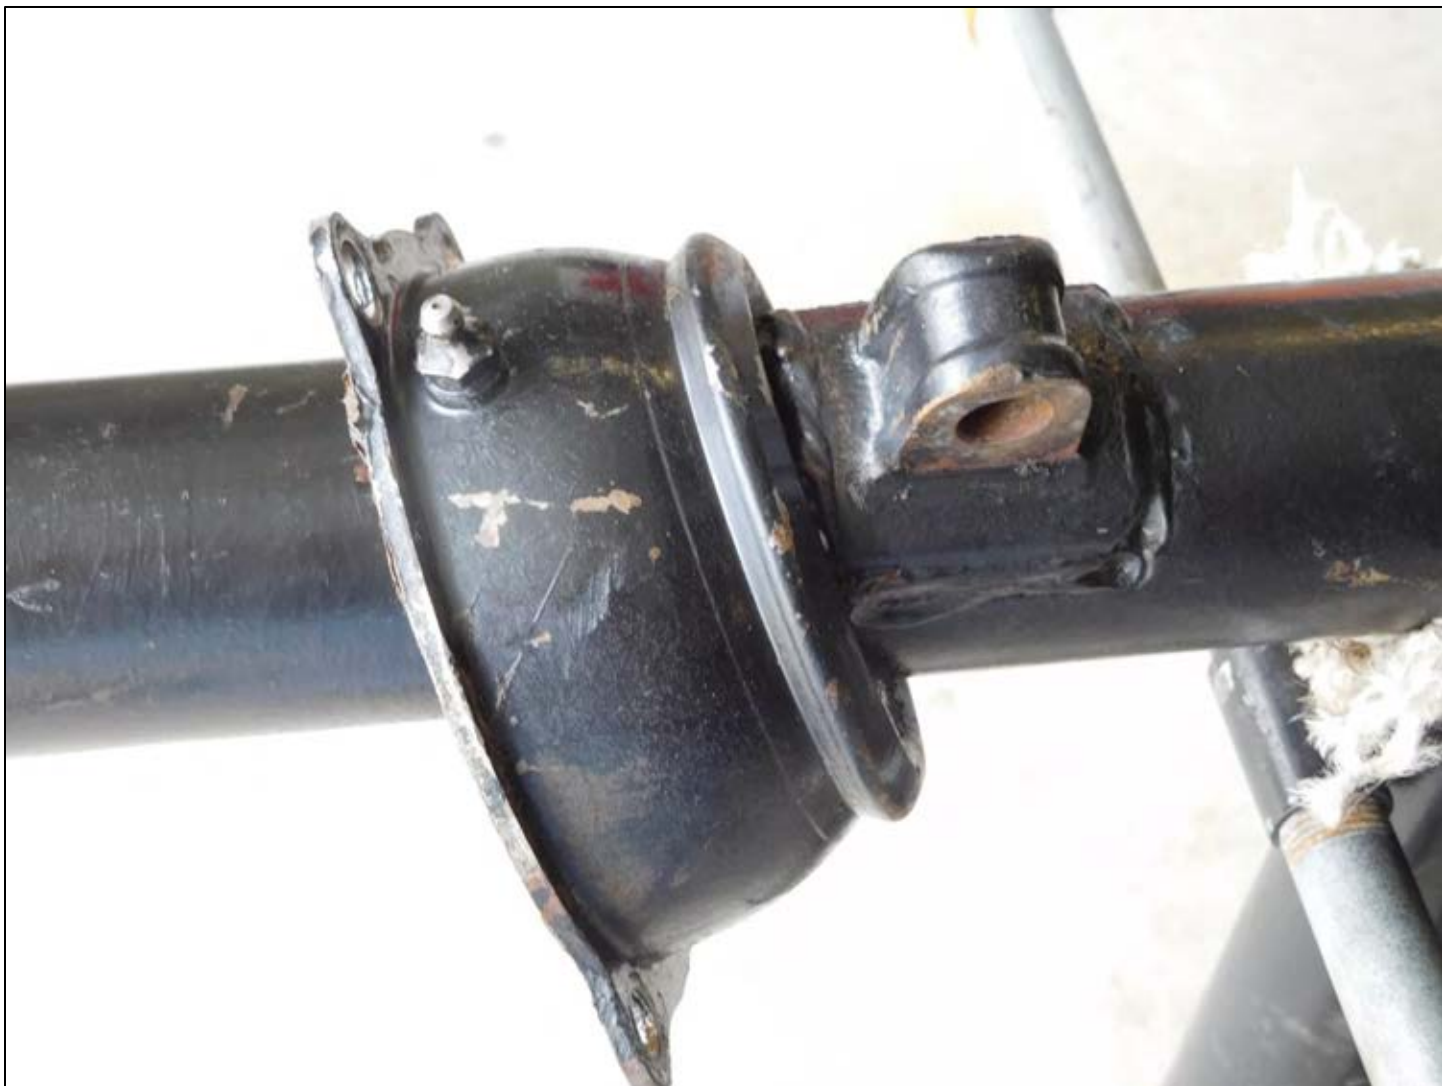
Shown here is the U-joint housing that is one piece and does not come off. Note a grease fitting is located on the housing for greasing the U-joint, the speedo drive gear, and the front roller bearing. On a Model A the grease fitting is located on the transmission rear bearing retainer. The housing has only four mounting bolt holes, the Model A has six.

Note the circular attachment to the right of the U-joint housing, this is where the front of the radius rods bolt on.

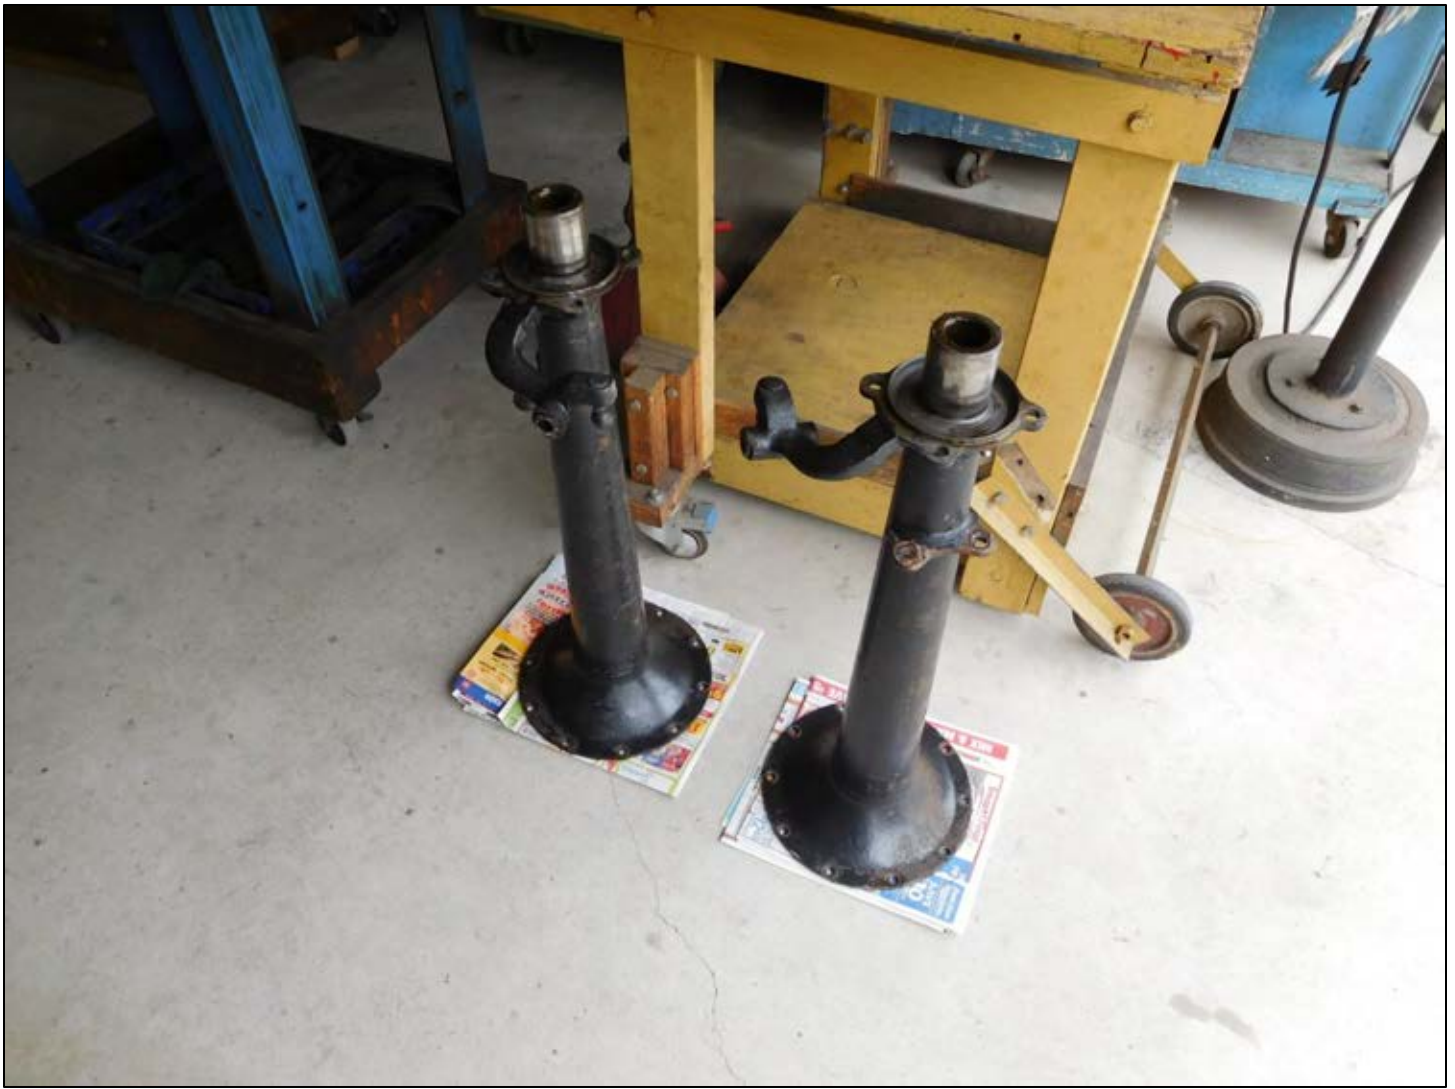
Both axle housings have been removed and will have the seals knocked out. New ones will be installed. After they have been cleaned up both carrier bearing races will be removed and new ones installed. The large spring perches are clearly seen here.

Note the two-hole brackets welded to the side of the housings. This is where the rear of the radius rods attach instead of to the backing plate mounting bolt holes as in a Model A.

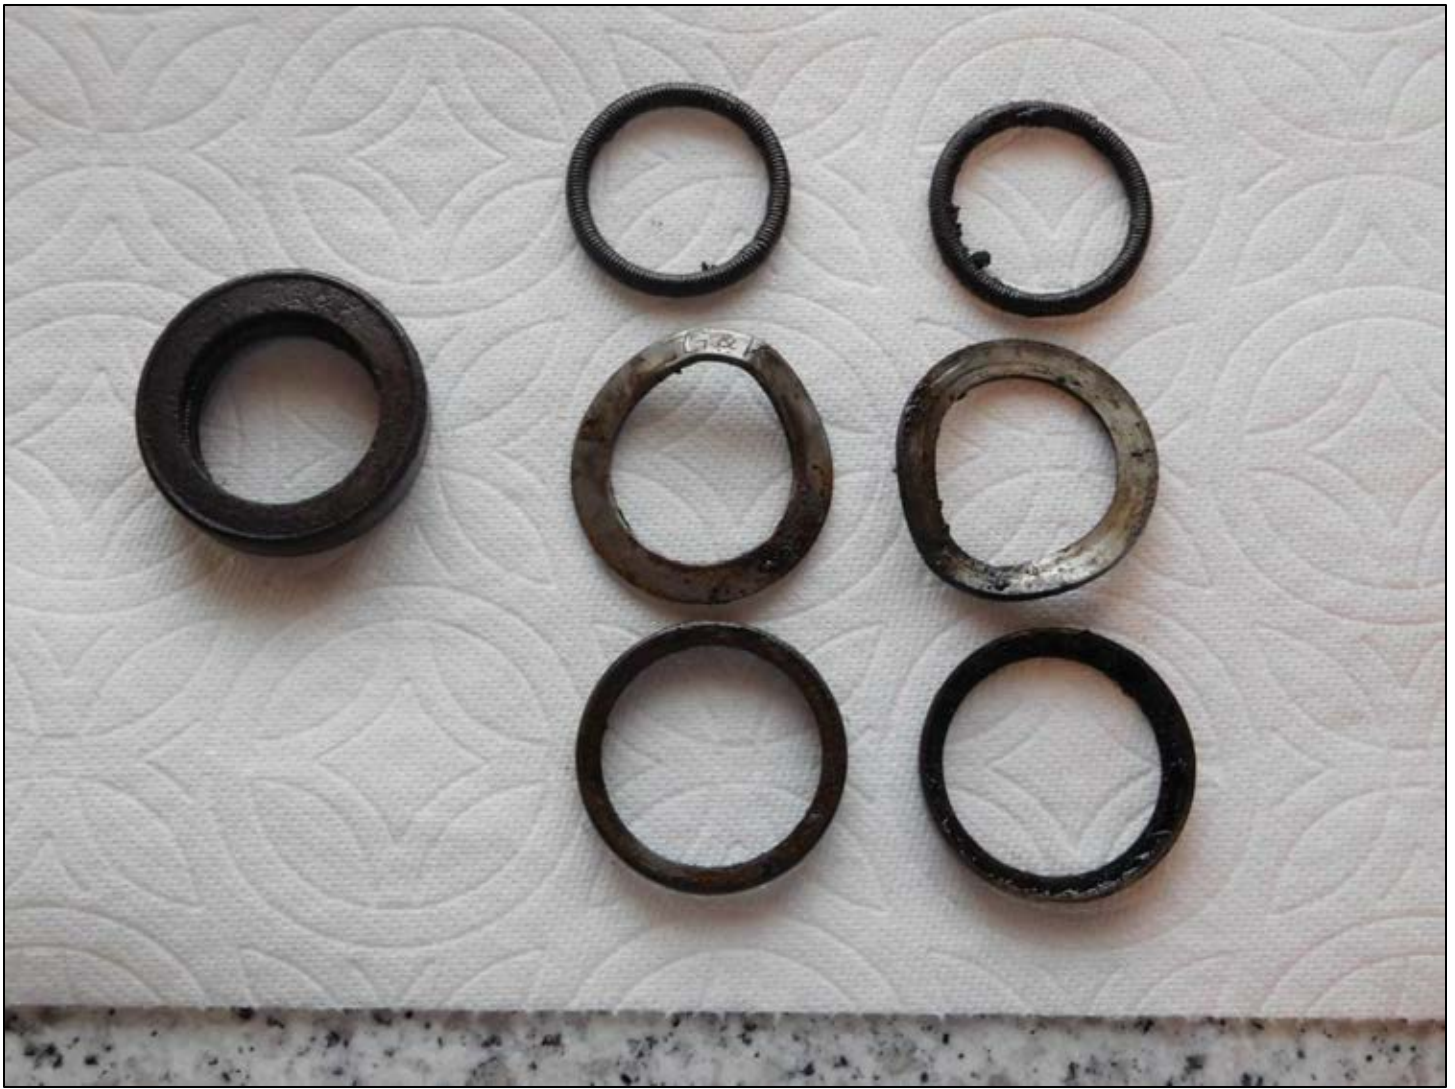
Shown here are the three grease seals that were removed from the unit. The one on the left came out of the front of the torque tube. It is the original that was installed at the factory. The two on the right came out of the two axle housings, they are also the originals that were installed at the factory, both came apart during the removal process. In all three cases the leather portion of the seals had deeltiolated years ago, there was no sign of any remaining leather.

Stamped on all three seals was the letters J&K, I have no idea what this stands for. The original Model A seals had the letters CR stamped on them that stood for Chicago Rawhide. The seals used in the 1932 cars are the same as those used in the Model A.

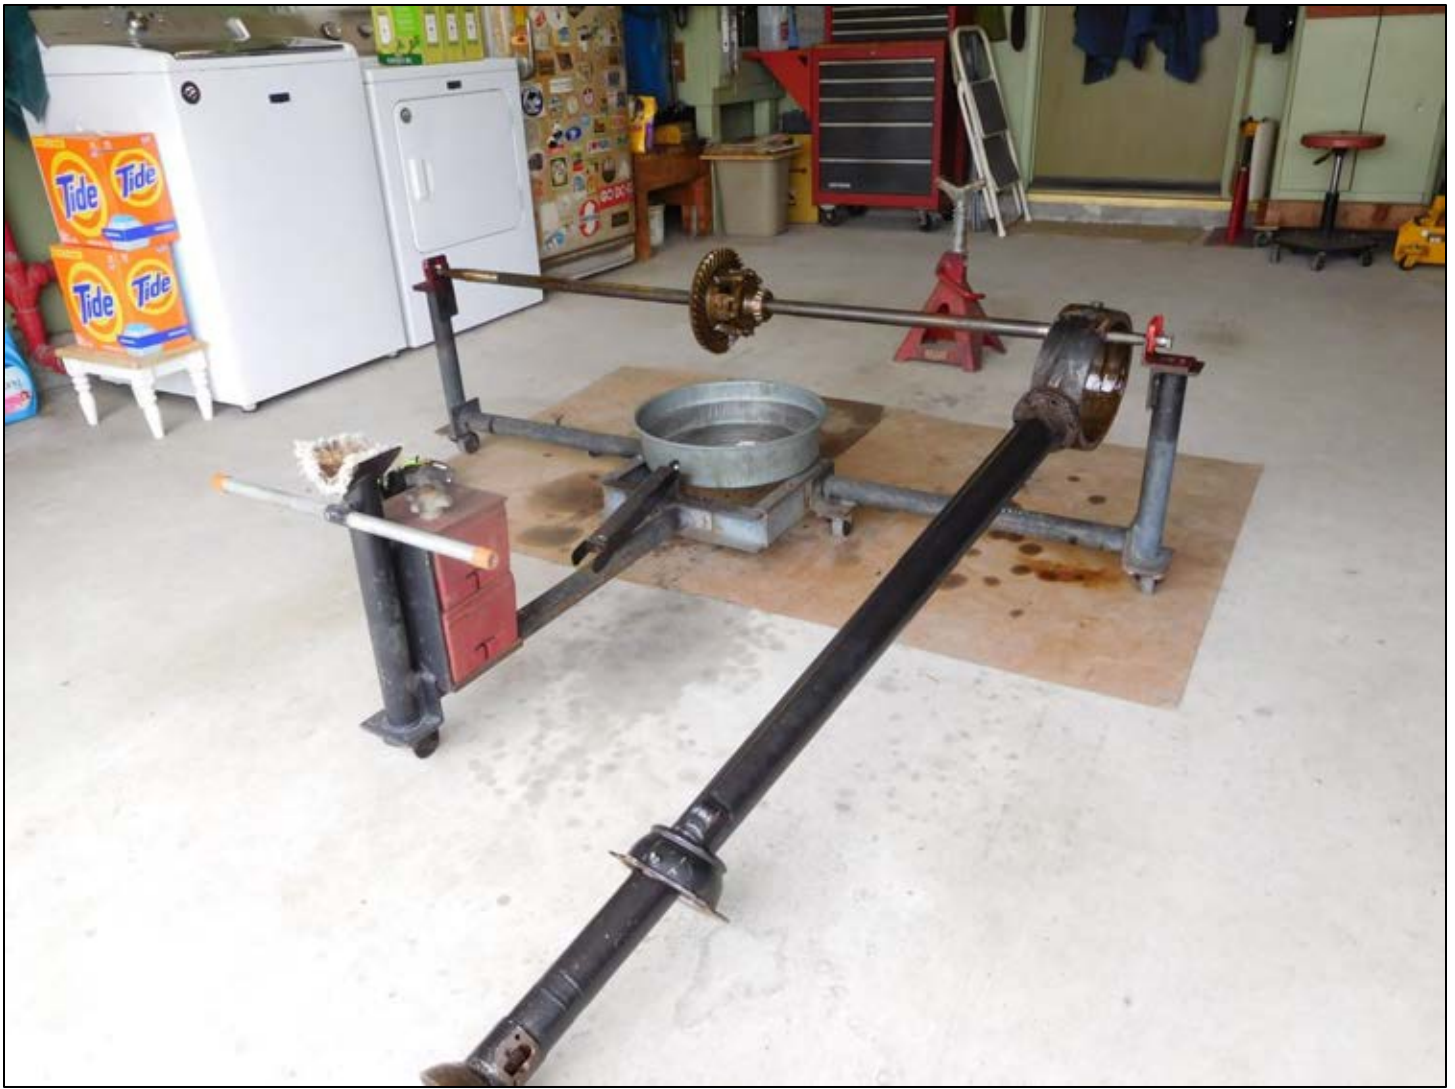
Shown here is the unit with both axle housings removed and the torque tube and banjo ready to be lifted off. Because the speedo drive gear is frozen to the drive shaft it was not possible to pull the torque tube off as part of the disassembly process. The drive shaft and the pinion gear cannot be removed until the issue with the jammed speedo drive gear is resolved.

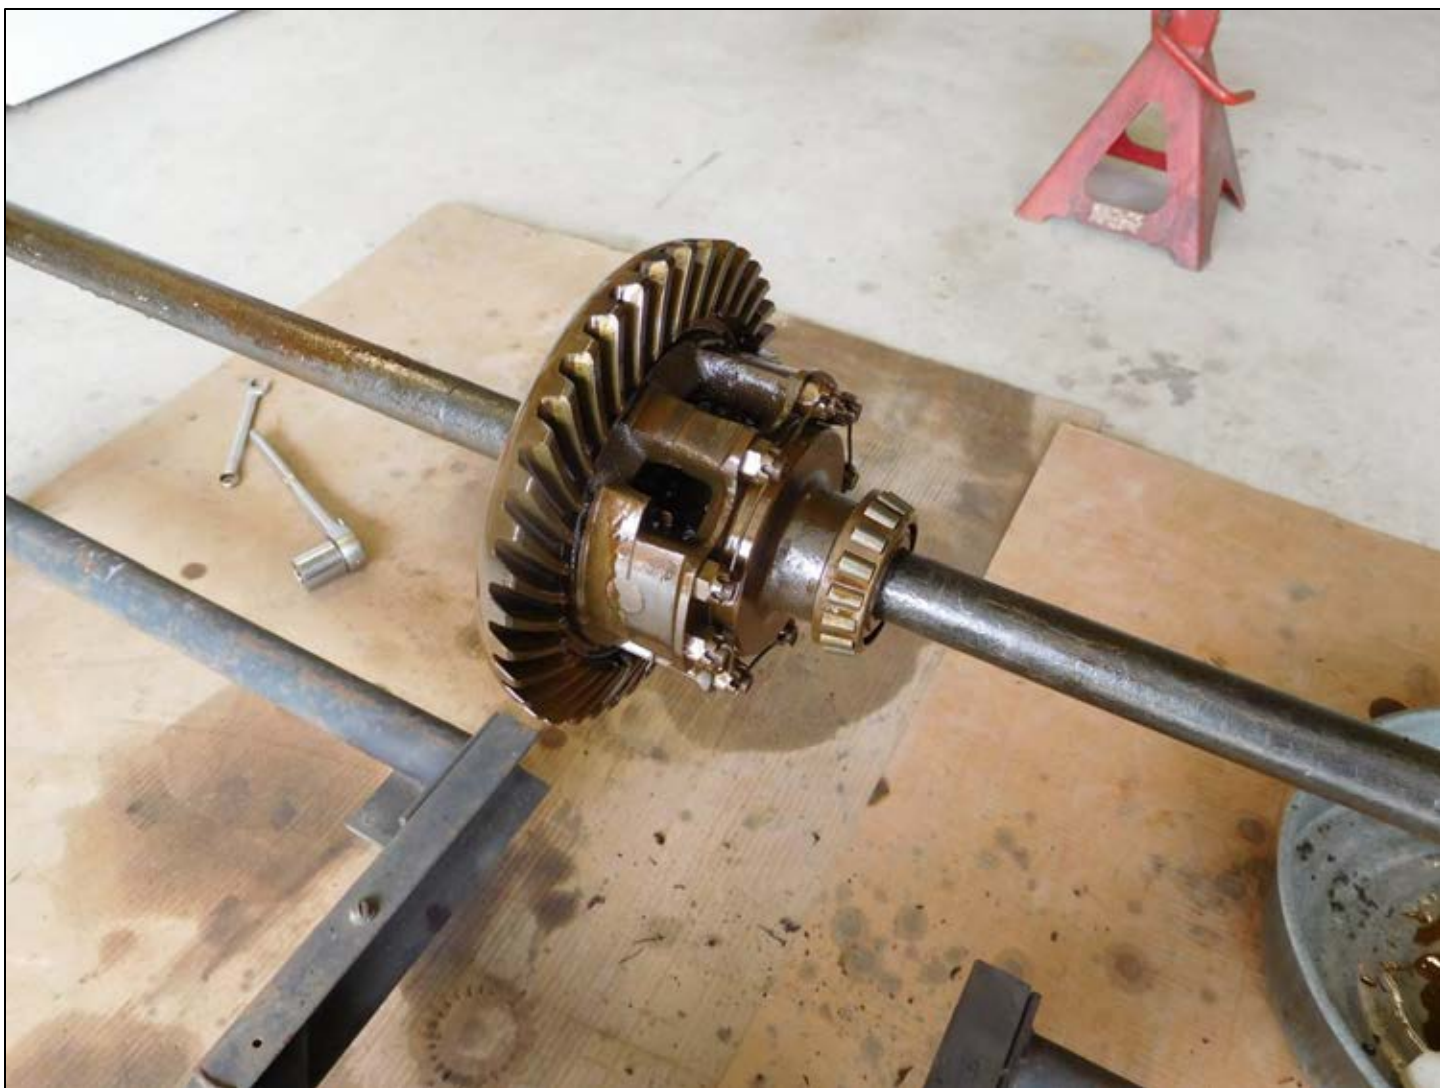
Shown here is a close up of the carrier assembly. It is ready for disassembly.

It was determined that the ring & pinion gear ratio was 433:1 (39\9), which was apparently common to the 1932's. Both were in very good condition. This is considered a low gear ratio The Model A did not use this ratio.

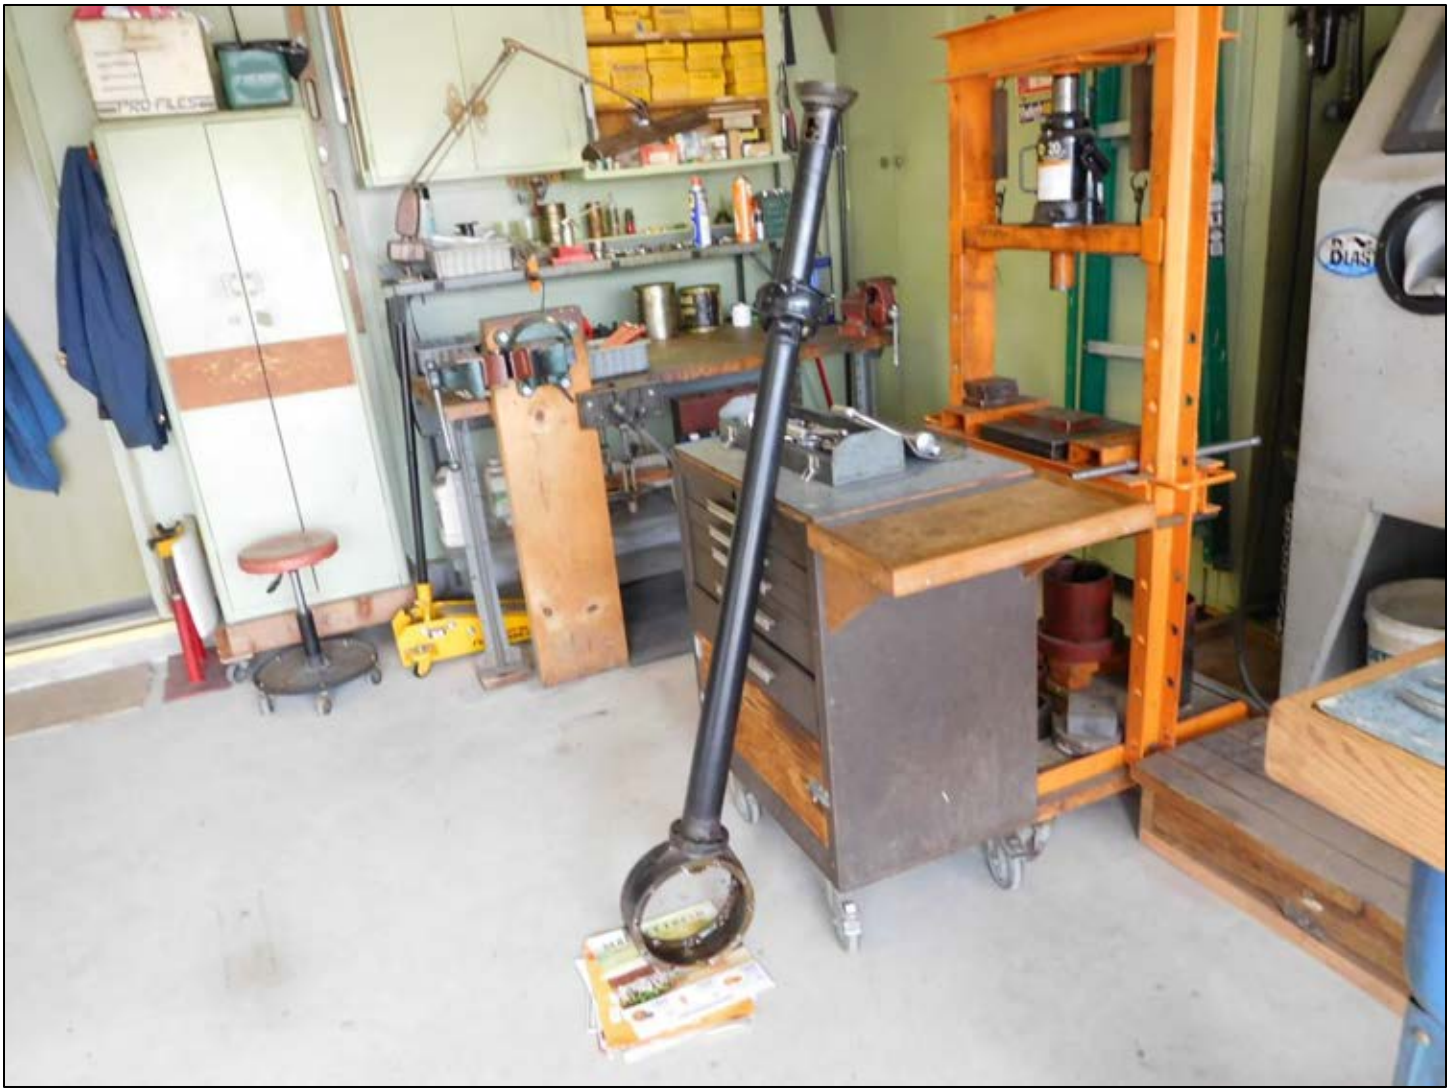
Shown here is the torque tube and banjo with the drive shaft and pinion gear still inside. The trick now is how to get the speedo drive gear off the drive shaft. Until that happens the assembly cannot come apart.

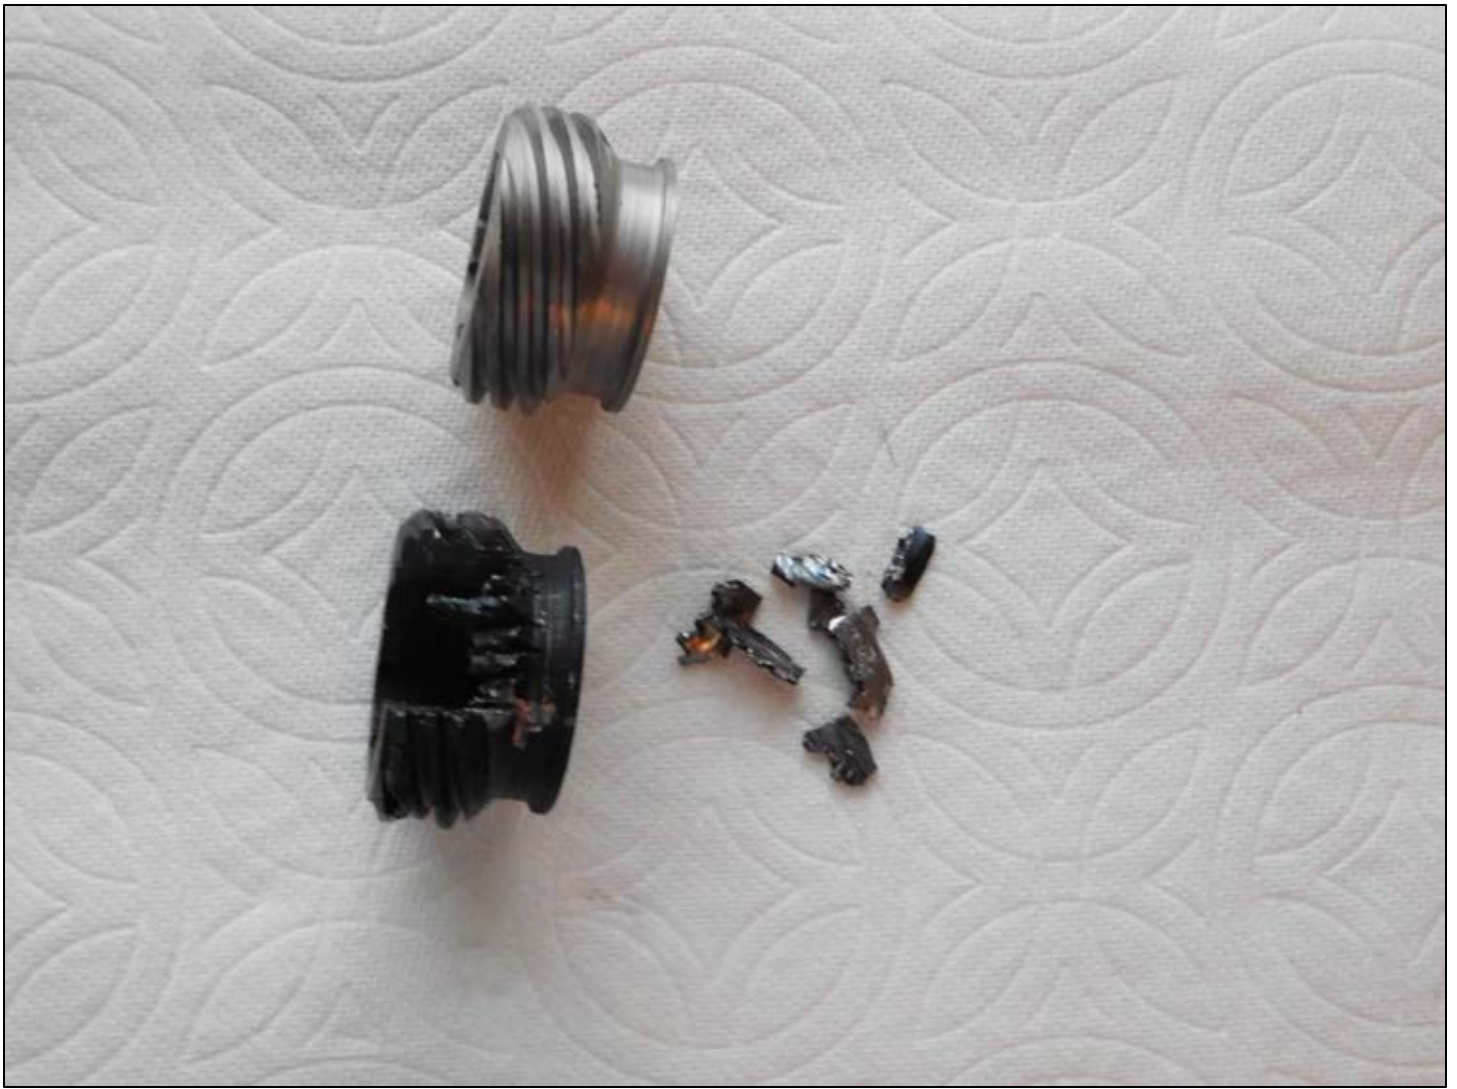
The photo shows the destroyed speedo drive gear and a serviceable one that will be used as a replacement.

The front roller bearing and race were found to be in terrible condition. They both were very badly pitted.

After about four hours of effort, which included multiple heating's of the speedo drive gear that was frozen to the drive shaft, a Dremel was used to cut away a portion of the gear, and after much coaxing I was able to drive the gear off the shaft.

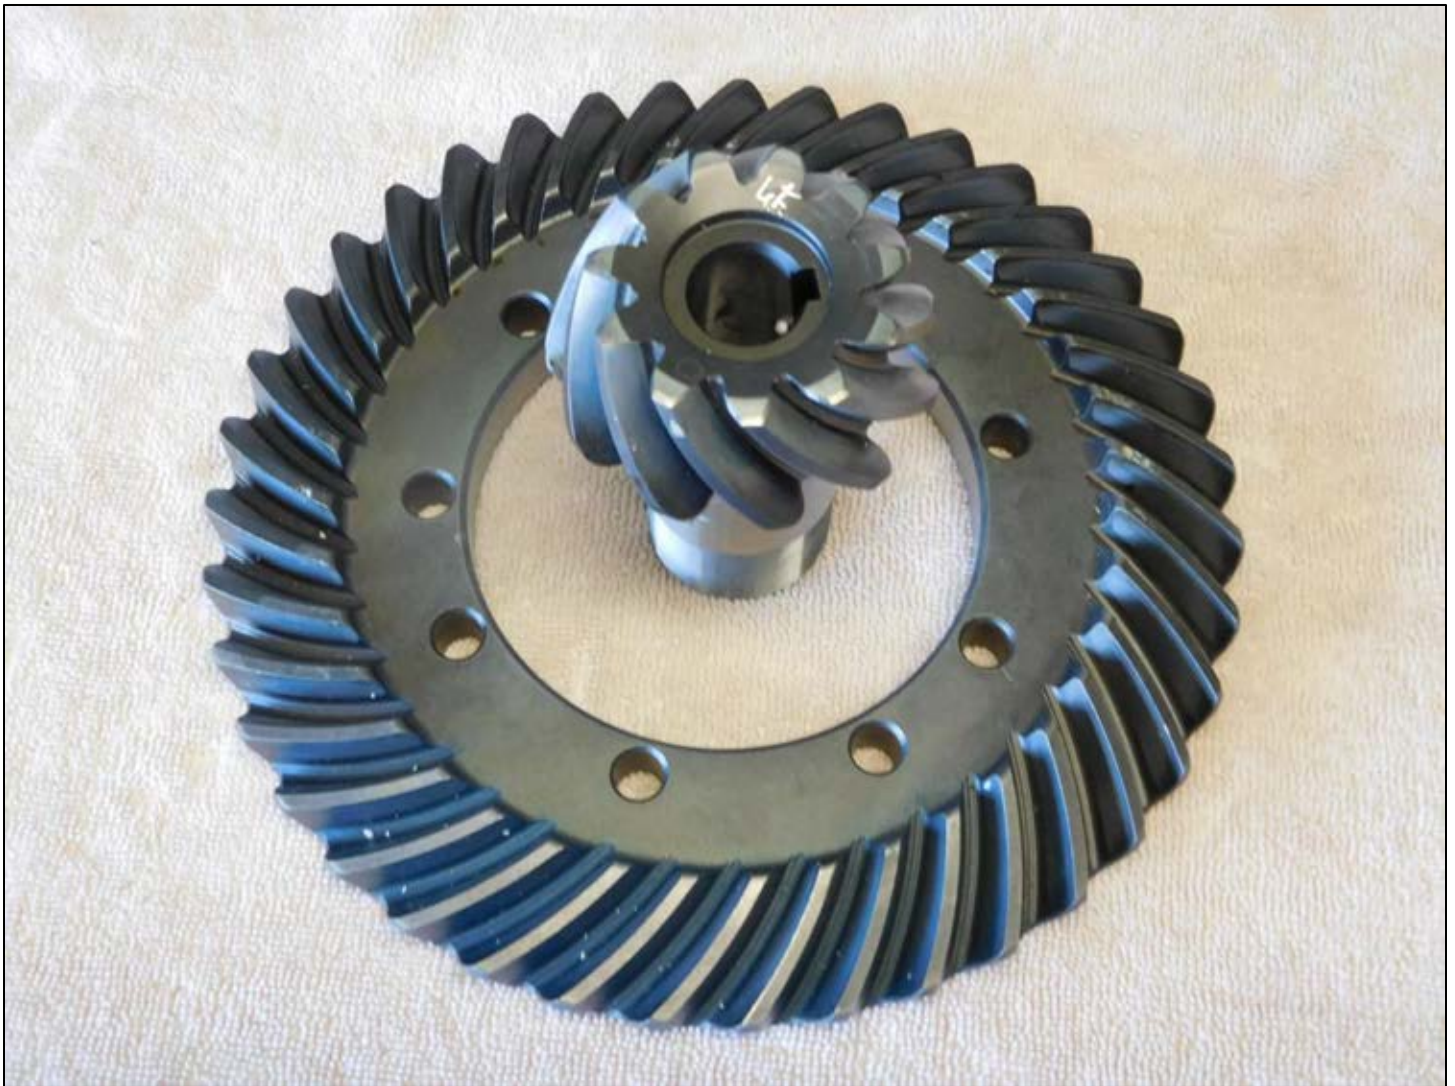
The new 354:1 ring & pinion gear set supplied by the owner is shown here. There are 39 teeth on the ring gear and 11 teeth on the pinion gear.

Unfortunately, the gear set comes from a poor-quality supplier that does not understand the need for the sleeve on the pinion gear to be machined such that there are two different diameters. The dimension closest to the pinion gear where the first bearing resides should be .0015" larger in diameter than where the second bearing resides. The first bearing should press on with an interference press fit, the second bearing should be a snug sliding fit to accommodate setting the pre-load. The pinion sleeve will have to be machined before it can be installed.

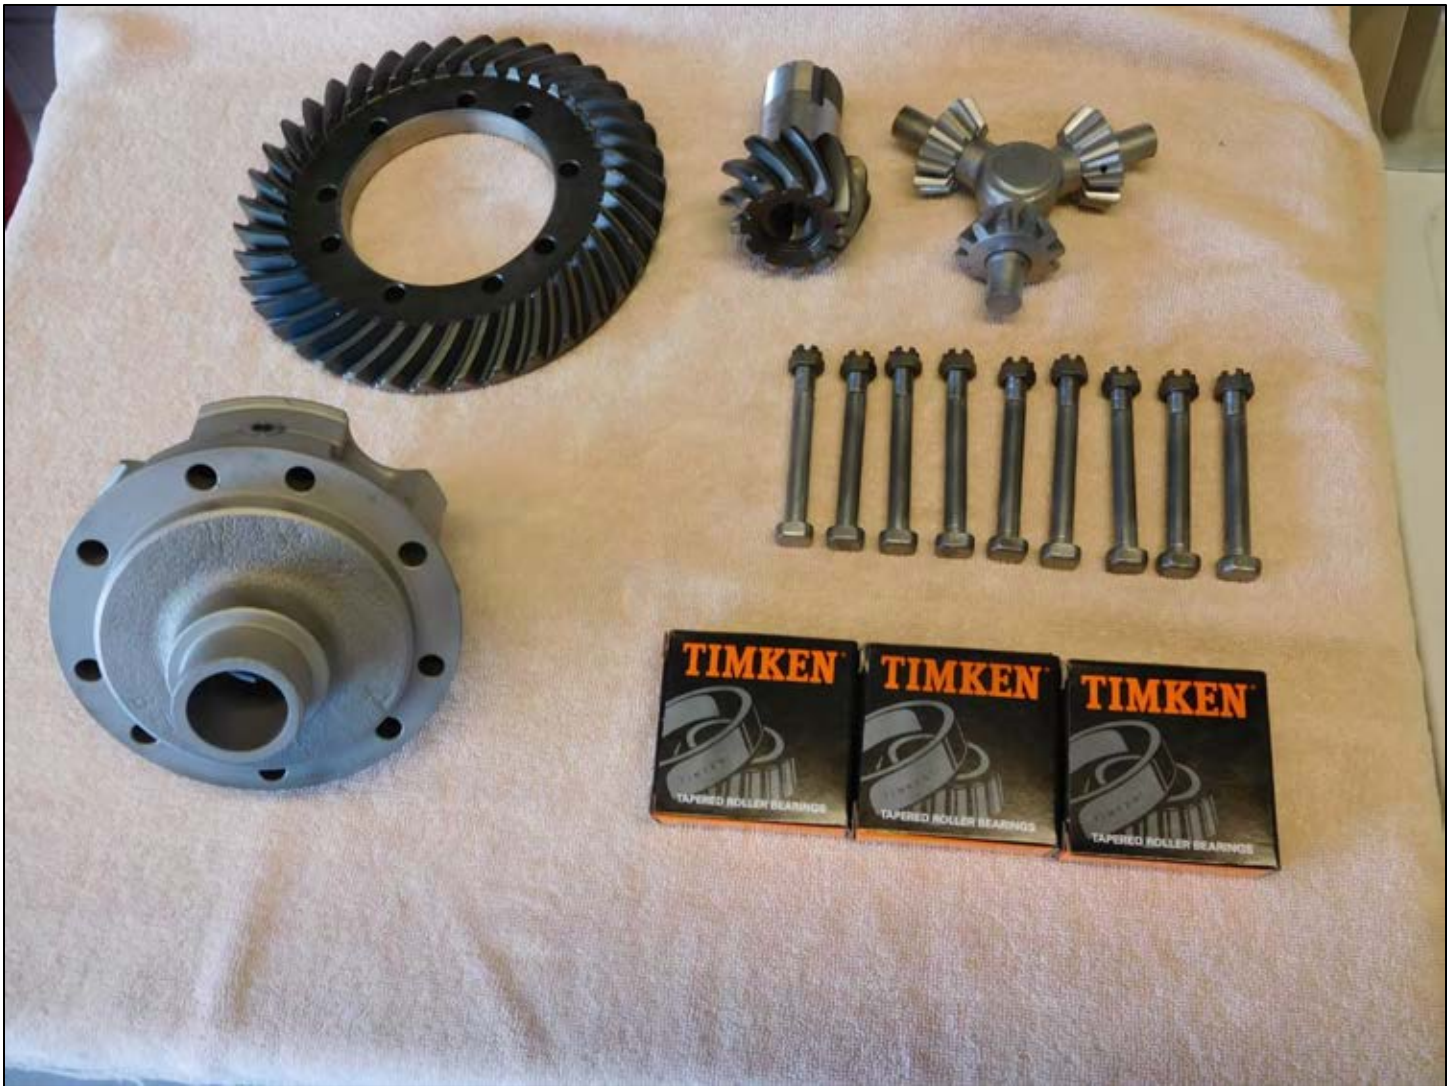
Shown here is the carrier after it has been cleaned up and bead blasted. It was found to be in excellent condition with little or no wear on the inside and the bearing hubs were not damaged due to the bearings spinning from being set up too tight. It is believed that this is the first time this rear axle assembly has been apart because the carrier bearings were found to be the originals with the Ford logo and the original part number on them.

The nine carrier bolts were bead blasted and wire wheeled. The spider gear assembly was also bead blasted. The new 354:1 ring & pinion gear set is shown here. The three new bearings shown here will have two installed on the carrier and one installed on the pinion gear after it has been machined.

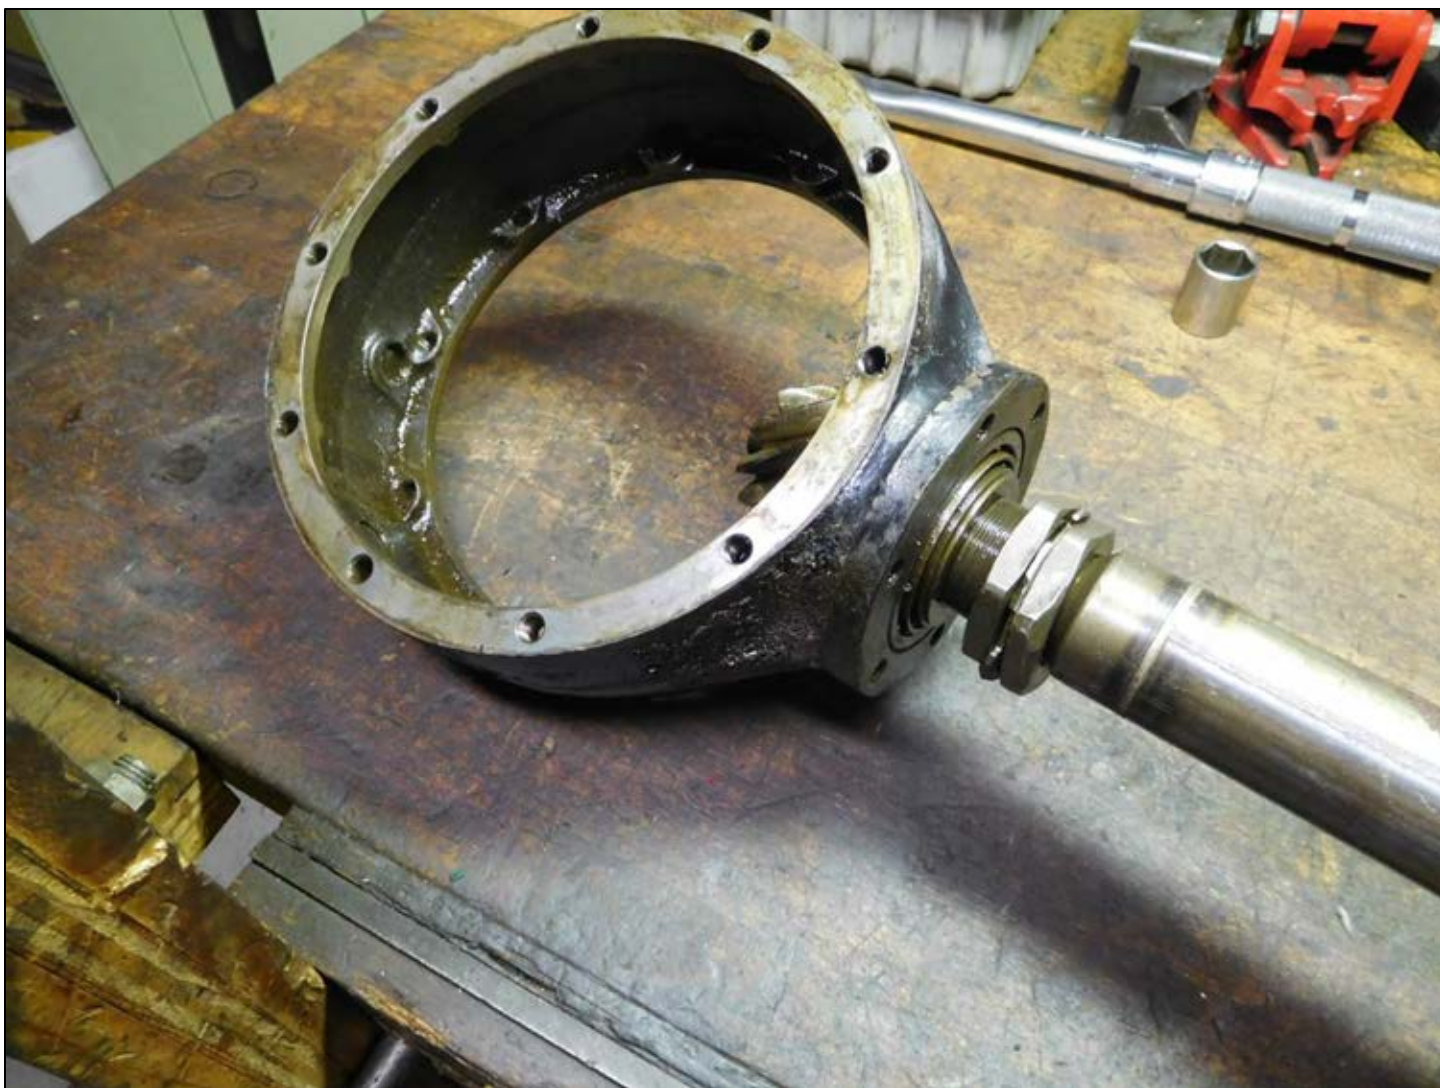
Another show stopper:

Once the torque tube was removed after the removal of the frozen speedo drive gear it was discovered that the drive shaft was found to be a 1&3/4" diameter hollow tube welded over a smaller solid drive shaft. Apparently this is particular to the 1932 V8's. This prevents the two large nuts, lock and thrust washers, and the front pinion bearing from being slid off over the drive shaft and then the drive shaft with the pinion gear on it from being pushed out the side of the banjo.

In order to take this assembly apart the entire pinion assembly, including the double race, will have to be pulled from the banjo. However, because of the large diameter of the drive shaft my Model A pinion puller will not fit the shaft. Some other method will have to be improvised.

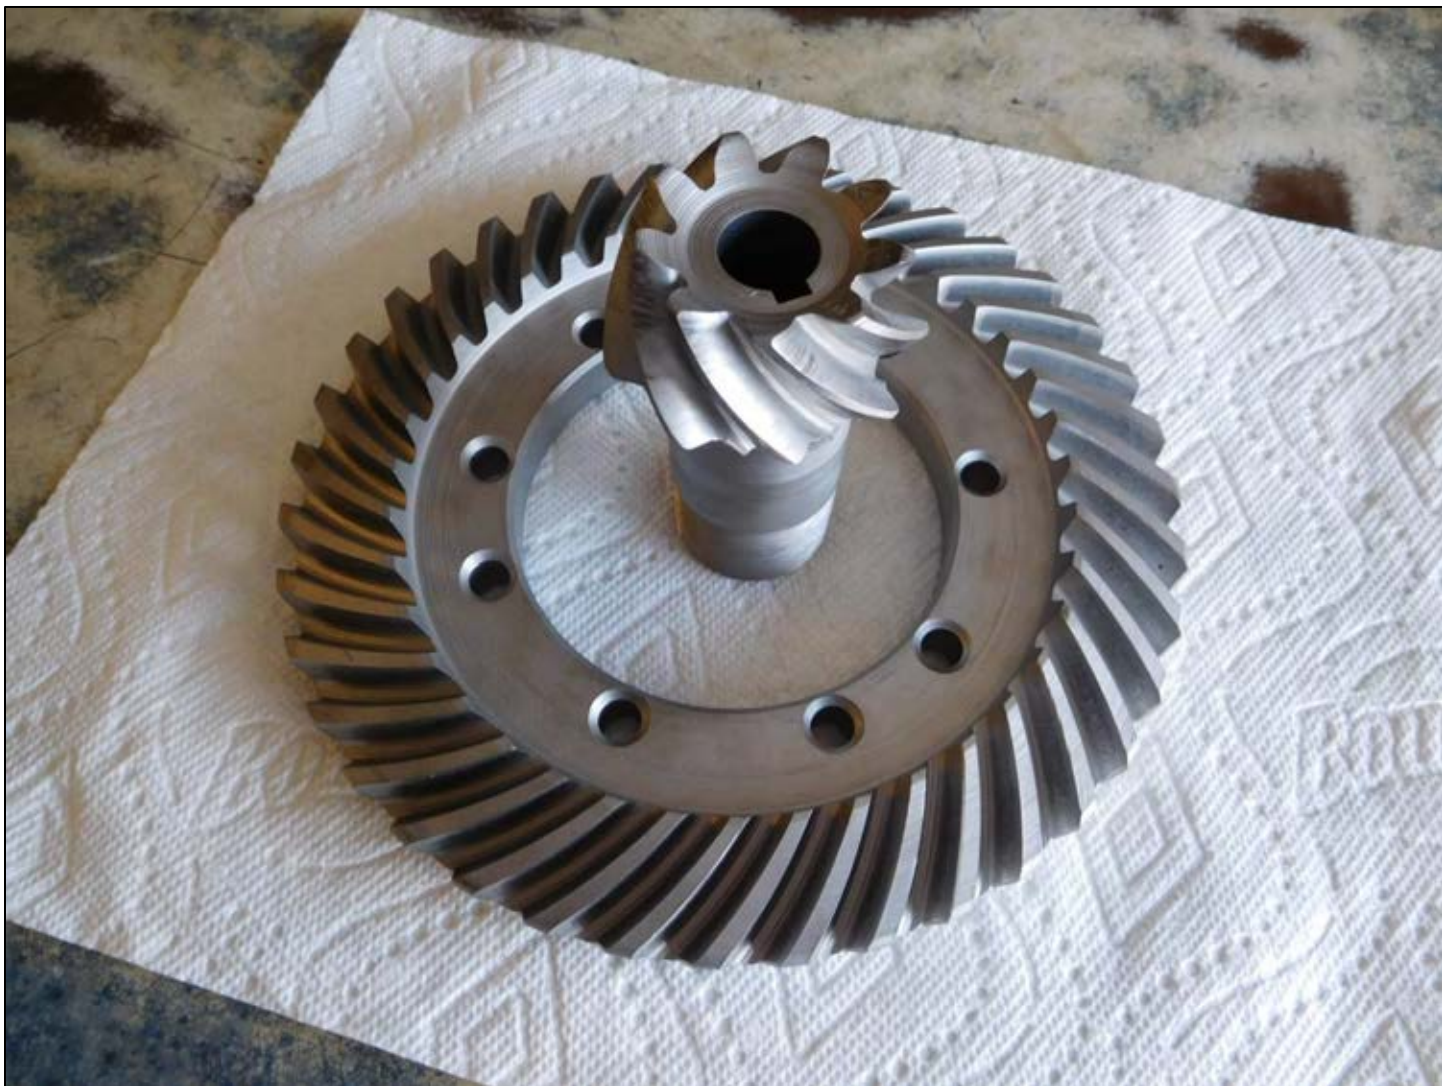
Shown here is the ring & pinion gearset that was removed from the 1932 rear axle assembly after it was degreased and bead blasted. The gear ratio is 4.33:1 (39 teeth on the ring gear, 9 on the pinion gear). The gear set is in excellent condition; however, it is of little value as the gear ratio is too low for today's modern roads.
