Differential Rebuild 1932 V8 Ford June 2, 2019

by Tom Endy

This job came into the shop for the purpose of having the ring & Pinion gear ratio changed from what ever found to a 354:1 ratio. The owner supplied a new gear set. The unit came out of a 1932 Tudor with a V8 engine. The early 1932's are similar to a Model A rear axle assembly; however, there are several differences. This will be a complete overhaul with new bearings, races, seals, and gaskets.

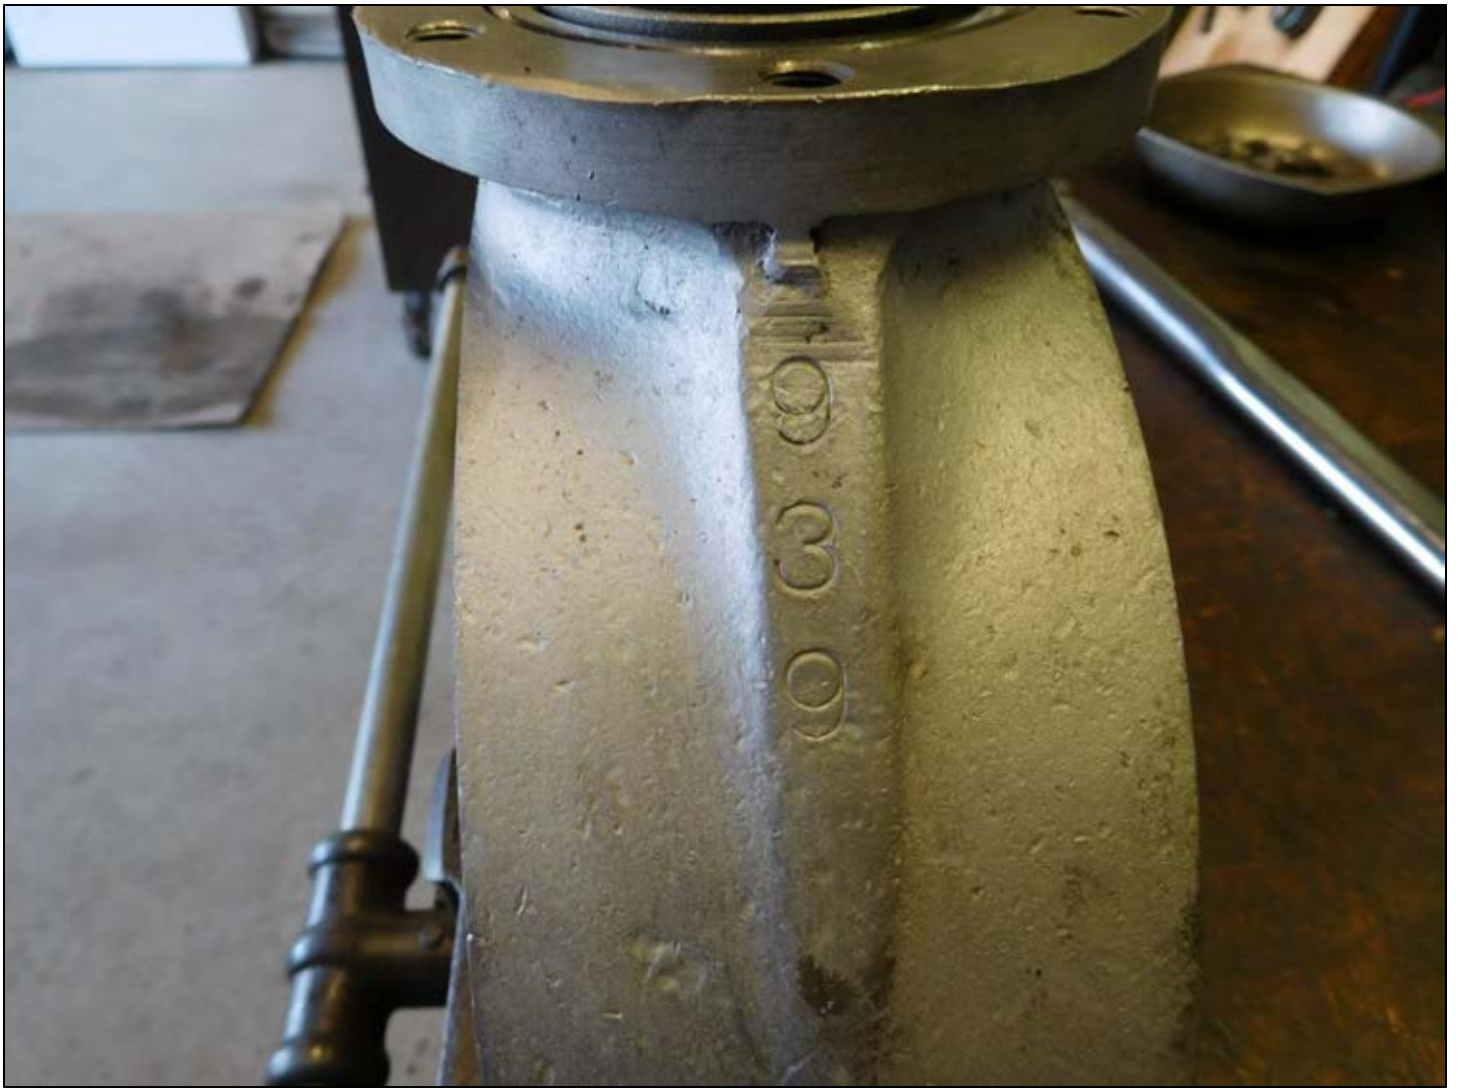
The numbers seen here stamped on the side of the banjo (939) apparently stand for the number of teeth on the ring and the pinion gears. Nine on the pinion gear, thirty-nine on the ring gear, a 433:1 gear ratio.

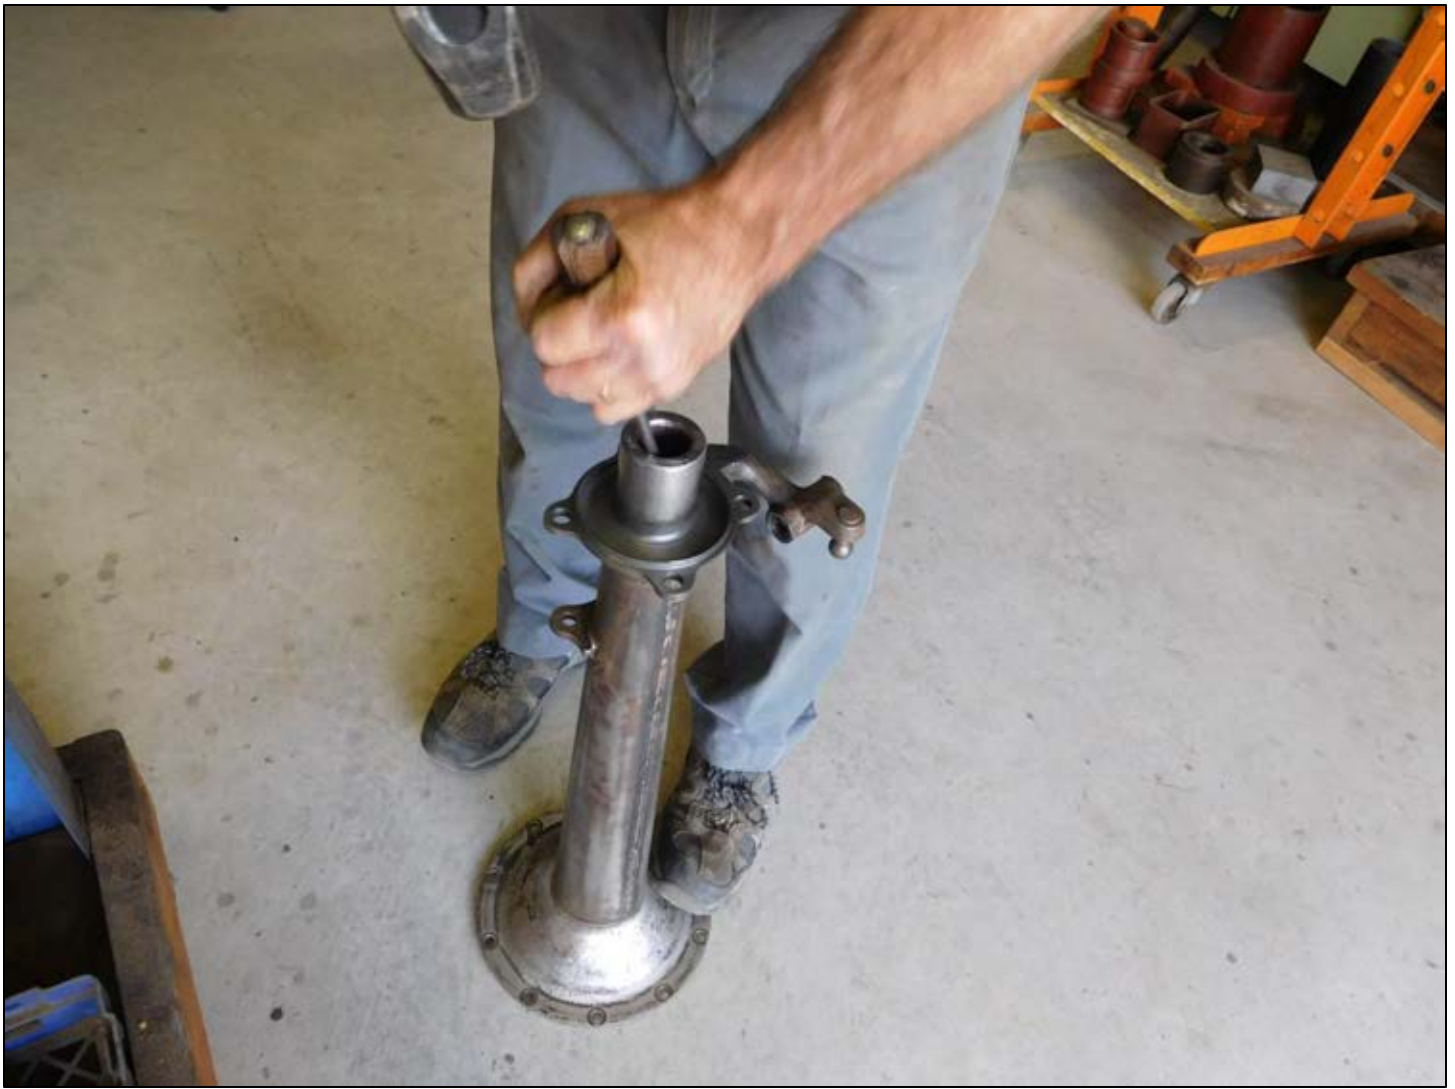
Another show stopper:

When it was time to install the new grease seals in the two axle housings it became apparent that both would not install. A closer inspection revealed that the outboard portion of both seals were still jammed into the two axle housings. The trick was to get them out. There was not much to grab onto with a screwdriver to drive them out. After much coaxing, the seal portions were driven down about 1\8". A combination screwdriver residing in my tool box became the tool to drive them out the rest of the way.

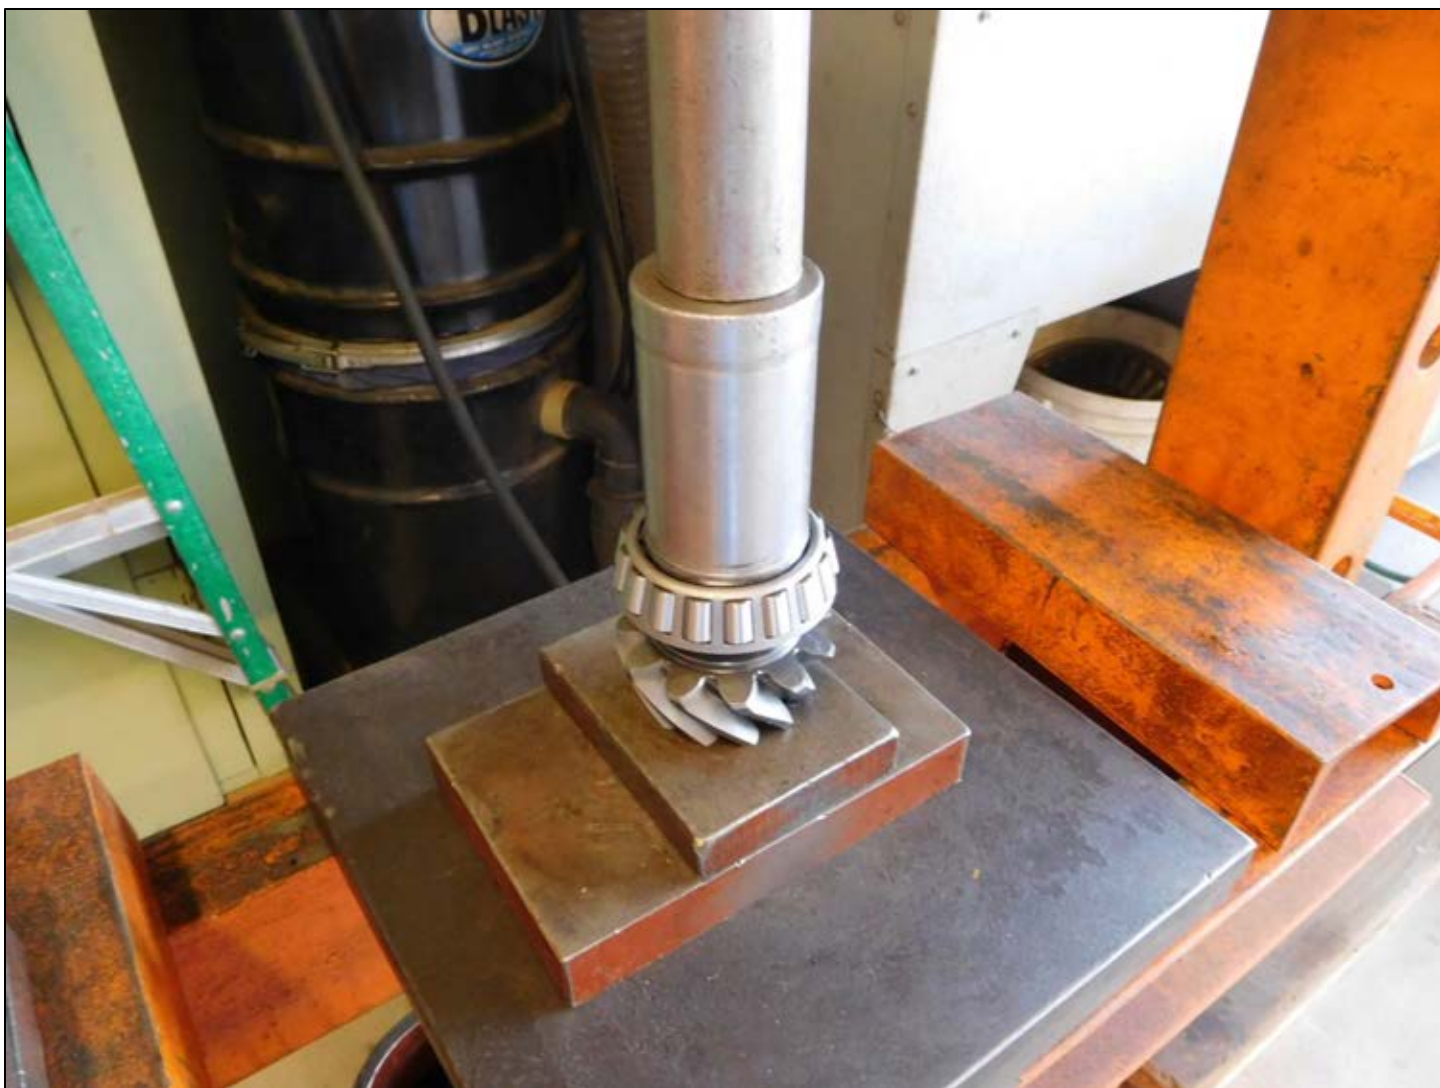
The new 354:1 pinion gear shown here has had the sleeve machined so that the front bearing is not an interference press fit, but a sliding snug fit. During the machining process it was discovered that the gear did not run true when attached to the tool that allows it to be mounted on a lathe. The run-out was off by about .002". Hopefully this will not affect the backlash adjustment.

This gearset came from one of the more notorious poor-quality suppliers. My recommendation is to purchase new ring & pinion gearsets from Bratton's Antique Auto.

The photo shows the rear bearing being pressed onto the pinion gear using a shop press. The rear bearing should and does press on with an interference press fit.
