Rear Axle Assembly Overhaul Pictorial

July 2018 by Tom Endy

This is a pictorial of a typical rear axle assembly that has been received for overhaul. It is long and tedious. However, for those who have taken on the task of overhauling a rear axle assembly themselves, the photos and captions may be of help.

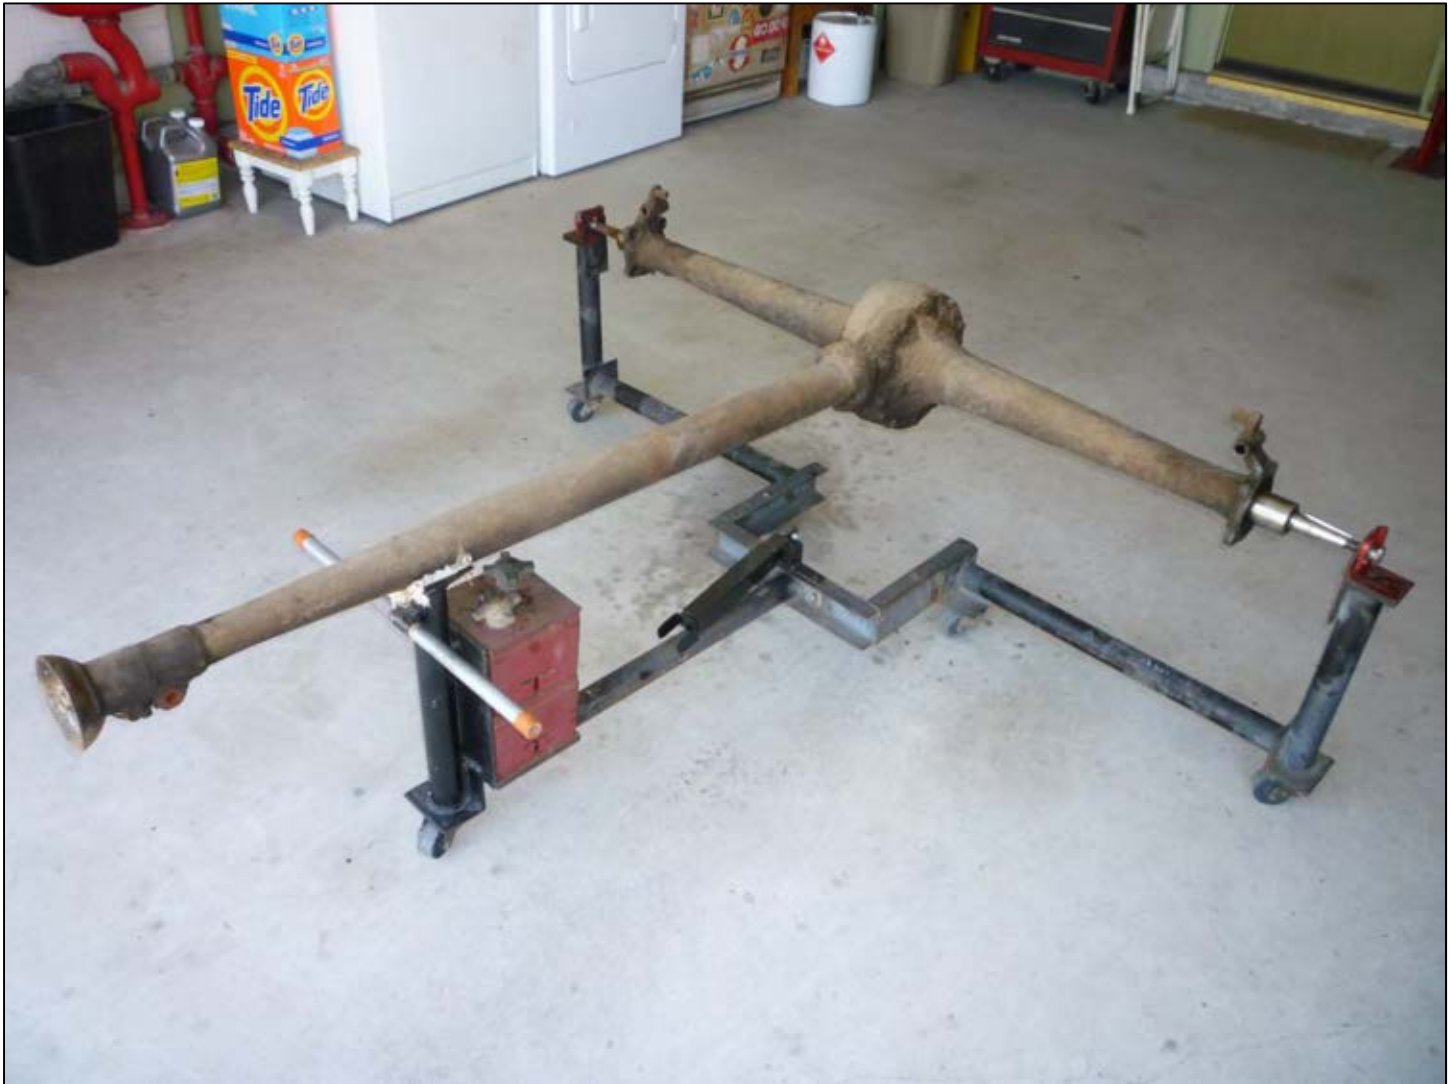
The job arrived in the back of a modern pick-up truck. It came out of a running Model A. The owner said the car had been stored in a shed for about 50 years. He was able to get it running and drove it around the neighborhood. However, an inspection revealed a section of the end of the right rear axle shaft was broken away at the key, and was the reason for the decision to have the entire rear axle assembly overhauled.

The exterior was extremely cruddy, one of the worst.

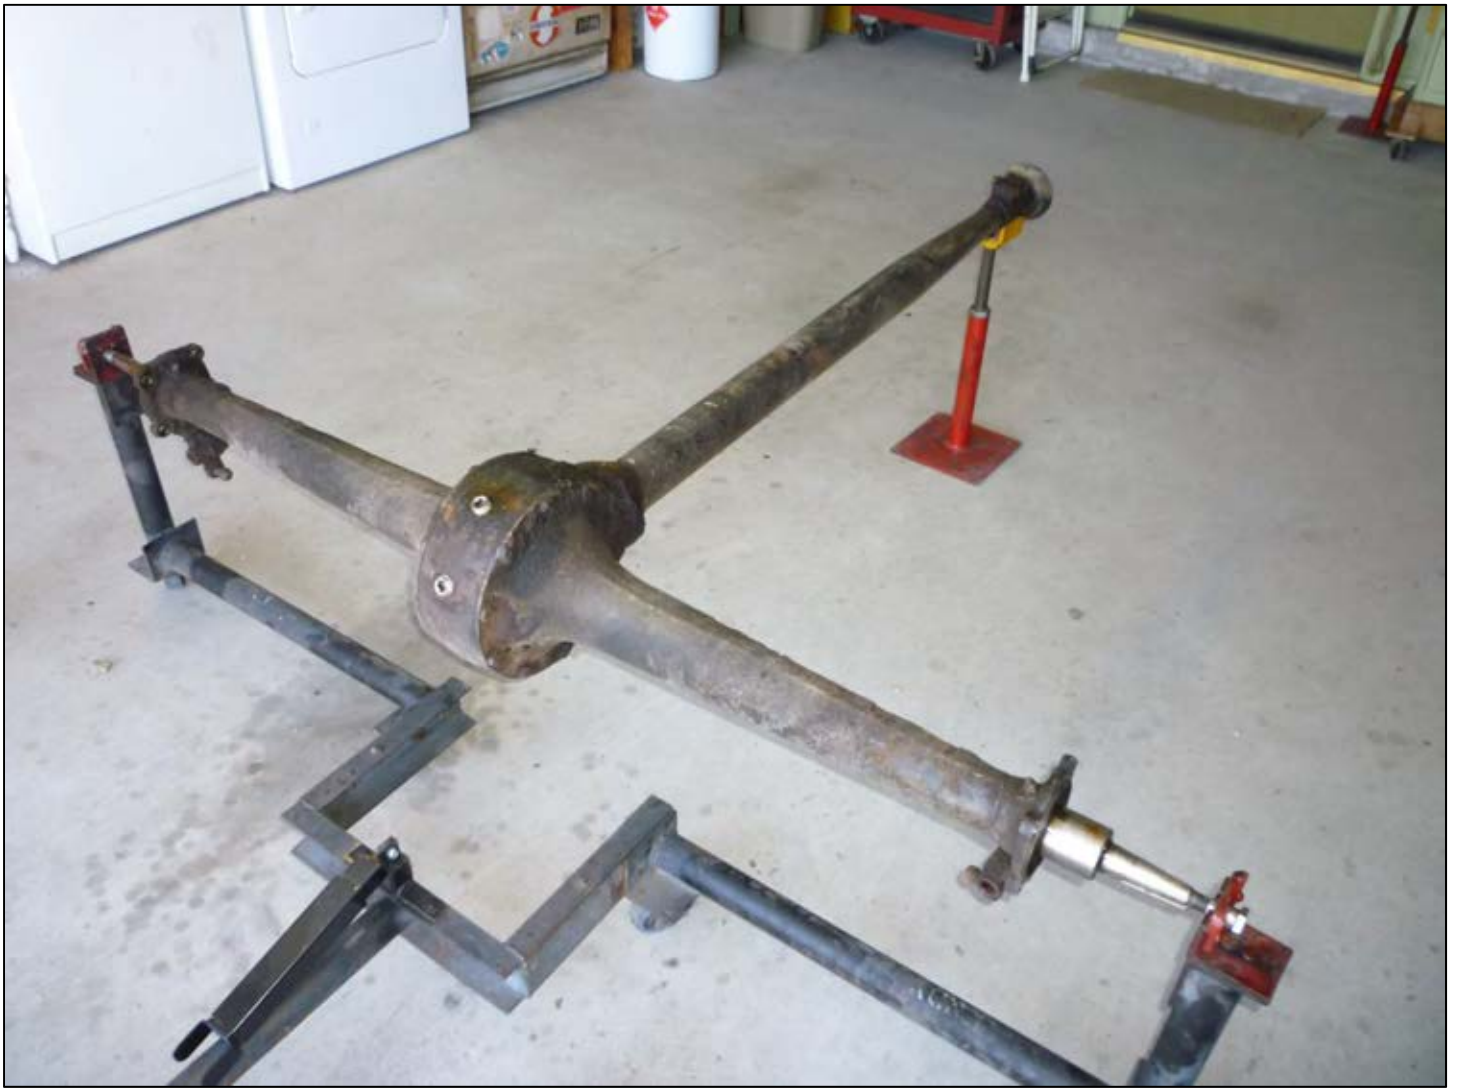
The bottom side was not as cruddy as the top side.

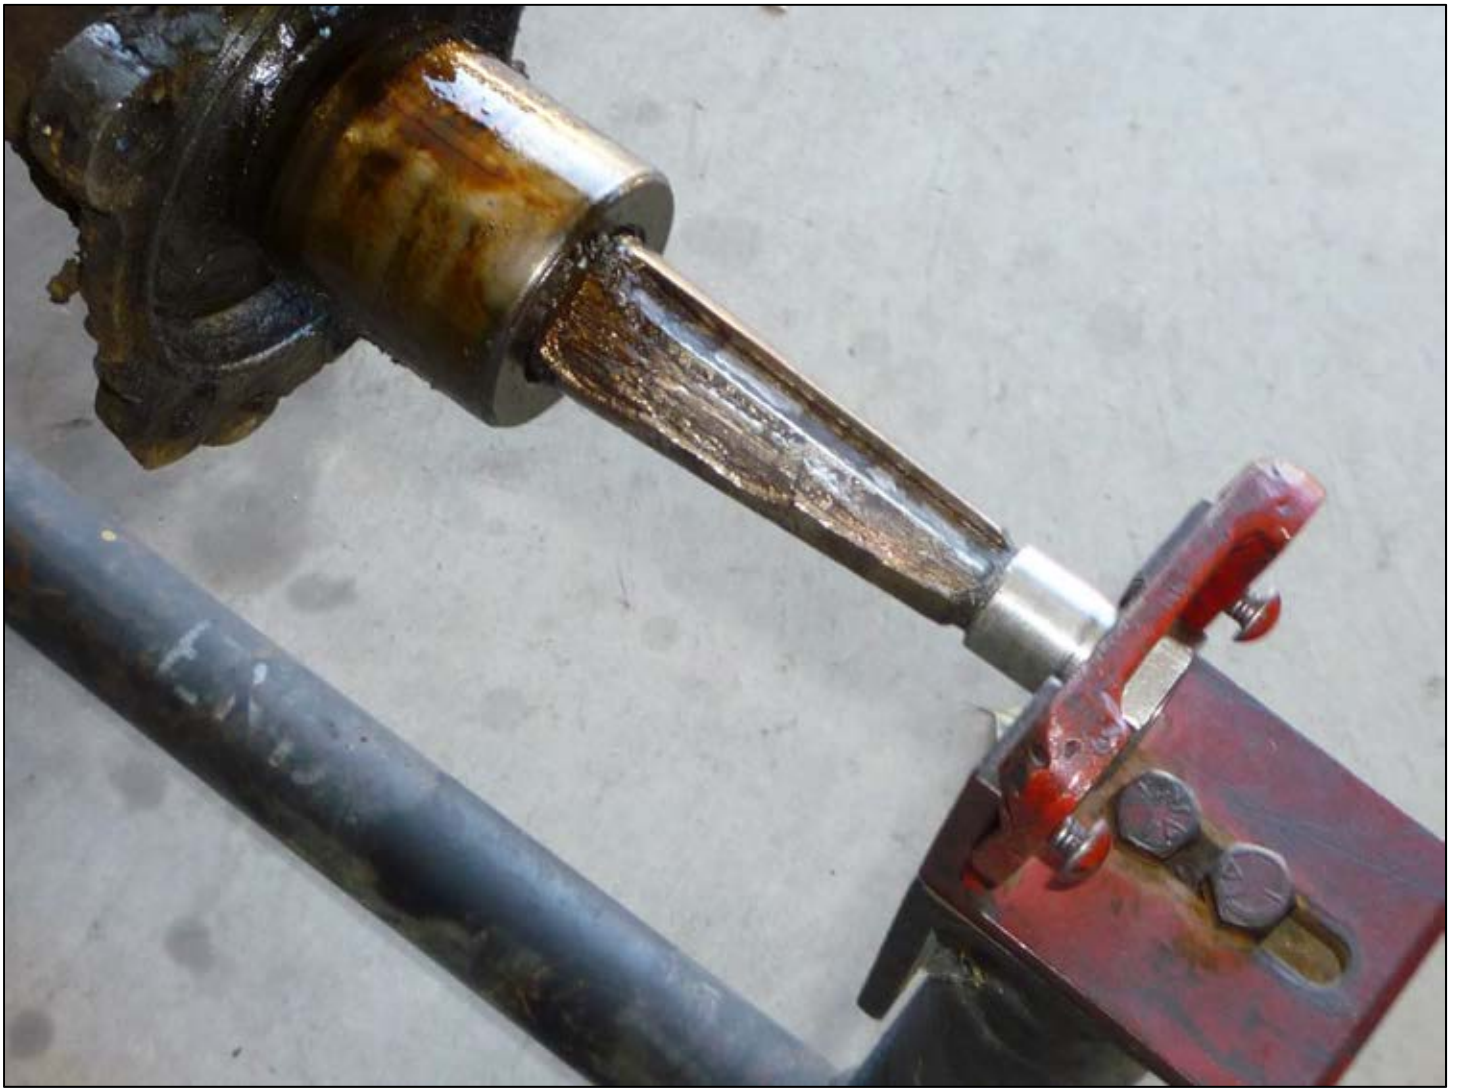
The end of the right axle shaft has a section broken off at the key and is the reason for the overhaul.

The damaged right axle shaft was replaced with serviceable original.

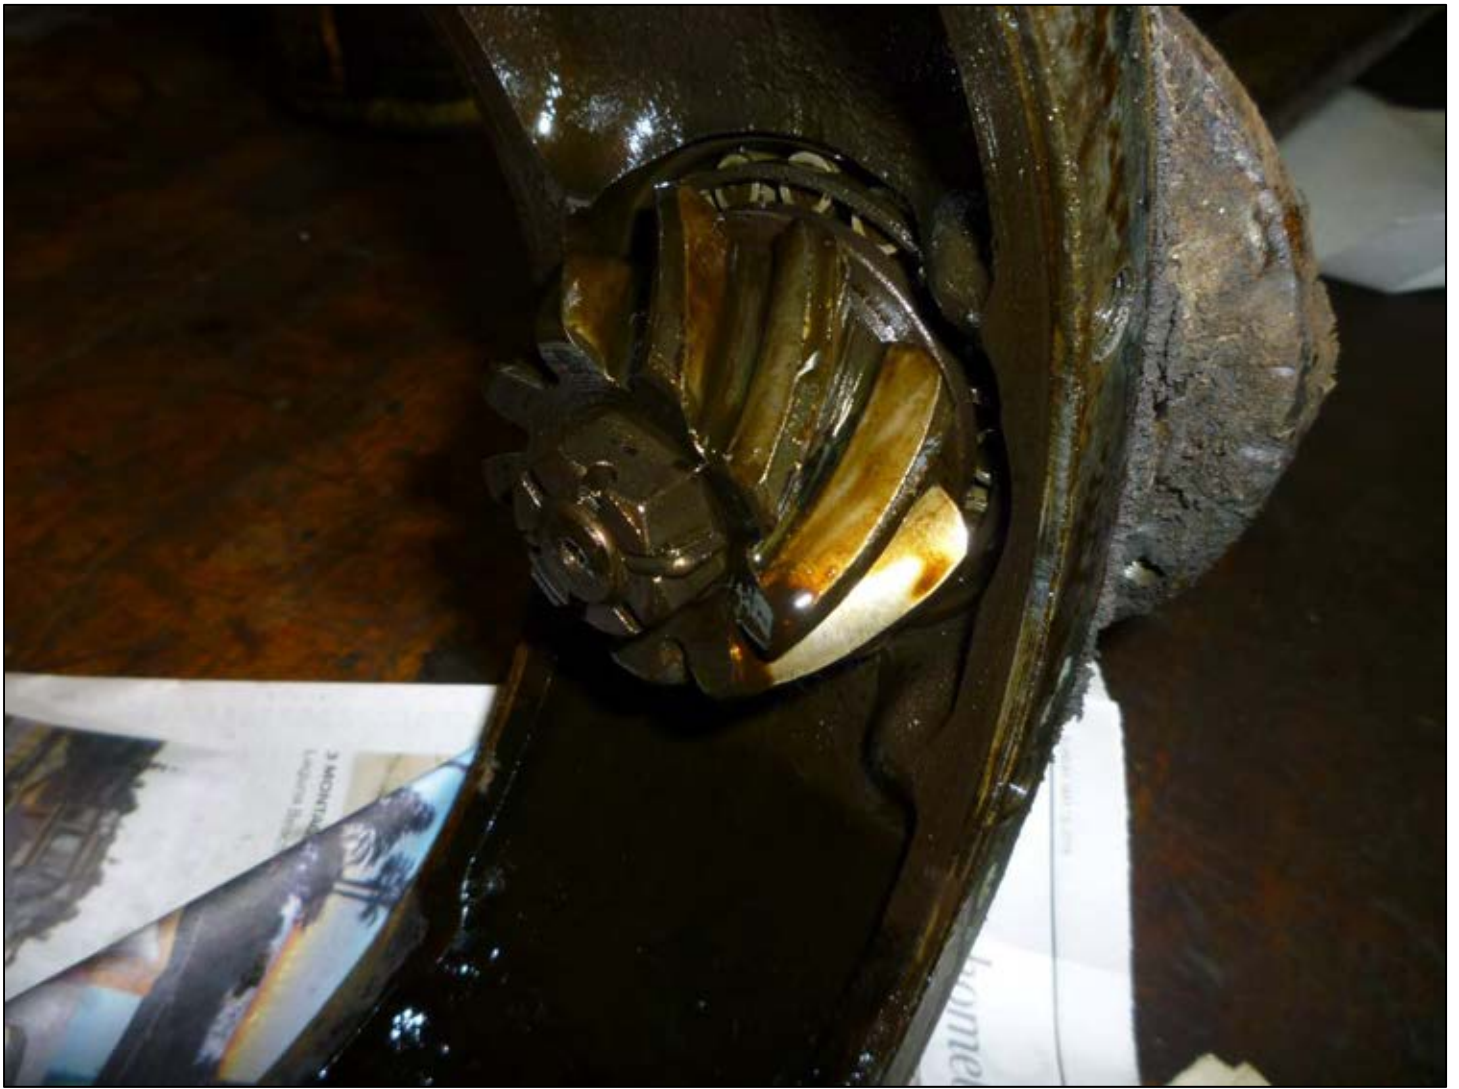
The inside of the rear axle assembly was surprisingly clean compared to the outside. The pinion gear seen here appears to be in very good condition. The cotter pin in the nut at the end of the drive shaft was installed properly with the legs bent down along the side of the nut.

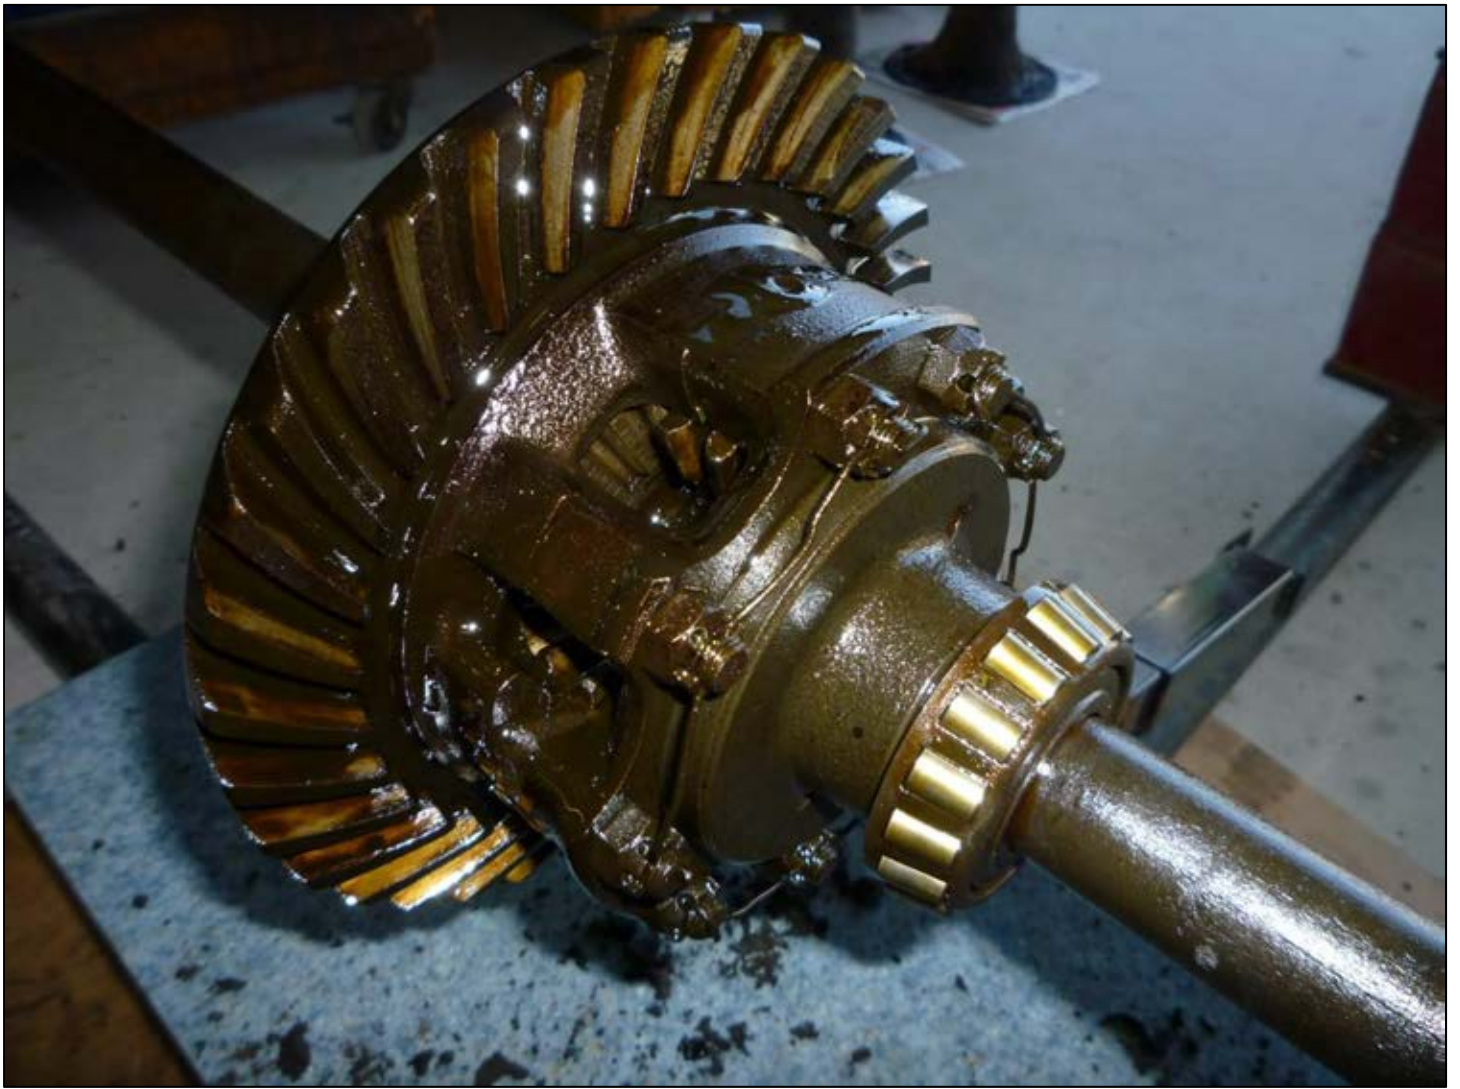
The ring gear also appears to be in very good condition

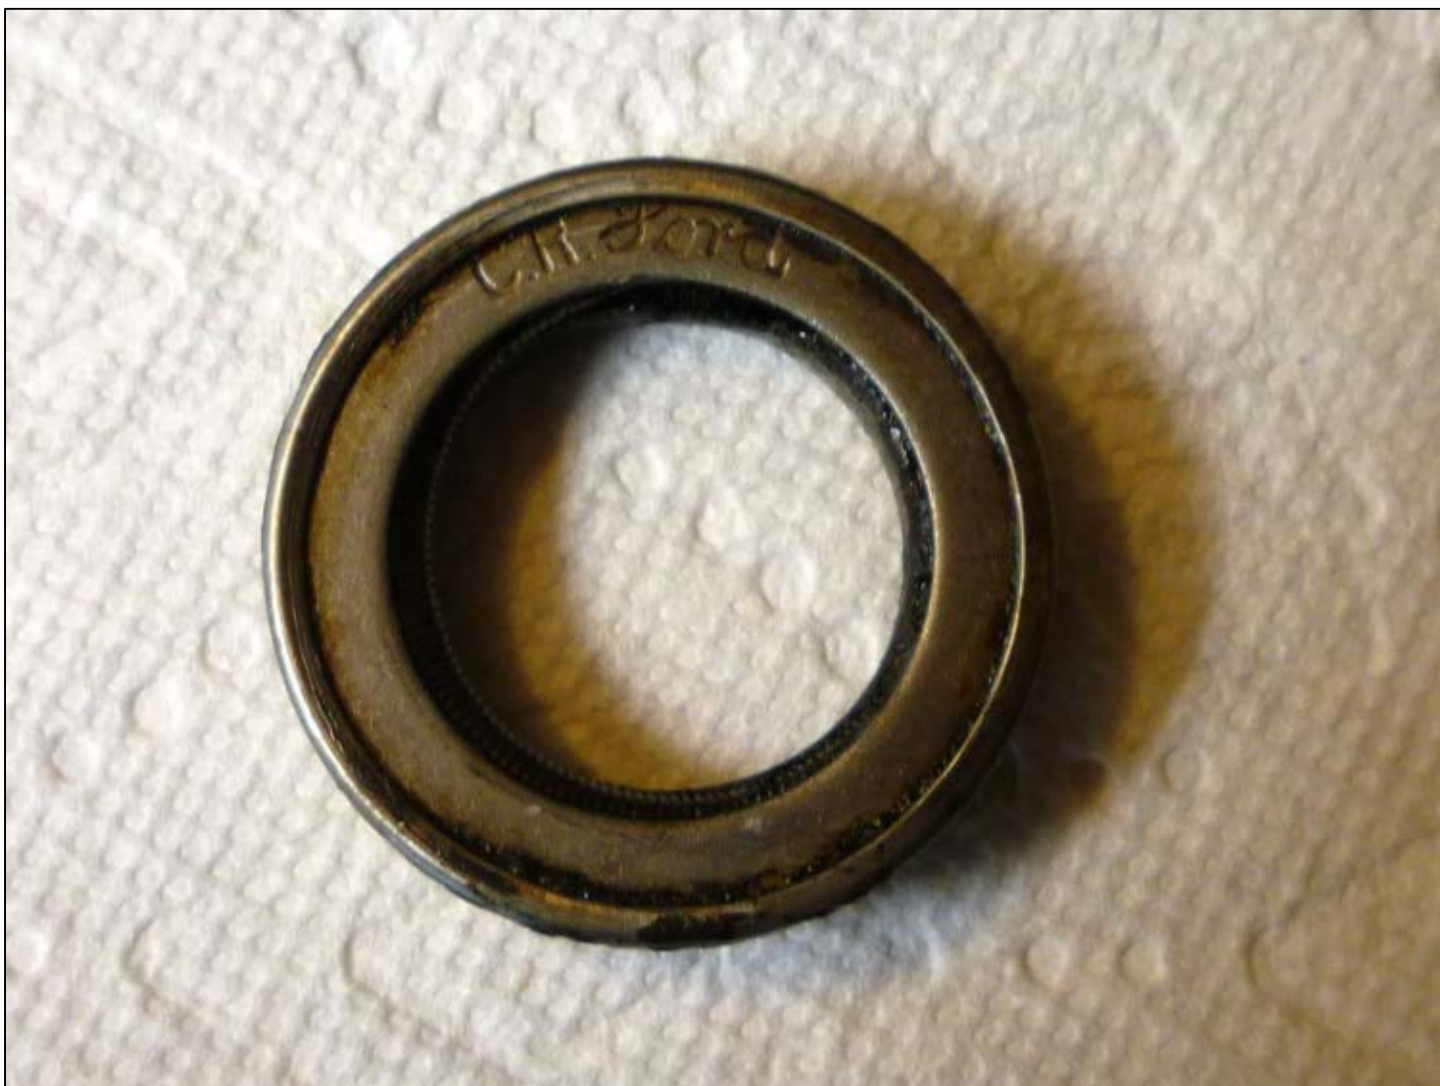
The original grease seals installed in a Model A at the Ford factory were made of leather. The letter CR stamped on the side next to the Ford logo stands for Chicago Rawhide.

The leather found on these particular seals was largely deteriorated, which is usually the case when original seals are discovered to still be installed in a rear axle assembly.

The three seals used in a Model A rear axle assembly are grease seals, not oil seals. There is a belief by some that the purpose of the seals is to keep the differential oil from traveling to the brake shoes and to the U-joint at the front of the torque tube. Their purpose is to direct the flow of grease to the rear wheel bearings and to the roller bearing in the front of the torque tube.

Quite often I have found completely deteriorate original seals in an overhaul job with no sign of differential oil having reached the brake shoes. What I do find is a large amount of grease that has centrifuged around the axle shafts and traveled toward the differential.

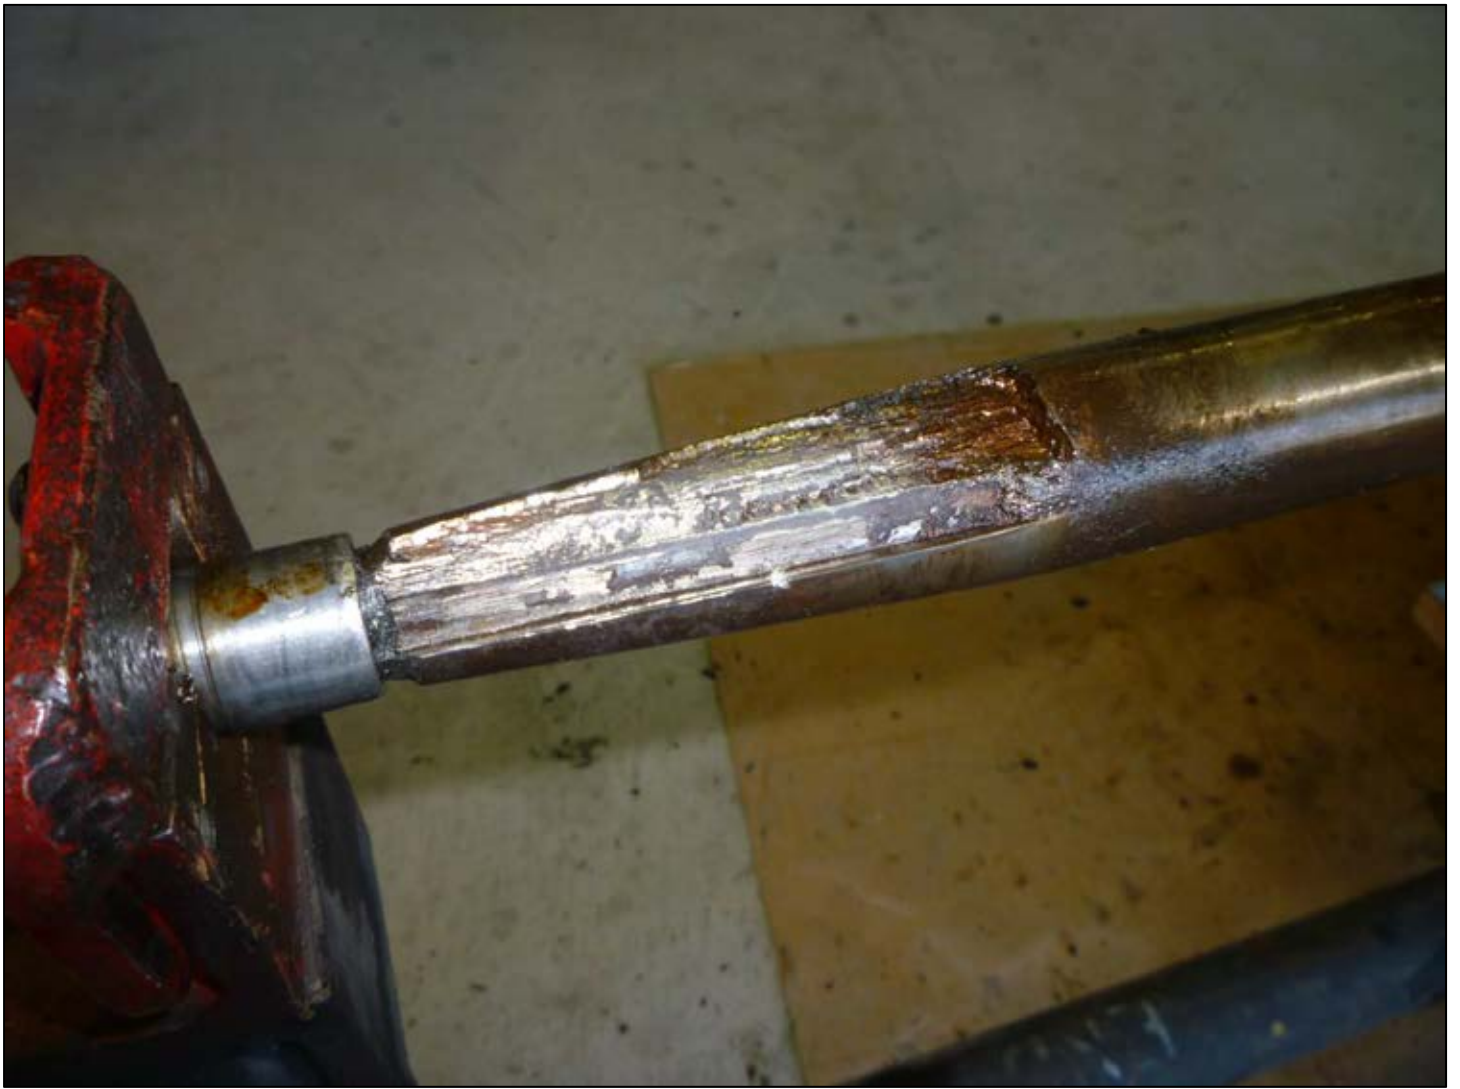
A closer look at the damaged right axle shaft:

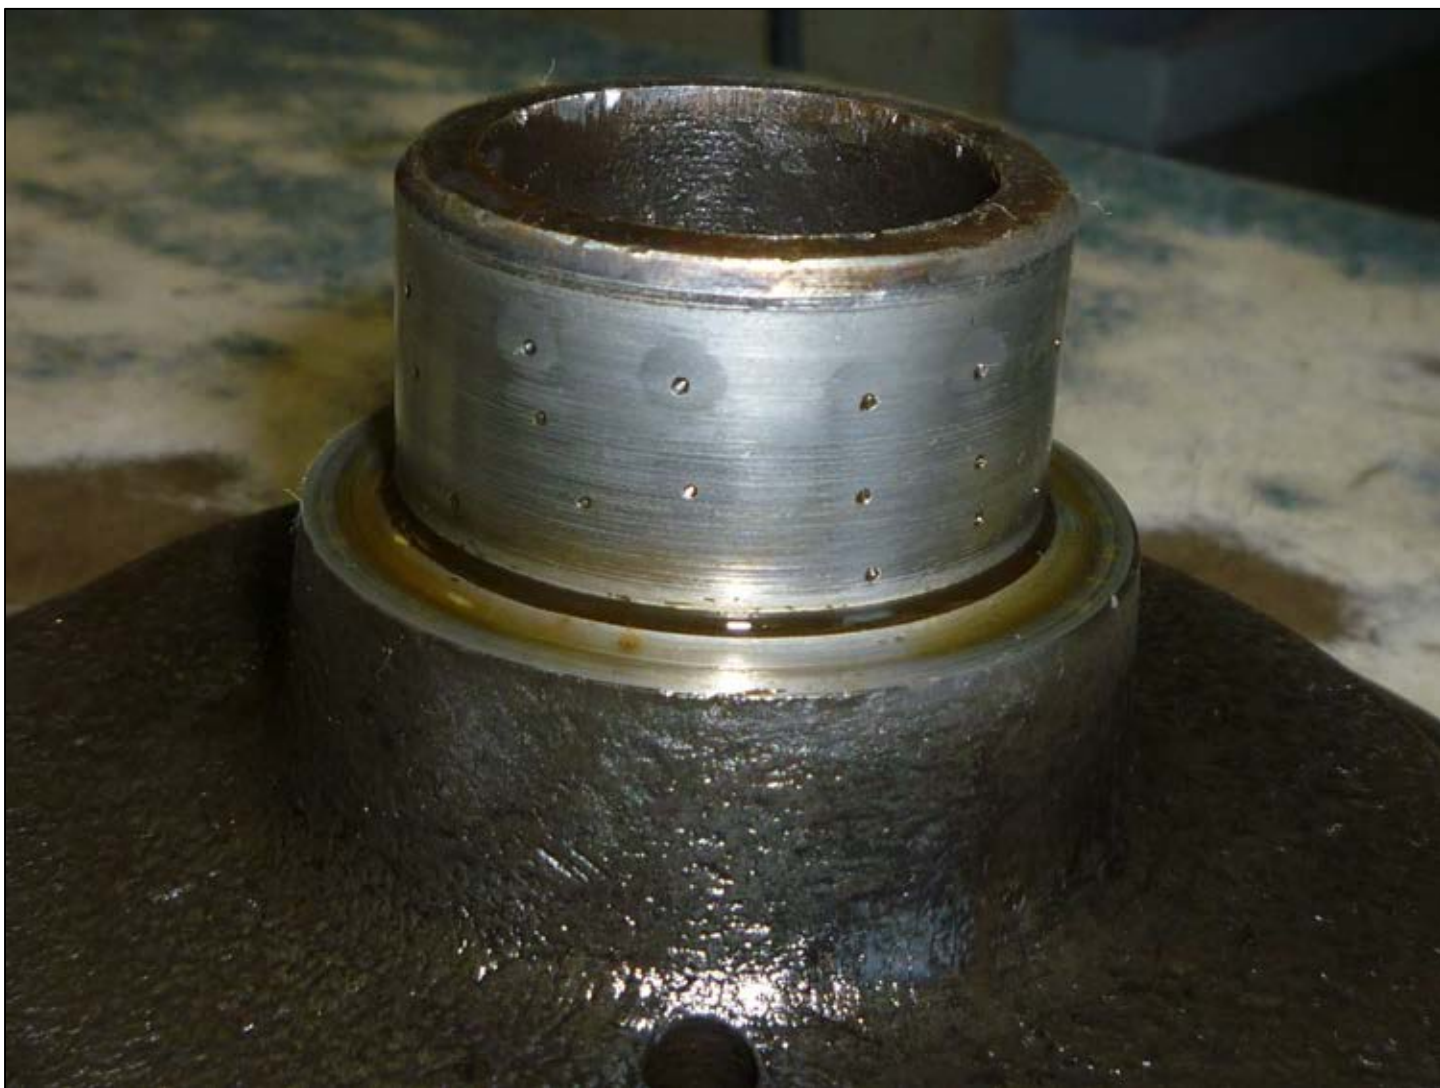
The ring gear half of the carrier was found spun. The bearing just fell off. If only one side of a carrier is found spun, it is always the ring gear side. My theory is that the ring gear side receives the initial torque from the pinion gear. The opposite carrier half was not spun.

Note the punch marks on the hub. This was done many years ago by a previous mechanic because he also found the ring gear side spun and the punch marks are his attempt at knurling.

The reason carrier bearings are often found spun is because people who have previously worked on the assembly did not understand the pre-load requirement. They simply put a single gasket on each side of the banjo and in most cases locked the carrier up. Henry's 40 horses broke it loose once the car was back on the road, and the result is the bearings are spun on their mounts. Setting the pre-load usually requires multiple banjo gaskets.

The carrier will be replaced (exchanged) with one that has had the hubs knurled.

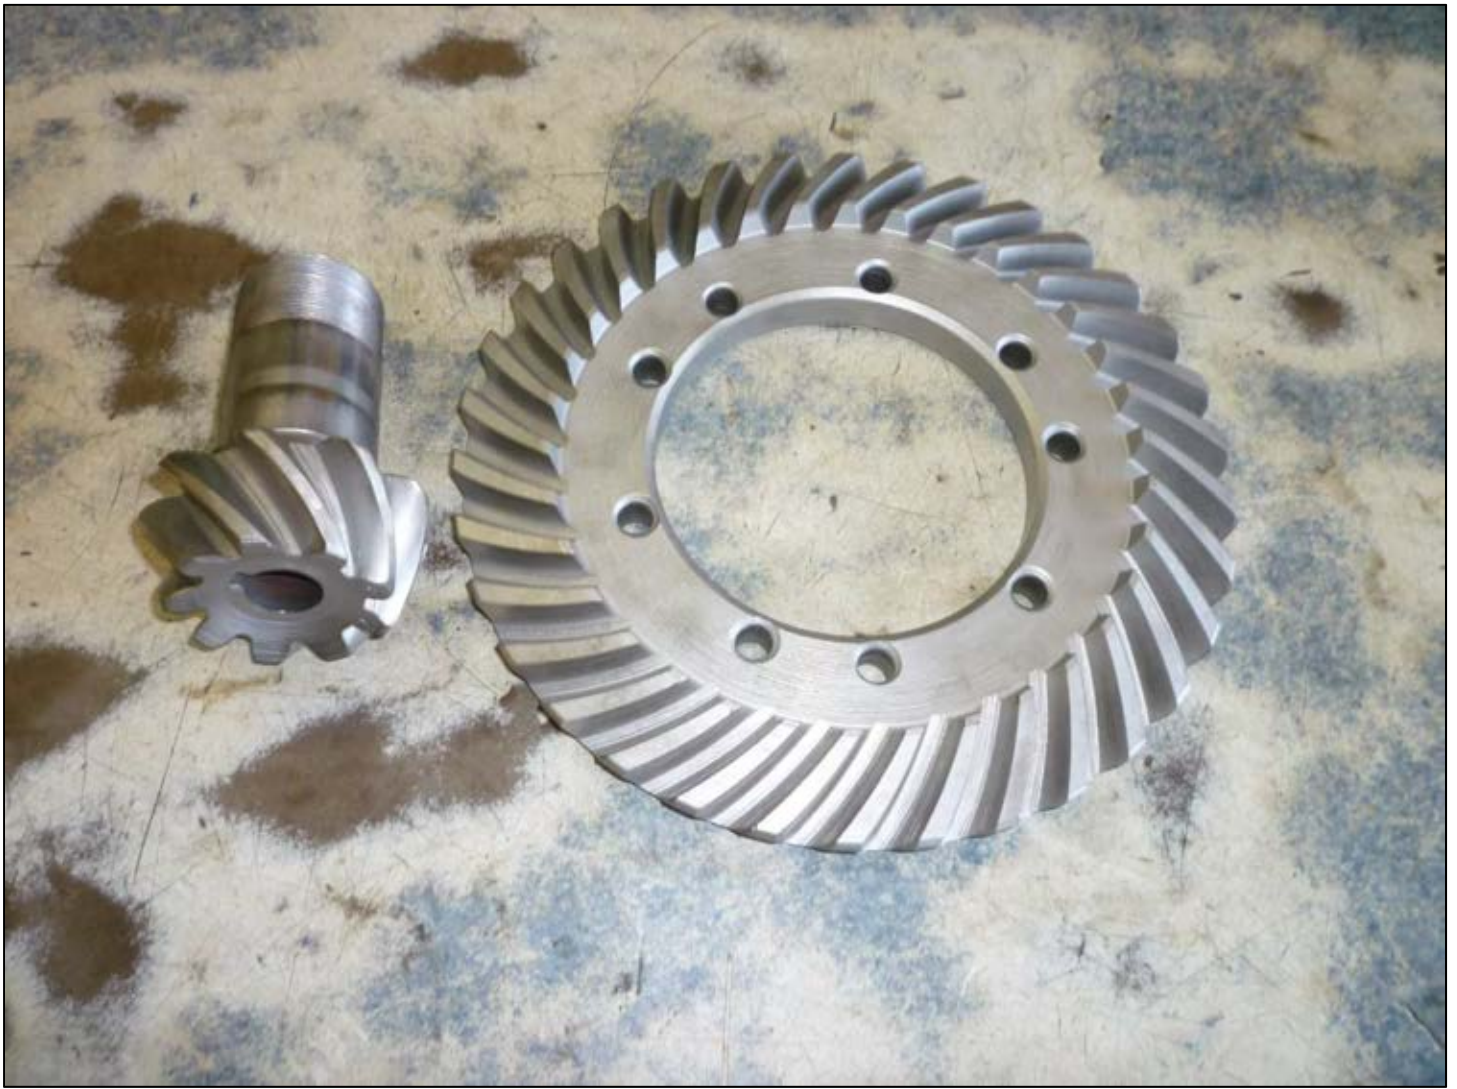
The ring & pinion gears were found to be in excellent condition. They are shown here after they were de-greased and bead blasted. The gear ratio is 378:1. There are 9 teeth on the pinion gear, and 34 on the ring gear.
