March 2019 Differential Overhaul

By Tom Endy

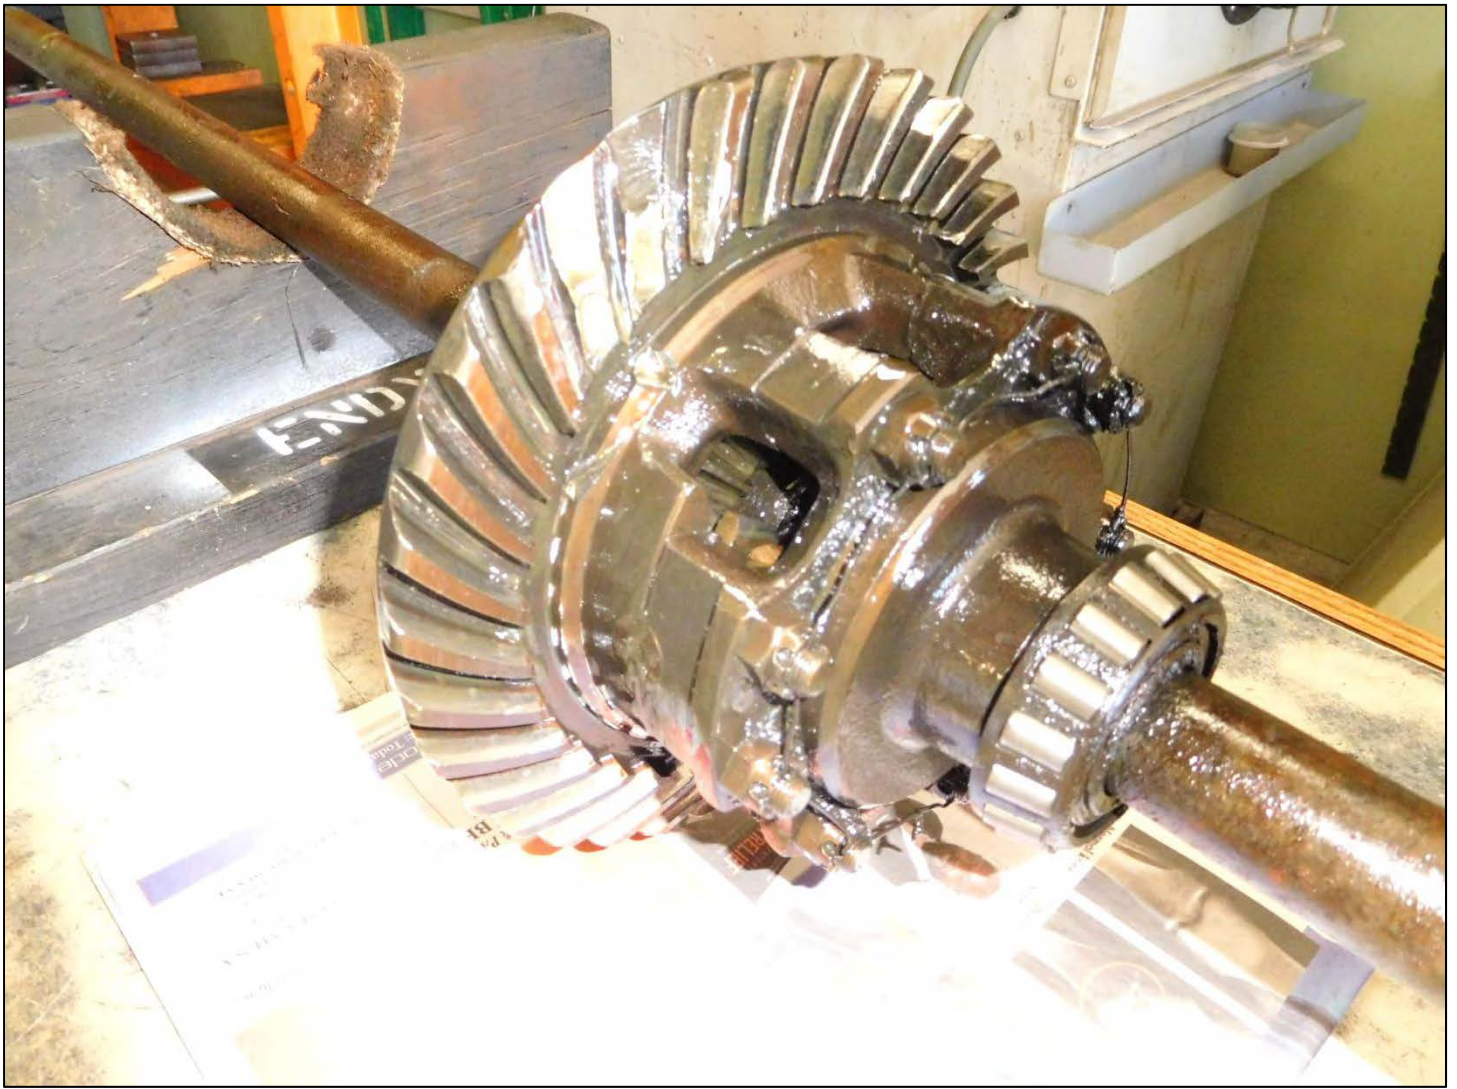
Three teeth were found knocked off the ring gear. Both bearings on the carrier were spun on their hubs. The inside of the carrier where the spider gears rotate was worn excessively. The carrier will have to be replaced along with the ring & pinion.

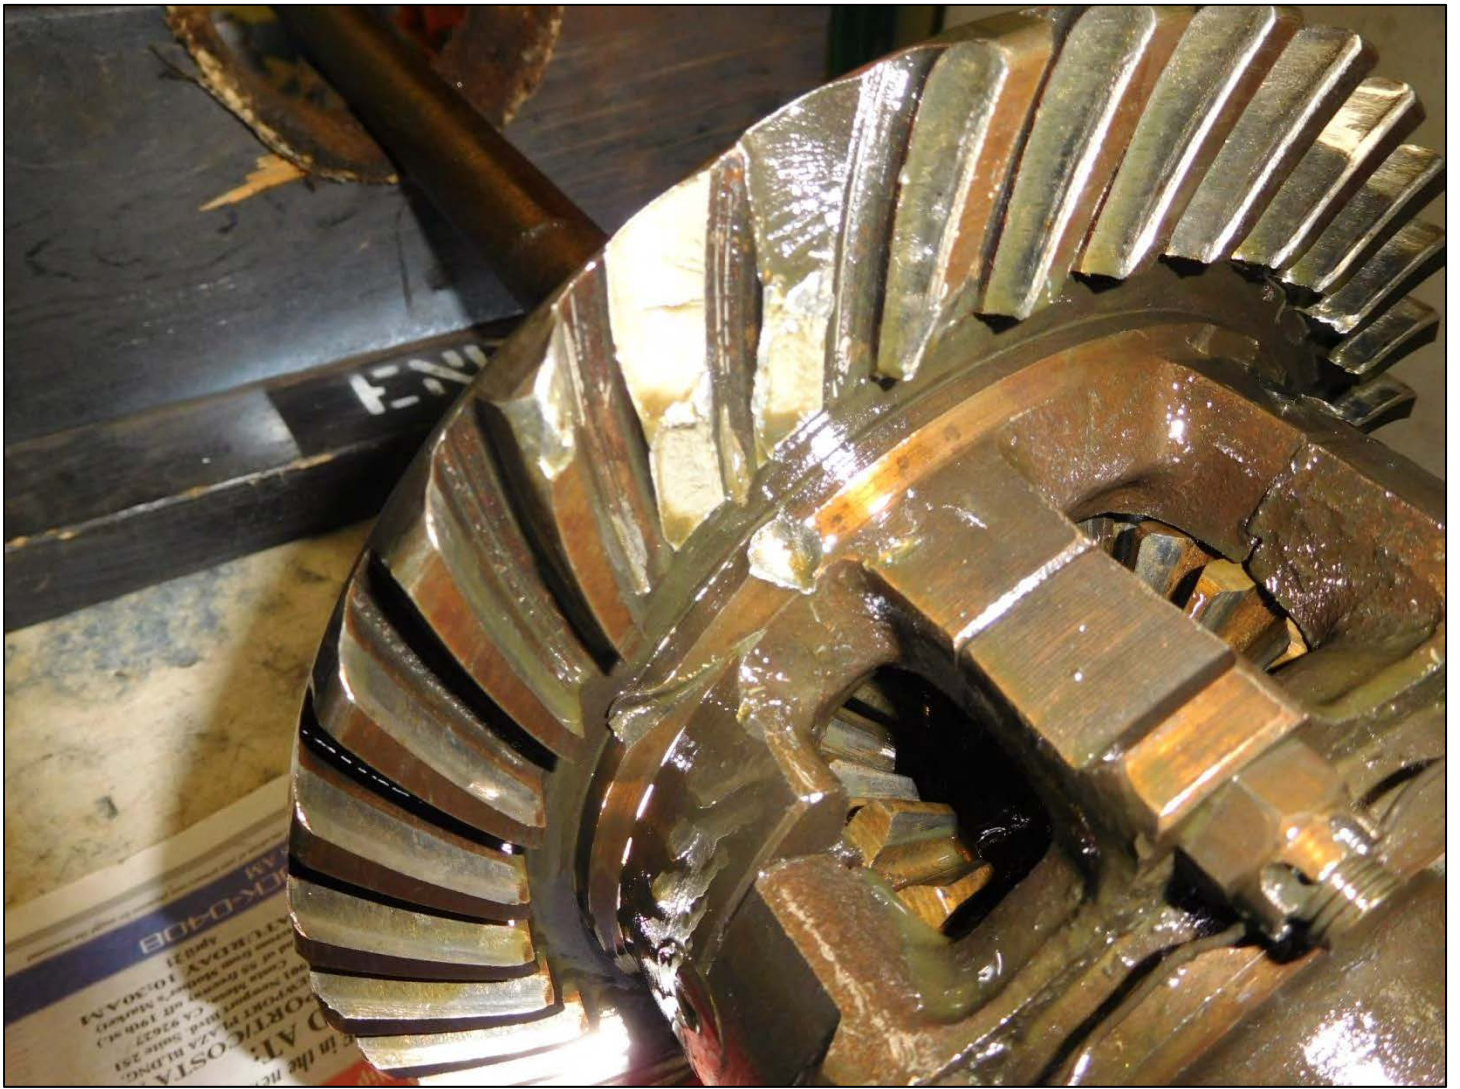
Close up view of the damaged area of the ring gear.

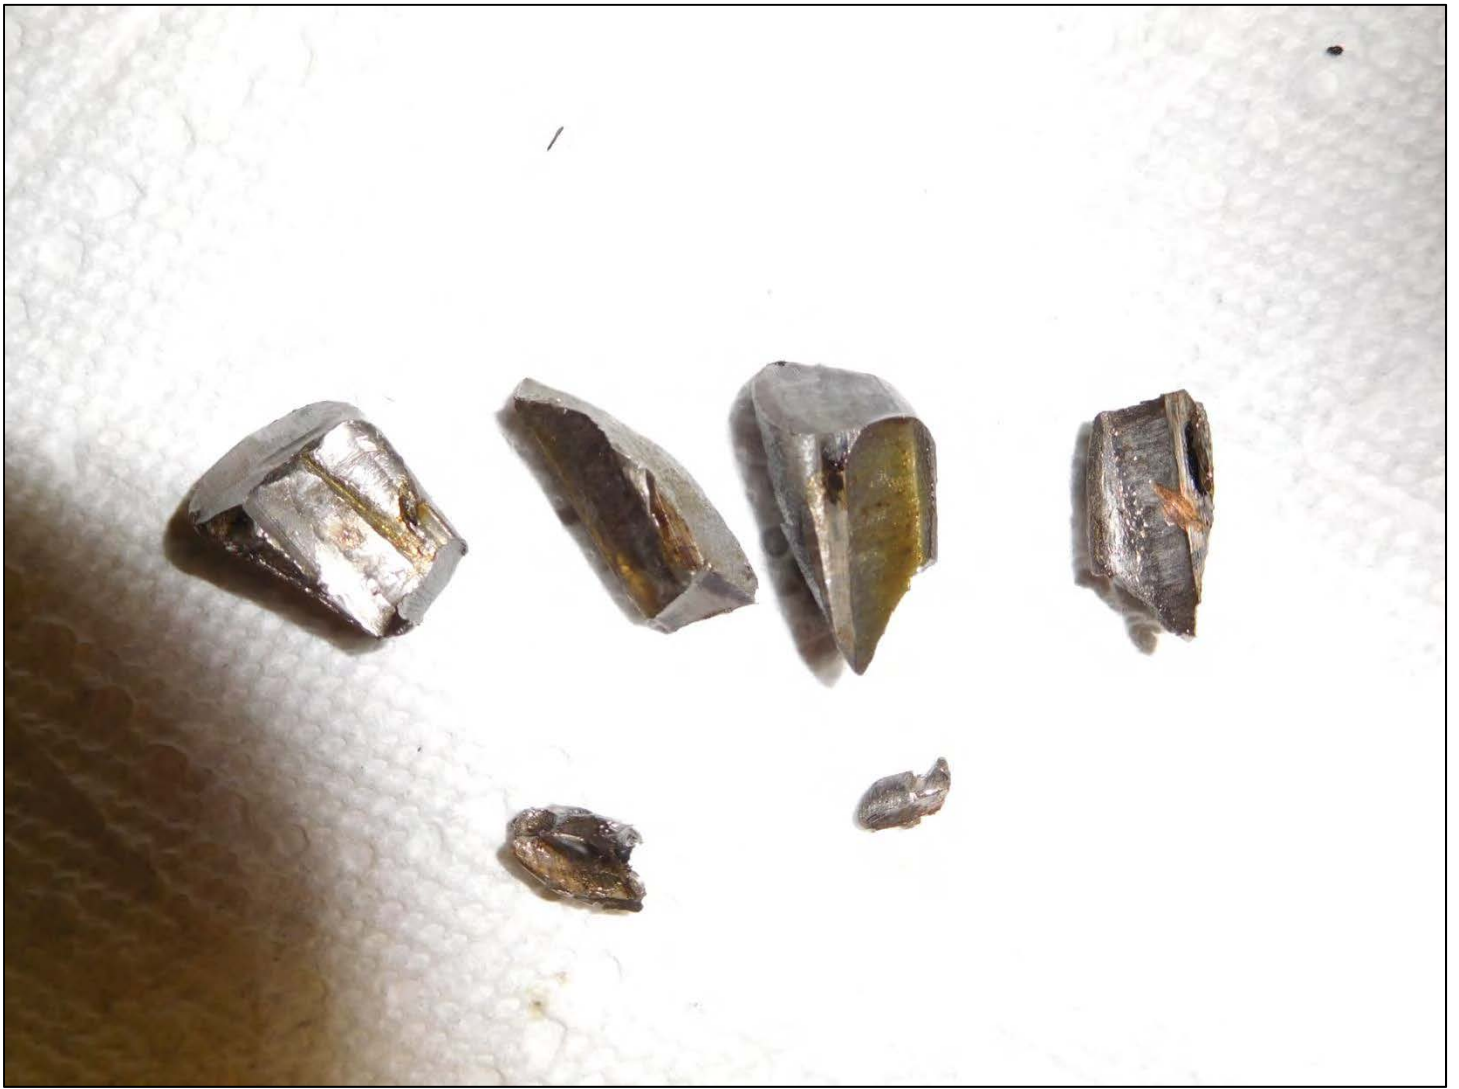
Teeth broken off the ring gear were found in the bottom of the banjo.

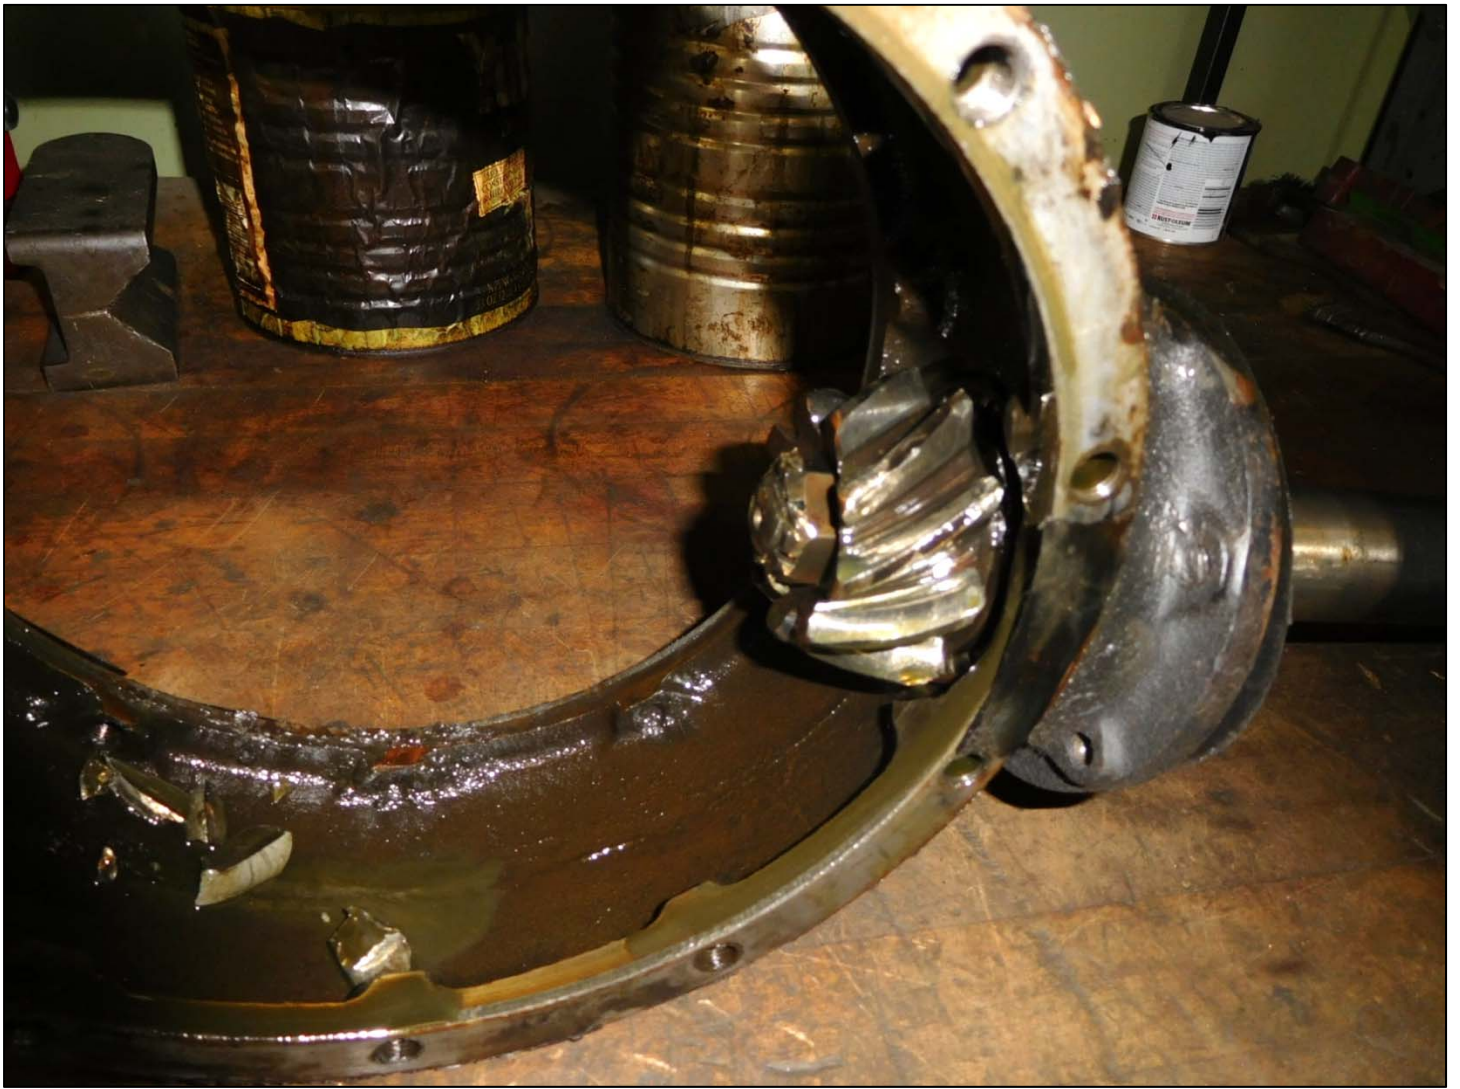
The pinion gear also suffered some damage. The broken teeth from the ring gear can be seen in the bottom of the banjo.

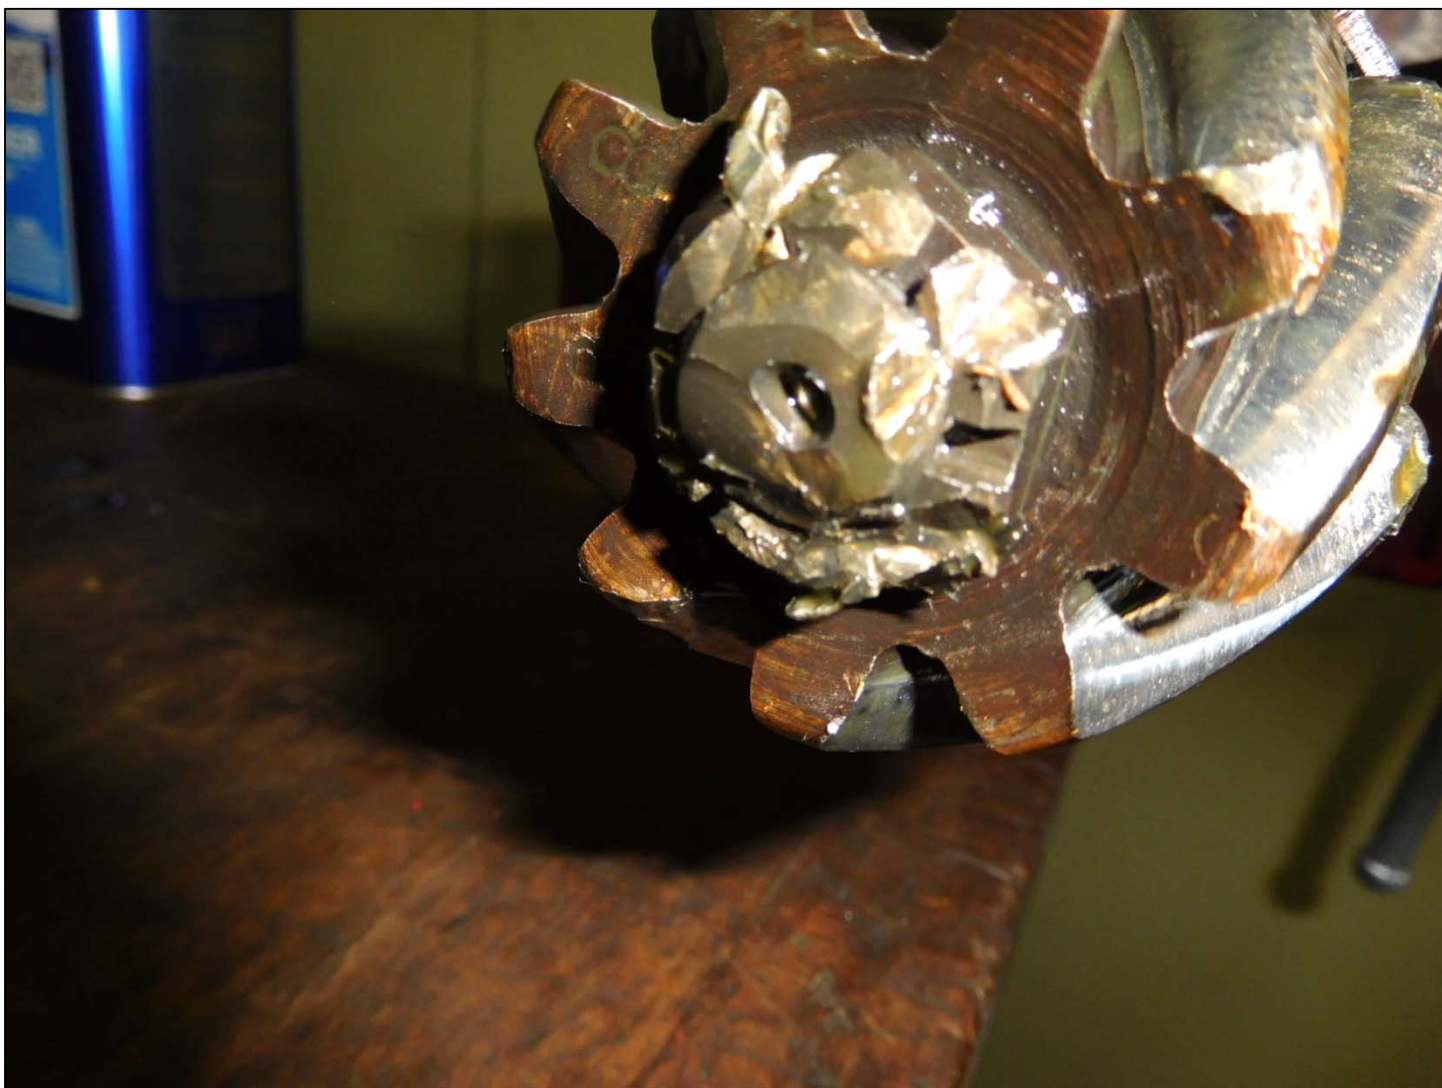
The nut on the end of the Mitchell stub shaft took a terrible beating and offered a challenge to get it off. What I did was take a 15\16" 6-point socket and drive it on with a hammer. Once in place I applied an impact wrench and spun it off.

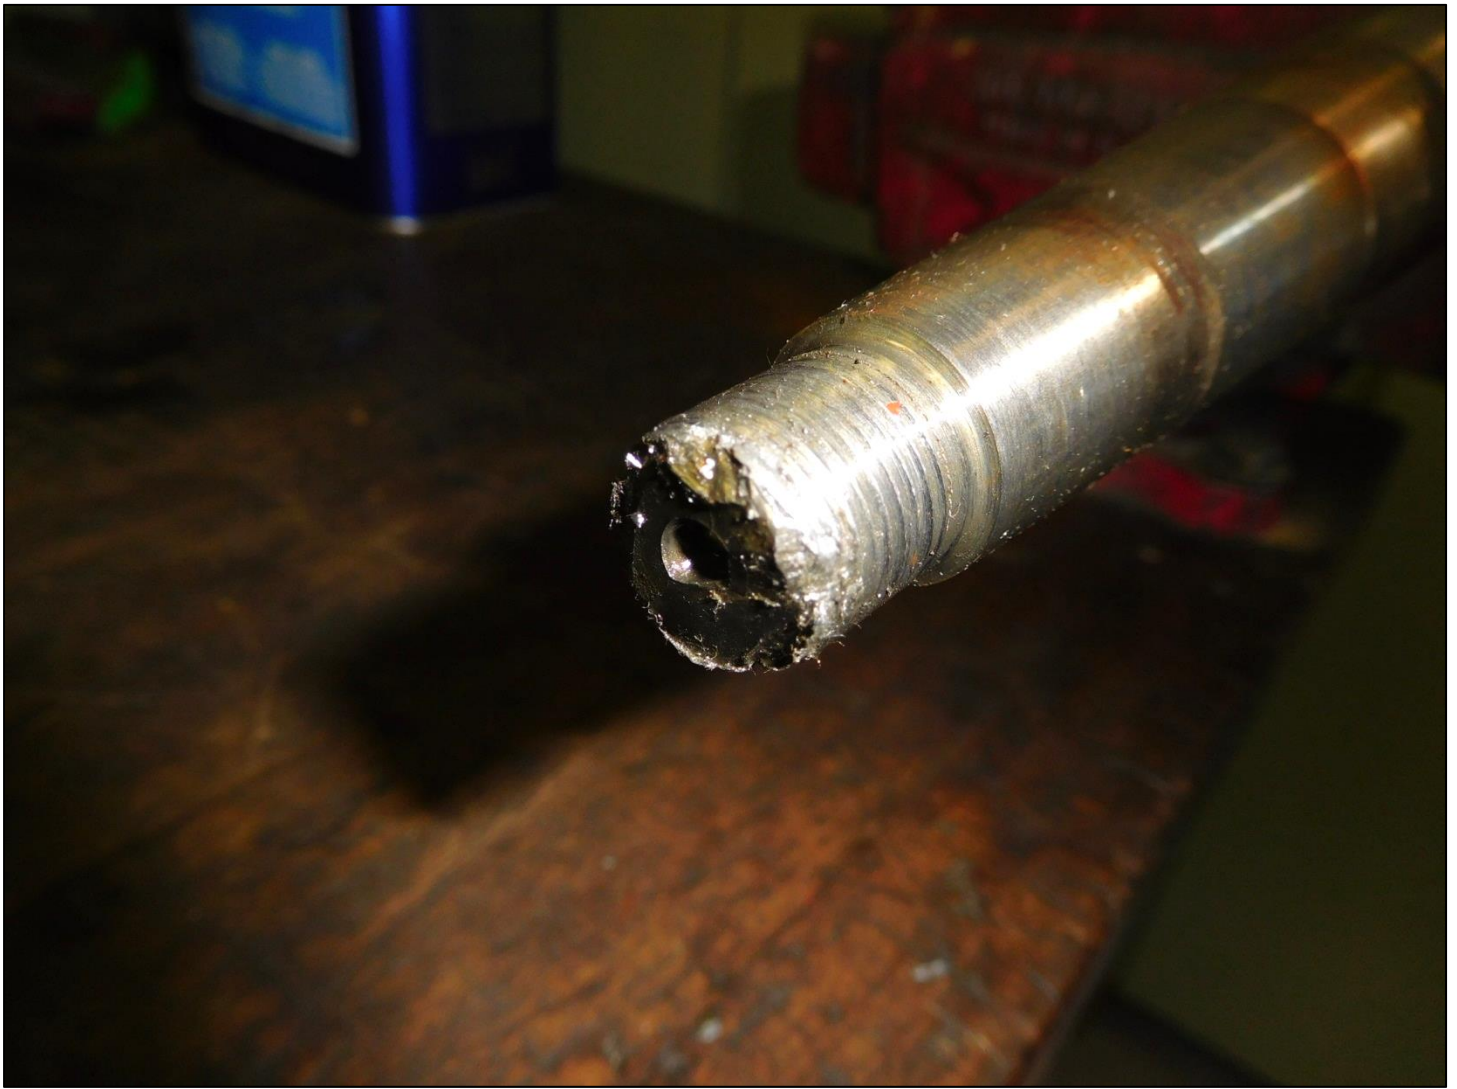
The end of the Mitchell stub shaft has part of the end missing clear up past the cotter pin hole. The end of the threads were slightly damaged, I ran a dye over the threads to clean them up.

When re-assembled with a new nut it will not be possible to insert a cotter pin. Hopefully the 100 pounds of torque and some lock-tight will hold it. The other alternative is to replace the stub shaft at a cost of about \$100. The owner was contacted and he opted for a new replacement Mitchell stub shaft. The cost of the replacement, however, was \$150.

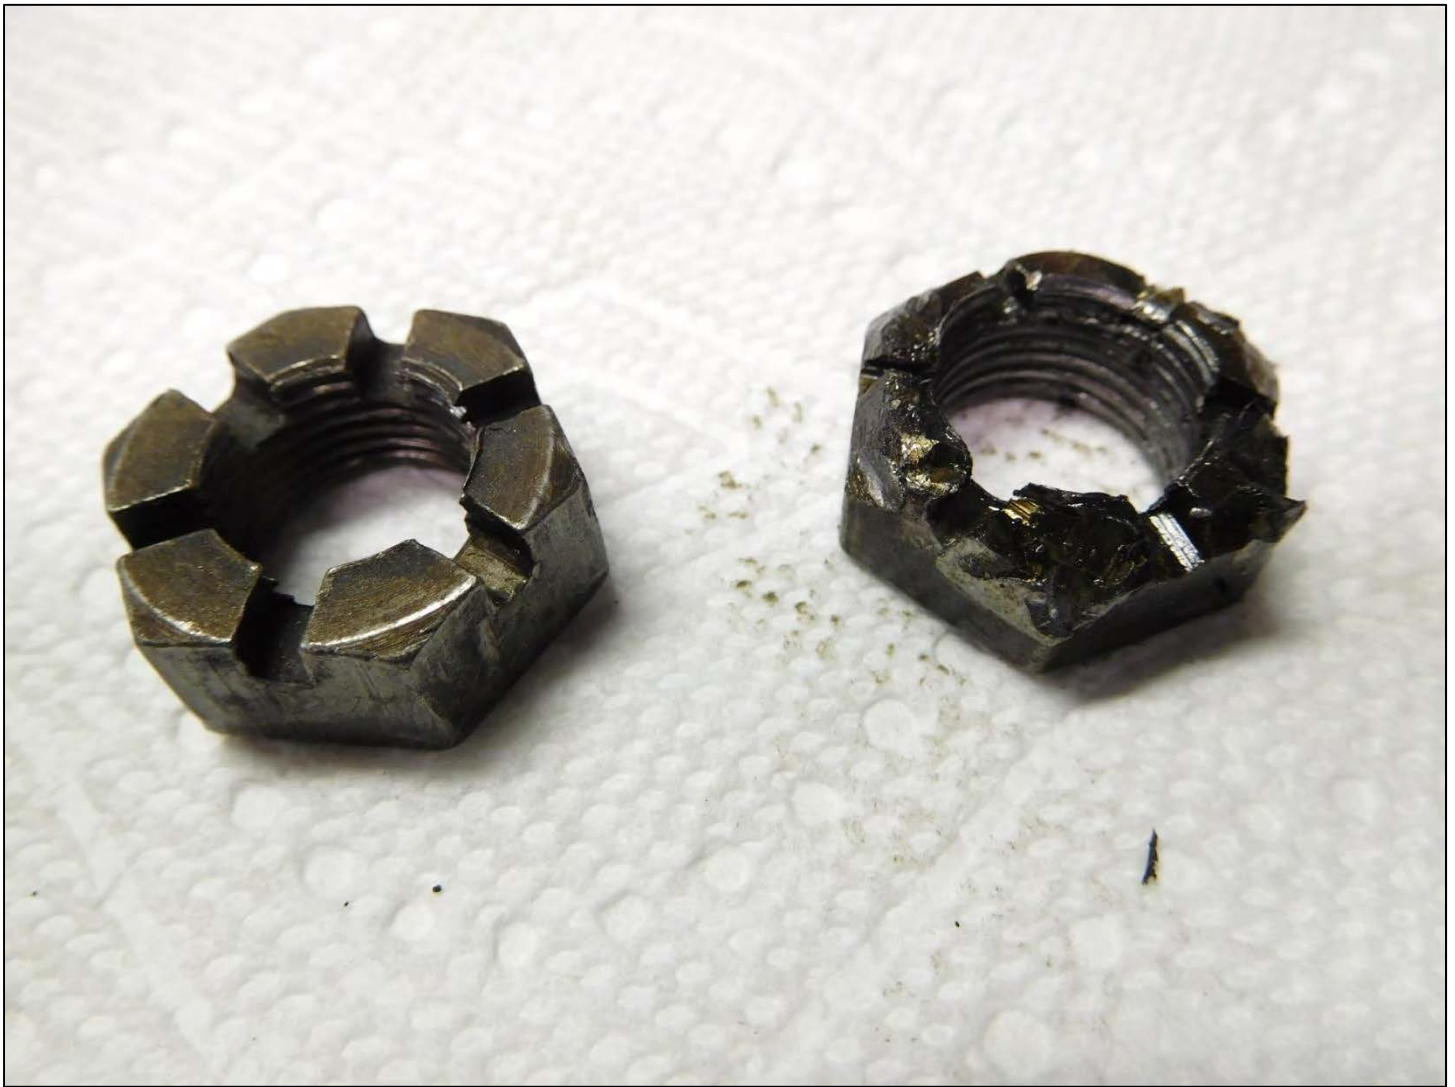
Comparison of a replacement serviceable nut and the damaged one removed.

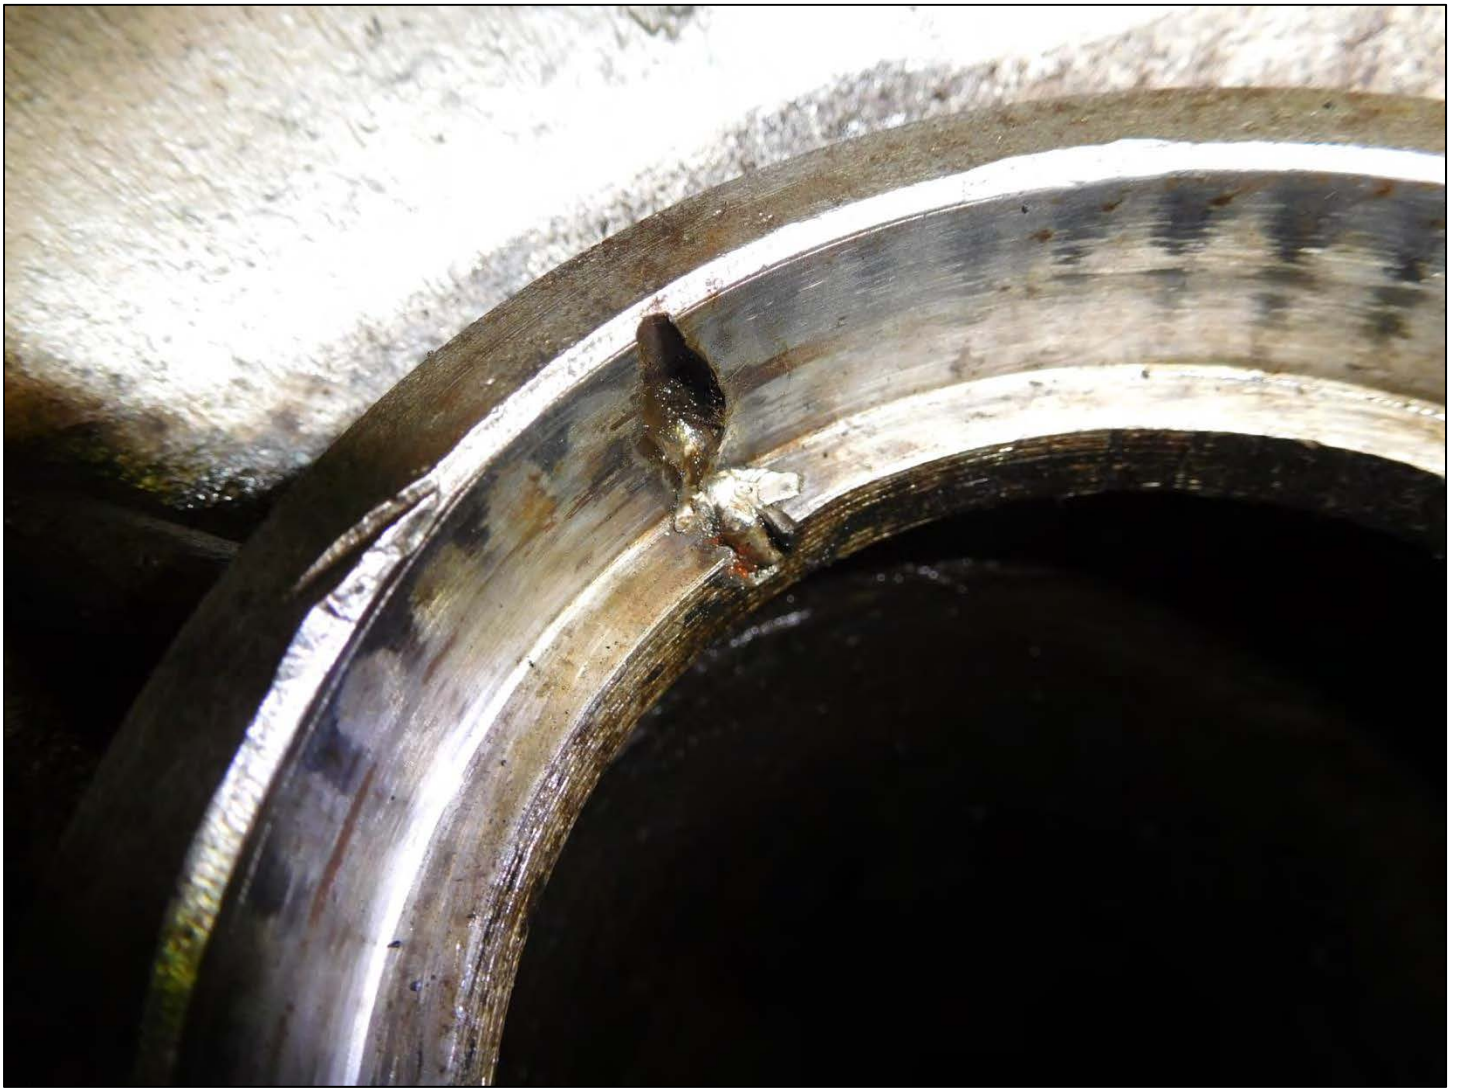
This photo shows the recess in one of the axle housings where the bearing race installs. After the race was removed it was noticed that there was a slice in the race seat along with a protruding burr. I suspect this occurred at a previous overhaul when the mechanic apparently took a cutting disk and cut the race in half in order to remove it and accidentally cut into the seat. The burr was removed with a chisel and a hammer.

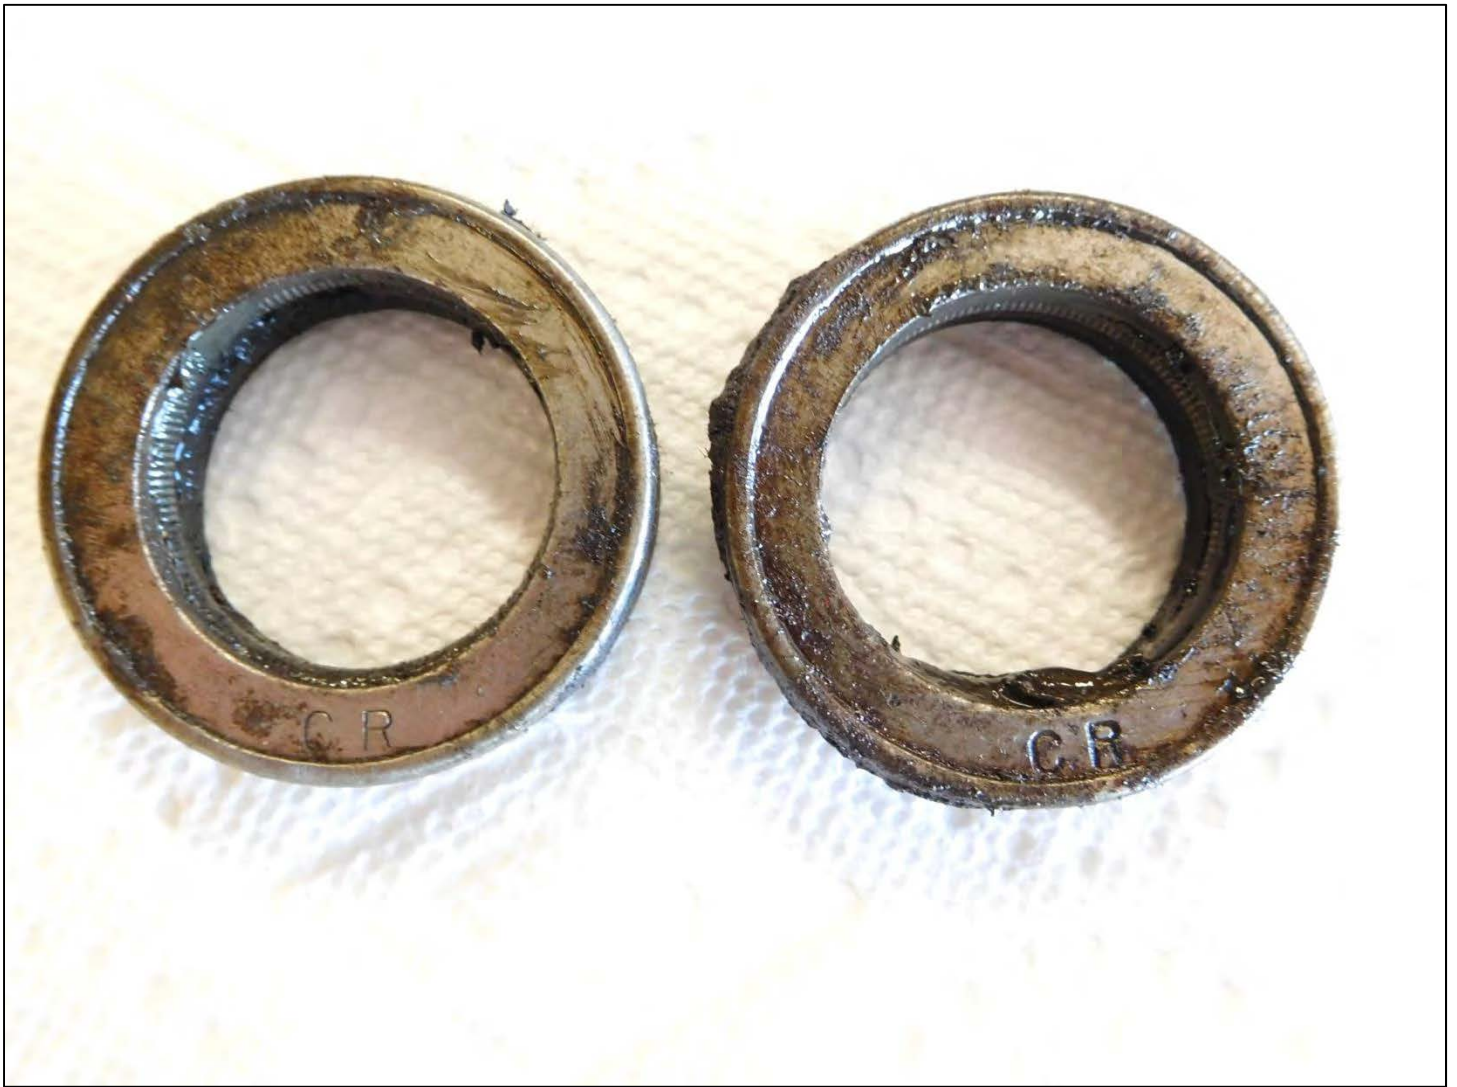
Shown here are the two seals removed from the two axle housings. Note these are the original seals that Henry installed in the factory 80 plus years ago. They were made of leather and have the letters CR stamped on them that stand for Chicago Rawhide. After 80 plus years the leather is completely gone and the springs are protruding and there is no sealing left.

Quite often I find the original seals still installed during an overhaul. These are items that are often overlooked during previous overhauls.
