# Differential Overhaul May 9, 2019 (LB)

by Tom Endy

This rear axle assembly overhaul project arrived in the back of a pick-up truck and will receive a Mitchell overdrive during the overhaul process. In addition, the transmission and bell housing from the project car were also brought and will be overhauled/restored. The project car is a 1929 Tudor. The owner is a member of the Santa Anita A's of Arcadia, California.

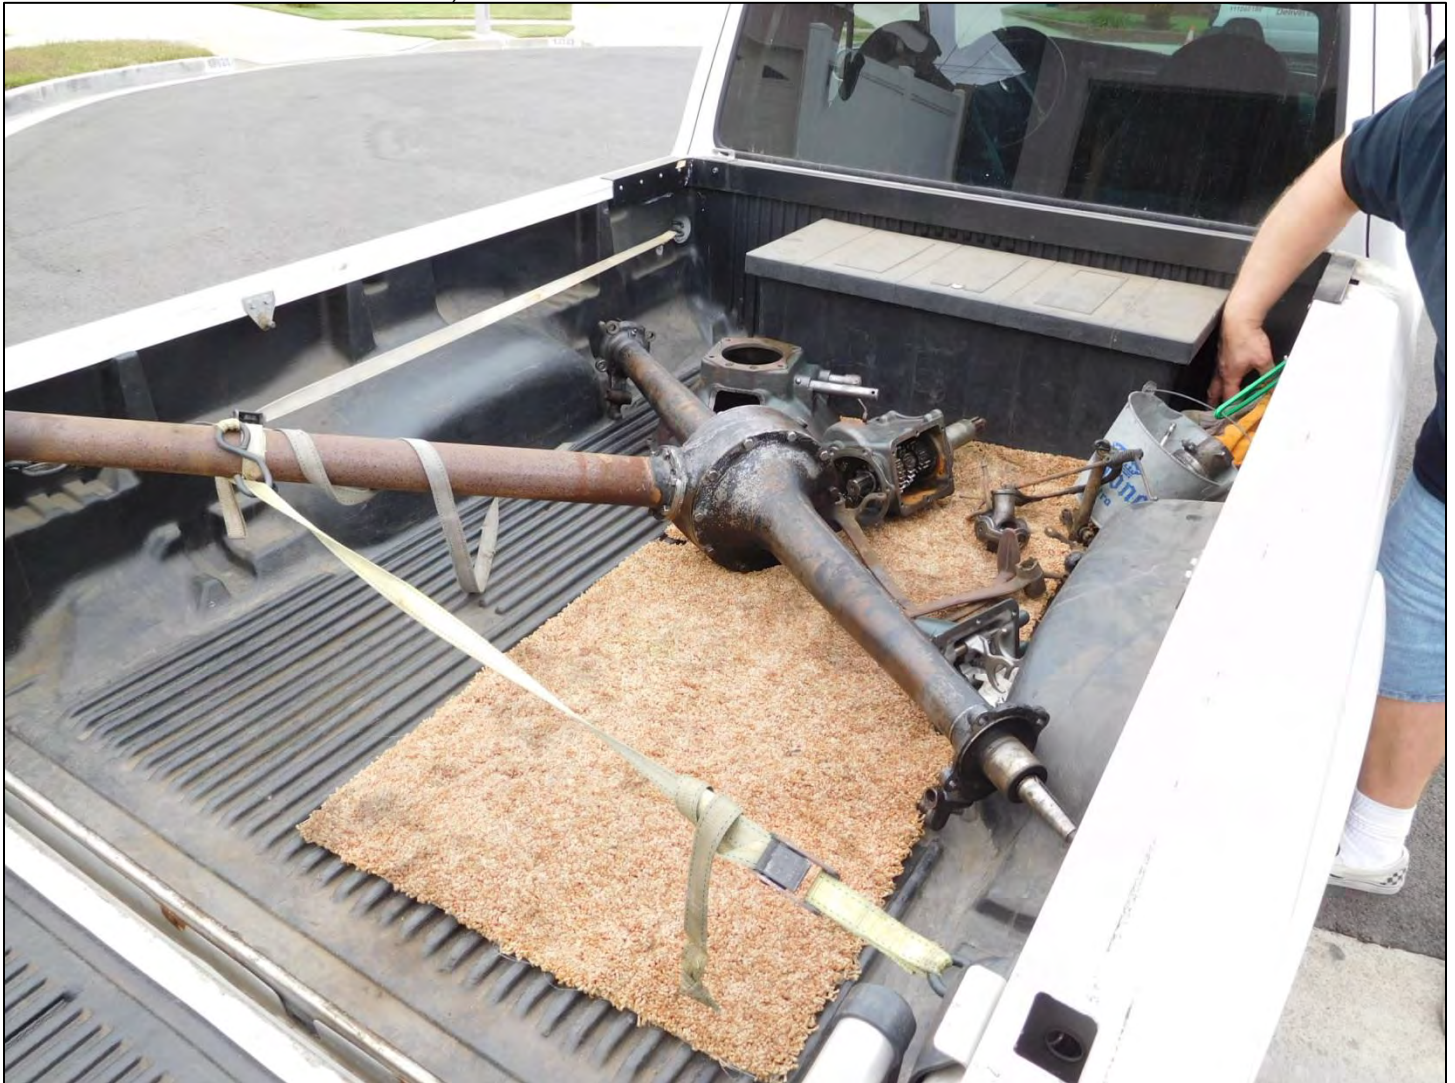
The rear axle assembly was removed from the project car that had been in storage for many years before being transported for overhaul. It is shown here arriving in typical cruddy condition.

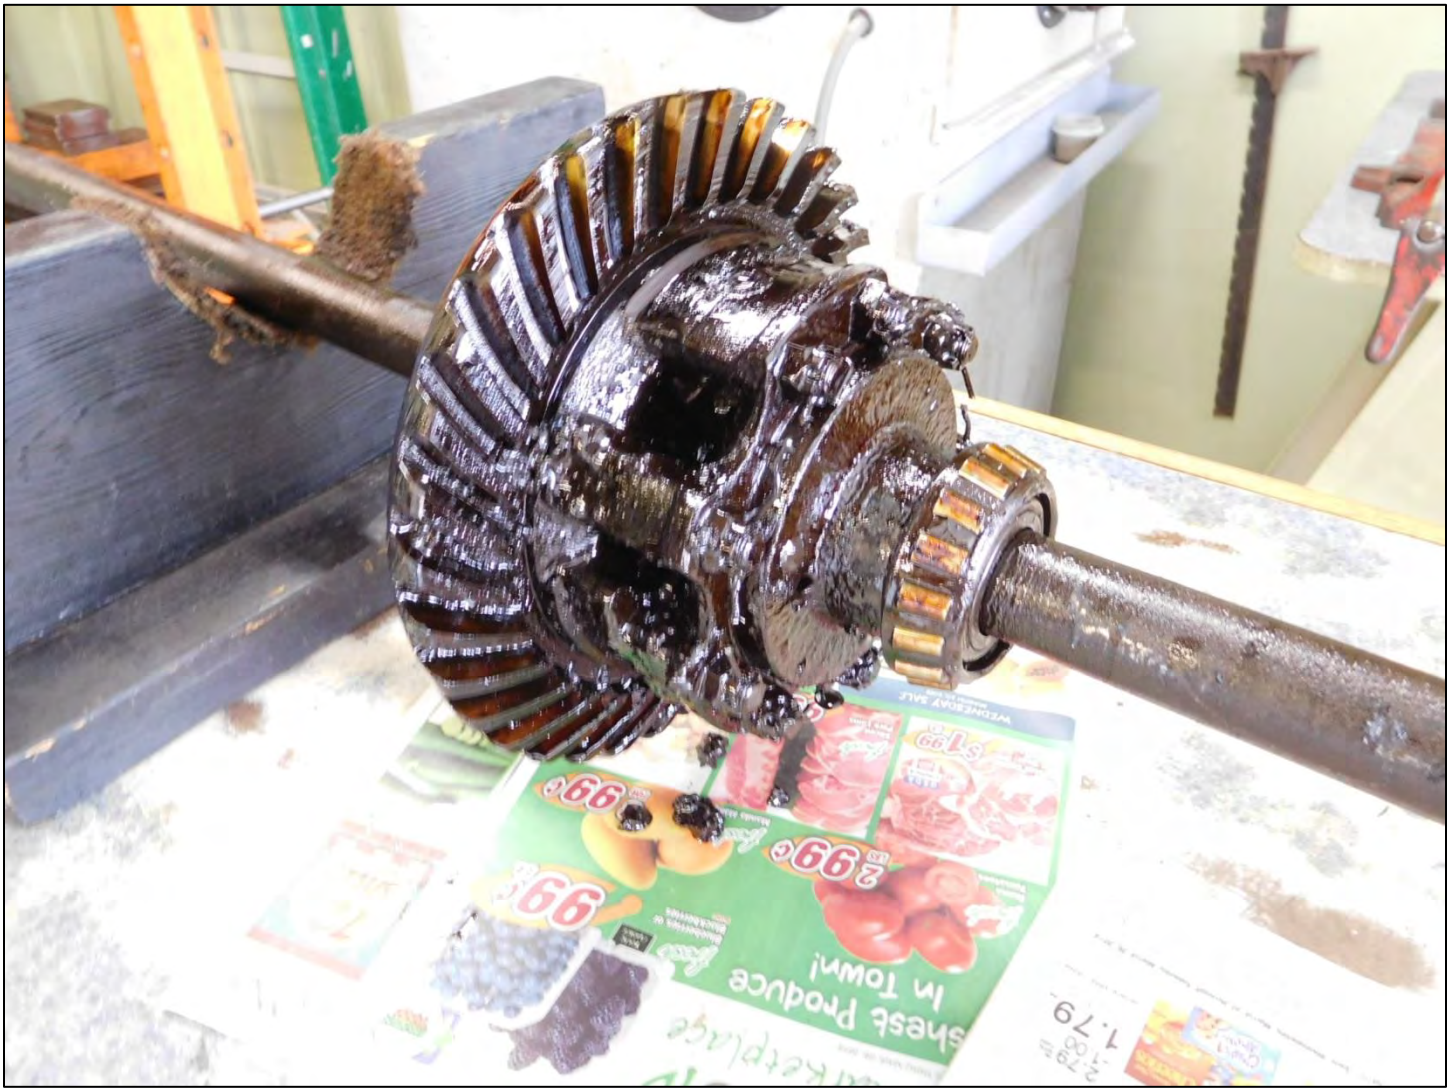
**The ring gear, carrier assembly, and both axles were found extremely cruddy. Both bearings were found to have spun on the carrier hubs because they were set up too tight the last time the rear axle assembly was overhauled. It was also found that the inside of the carrier was extremely worn and is not a candidate for knurling and reuse.**

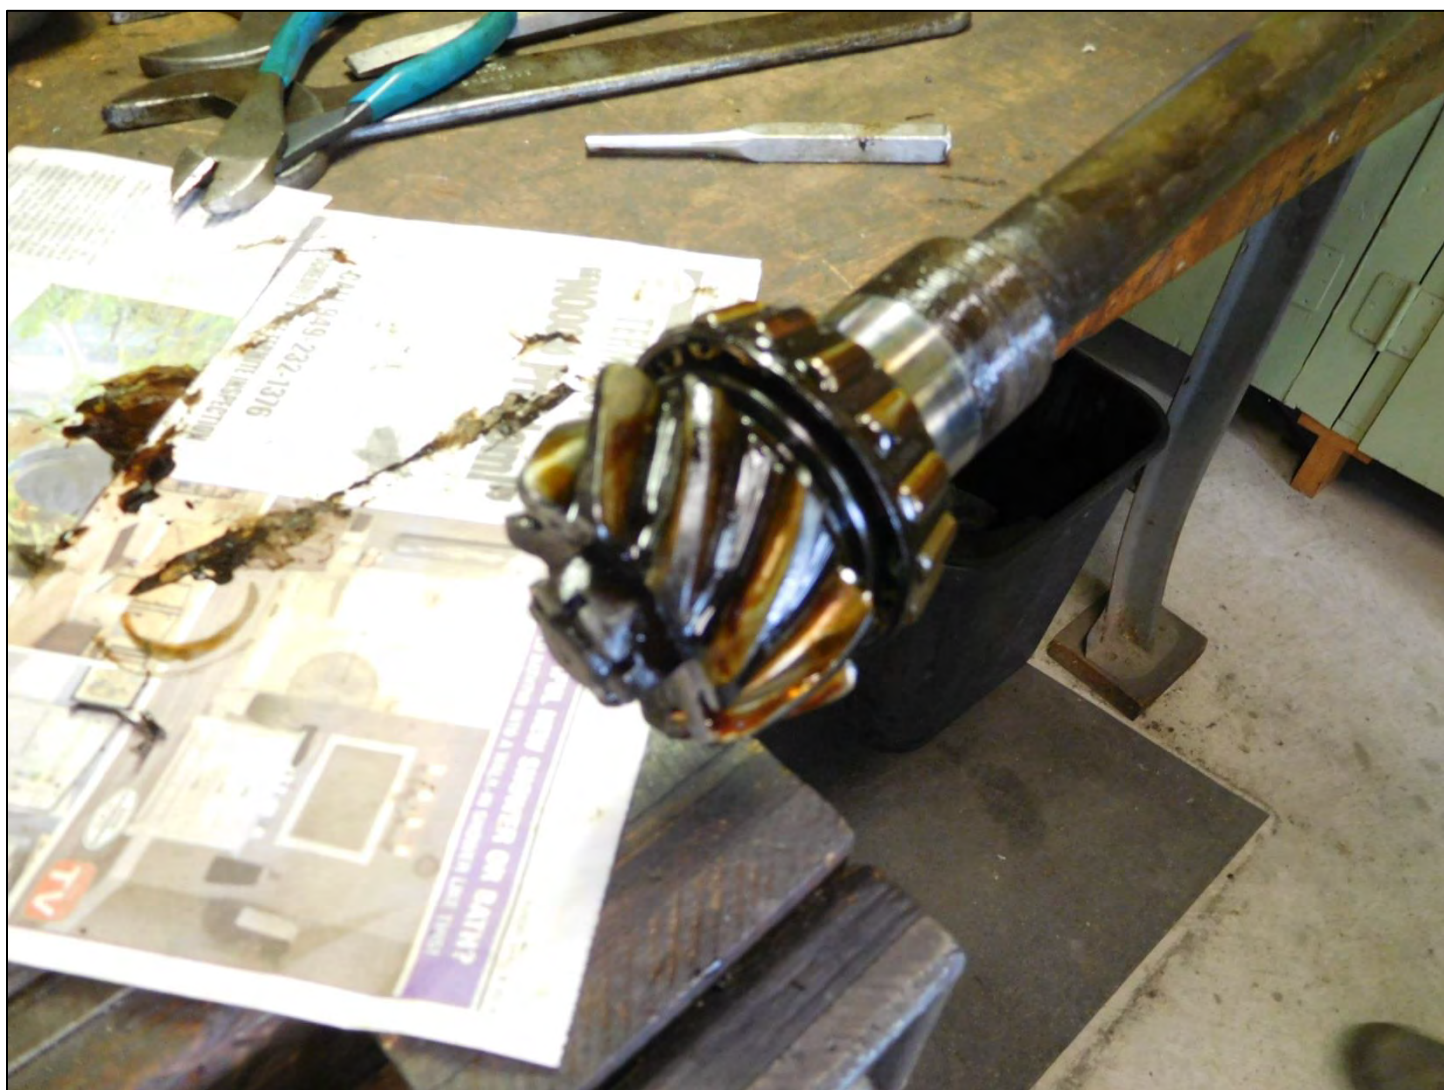
**The pinion gear is also extremely cruddy. It will be removed from the drive shaft and the drive shaft will be set aside in favor of a Mitchell stub shaft as the project will receive a Mitchell overdrive.**

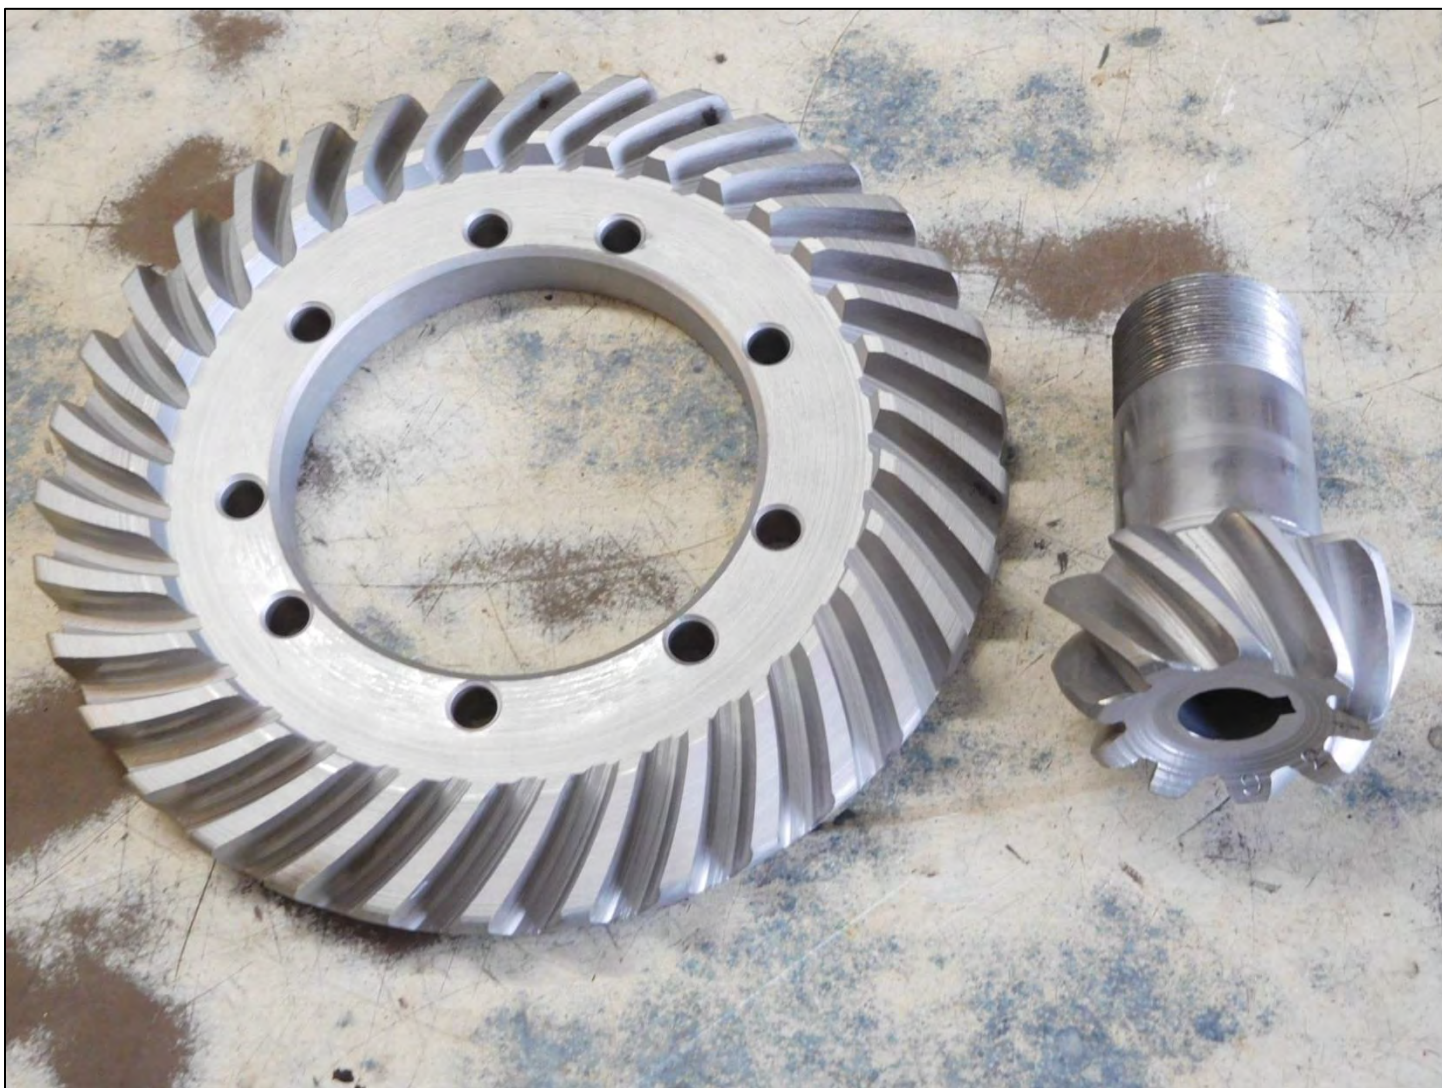
**The ring & Pinion removed from the project car are originals and have both been degreased and bead blasted. They are in excellence condition and are a 378:1 ratio (34-9).**

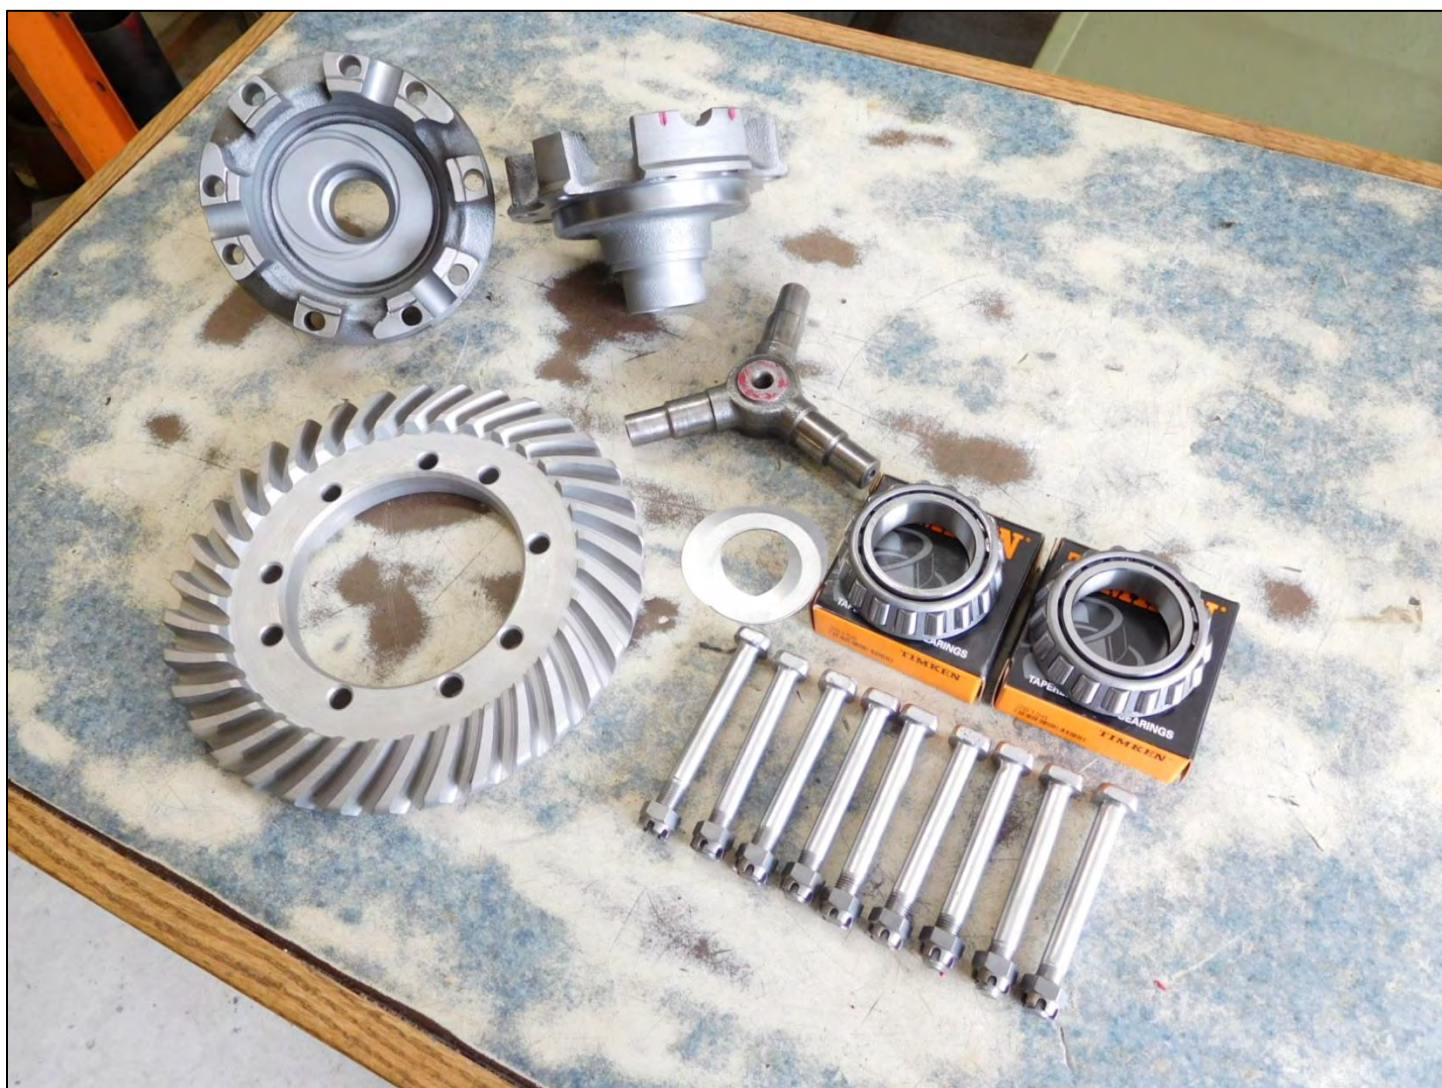
**Shown here are all the components necessary to assemble the carrier. A replacement carrier that has had the hubs knurled will be used. Shims will be required to replace material that was machined off the bearing stops when the knurling was done. The nine carrier bolts have been bead blasted and wire wheeled. The carrier bolts removed from the project were replaced because they were found to be the earlier carrier bolts that are not compatible with the later carrier seen here.**

**The modified three legged spider gear yoke seen here is a tool that will be installed temporarily to facilitate setting the carrier bearing pre-load.**

**The two carrier bearings will be pressed onto the carrier hubs that have been knurled. The reason for the shims is because pre-determined material was machined off the carrier bearing stops during the knurling procedure in order to true them up.**

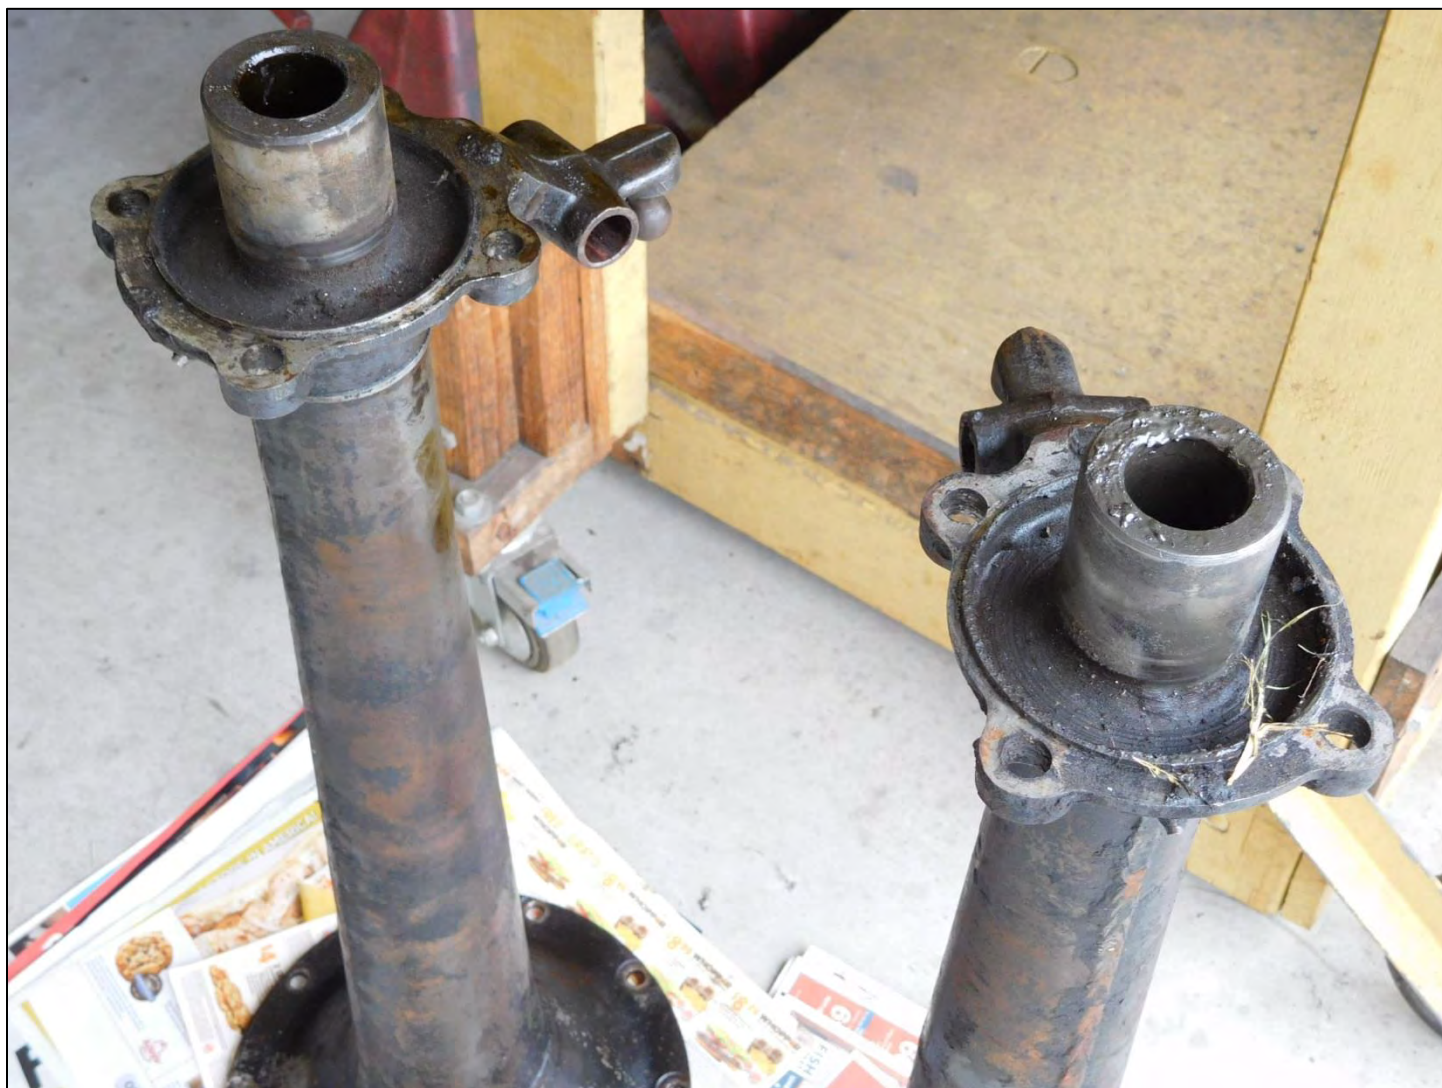
**Both axle housings have been removed and both grease seals have been removed. The grease seals were found to be the originals installed by Henry Ford. The original seals were made of leather and were found to be fully deteriorated. Both axle housings are extremely cruddy and will undergo a thorough cleaning before proceeding with the overhaul process.**

**Both shackle bushing were found to be excessively worn and were removed. Half of each bushing was worn away. New bushings will be installed**

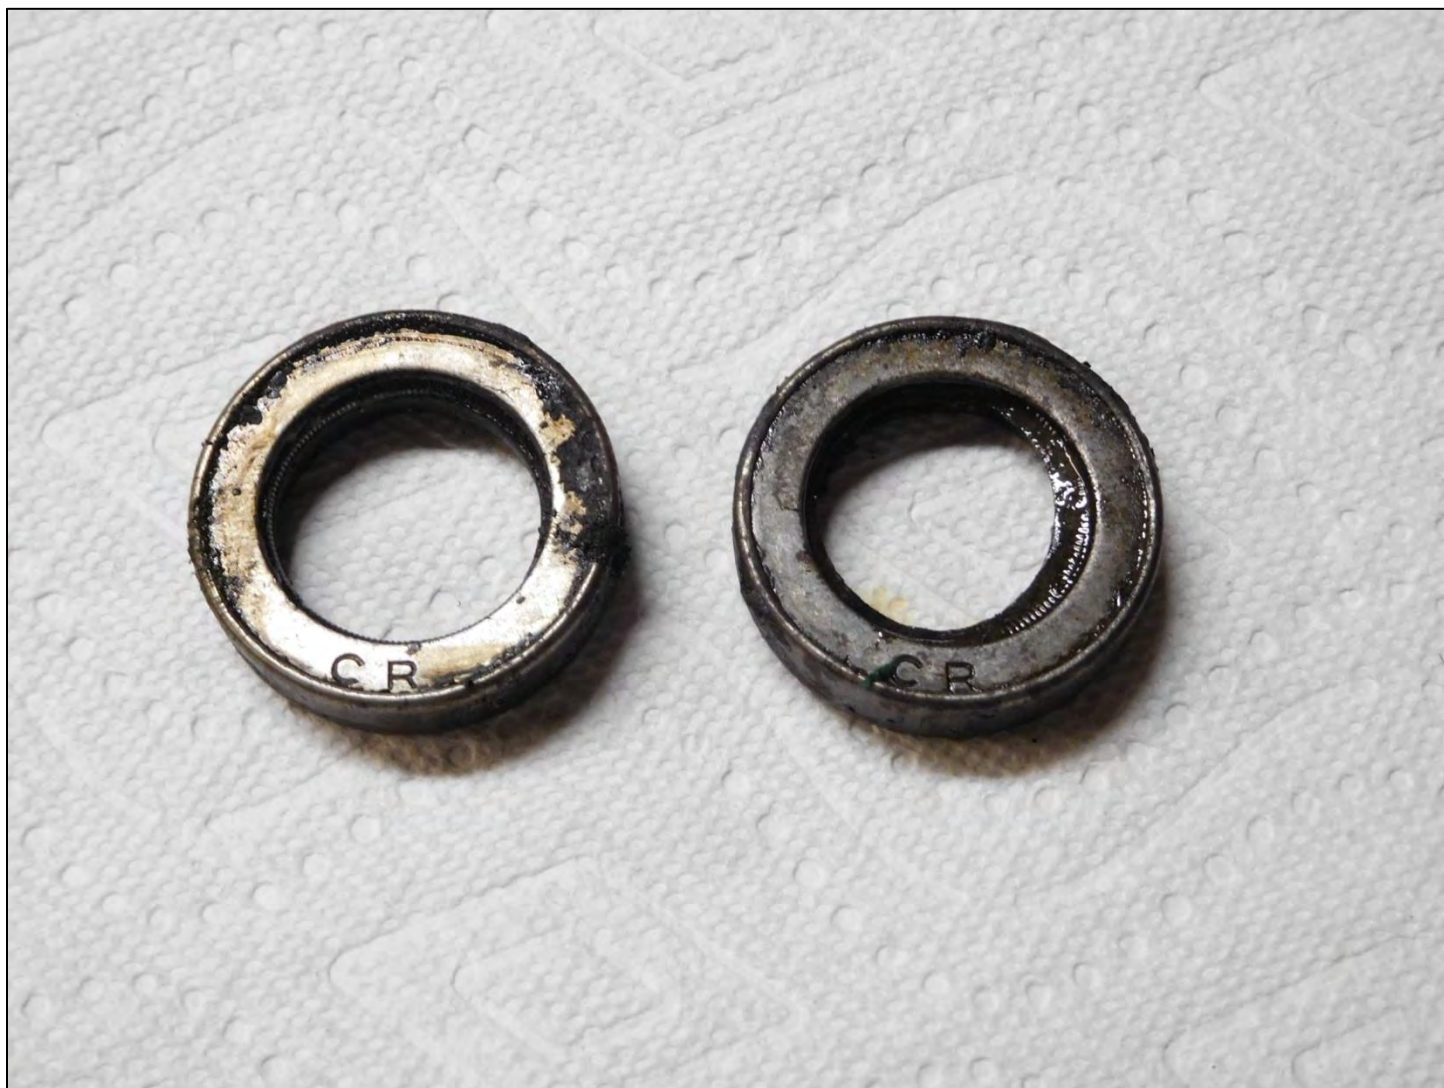
**Shown here are the two removed axle housing grease seals. They are the originals installed at the factory in 1929. The seals used in those days were made of leather. The letters CR stamped on the seals stands for Chicago Rawhide. The leather portion of the seals disappeared years ago.**

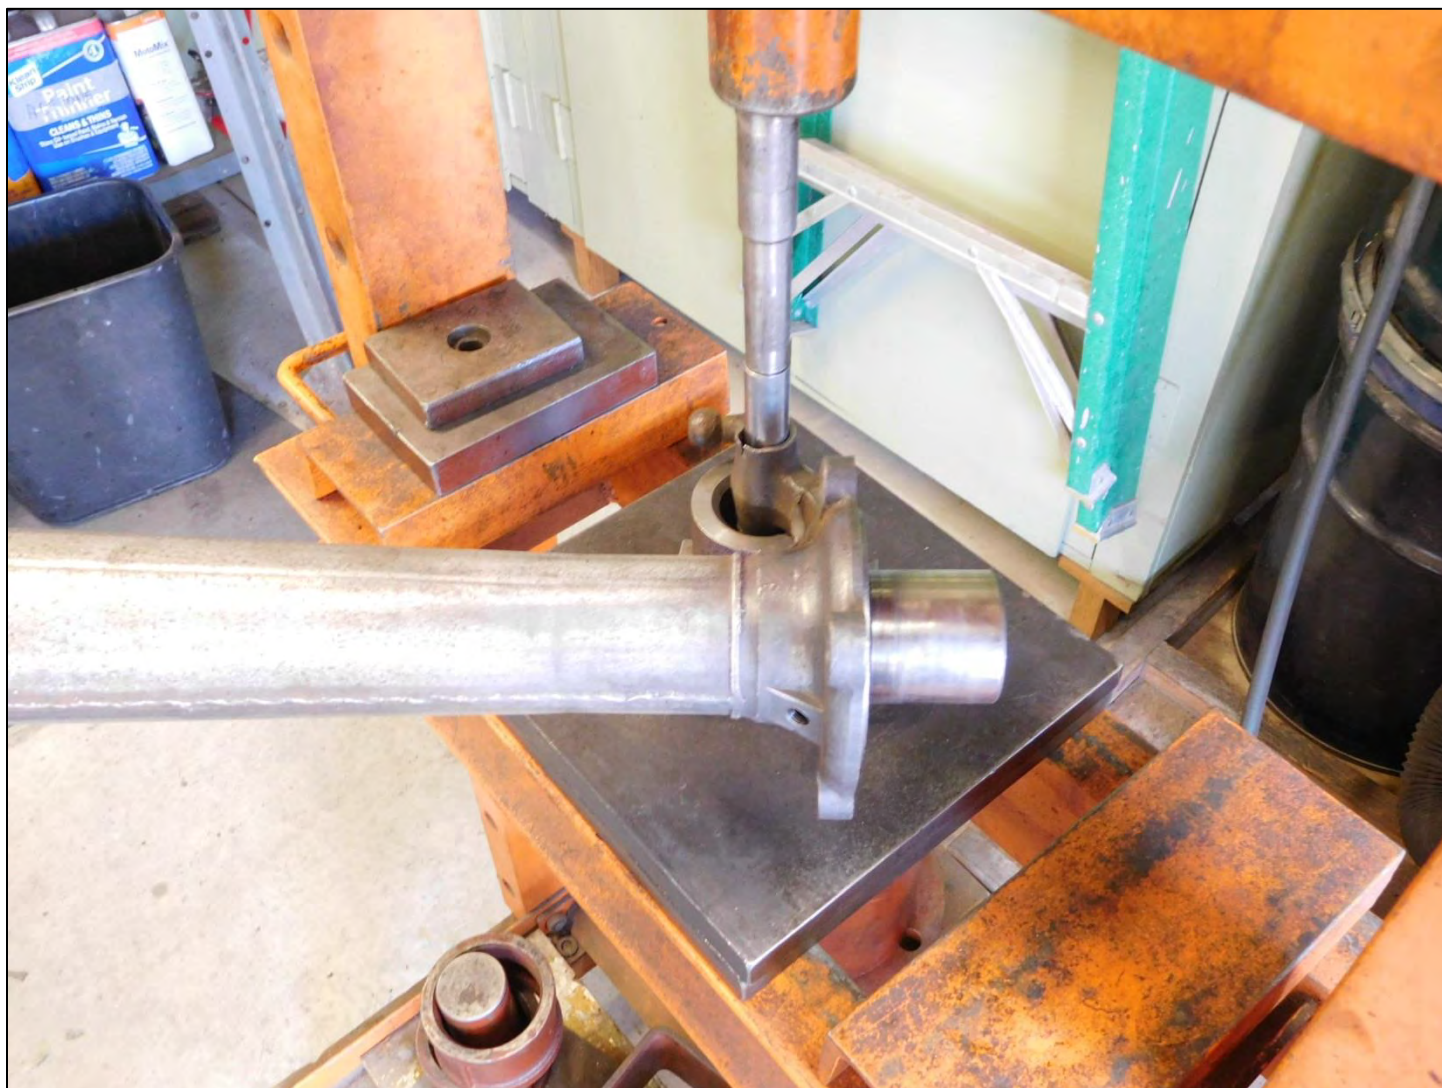
**New shackle bushings were installed in both housings. The shackle bosses in both housing have been damaged as the original bushings had worn through. The new bushings, however, pressed in tight and will be adequately serviceable.**

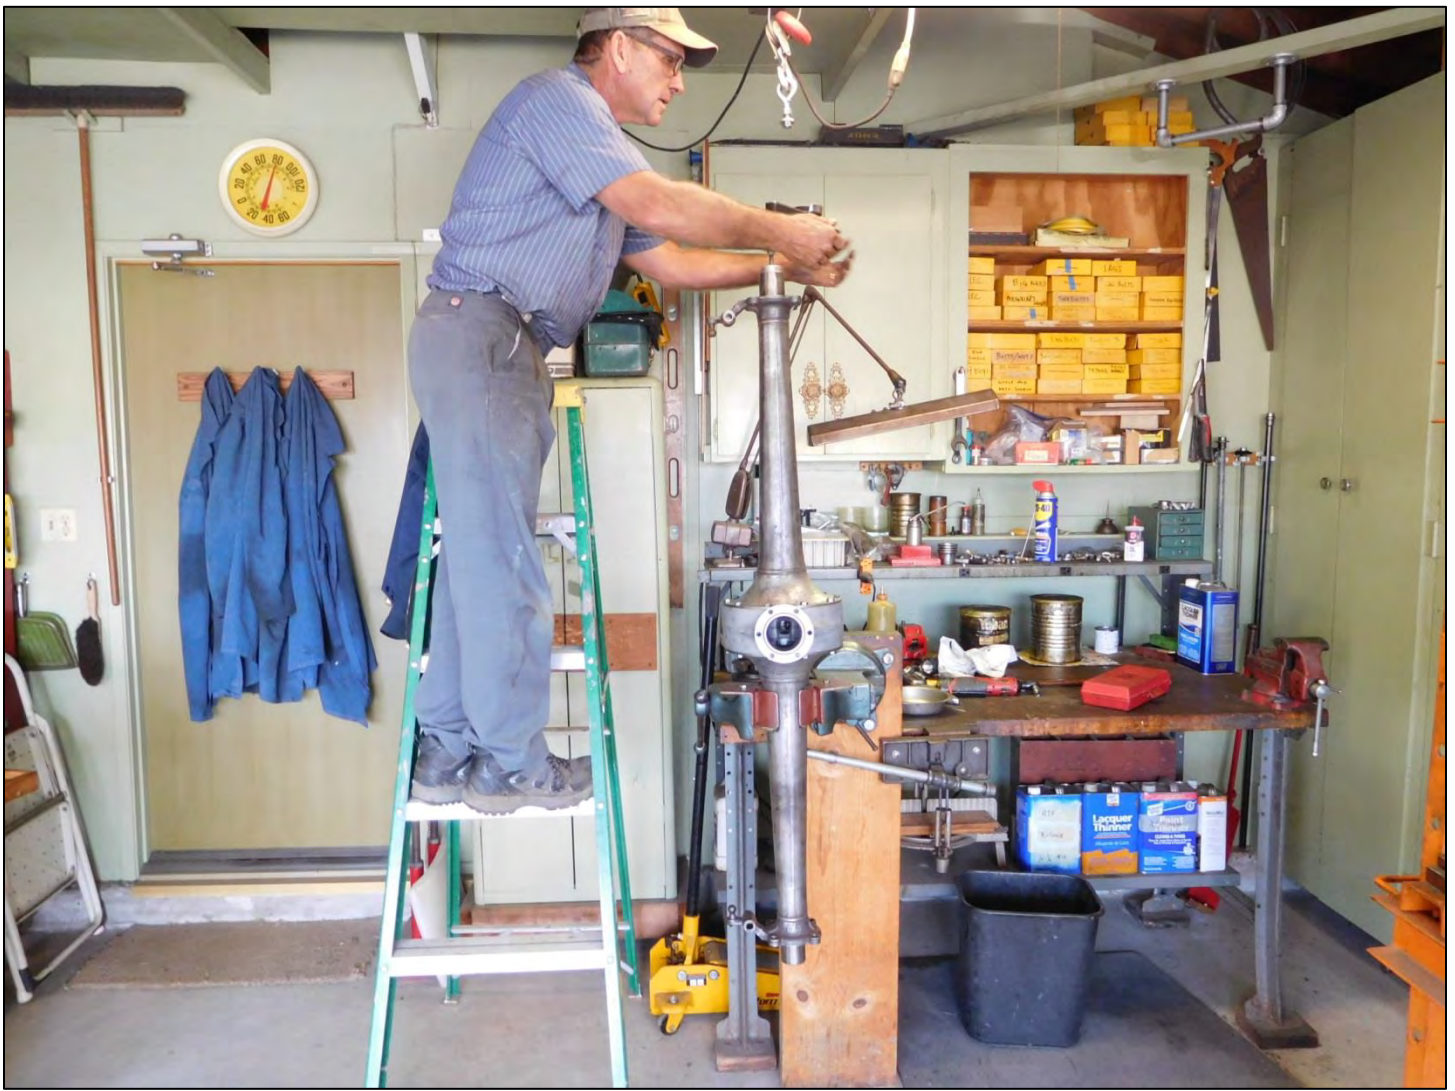
**After a series of trial and error installations of banjo gaskets the carrier bearing pre-load is checked with a dial indicator inch pound torque wrench. Shown here is Bryan making the check. As the wrench is turned it will turn the carrier through a threaded shaft screwed into the modified spider yoke attached to the carrier. The reading is read from the dial on the torque wrench. The target value is 20 inch pounds; however, my window of acceptance is anything between 14 and 22.**

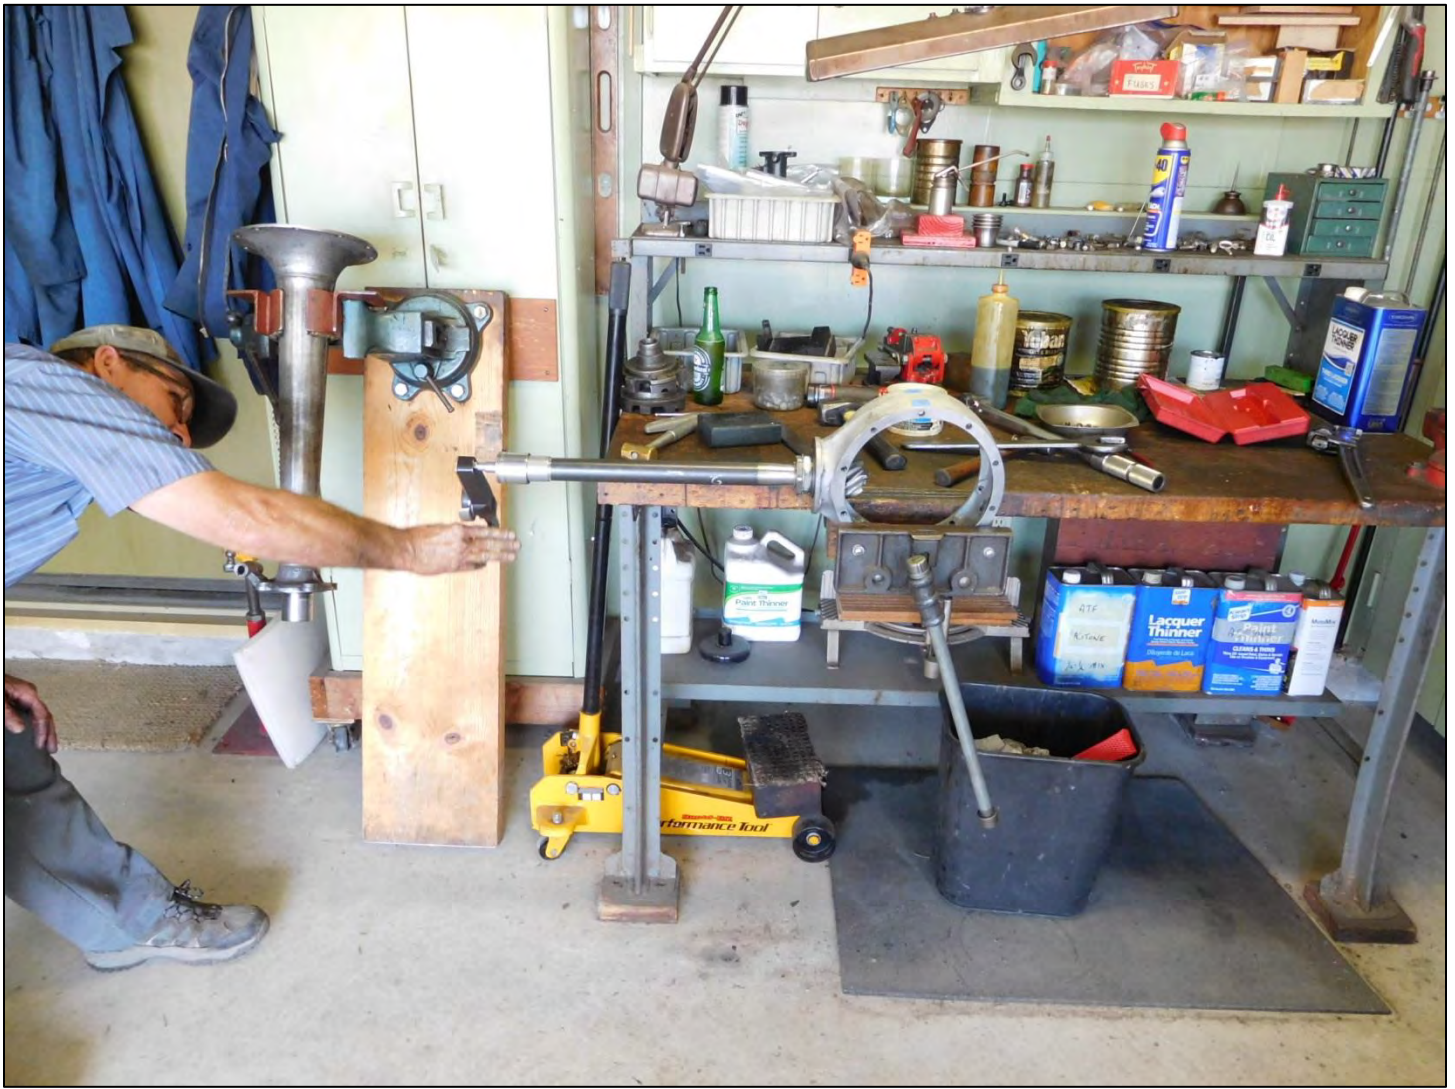
**Shown here is Bryan checking the pinion bearing preload with an inch pound dial indicator torque wrench. The stub shaft is rotated by the torque wrench and the reading is taken off the dial on the torque wrench. The target value is 20 inch pounds; my acceptable window is between 14 and 22.**

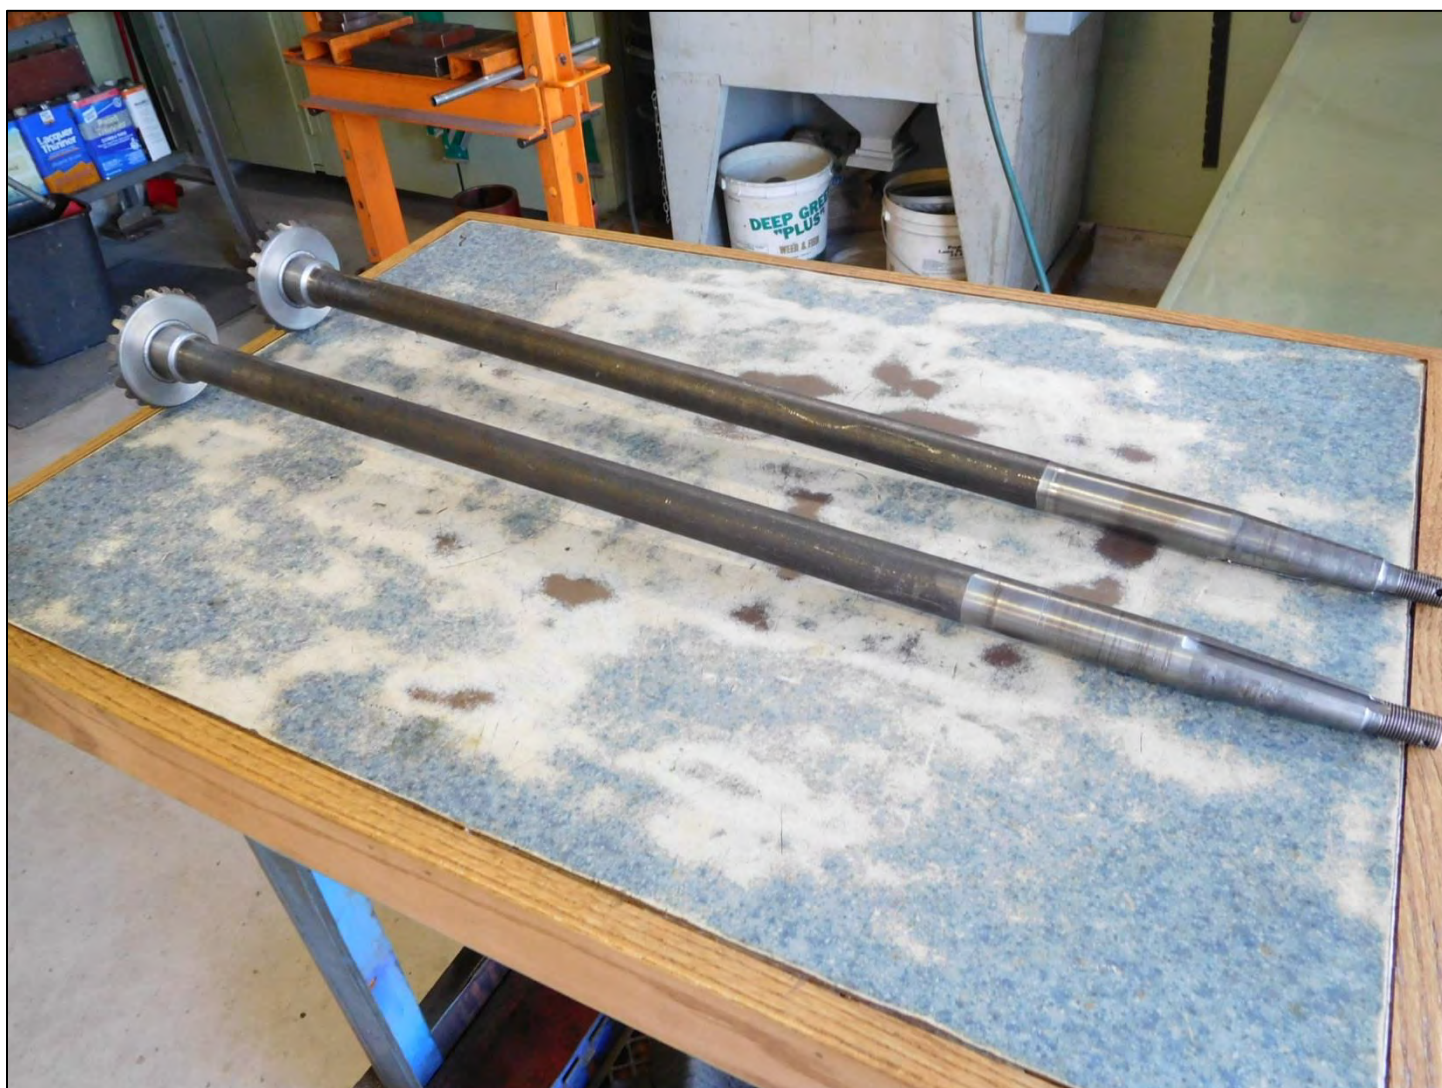
**Shown here are the two axle shafts after they had been cleaned up. The threads were inspected and found to be in excellent condition. The locking key slot was inspected for cracks and none were found. Both axles are in excellent serviceable condition.**
