# Differential Overhaul June 20, 2019 (SL)

by Tom Endy

This rear axle assembly arrived in the back of a modern SUV after being removed from a 1931 roadster. The owner complaint was that the ring & pinion were jammed up. The unit had a Borg Warner overdrive installed that the owner removed before bringing it over. The overhaul will include a new 378:1 ratio ring & pinion gear set and a new Mitchell 26% overdrive will also be installed.

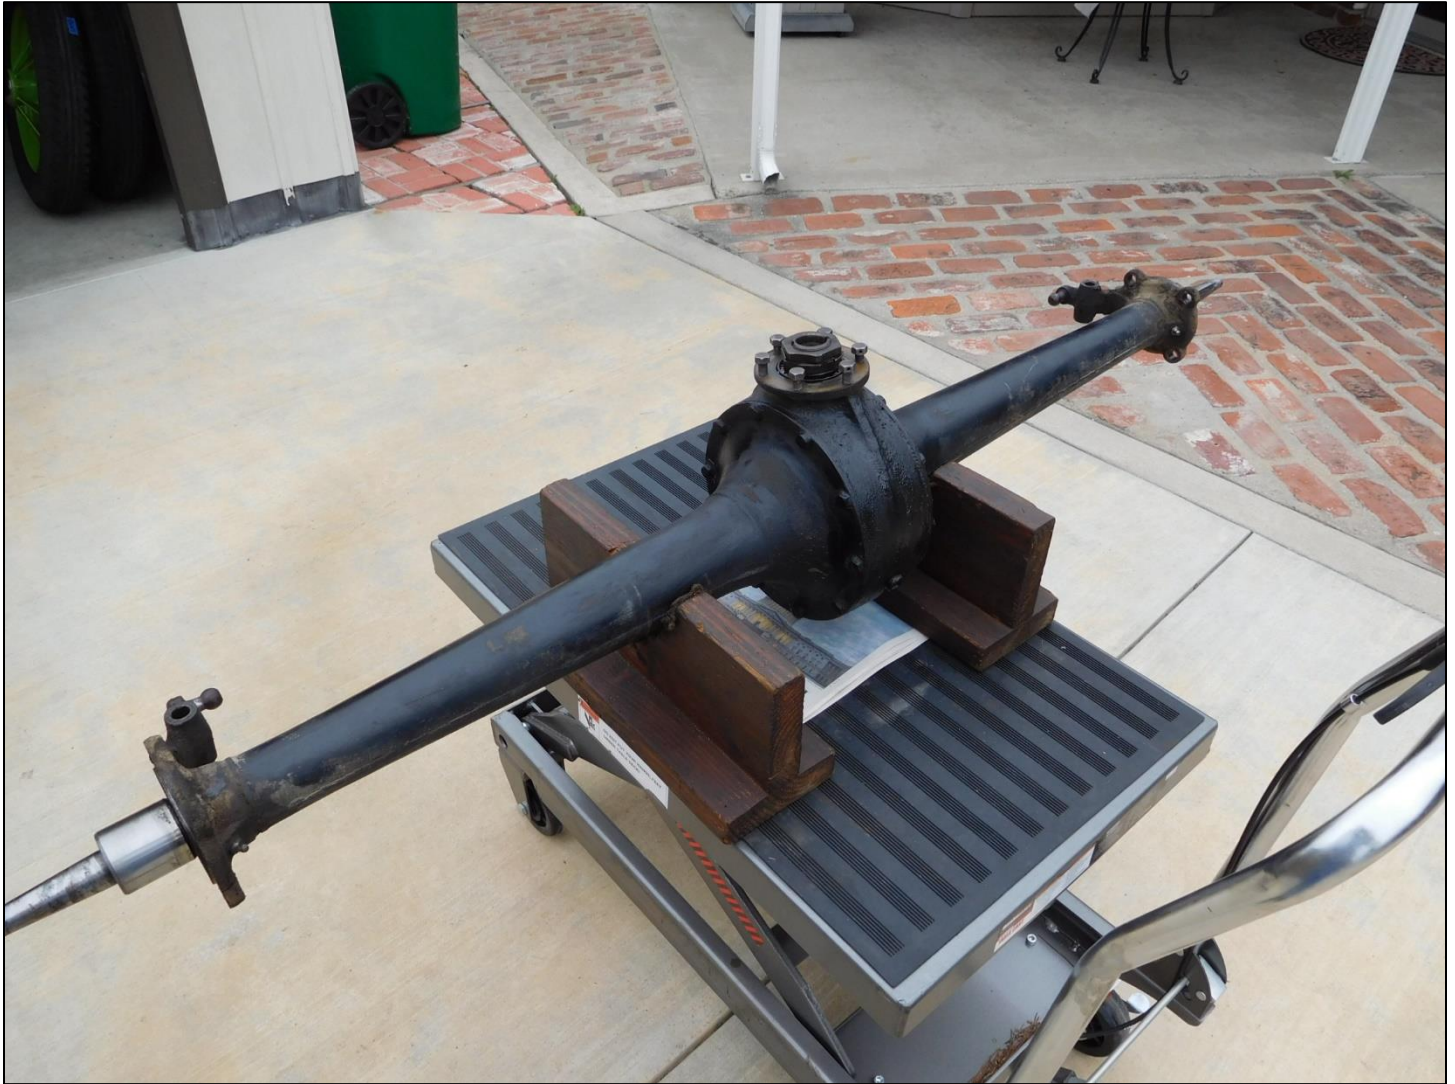
Note there is no Borg Warner stub shaft seen sticking out of the banjo. The owner said that when he pulled the Borg Warner overdrive unit off the banjo the stub shaft came out with it. This does not seem possible as there should be a nut on the end of the stub shaft inside the banjo that would have prevented that from happening.

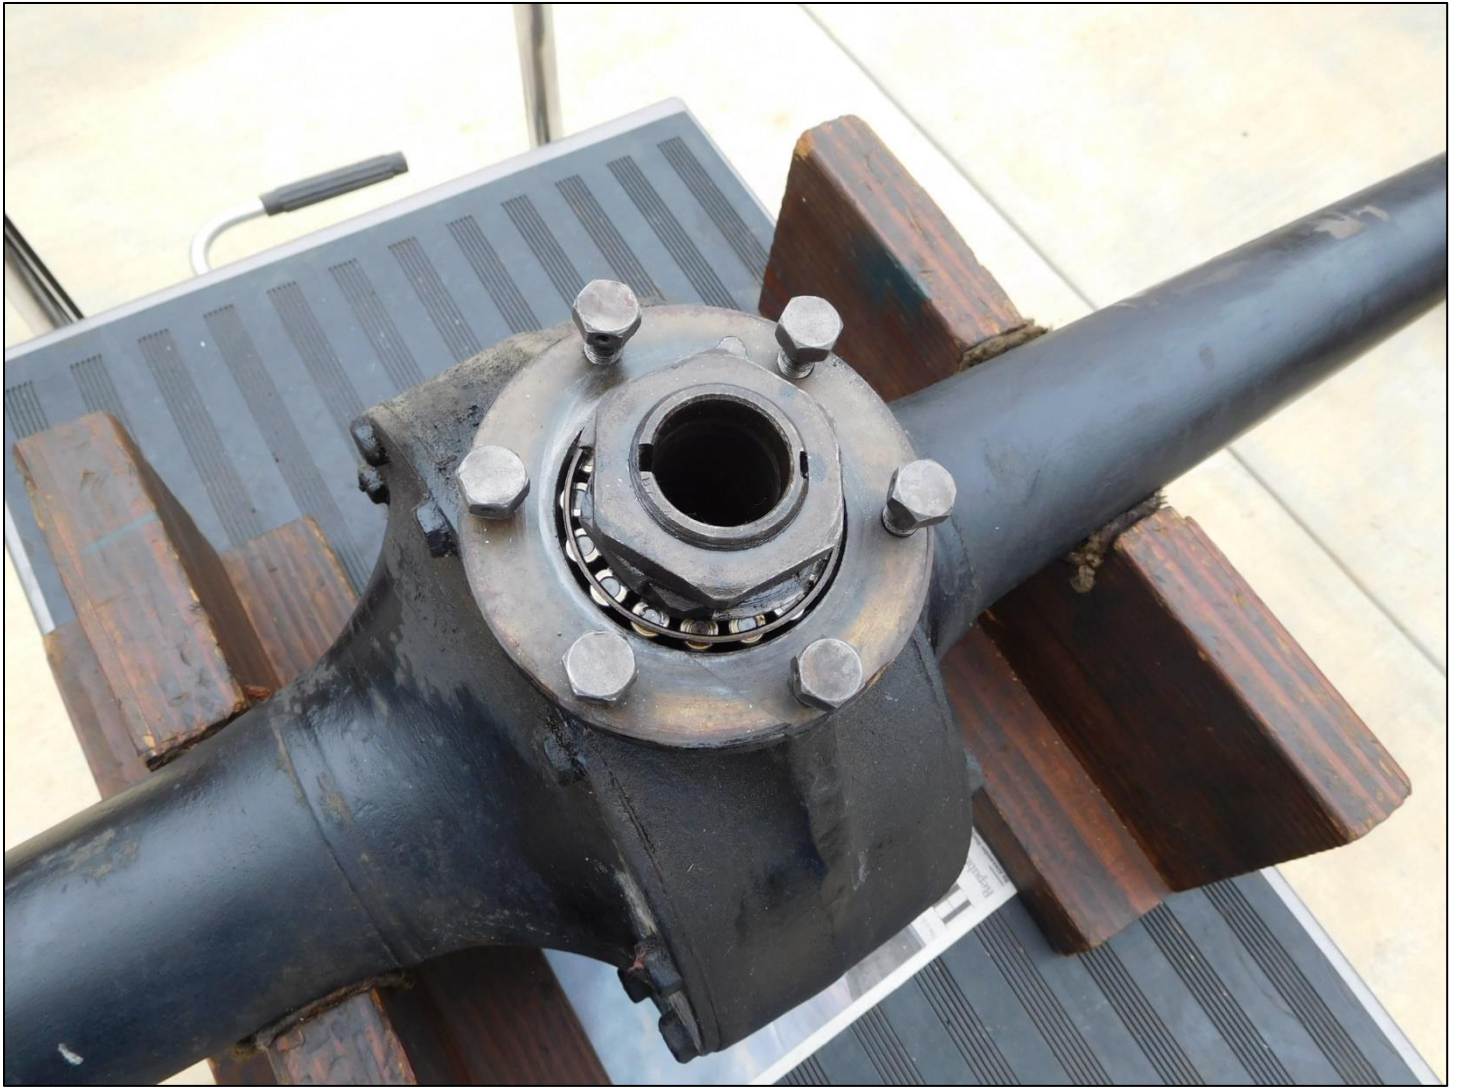
**A close-up photo showing where the Borg Warner stub shaft should be protruding from.**

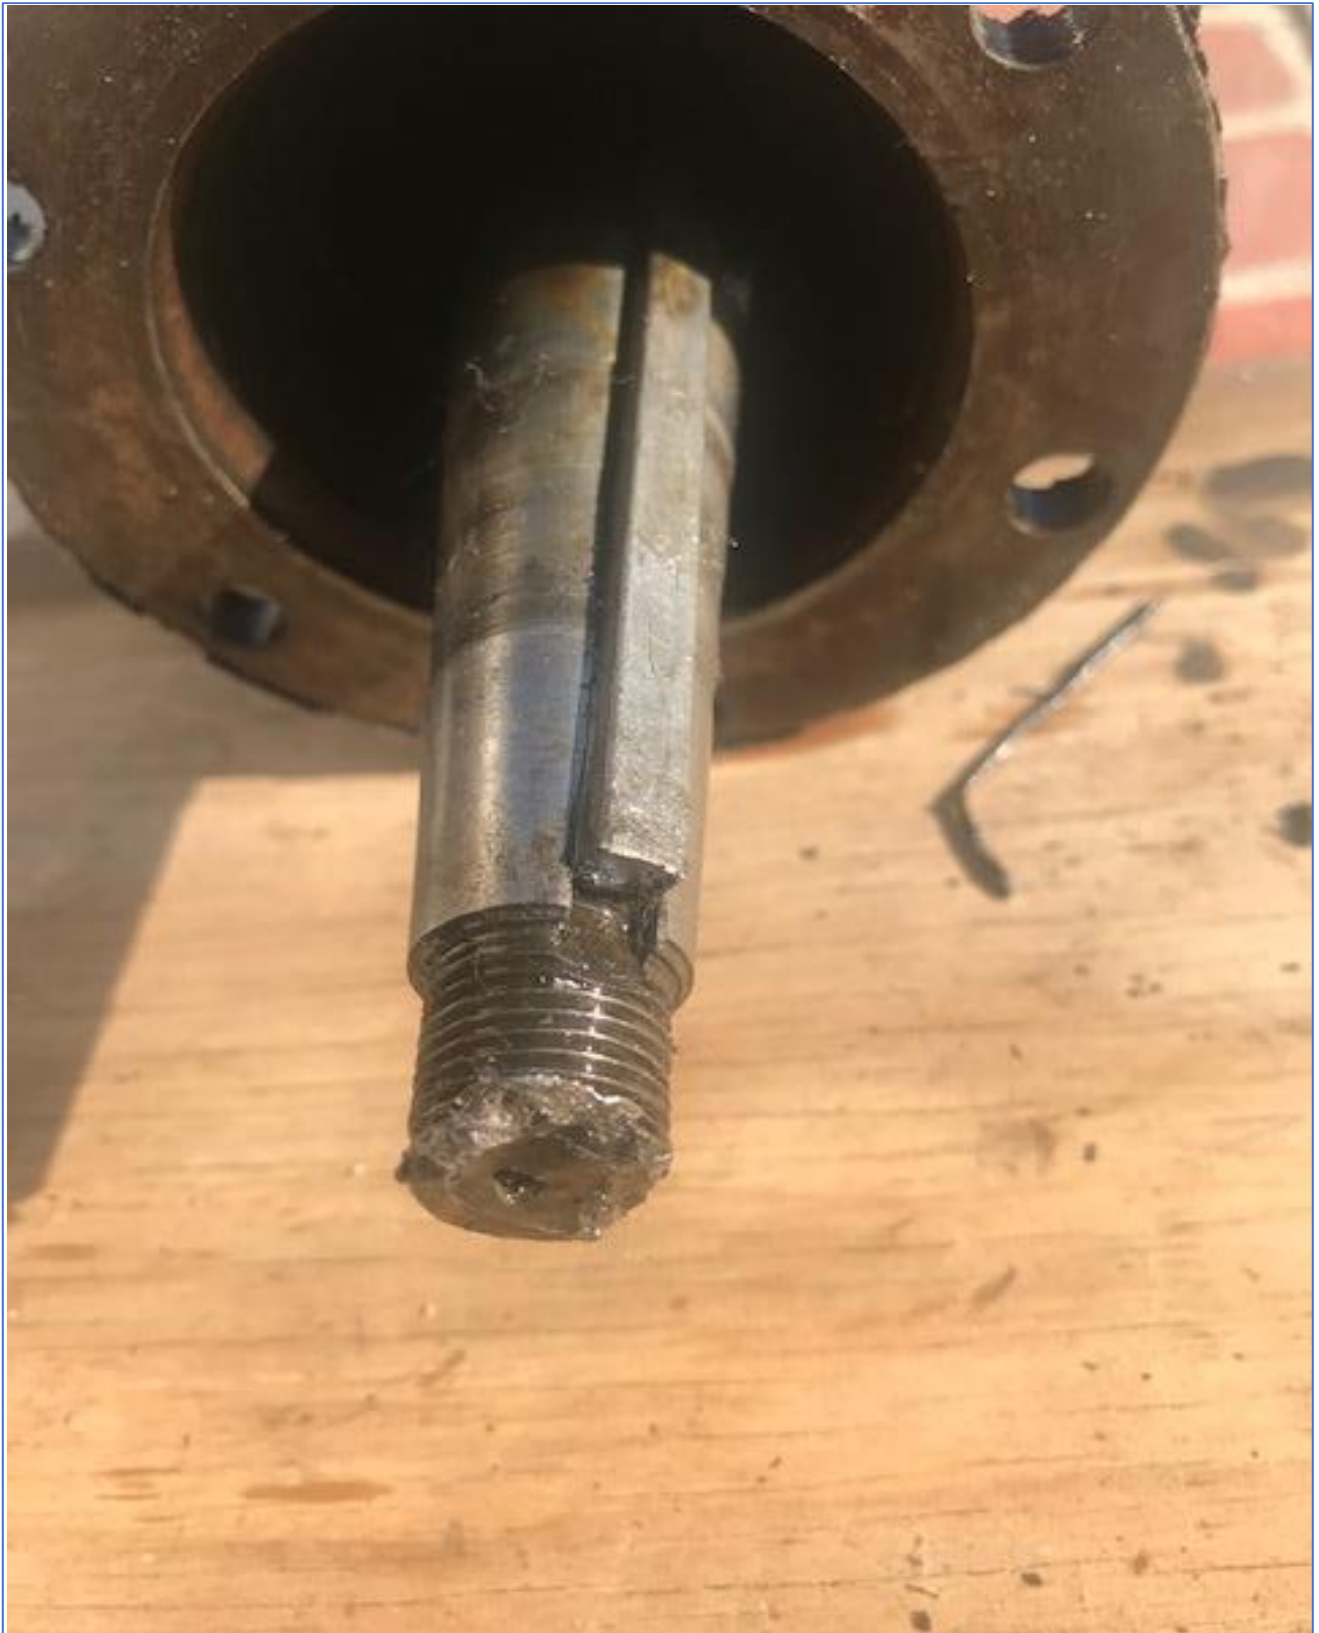
**The owner supplied this photo of the Borg Warner stub shaft that came out of the rear axle assembly when he pulled the Borg Warner overdrive off. It is still attached to the overdrive. Note how torn up is the threaded end where the nut was supposed to be.**

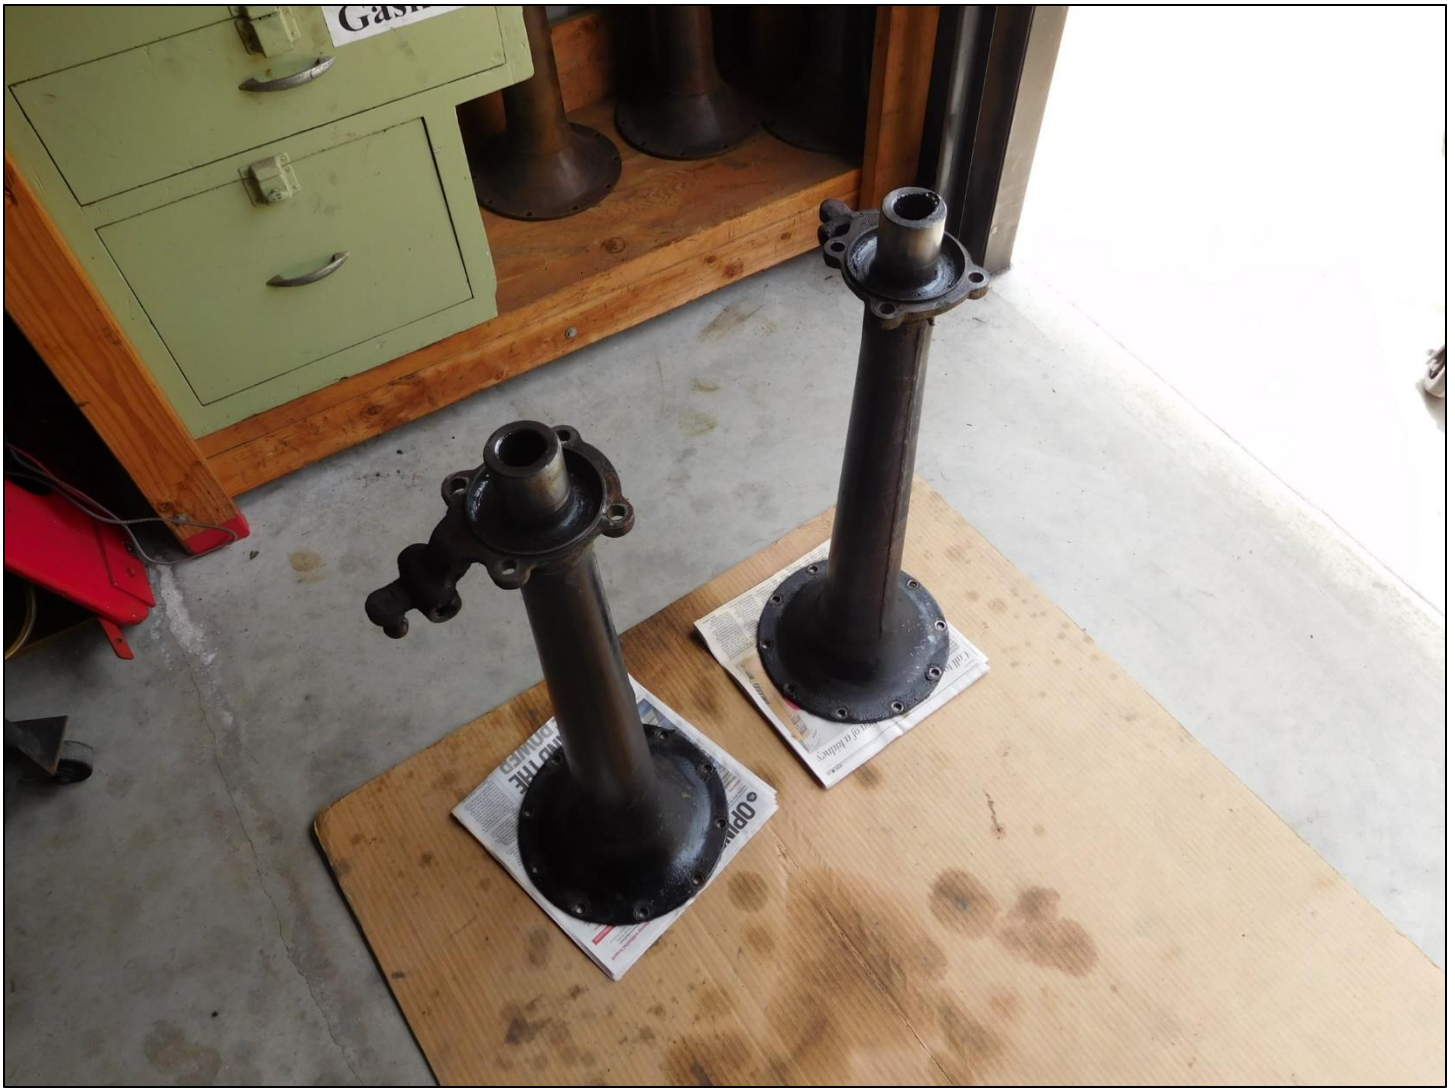
**The two axle housings have been removed. The grease seals and the carrier bearing races have been removed and the housings are ready for clean-up.**

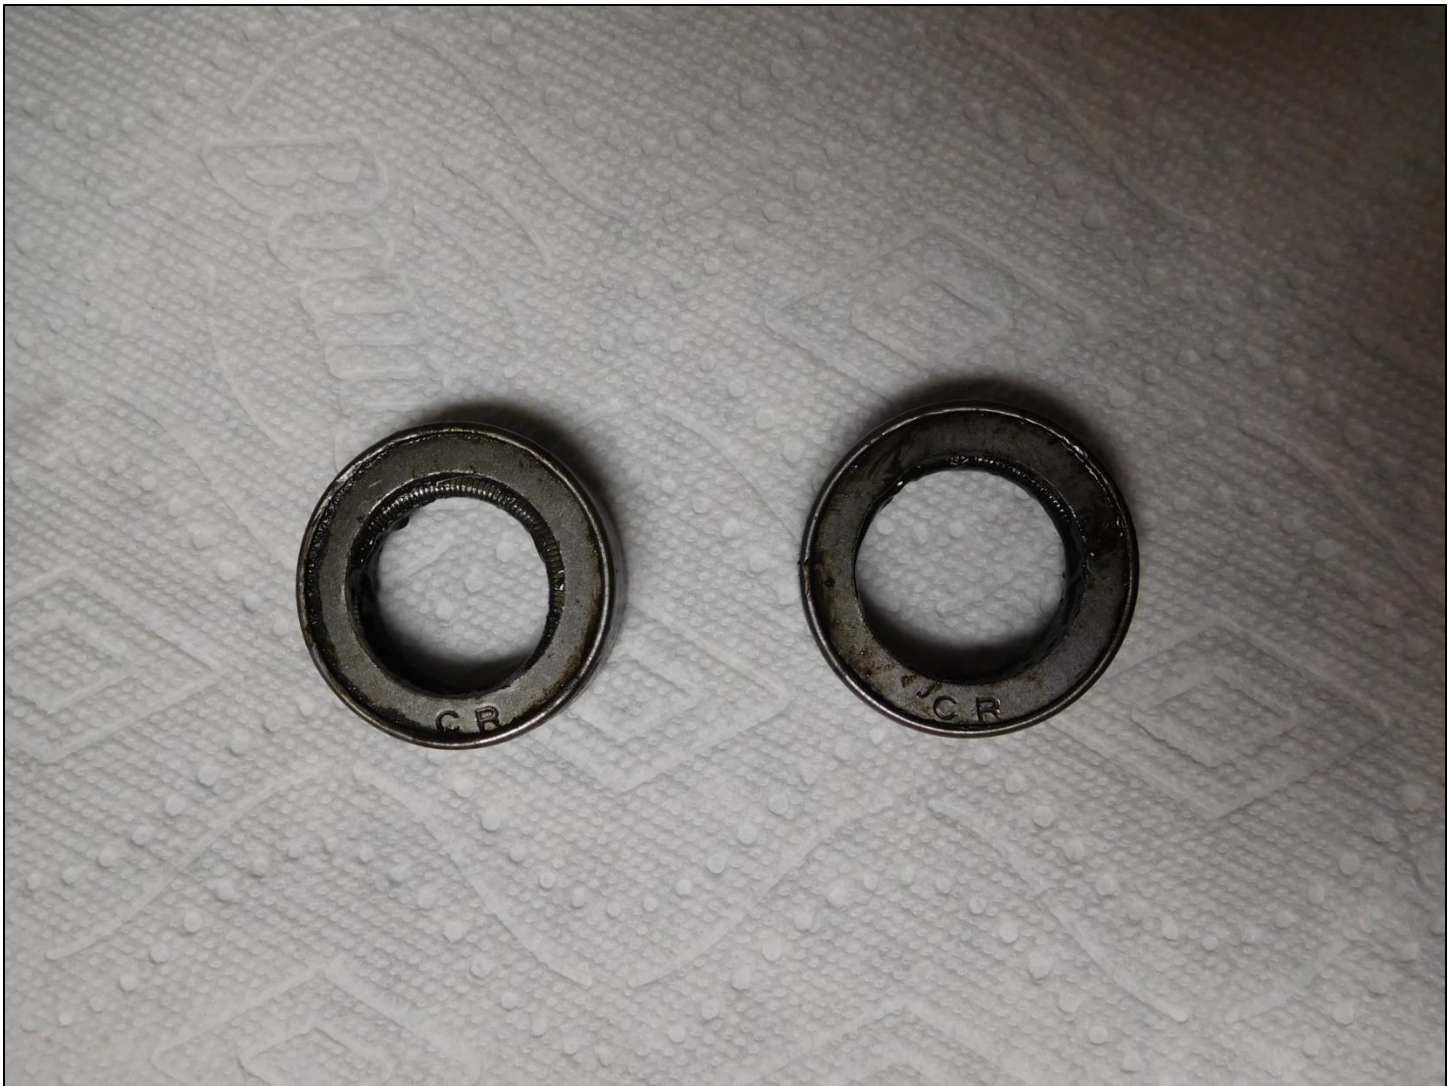
**Shown here are the two grease seals removed from the two axle housings. Note these are the original leather seals Henry Ford installed at the factory. The leather disappeared years ago and there was no sealing going on. This was evidenced by large amounts of grease found inside the axle housings. The seals are there for the purpose of directing grease pumped in through the grease fitting at the end of the axle housing to go toward the rear wheel bearing. Without the seal the grease just flows into the void on the inside of the axle housing.**

**The CR stamped on the seals stands for Chicago Rawhide, the original manufacturer of the seals.**

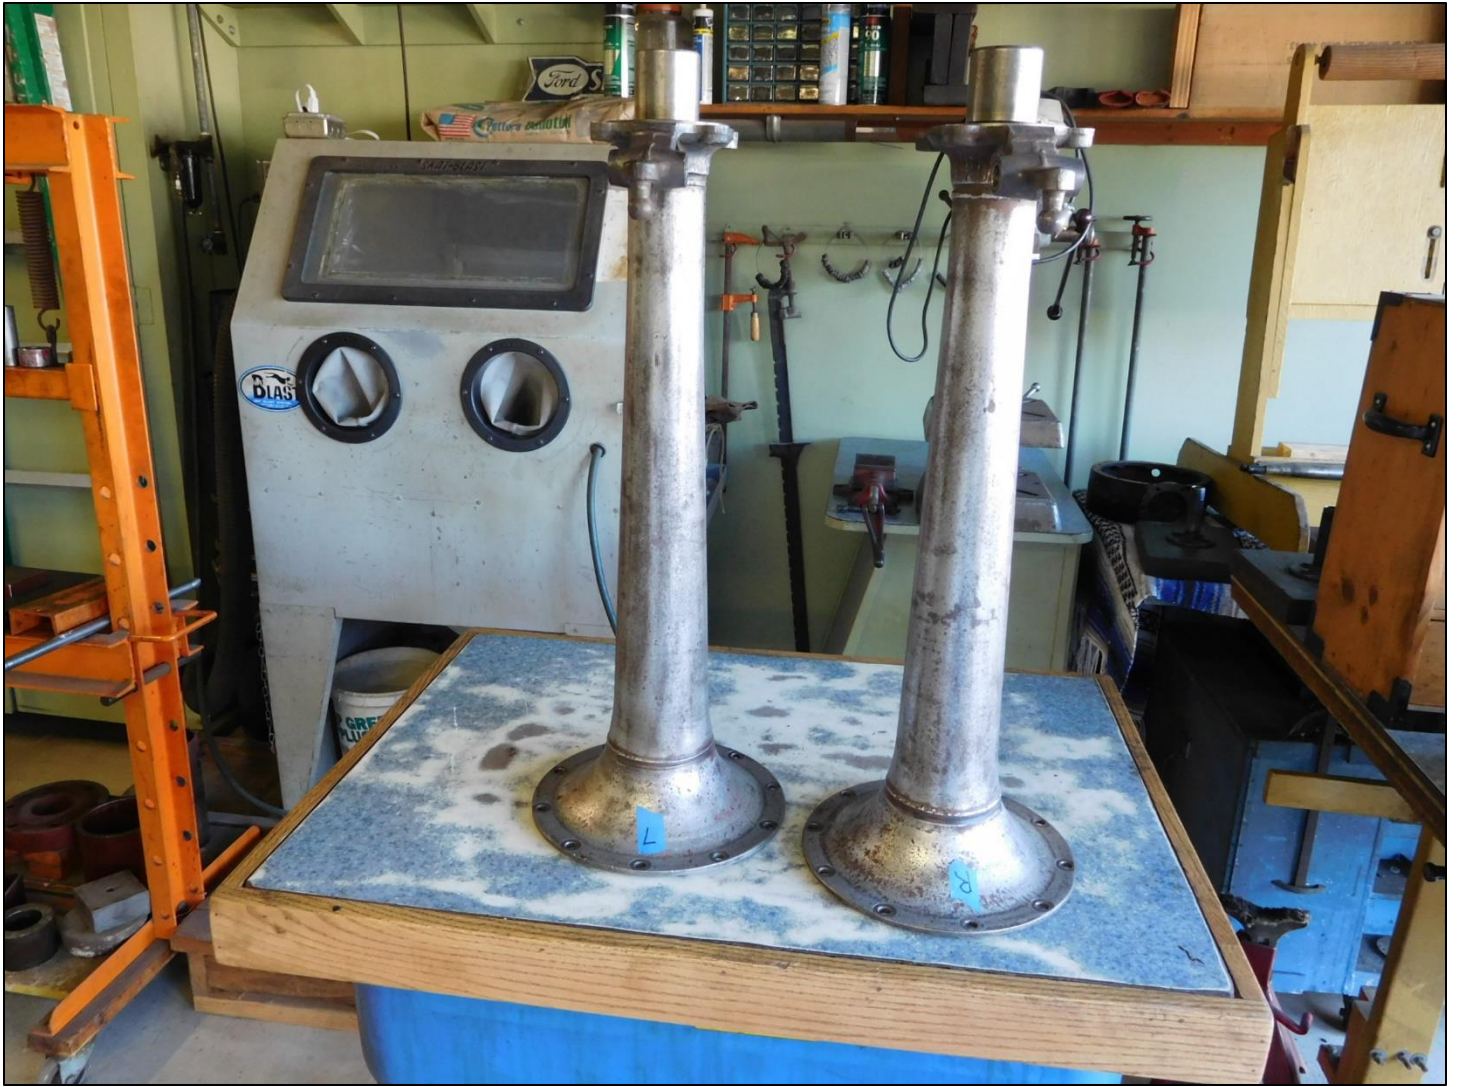
**Both axle housings have been cleaned up, new races and seals have been installed.**

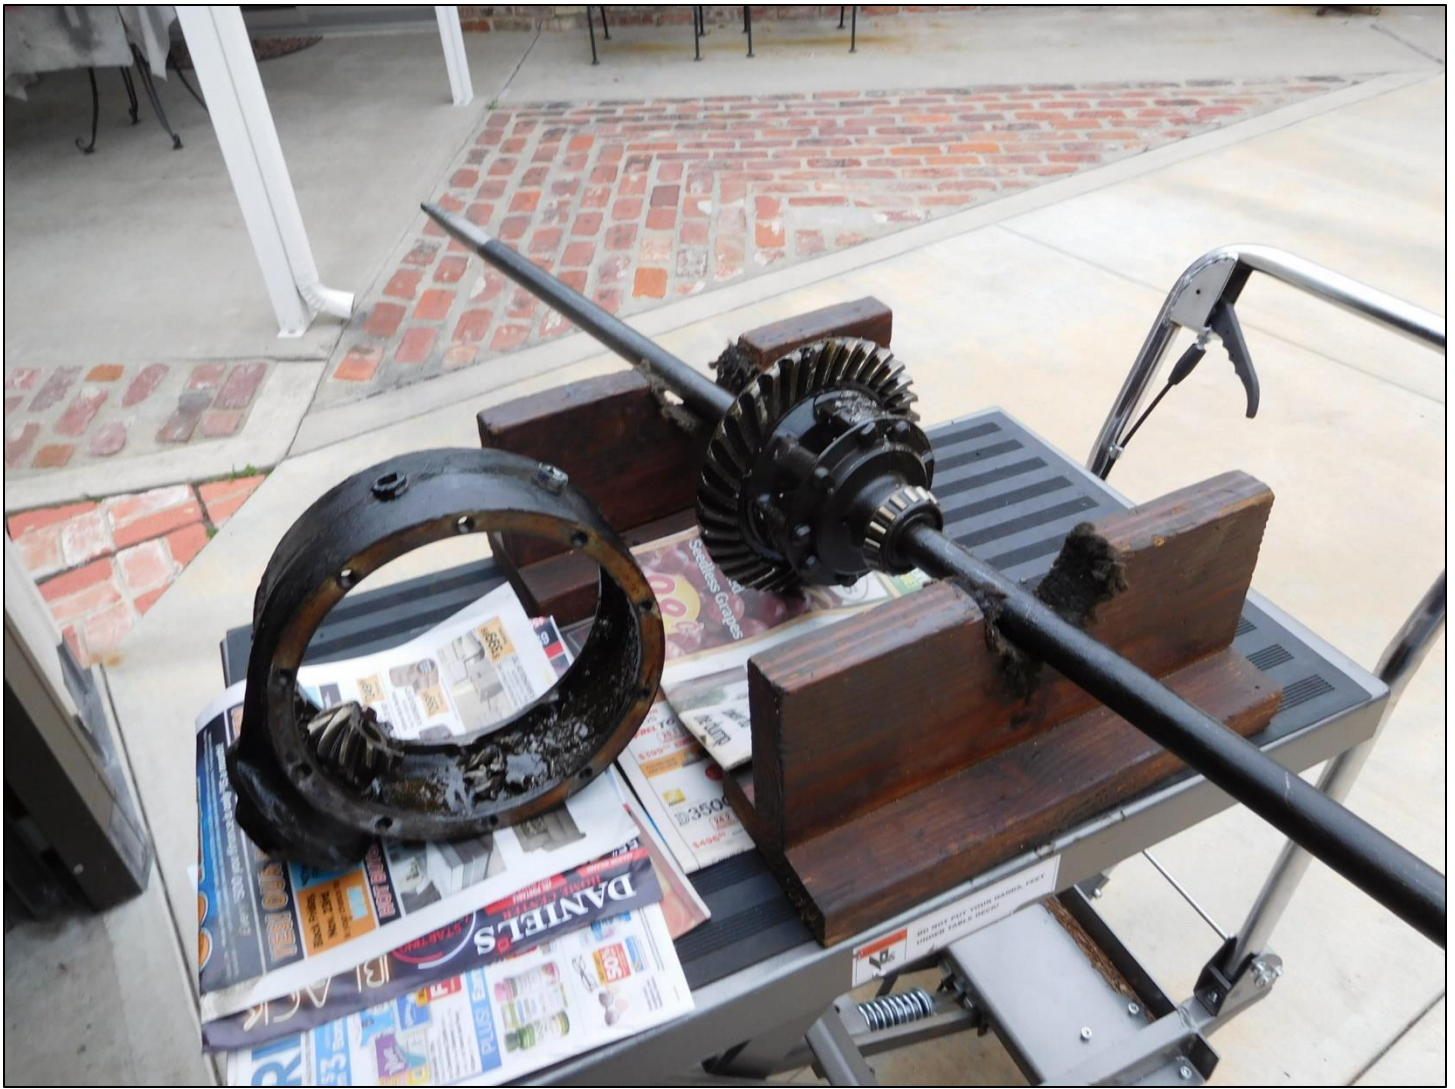
**This photo shows after the two axle housings were removed: The banjo with the pinion gear still installed and the carrier assembly with the two axle shafts still installed. Note the metal debris in the bottom of the banjo.**

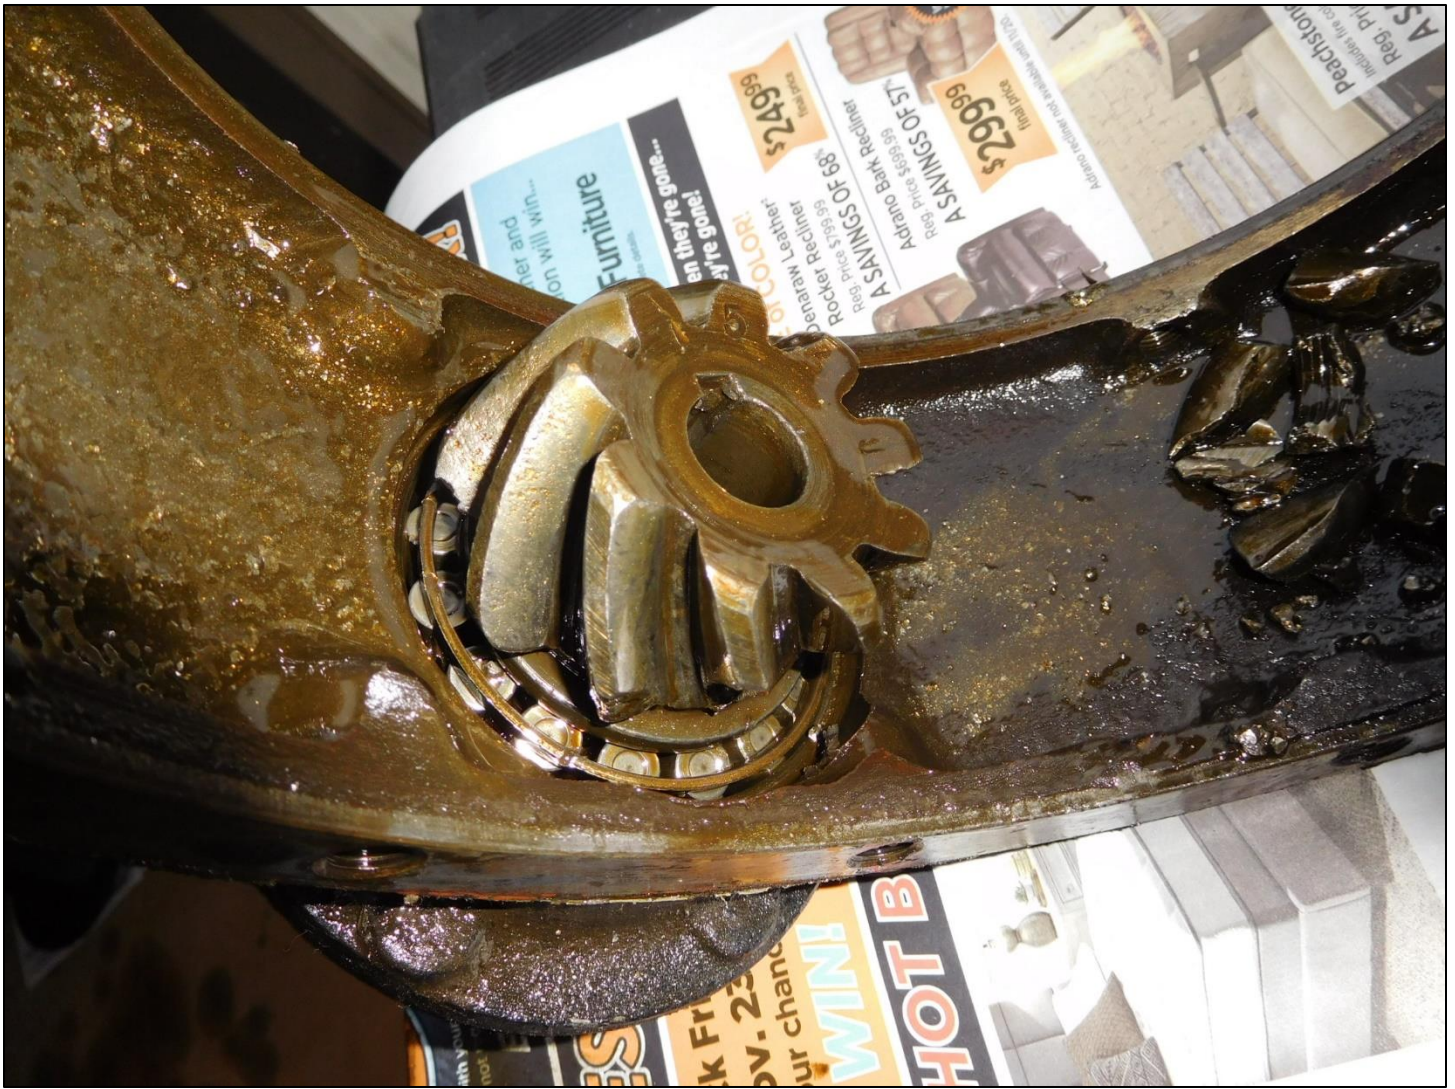
**This photo shows the pinion gear with the nut missing from where the threaded end of the stub shaft would have protruded and secured with a nut and cotter pin. Note the broken teeth from the pinion gear in the bottom of the banjo.**

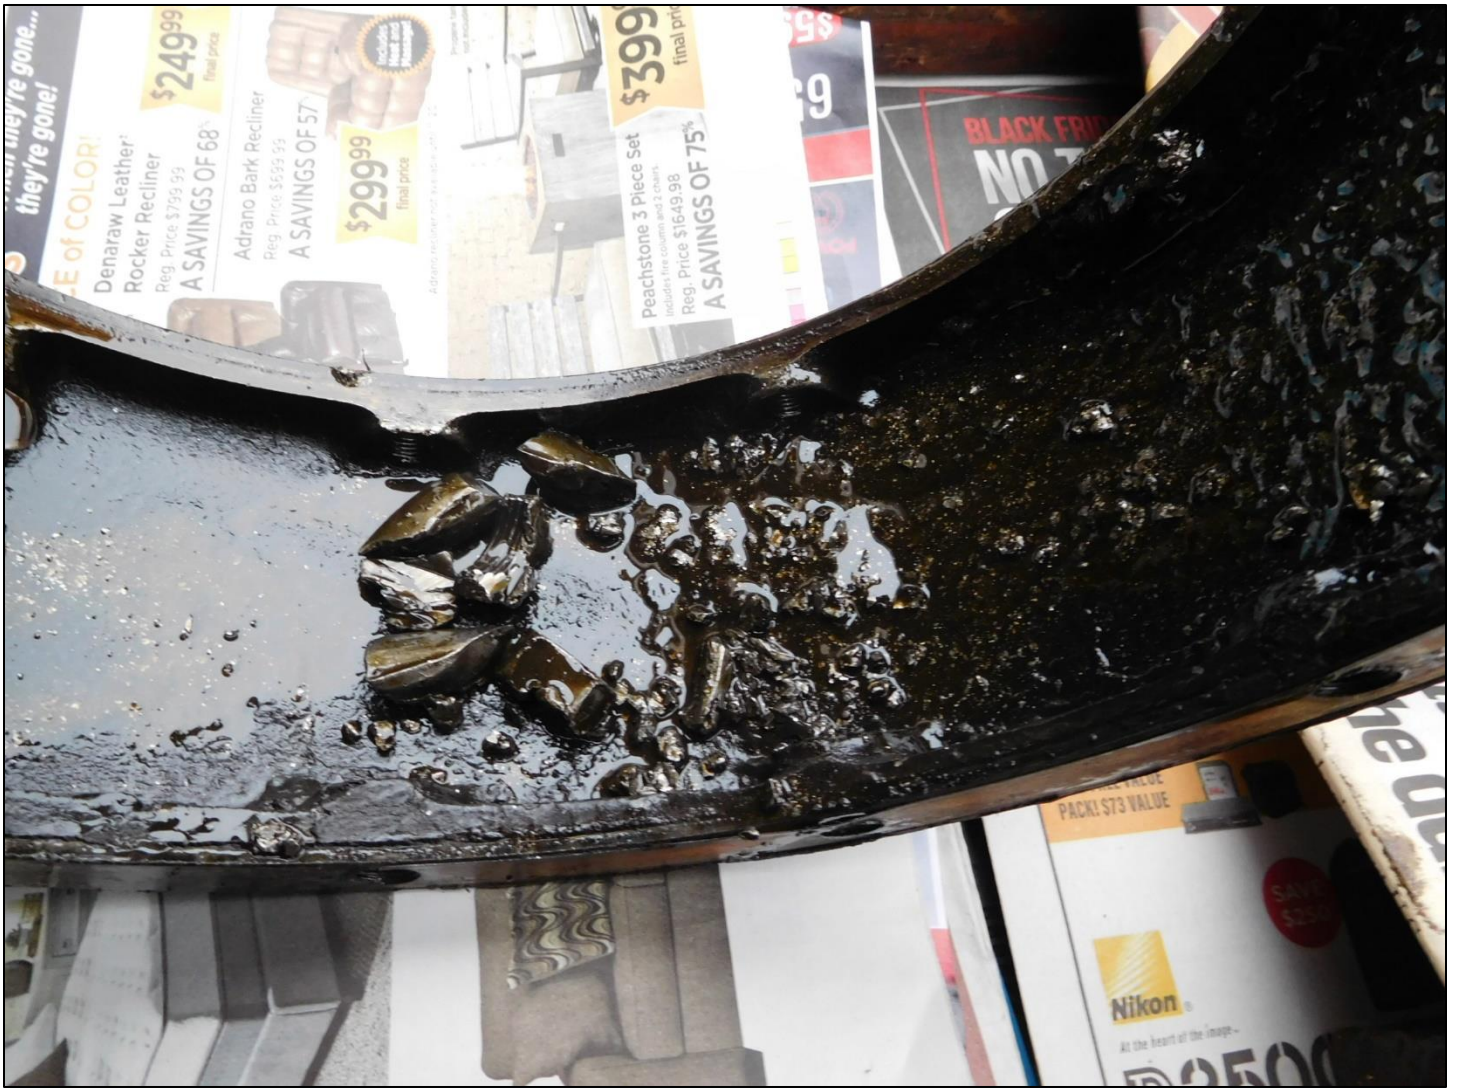
**Close up of broken teeth from the pinion gear in the bottom of the banjo.**

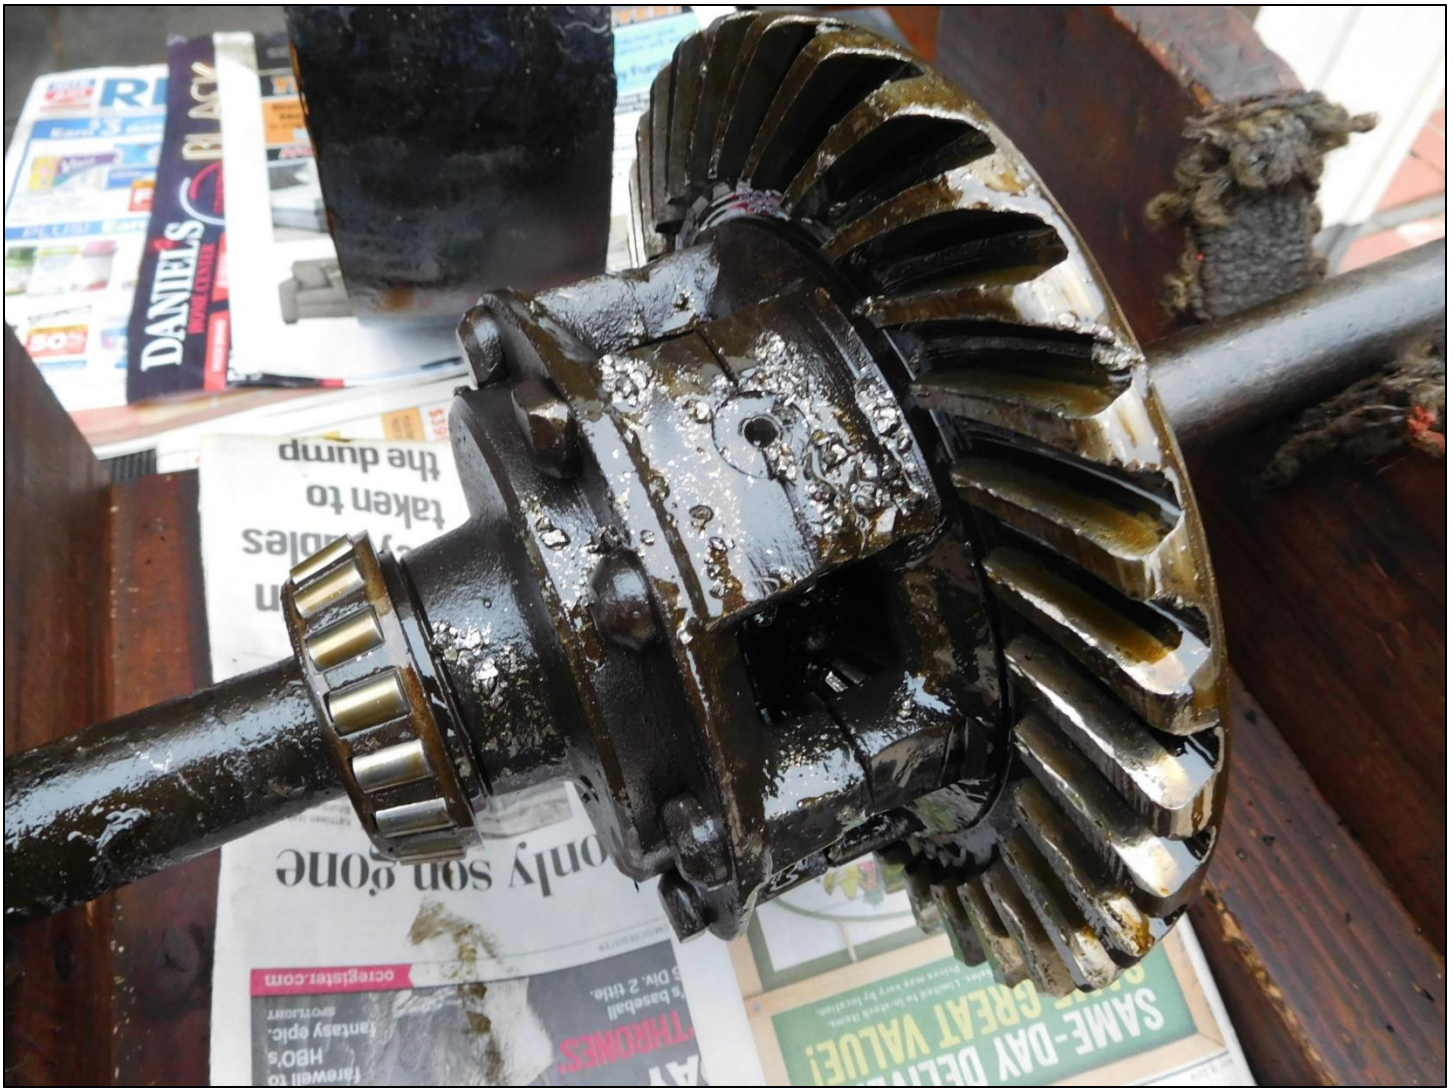
Shown here is metal debris from the pinion gear scattered on the carrier assembly. The teeth on the ring gear are also battered.

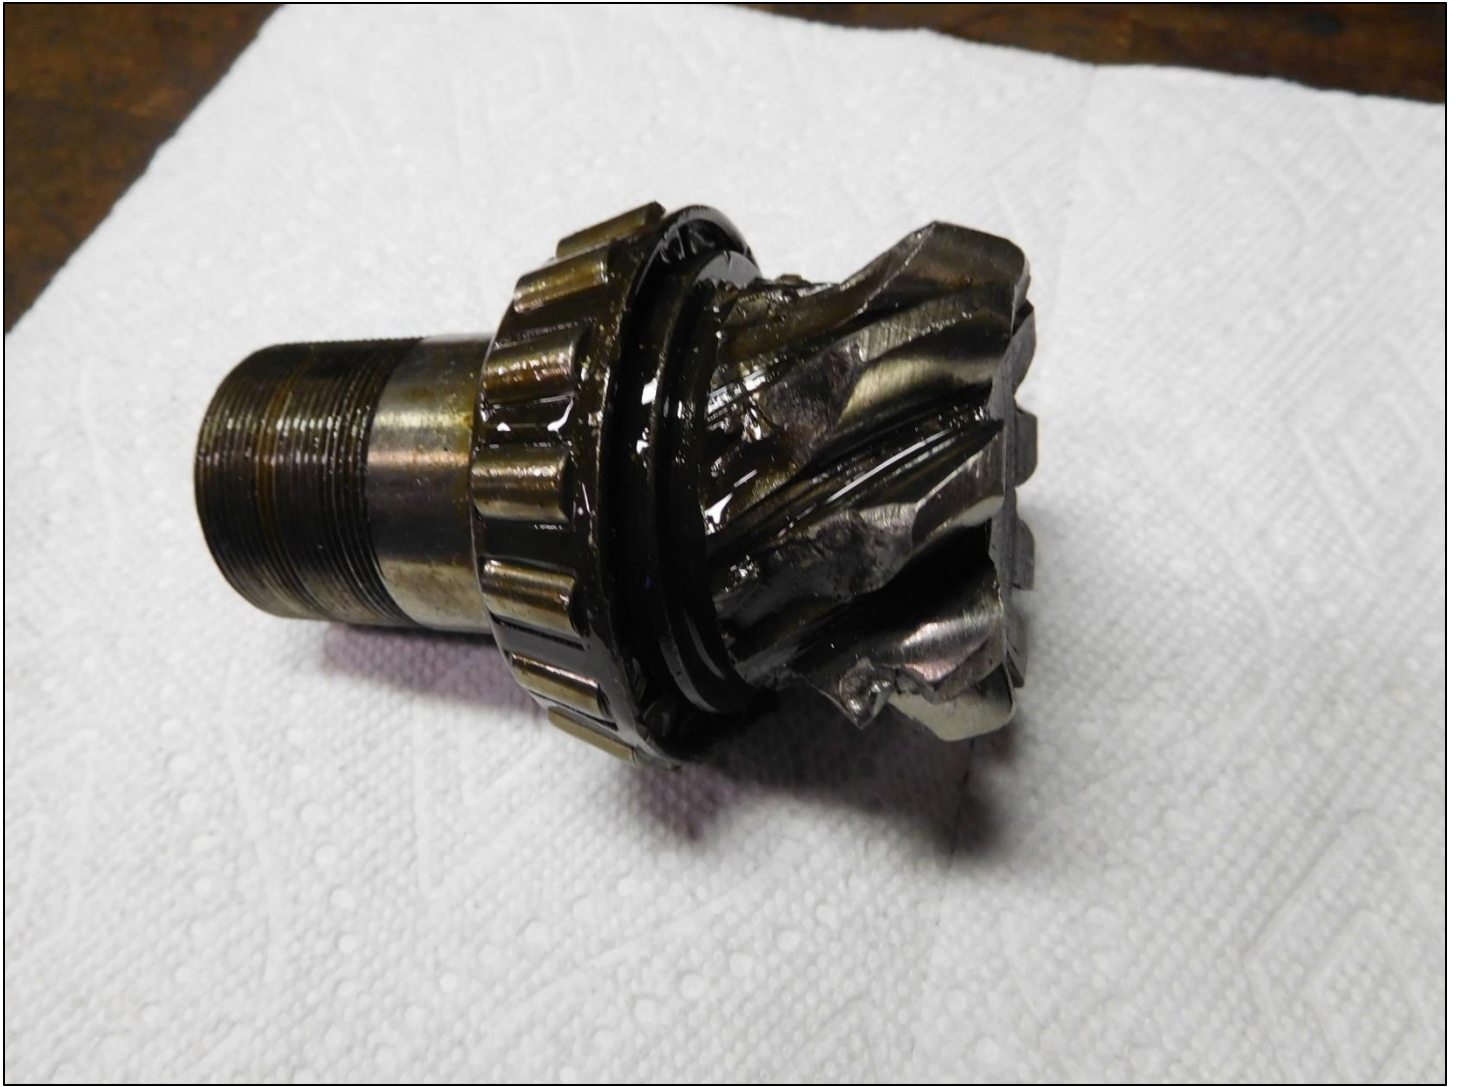
**Shown here is the damaged pinion gear. Note the many teeth missing from the gear.**

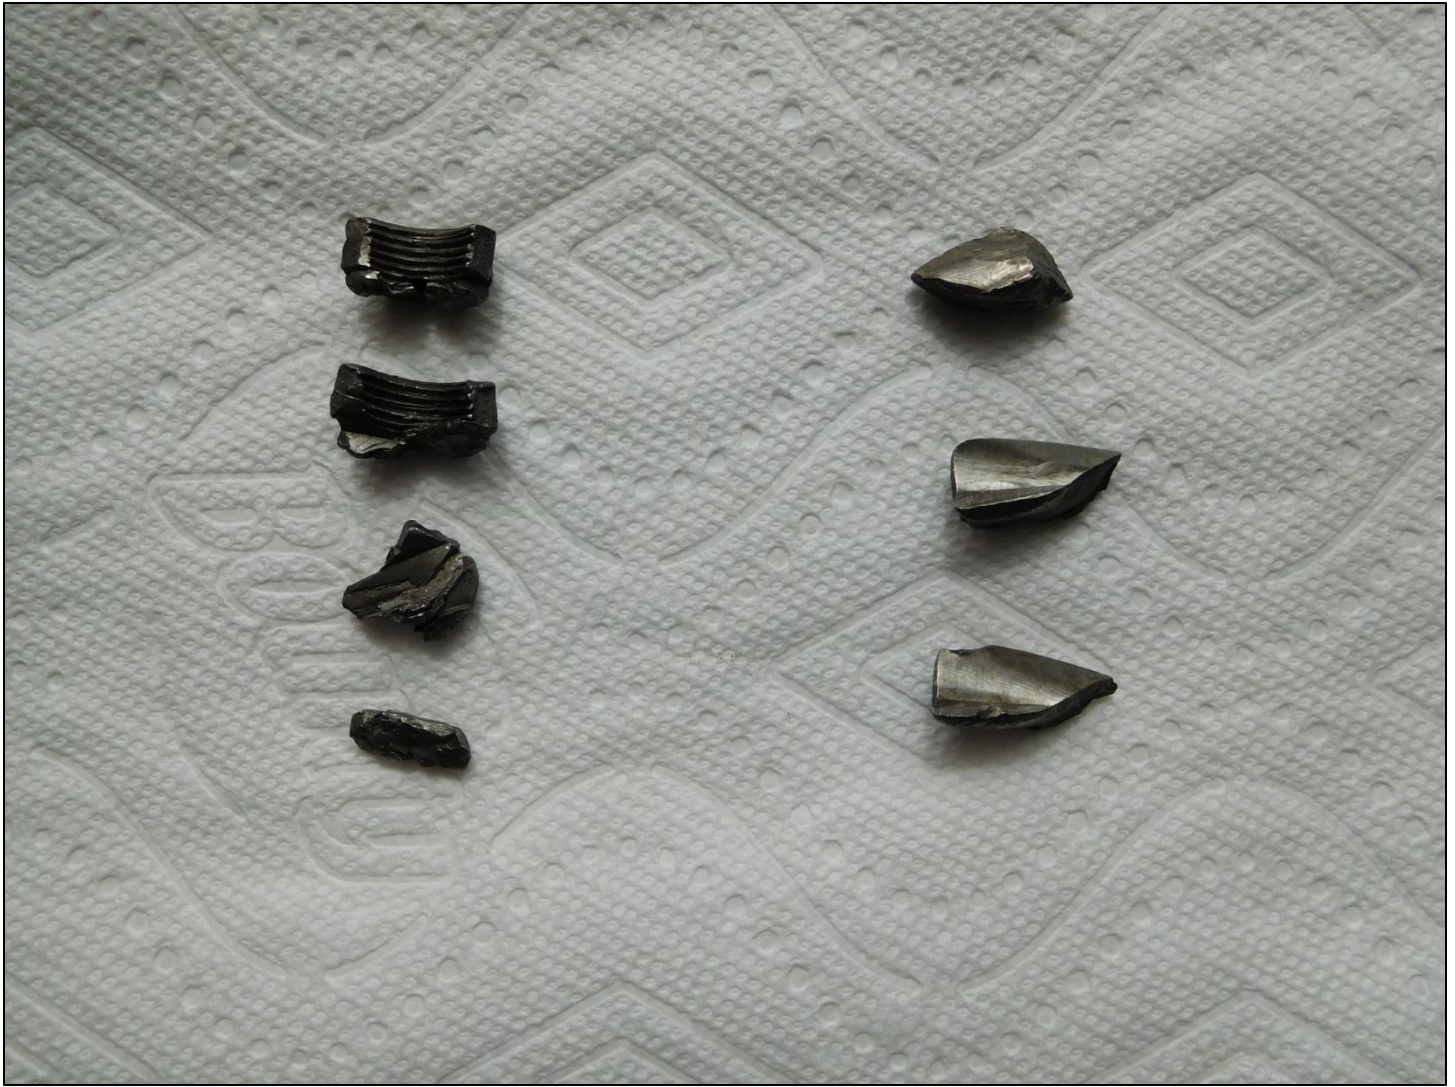
Shown here is some of the debris removed from the banjo. On the left is the remnants of the nut that was on the end of the stub shaft, it appears to have been cut in two. To the right are three teeth broken off the pinion gear.

I suspect that when the Borg Warner overdrive was installed, the nut on the end of the stub shaft was not sufficiently tightened and a cotter pin was not installed. Eventually the nut backed off the threaded end of the stub shaft and hit the rotating carrier, which cut it in half and the pieces became jammed in the ring & pinion gears. I was not able to find any pieces of a cotter pin among the debris.

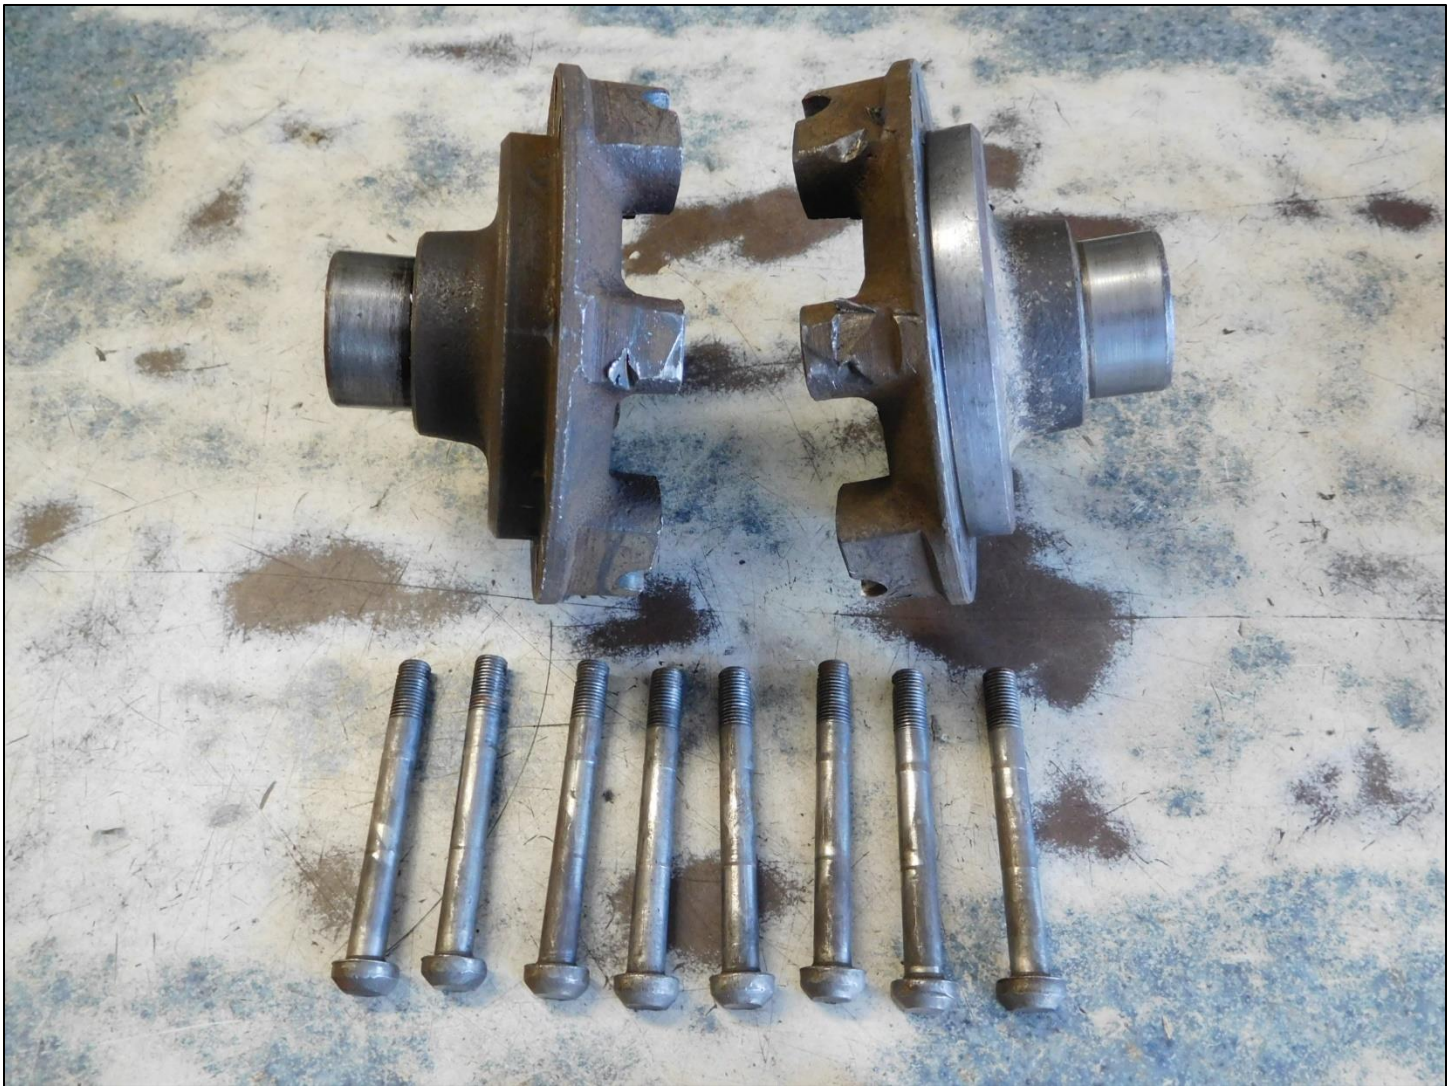
**Shown here is the carrier that was removed. It is the early version used in the 28-29 cars. The two halves are identical part numbers. The ring gear can mount on either side. The area where they join together is not notched as are the later carriers. The bolts used were different, they have a half dome head that locks into the ridge on the opposite side of the ring gear.**

**The carrier has the bearing mount hub spun on the side the ring gear was on. It also suffered some exterior damage due to all the broken parts adrift in the banjo. The carrier will be replaced with a serviceable later version that has had both hubs knurled. A set of later style bolts will also be used.**
