# Differential Overhaul June 20, 2019 (SL)

by Tom Endy

This rear axle assembly arrived in the back of a modern SUV after being removed from a 1931 roadster. The owner complaint was that the ring & pinion were jammed up. The unit had a Borg Warner overdrive installed that the owner removed before bringing it over. The overhaul will include a new 378:1 ratio ring & pinion gear set and a new Mitchell 26% overdrive will also be installed.

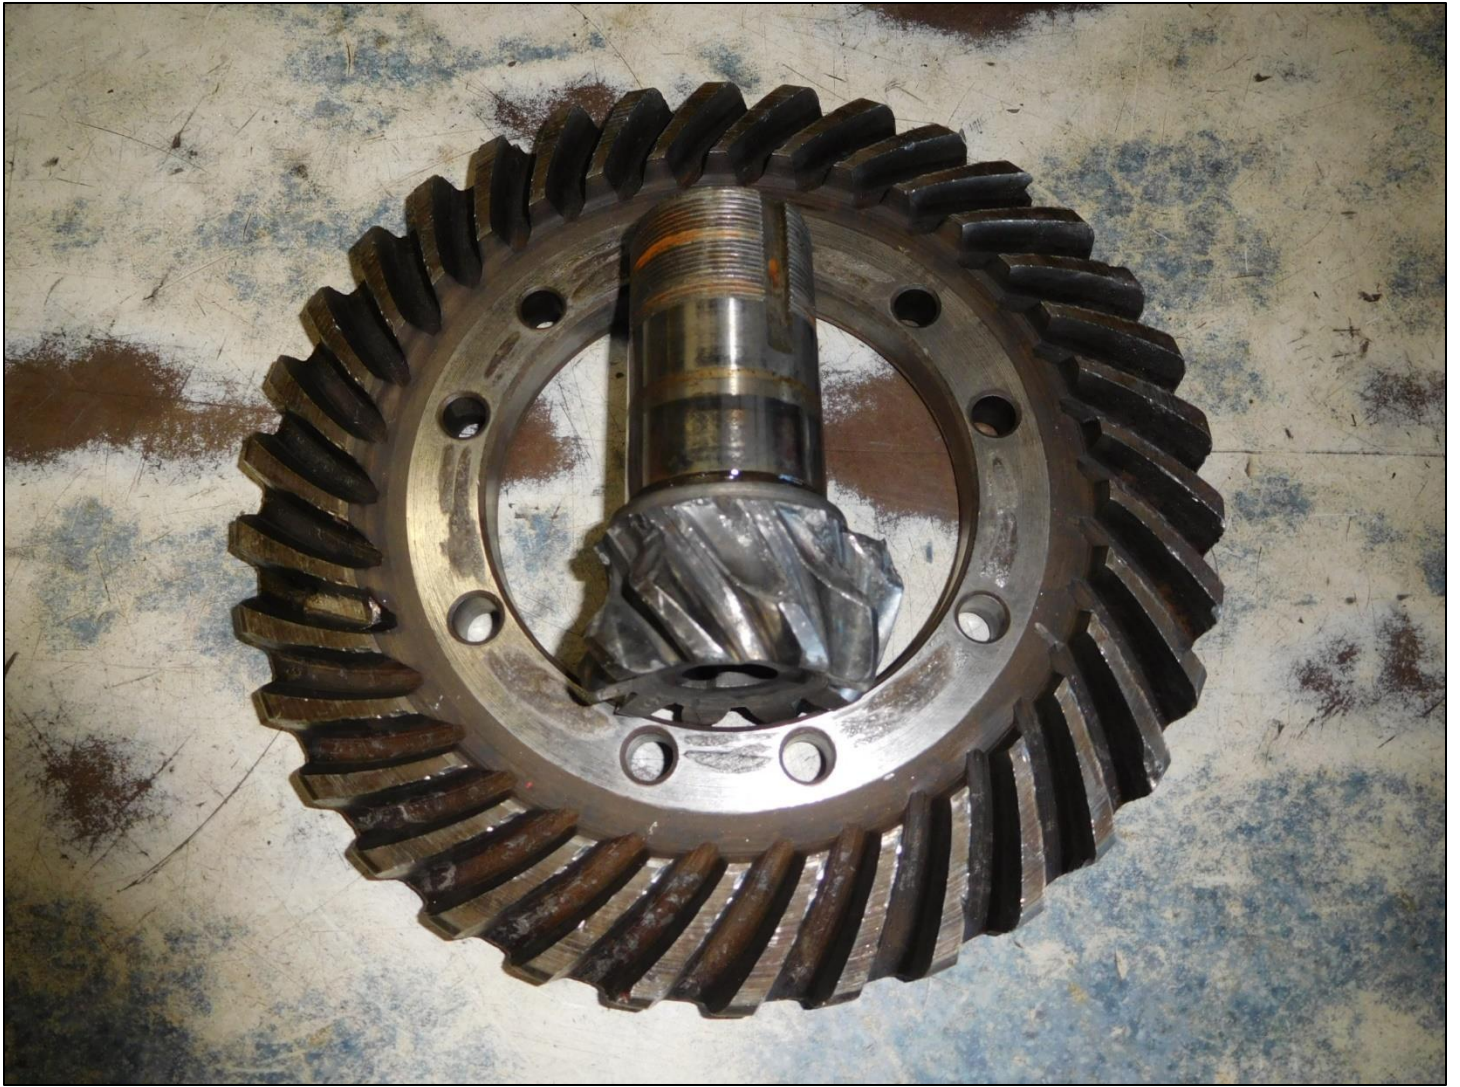
**Shown here is the damaged ring & pinion that was removed. It is an original 378:1 gear ratio. It is definitely not serviceable.**

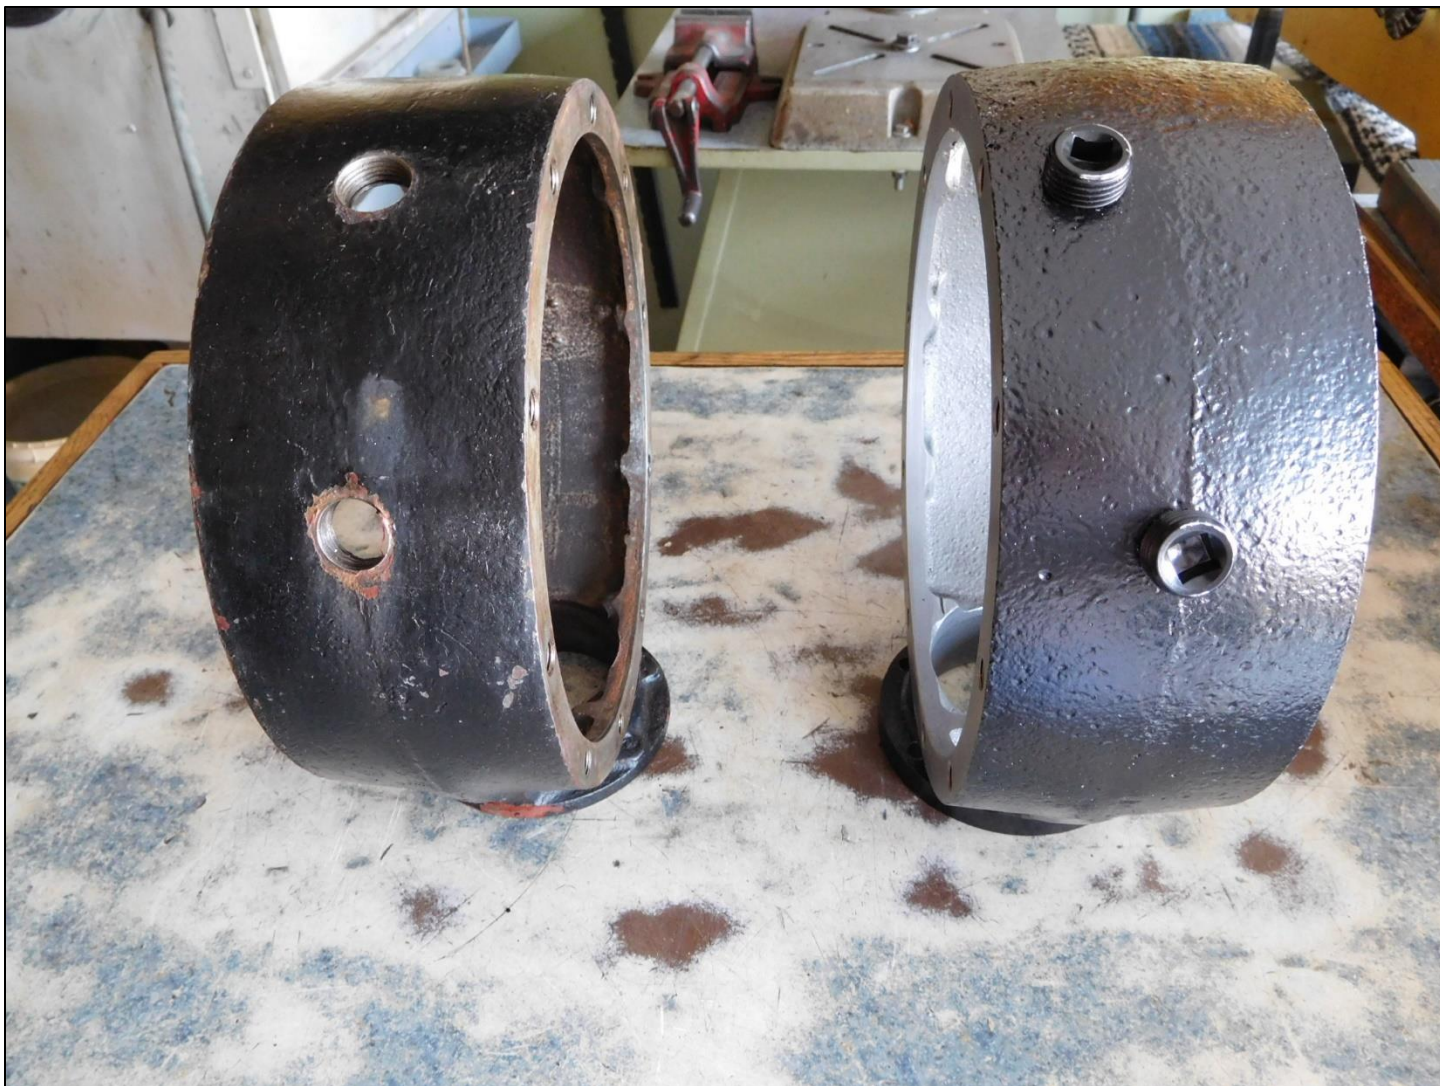
**The banjo on the left is the one removed. It is a 1929 to mid-1930 with the drain hole and the fill hole in line in the center of the banjo. The banjo on the right is a mid-1930 through 1931 with the fill hole off the center line to the left. Since the car is a 1931 roadster, the 1931 banjo on the right will be exchanged and installed.**

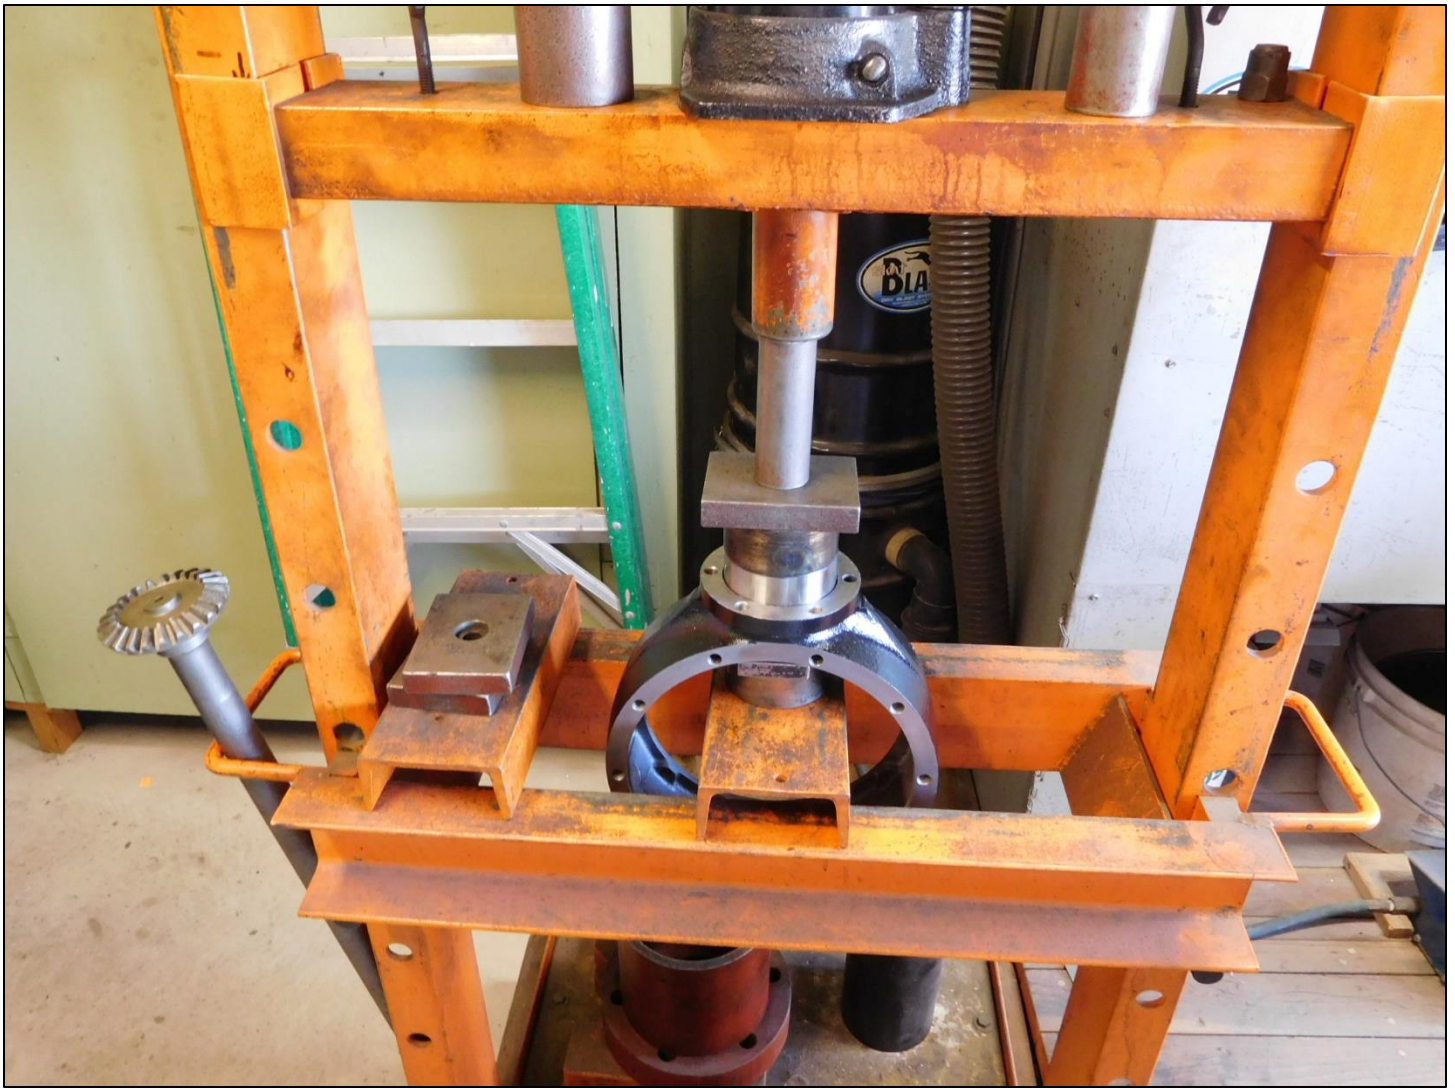
**Shown here is a new double pinion bearing race being pressed into the 1931 banjo. Note how the banjo is positioned on the press. The banjo should never be set with the banjo bottom sitting on the base of the press as the force of the press will distort it into the shape of a football. A support should be placed directly under the banjo flange to absorb the pressure of the press.**

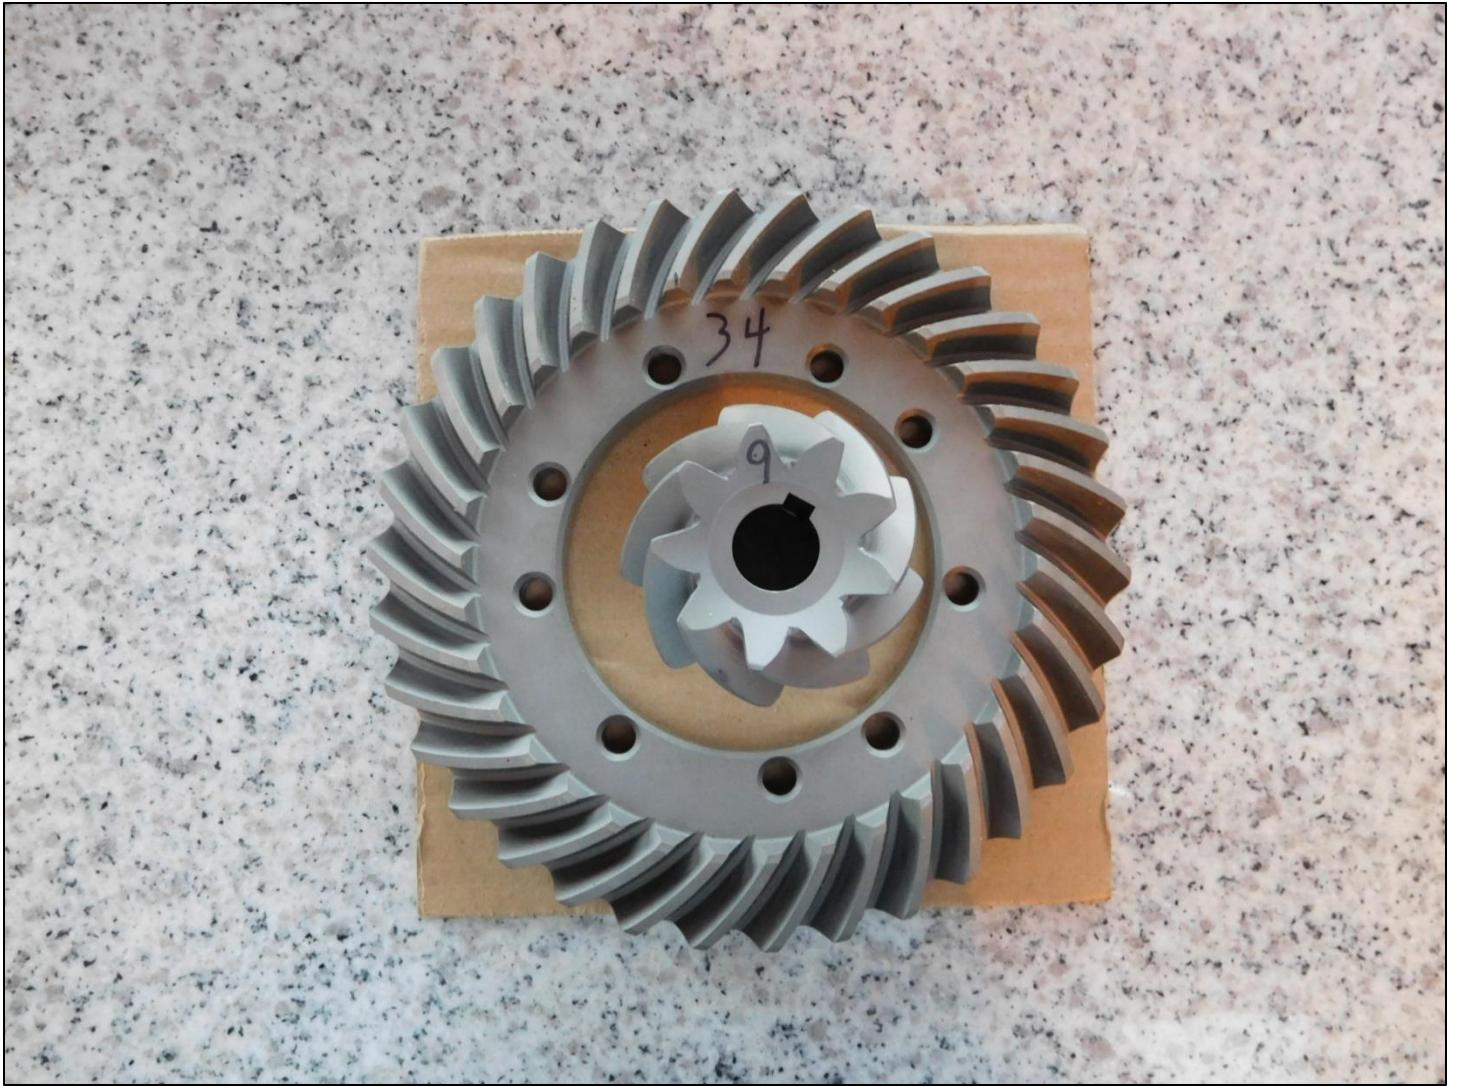
**The new 378:1 gear ratio ring & pinion gear set showed up from the supplier. Nine teeth on the pinion, 34 teeth on the ring gear.**

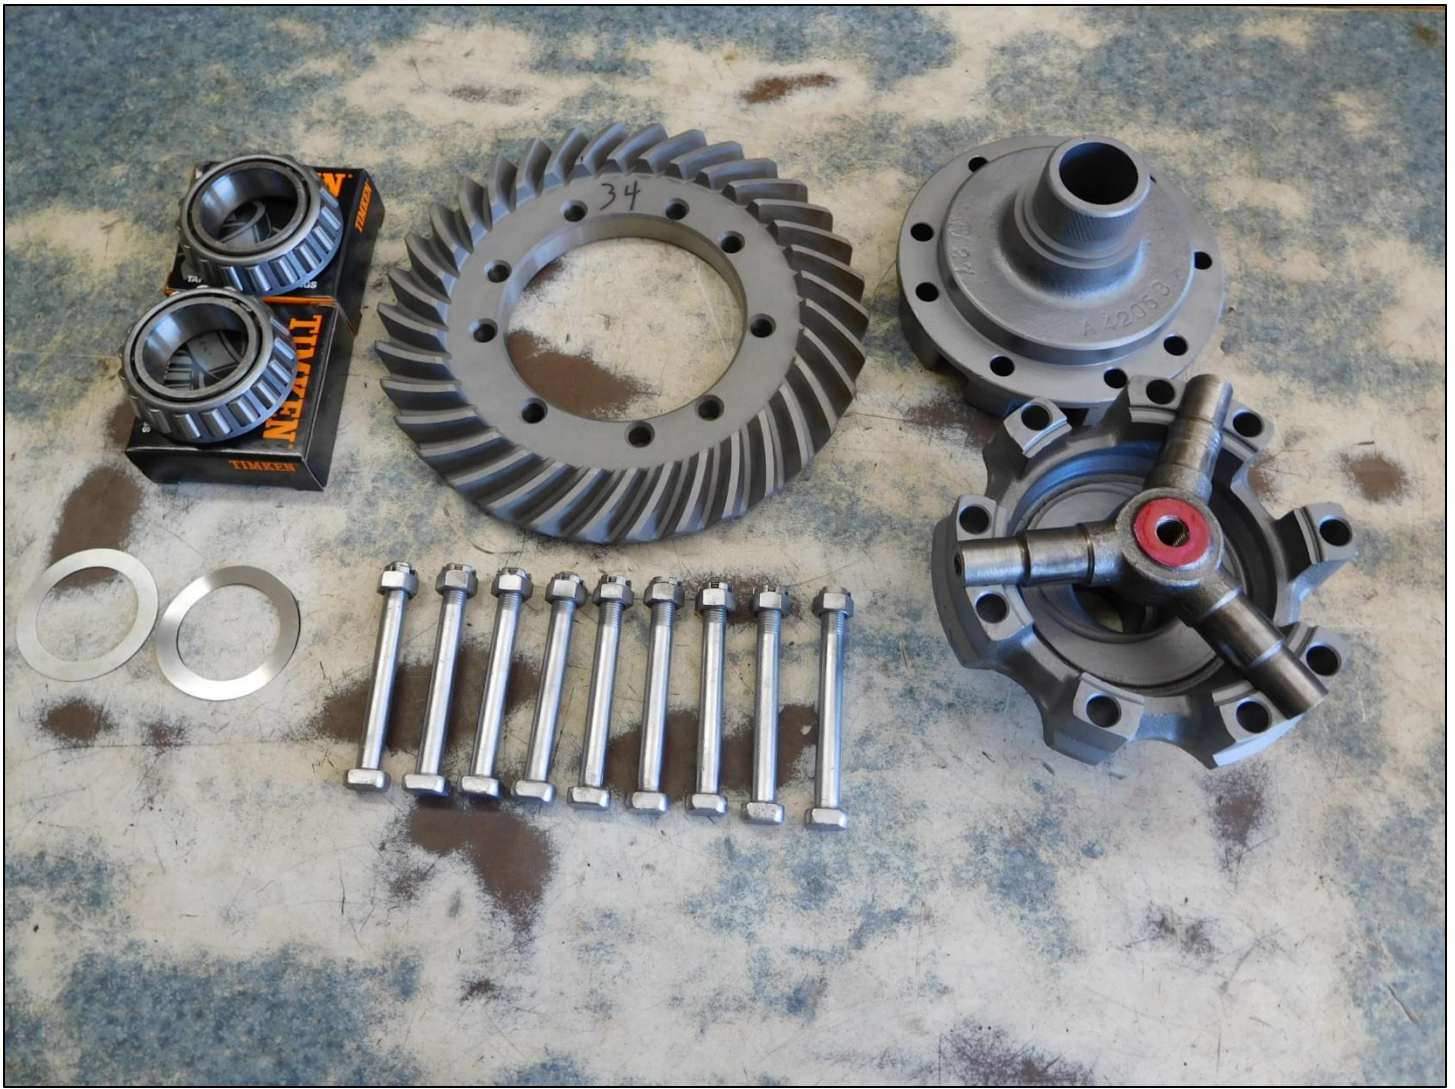
**The new ring gear is about to be installed on the replacement carrier that has had both bearing hubs knurled. Inside the two carrier halves is part of the pre-load tool (red paint). Nine carrier bolts and nuts hold the carrier assembly together. The two bearings will be pressed onto the hubs with a .005 bearing shim under each bearing. The shims are to compensate for material that was machined off the bearing stops to clean them up when the knurling was done.**

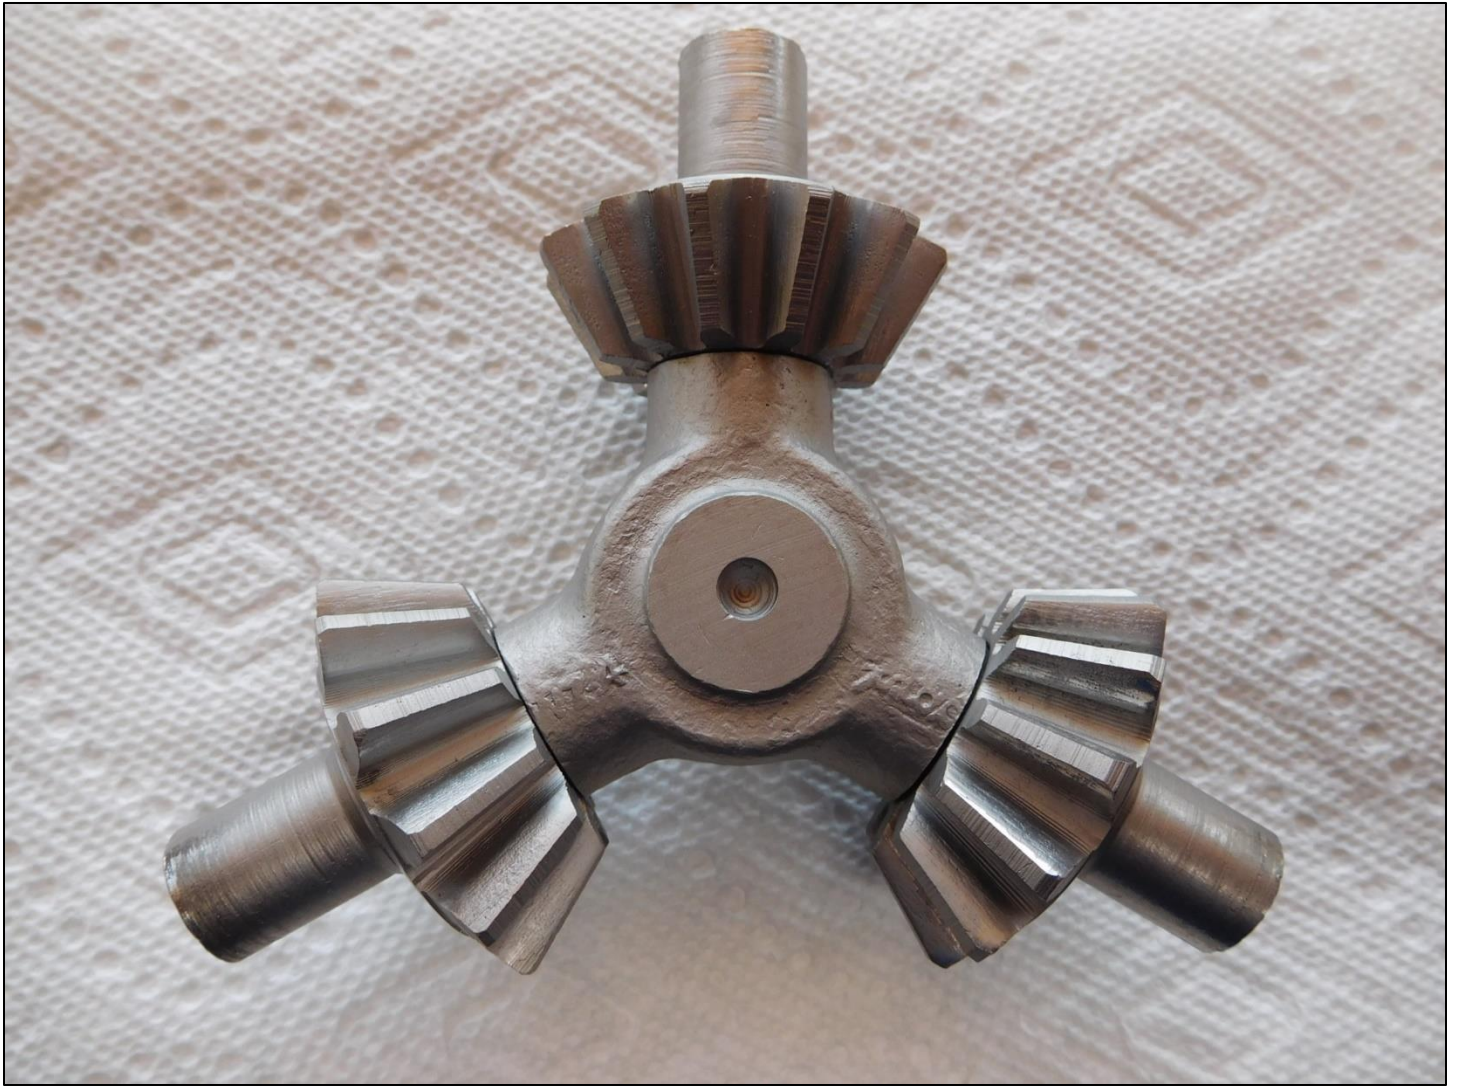
**Shown here is the spider gear assembly that survived the devastation inside the banjo after it was cleaned up and bead blasted. It is in excellent condition.**

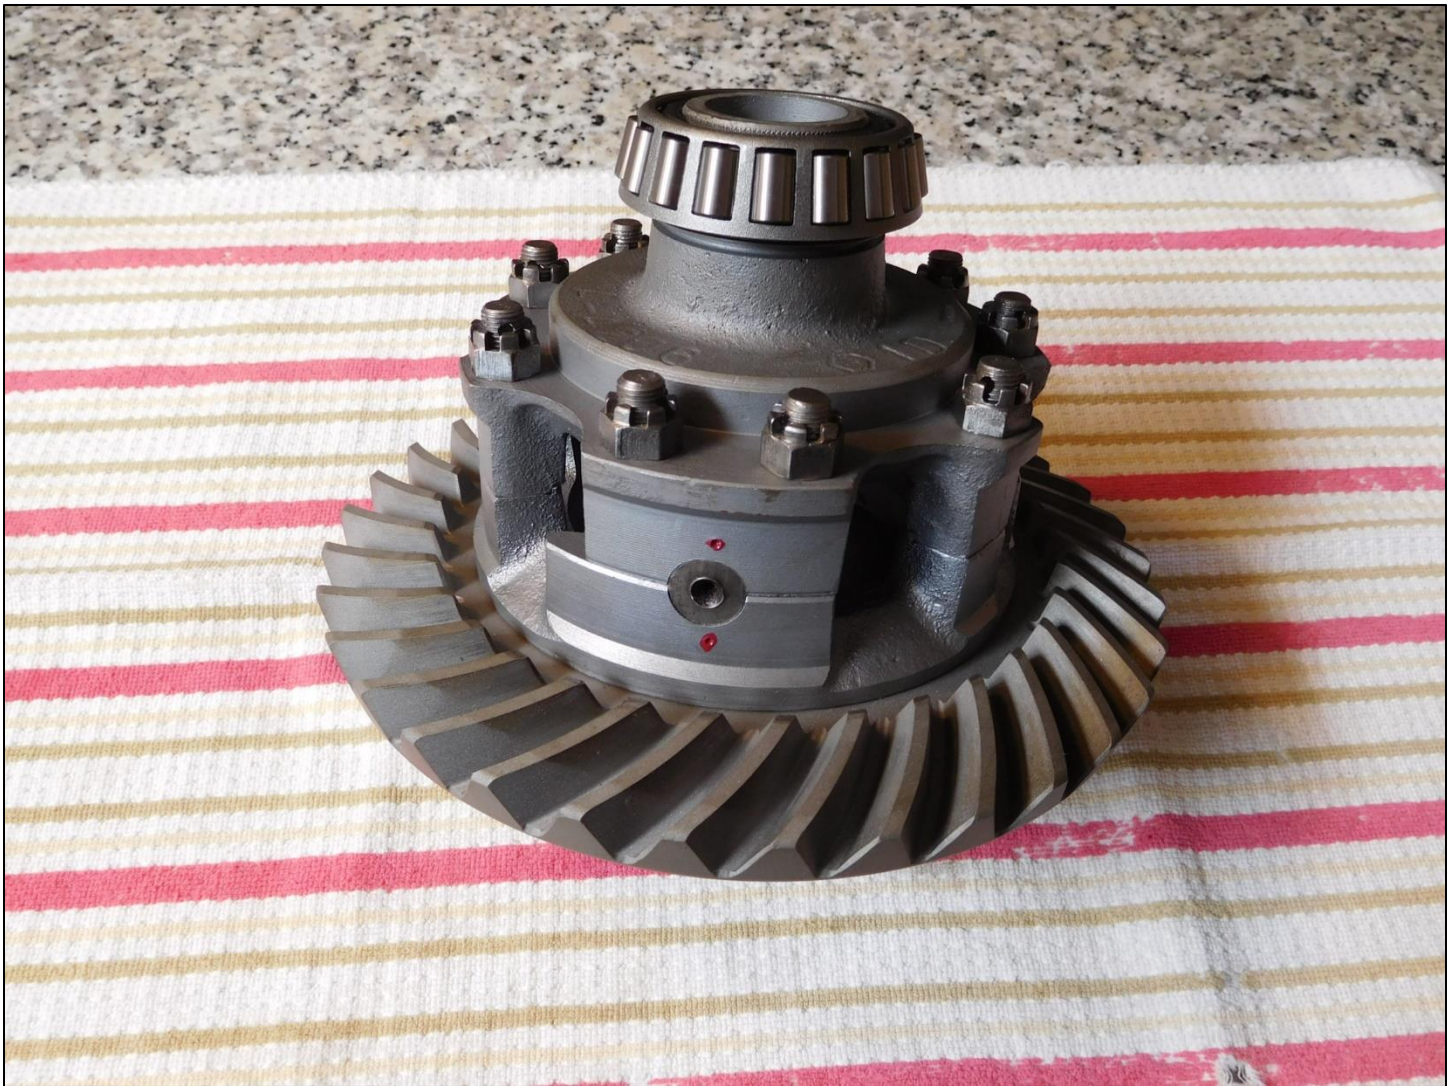
**Shown here is the carrier assembled. The spider gear assembly and the two axle shafts are not installed until final assembly. Inside the carrier is the tool used to set the pre-load on the carrier bearings.**

**The two red dots are markers placed there when the carrier was first disassembled. This is to allow it to go back together the way it came apart. The inside the carrier usually has wear marks from the back side of the three spider gears. They are not always equal and it is a good idea to have the carrier go back together with the wear marks lined up.**

**This particular carrier has virtually no internal wear marks.**

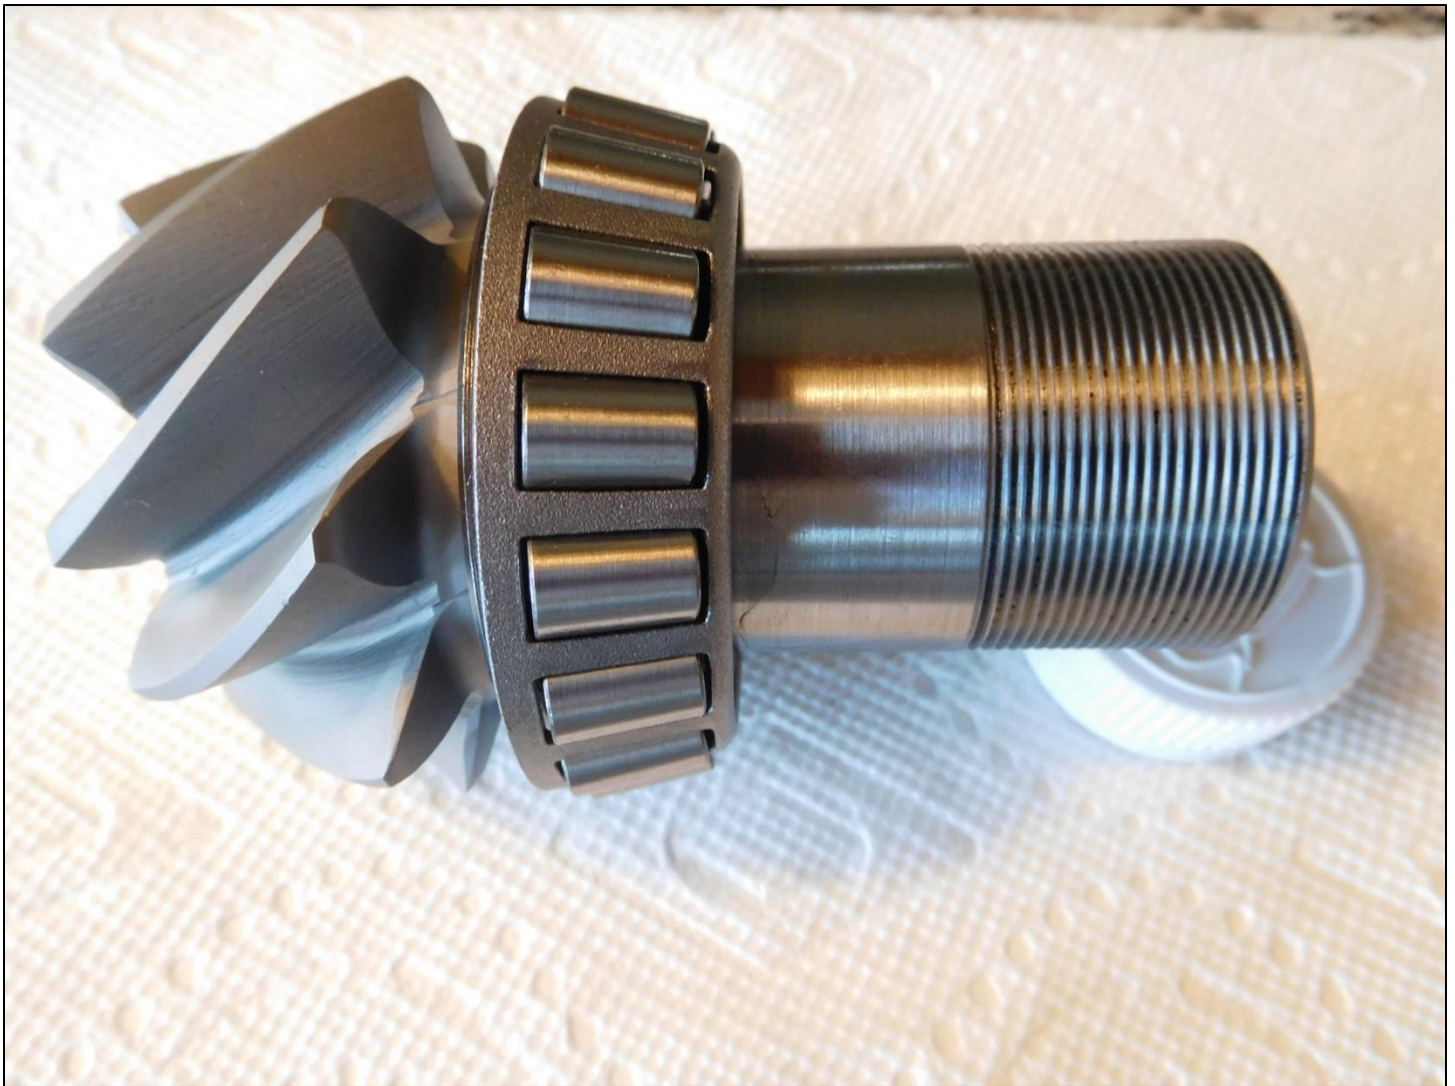
**Shown here is the new pinion gear. It was not machined correctly as is the case with most reproductions. The sleeve where the two bearings mount should be of two different dimensions. The bearing shown installed must press on with an interference press fit, and it does. The second bearing which installs to the right of the first bearing after it is inserted into the double bearing race in the banjo must be able to slide with a snug fit in order to achieve the pre-load setting and it did not. The difference in the two dimensions should be .0015. In this case the sleeve was all one dimension and was a .002 interference press fit along the entire length. In order to be able to install this pinion correctly I had to have the right end of the sleeve machined to remove metal to create a snug sliding fit.**

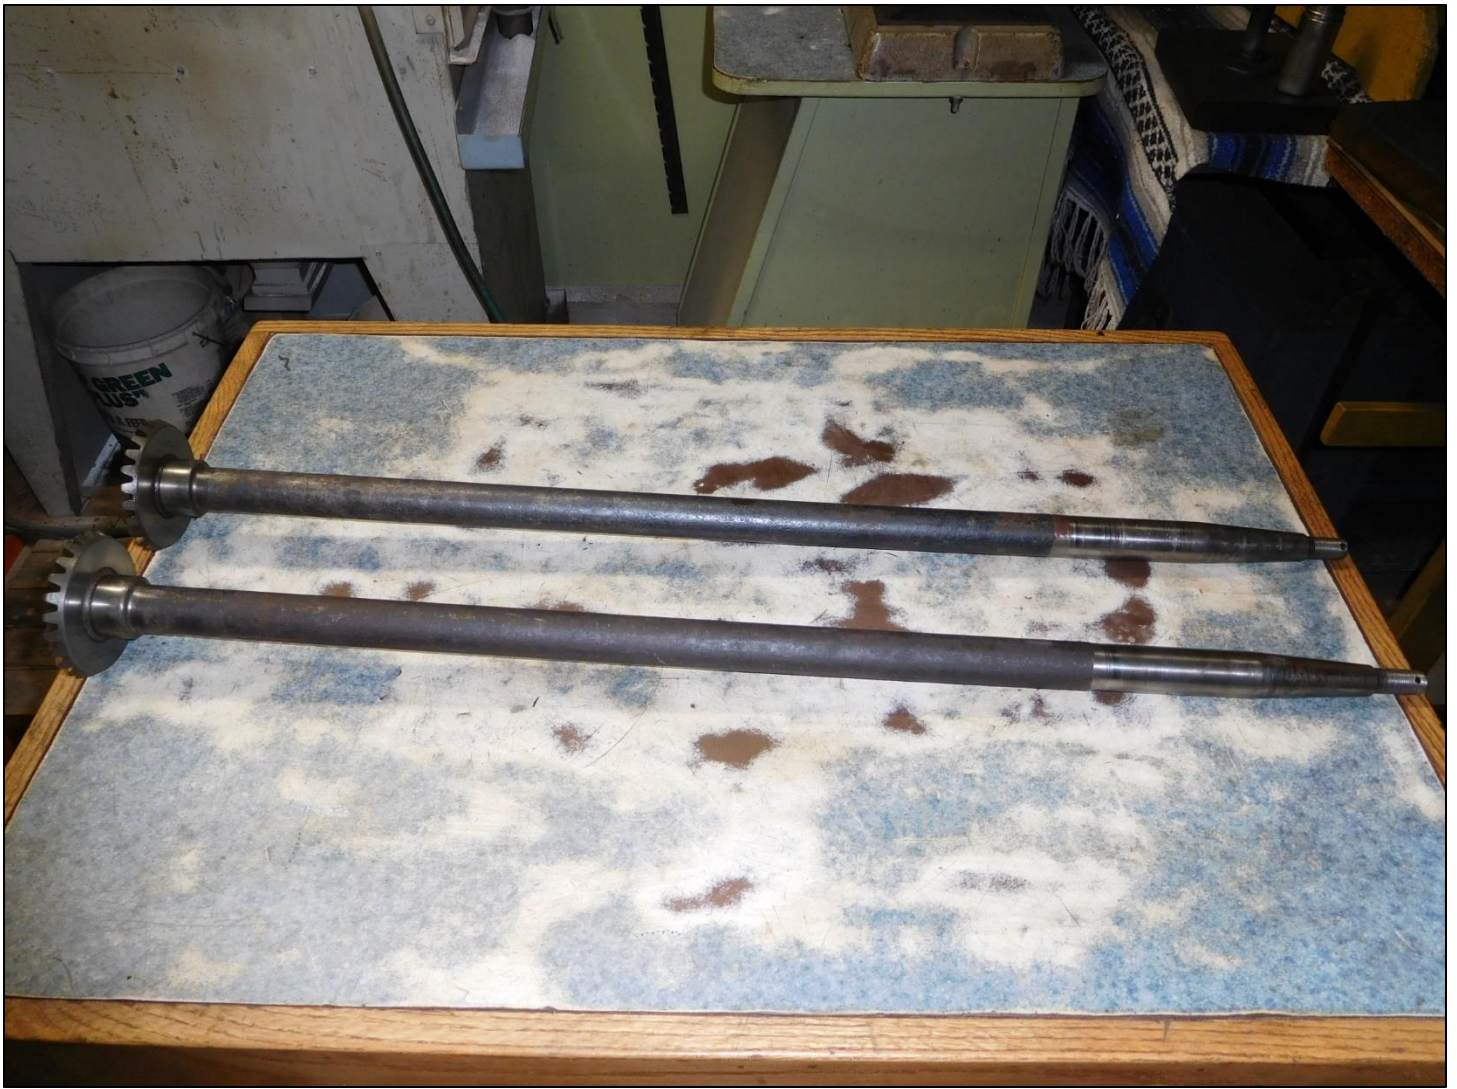
**Both axle shafts have been cleaned up and inspected. They were found to be in excellent condition. There are no cracks around the keys and the threads are in good condition.**

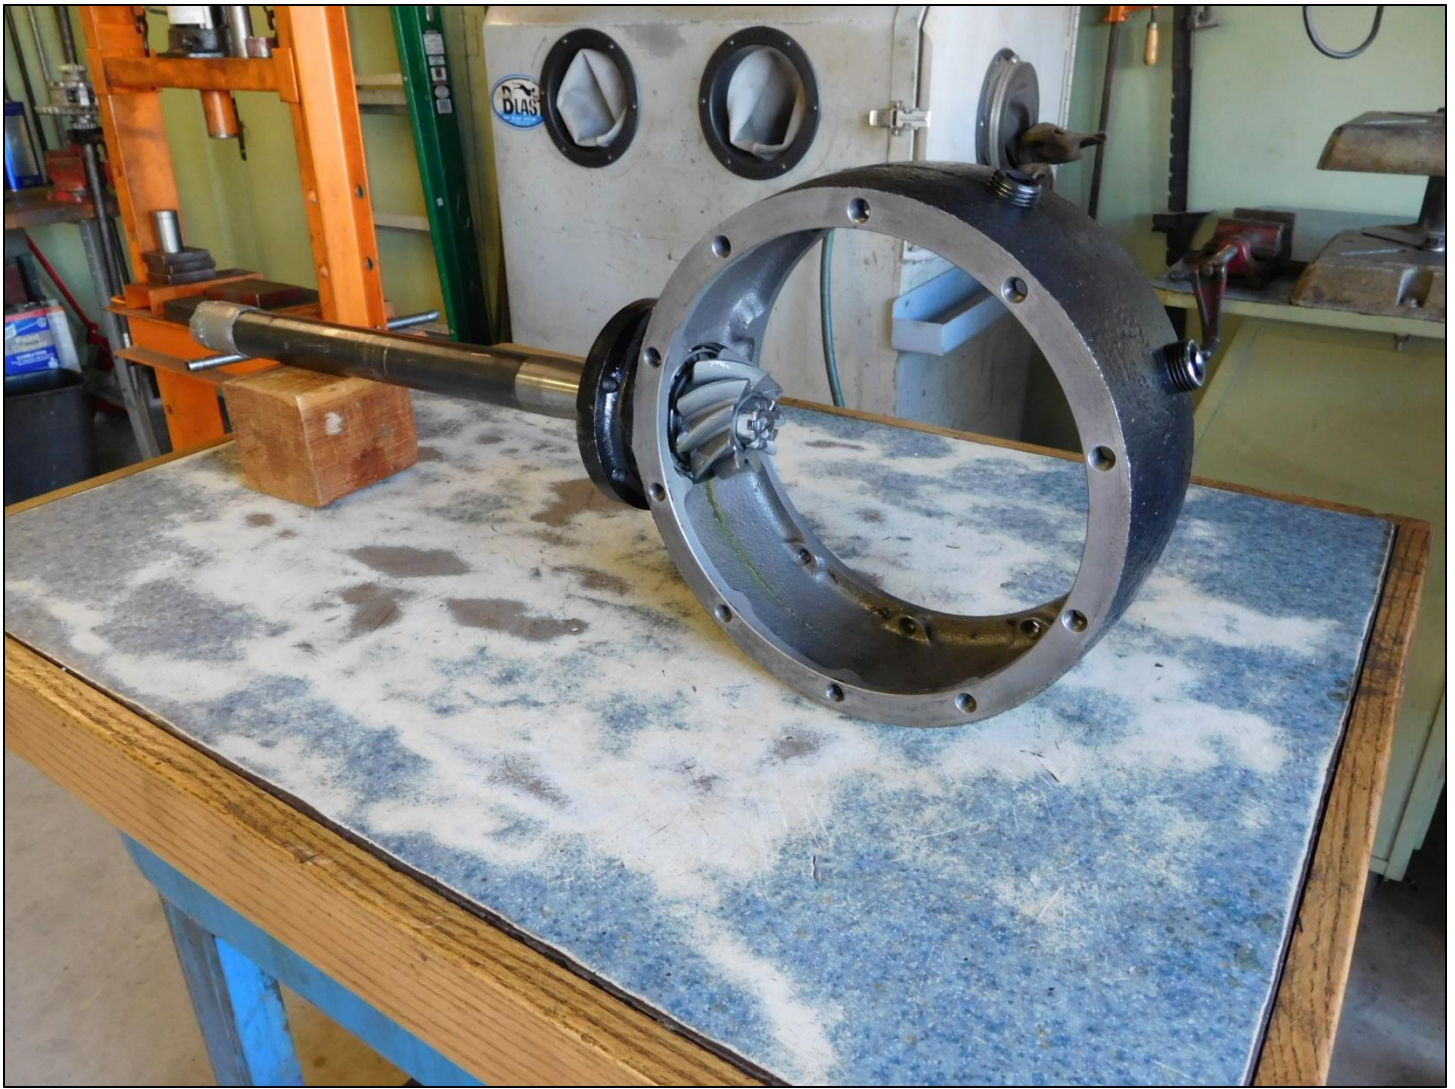
**Shown here is the pinion assembly and a Mitchell stub shaft installed in the banjo. The pre-load on the pinion bearings has been adjusted to a nominal 20-inch lbs. by adjusting the two large hex nuts on the other side of the banjo flange.**

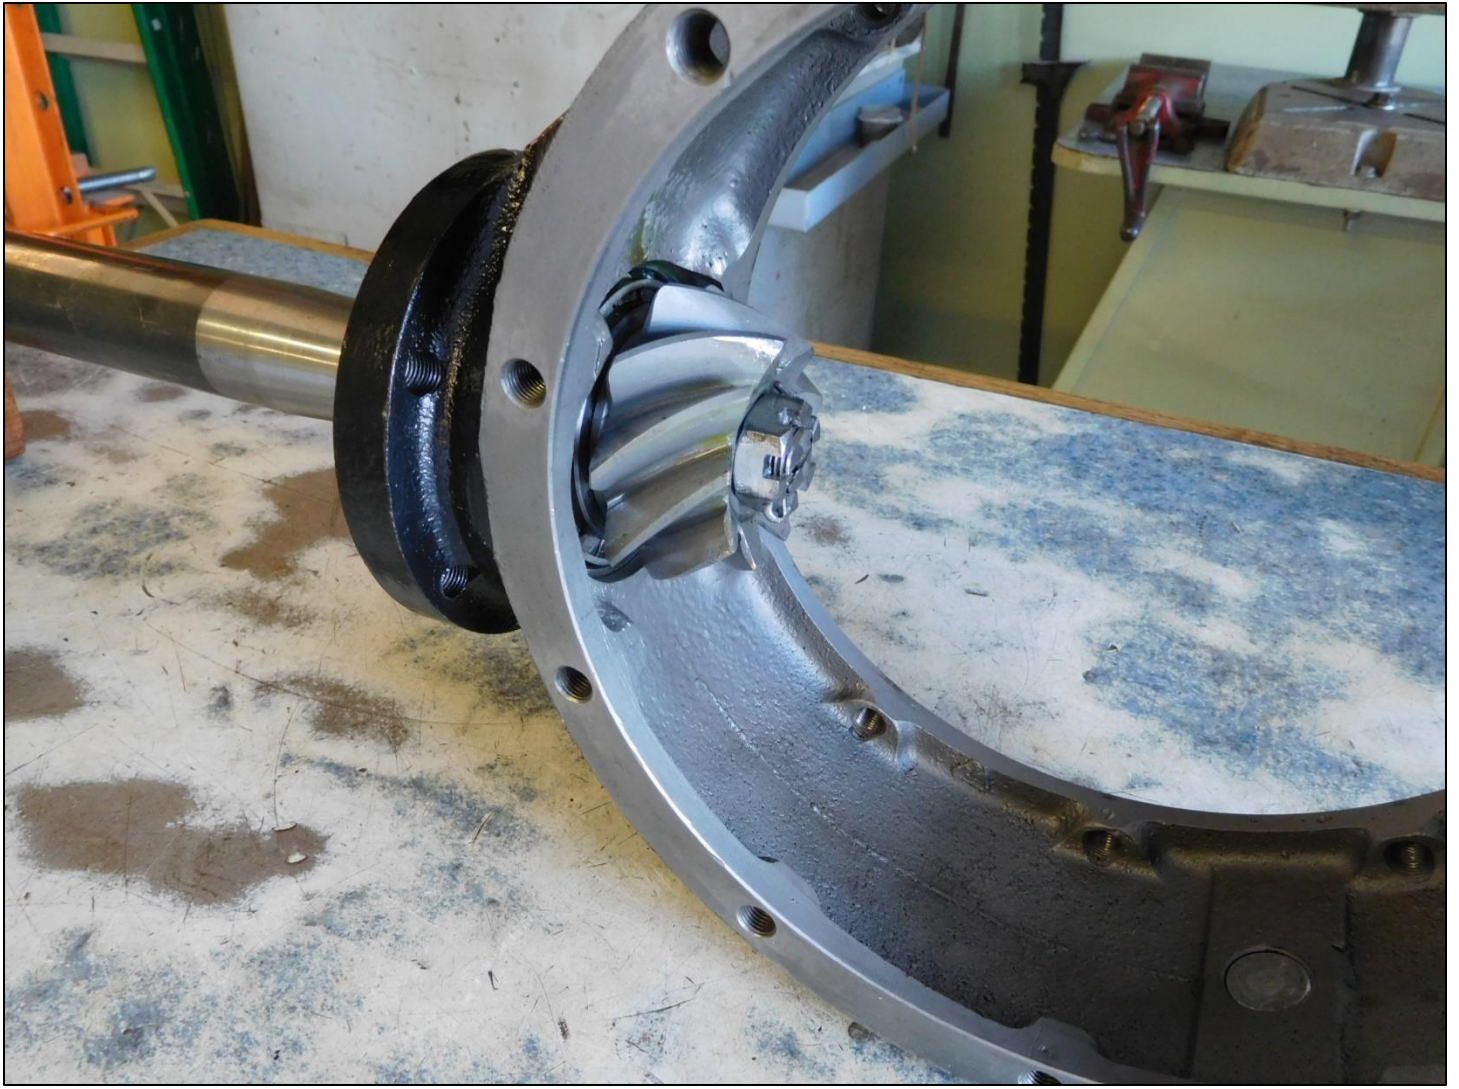
**The nut on the end of the stub shaft is torqued to a nominal 100 ft. lbs. A cotter pin is inserted and the legs are bent over the sides of the nut. The legs should never be bent over the end of the shaft as they could contact the rotating carrier.**

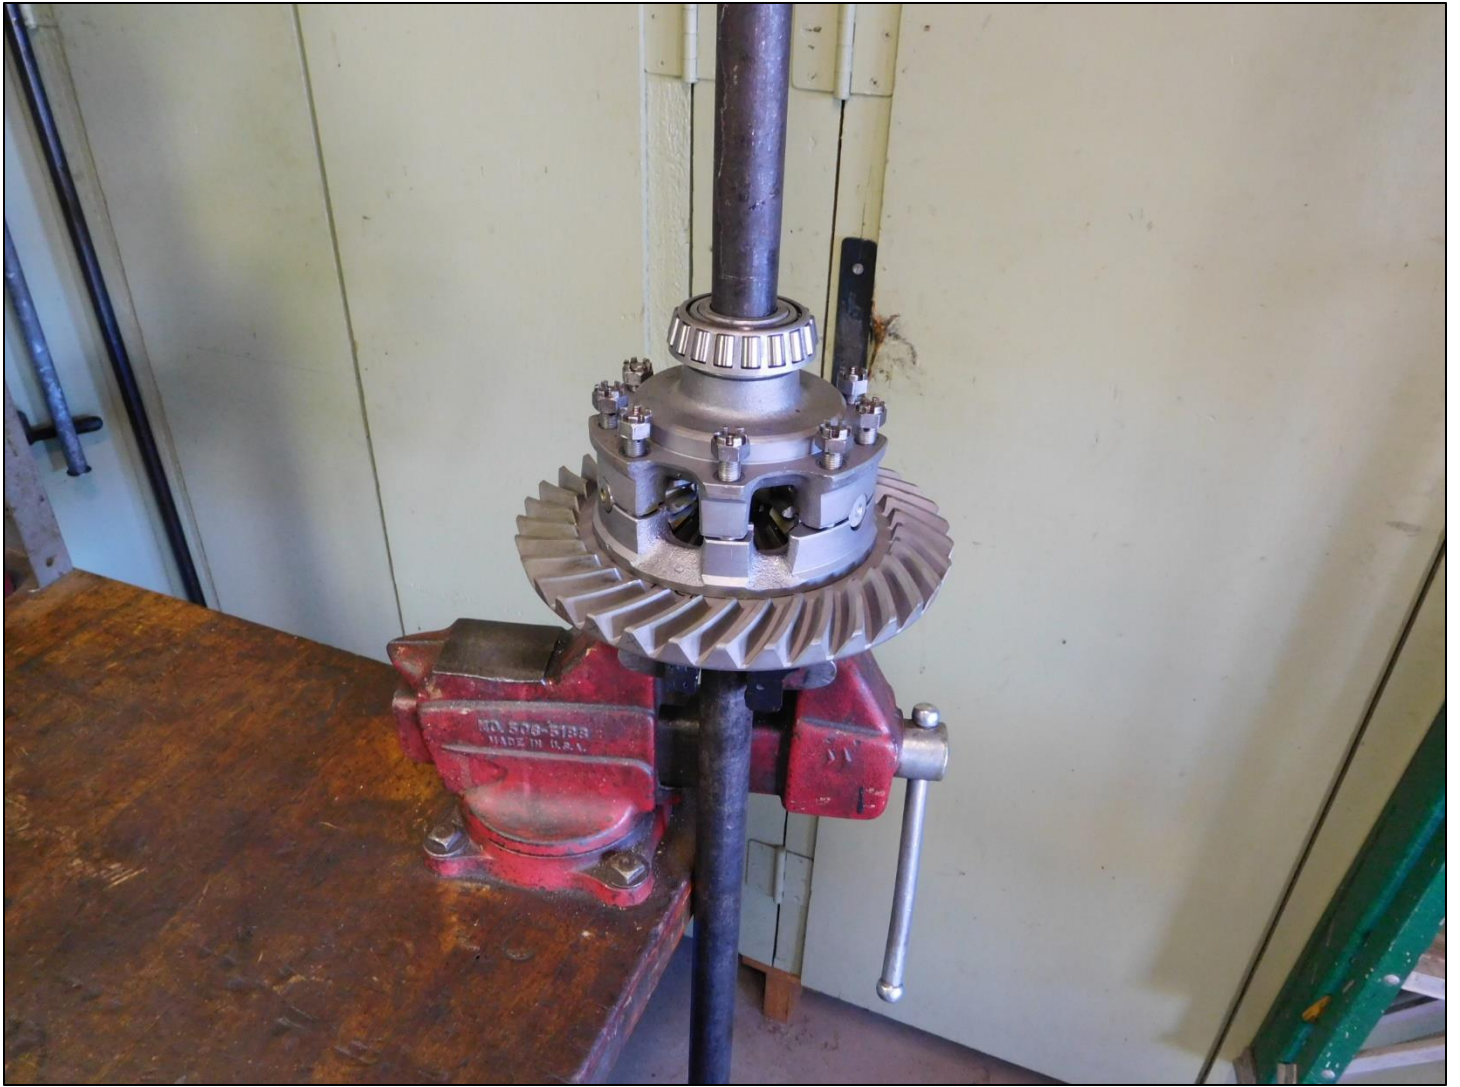
**The two axles along with the spider gears are shown here being assembled into the carrier.**

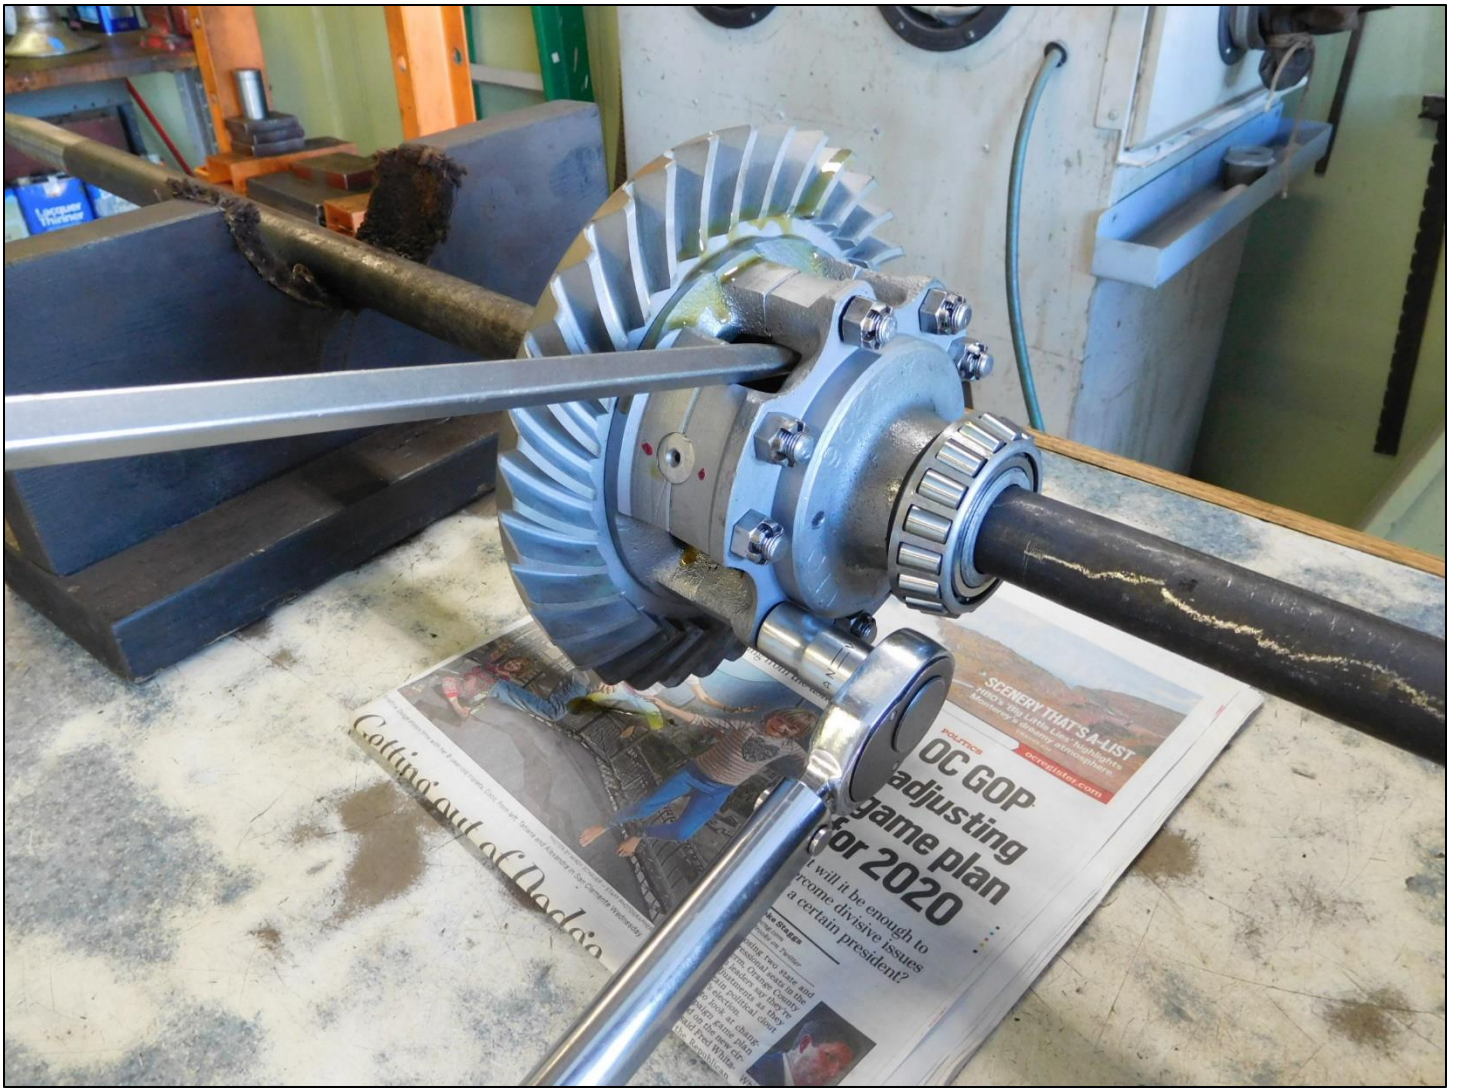
The nine carrier bolts and nuts are torqued to 35 ft. lbs. A large screwdriver is used to prevent the carrier from turning while the nut is being tightened.
