# Differential Overhaul June 20, 2019 (SL)

by Tom Endy

This rear axle assembly arrived in the back of a modern SUV after being removed from a 1931 roadster. The owner complaint was that the ring & pinion were jammed up. The unit had a Borg Warner overdrive installed that the owner removed before bringing it over. The overhaul will include a new 378:1 ratio ring & pinion gear set and a new Mitchell 26% overdrive will also be installed.

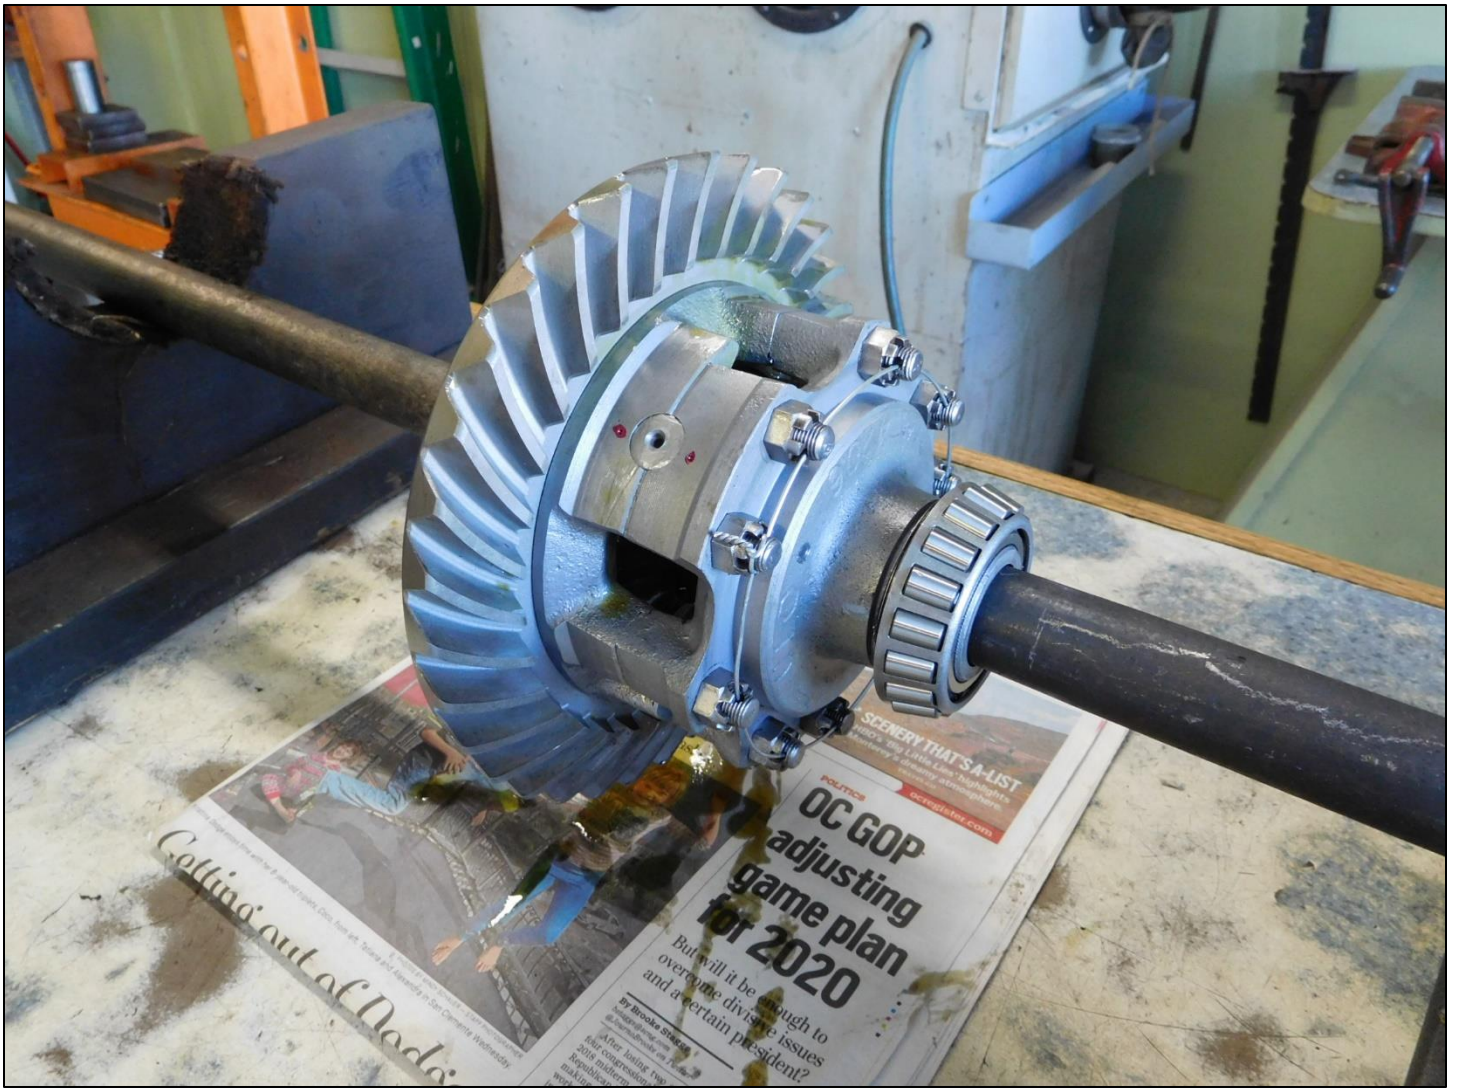
The nine carrier bolts are safety wired.

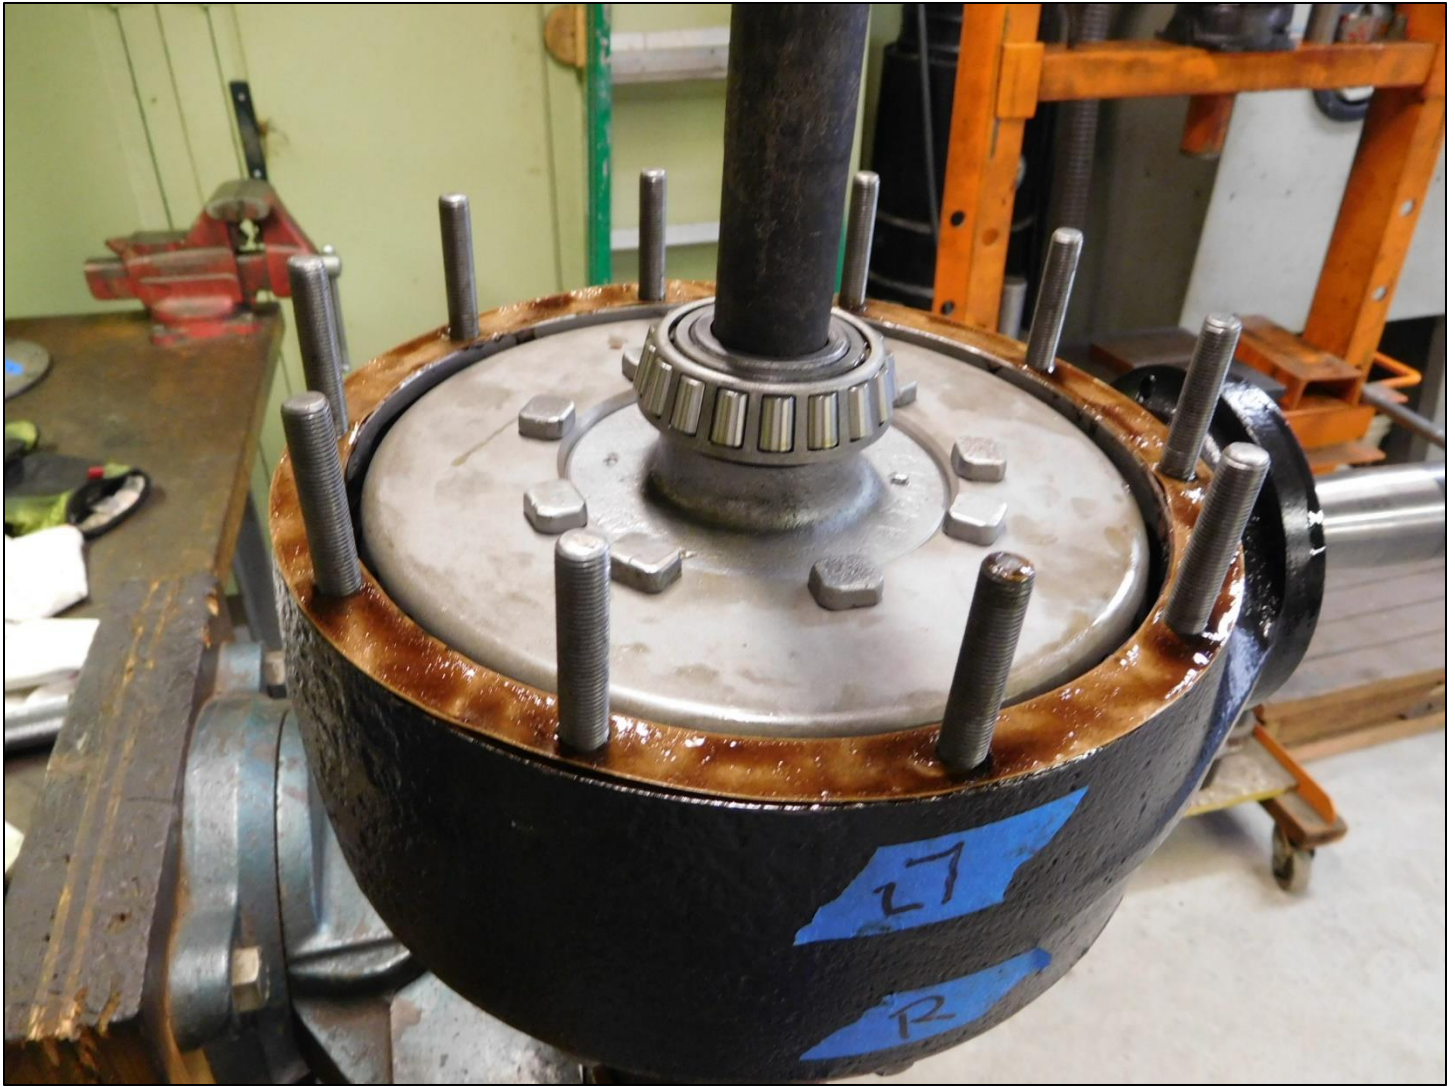
**Shown here is the final assembly. The carrier pre-load had previously been determined by the number of shims under the carrier bearings and the number of banjo gaskets used and was adjusted to a nominal 20-inch lbs. Alignment studs are used to align the gasket and Indian Head gasket sealer is applied to the gaskets.**

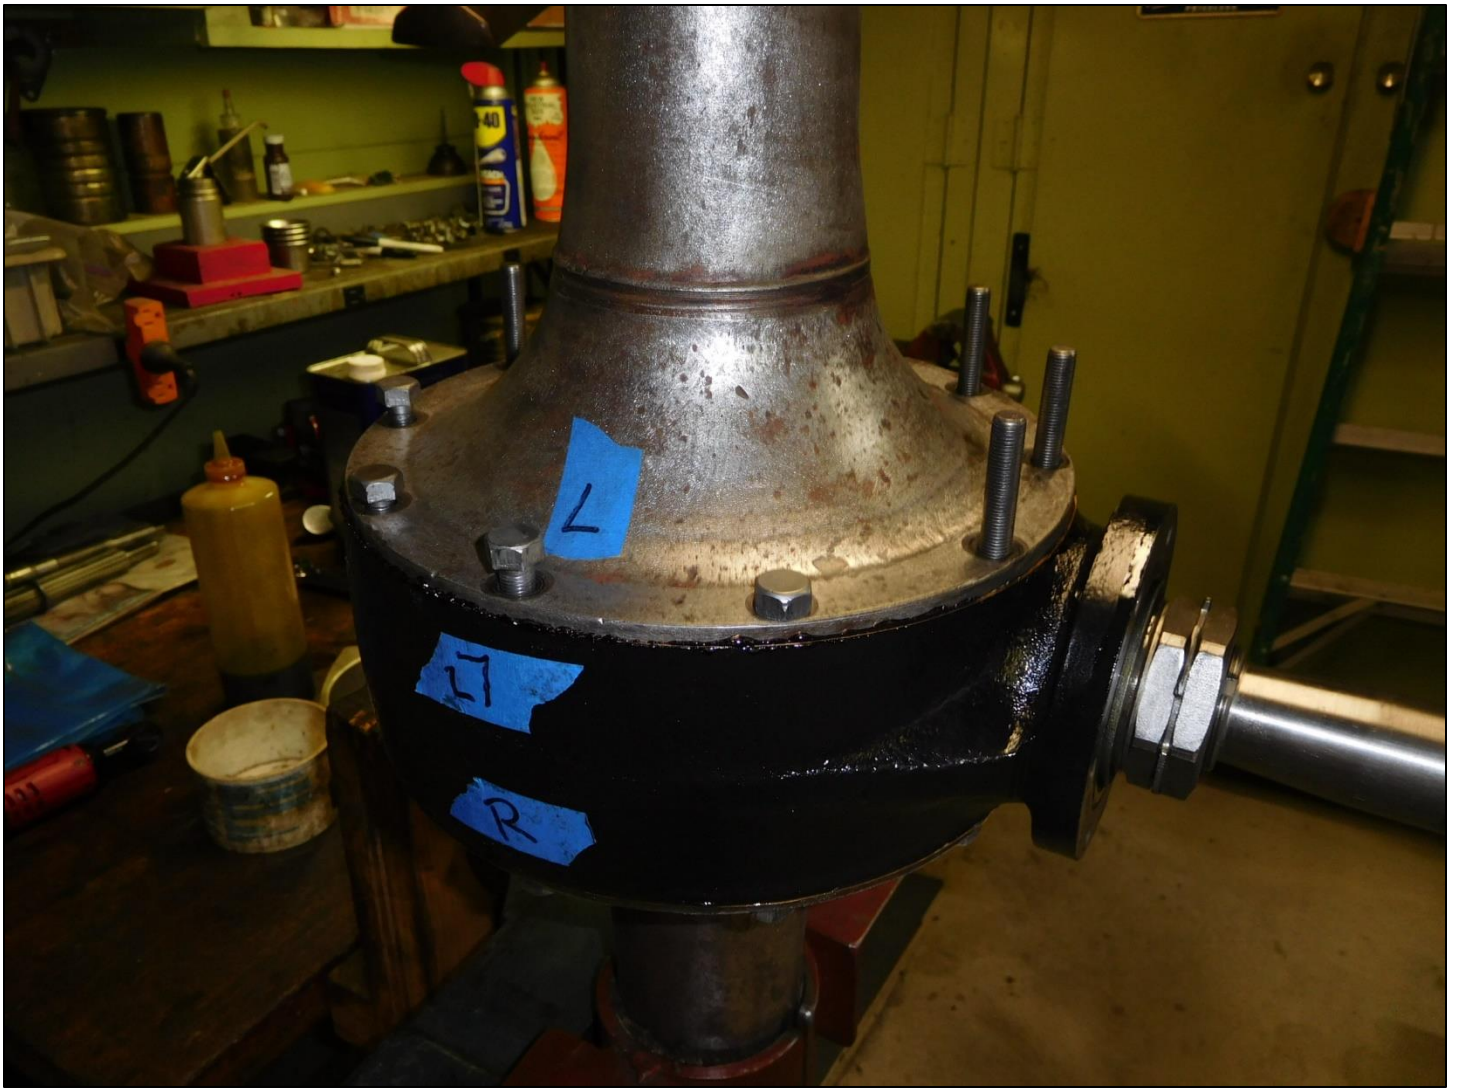
**The 20 banjo bolts are torqued to 35 ft. lbs.**

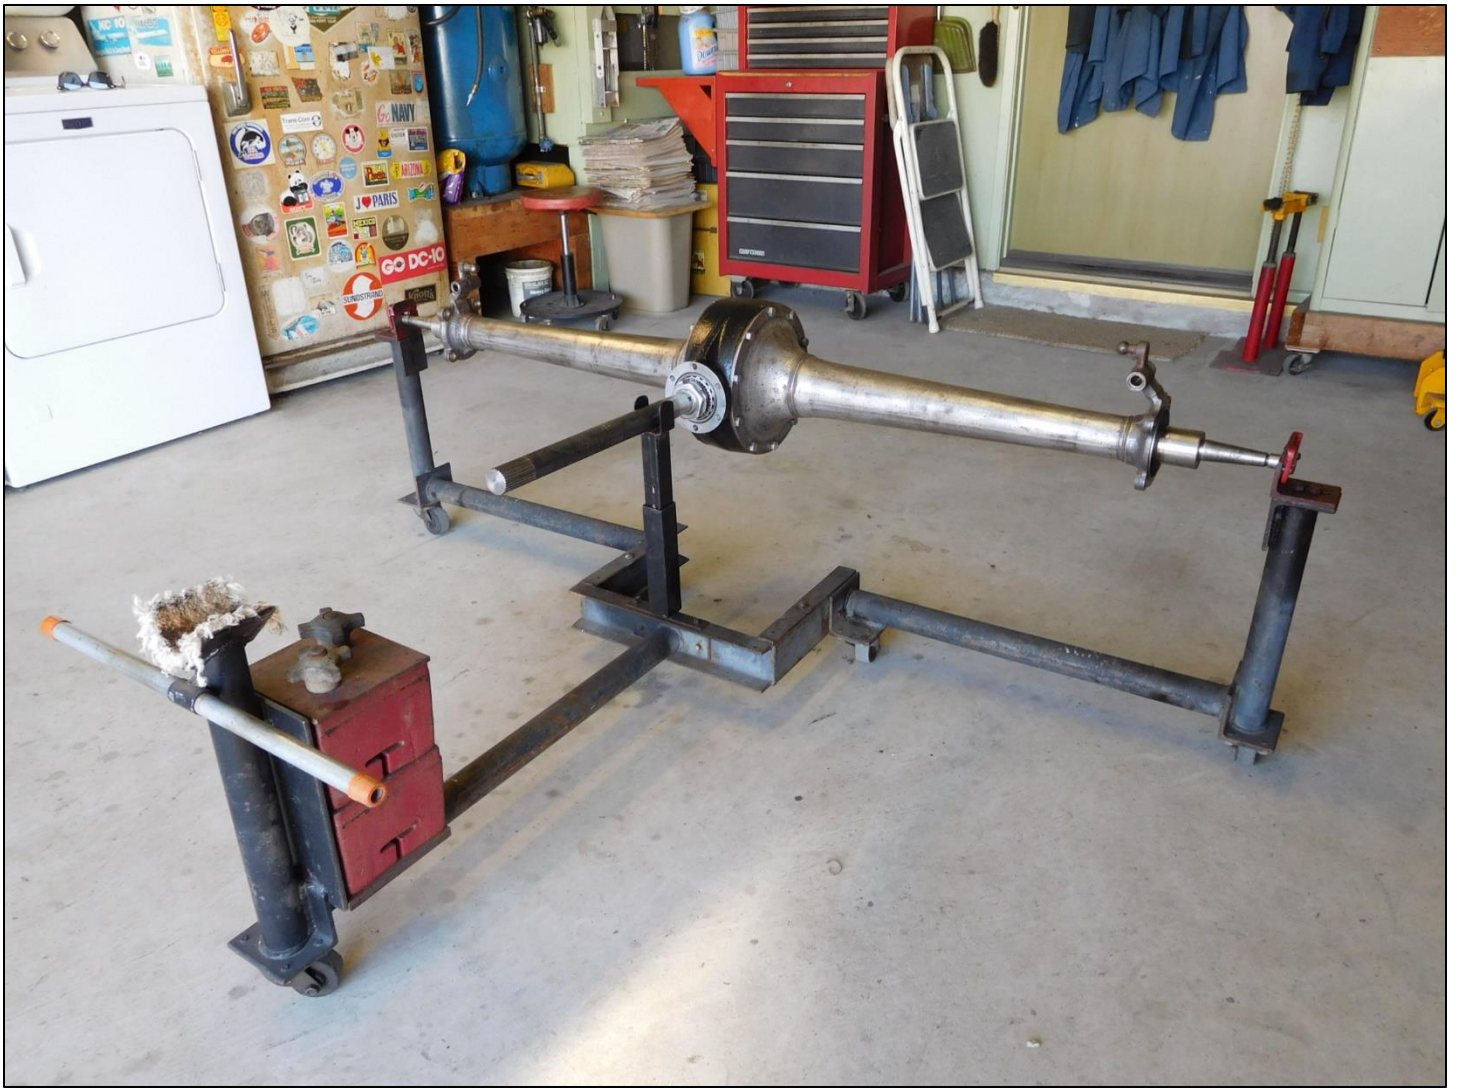
**The rear axle assembly is complete and the housings have been sanded. The next step is to paint it.**

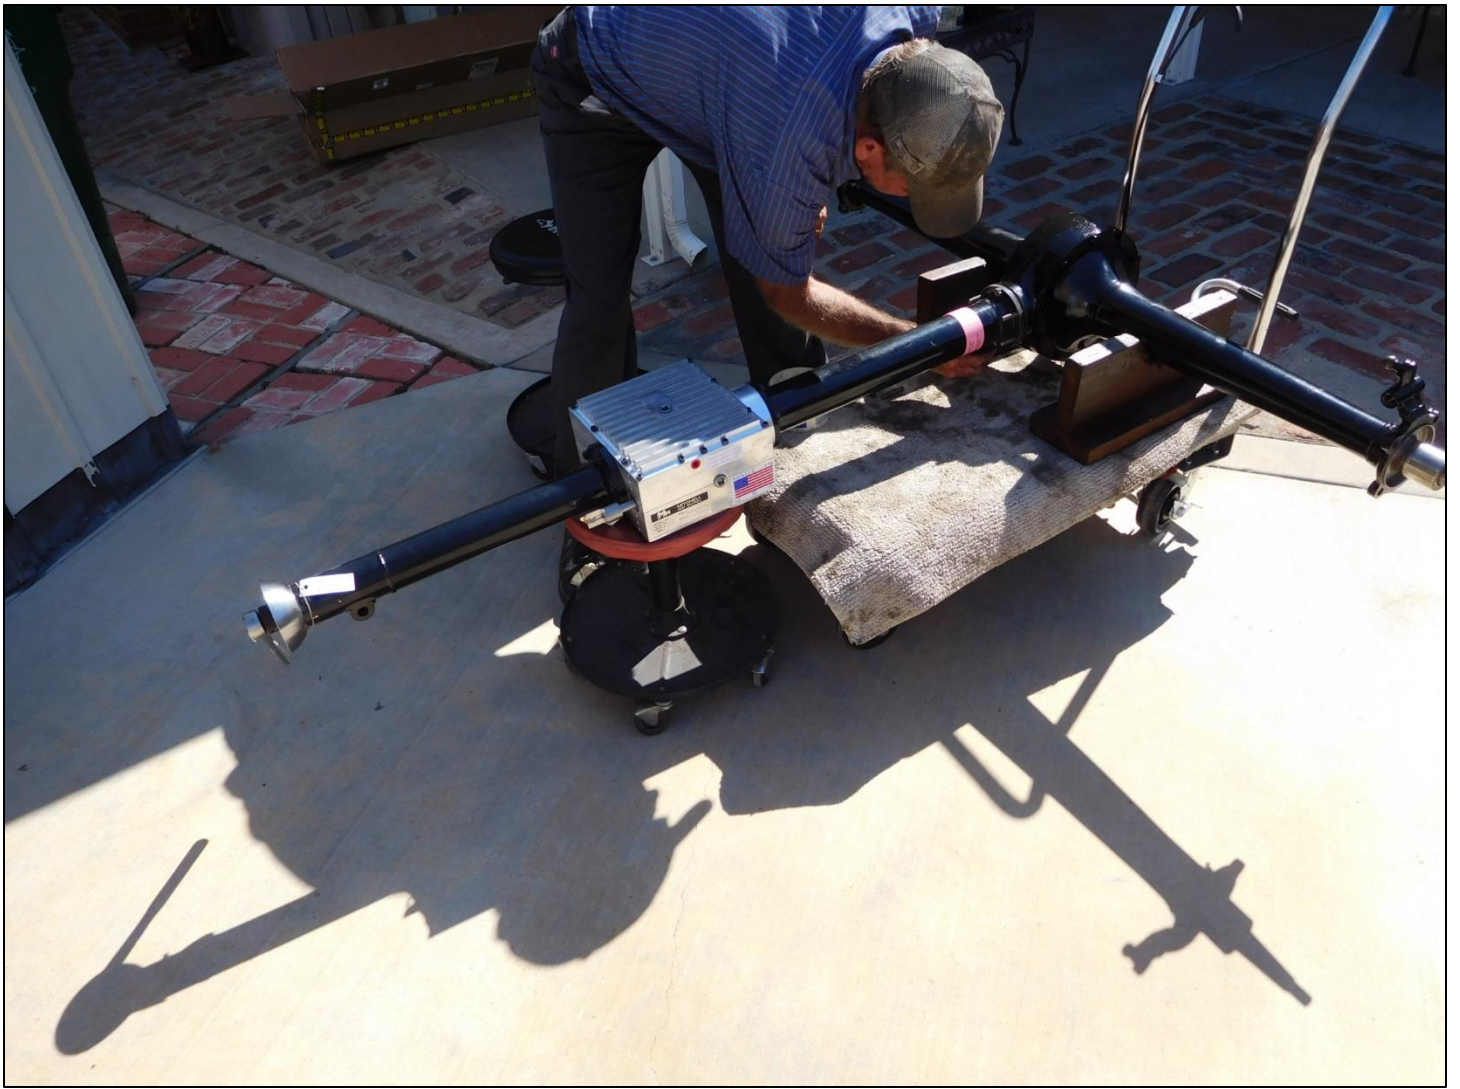
**The Mitchell overdrive arrived and is shown here being installed onto the overhauled rear axle assembly.**

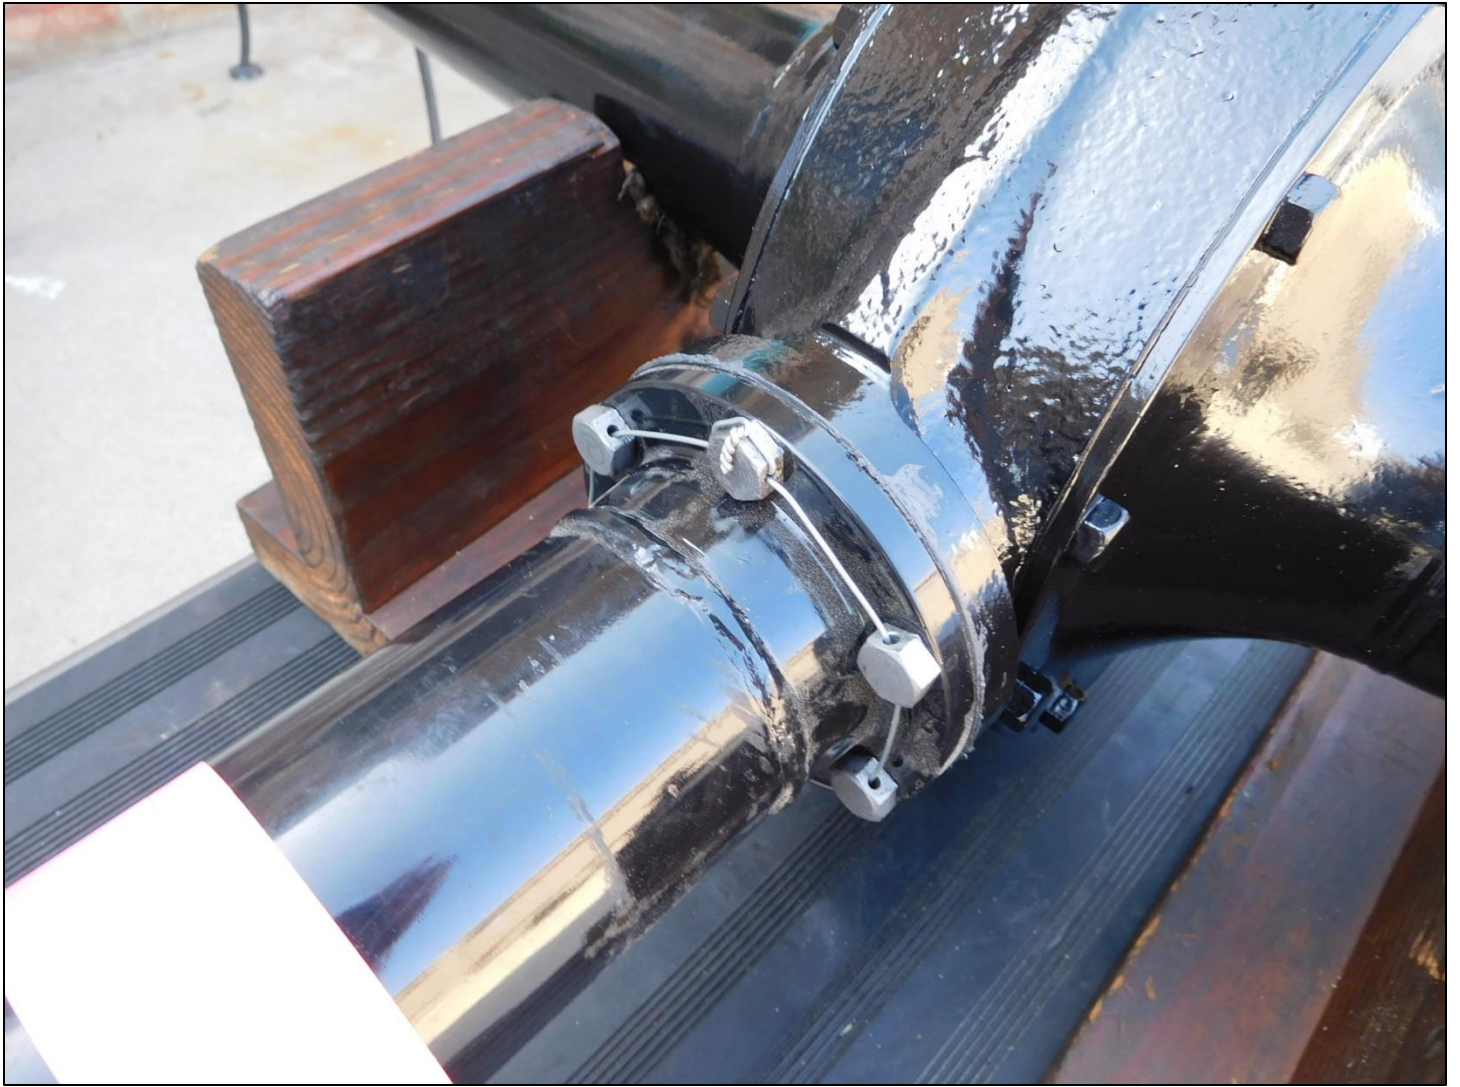
**The six mounting bolts are installed and safety wired.**
