# Differential Overhaul August 27, 2019

by Tom Endy

Another early 1932 rear axle assembly has arrived for overhaul and the installation of a 354:1 ring and pinion gear set. This one is out of a 1932 model B car with a four-cylinder engine. It is seen here ready for disassembly.

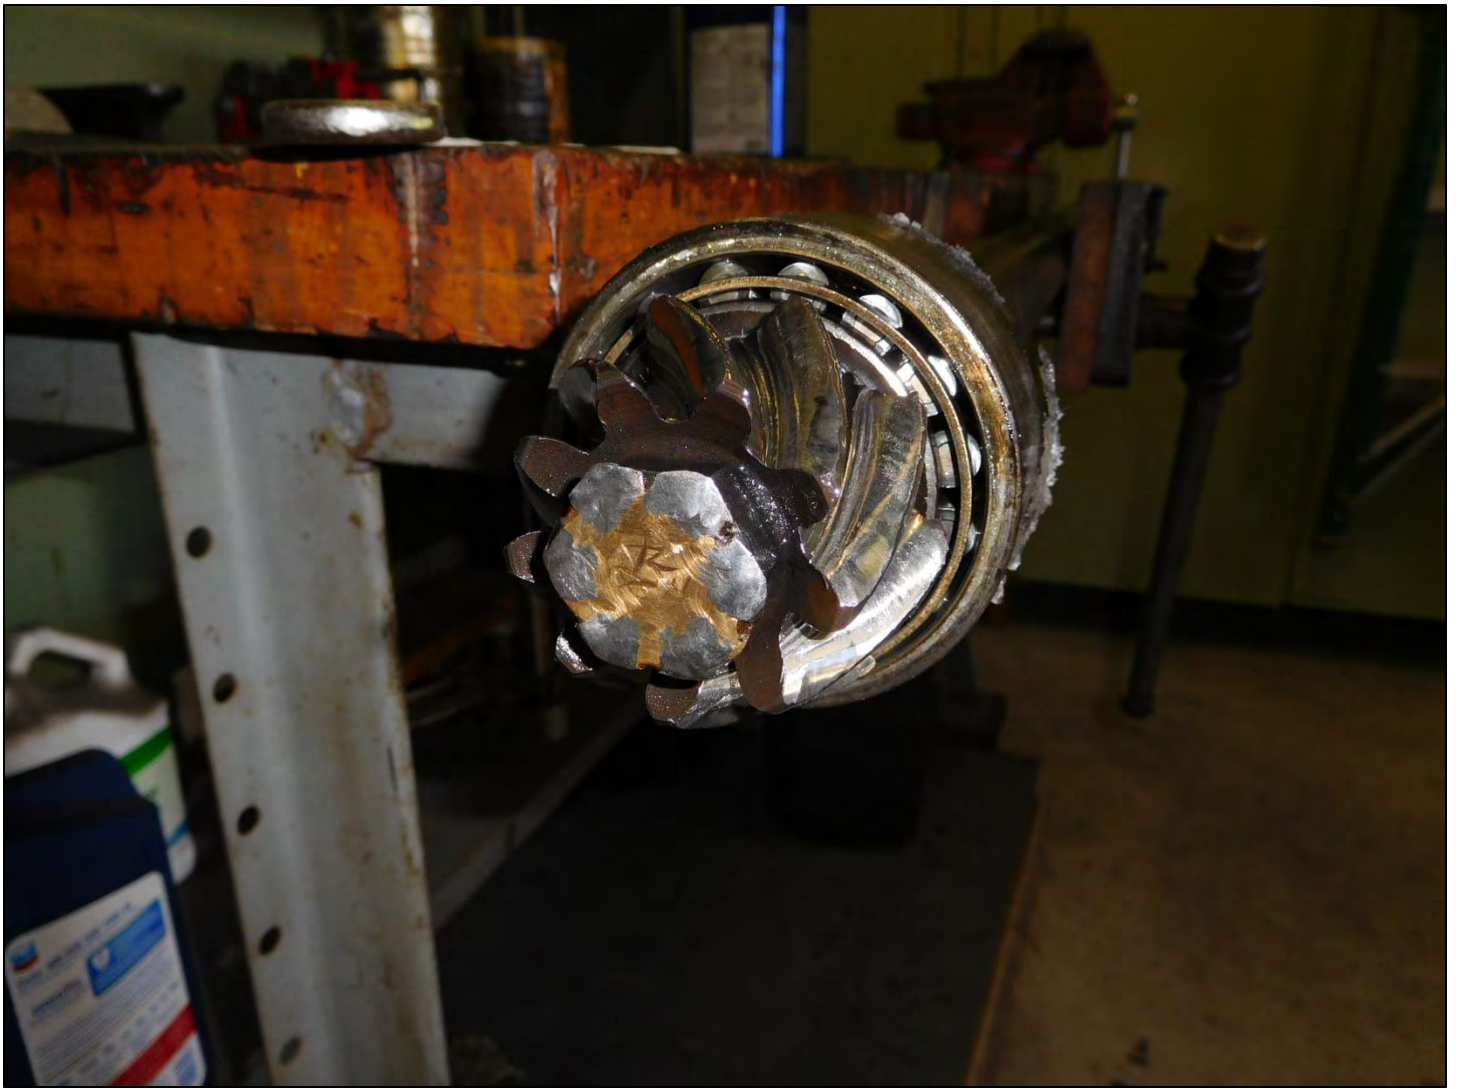
**The ring & pinion found inside was a 411:1 gear ratio; and it showed signs of extensive wear. The two pinion bearings and the double banjo race were in poor condition. The first obstacle discovered was that the nut on the end of the drive shaft had been braised onto the threaded end of the drive shaft and the threads had been cut off short. Shown here is the drive shaft clamped in a vice. Note the end of the drive shaft with the pinion gear assembly still attached. The two large pinion nuts had come loose and backed off and allowed the drive shaft to move back allowing the nut on the end of the drive shaft to come in contact with the rotating carrier. The nut was ground down and mushroomed such that a socket would not fit over it. The hex had to be ground down so that a socket could be hammered on. An impact wrench then spun it off.**

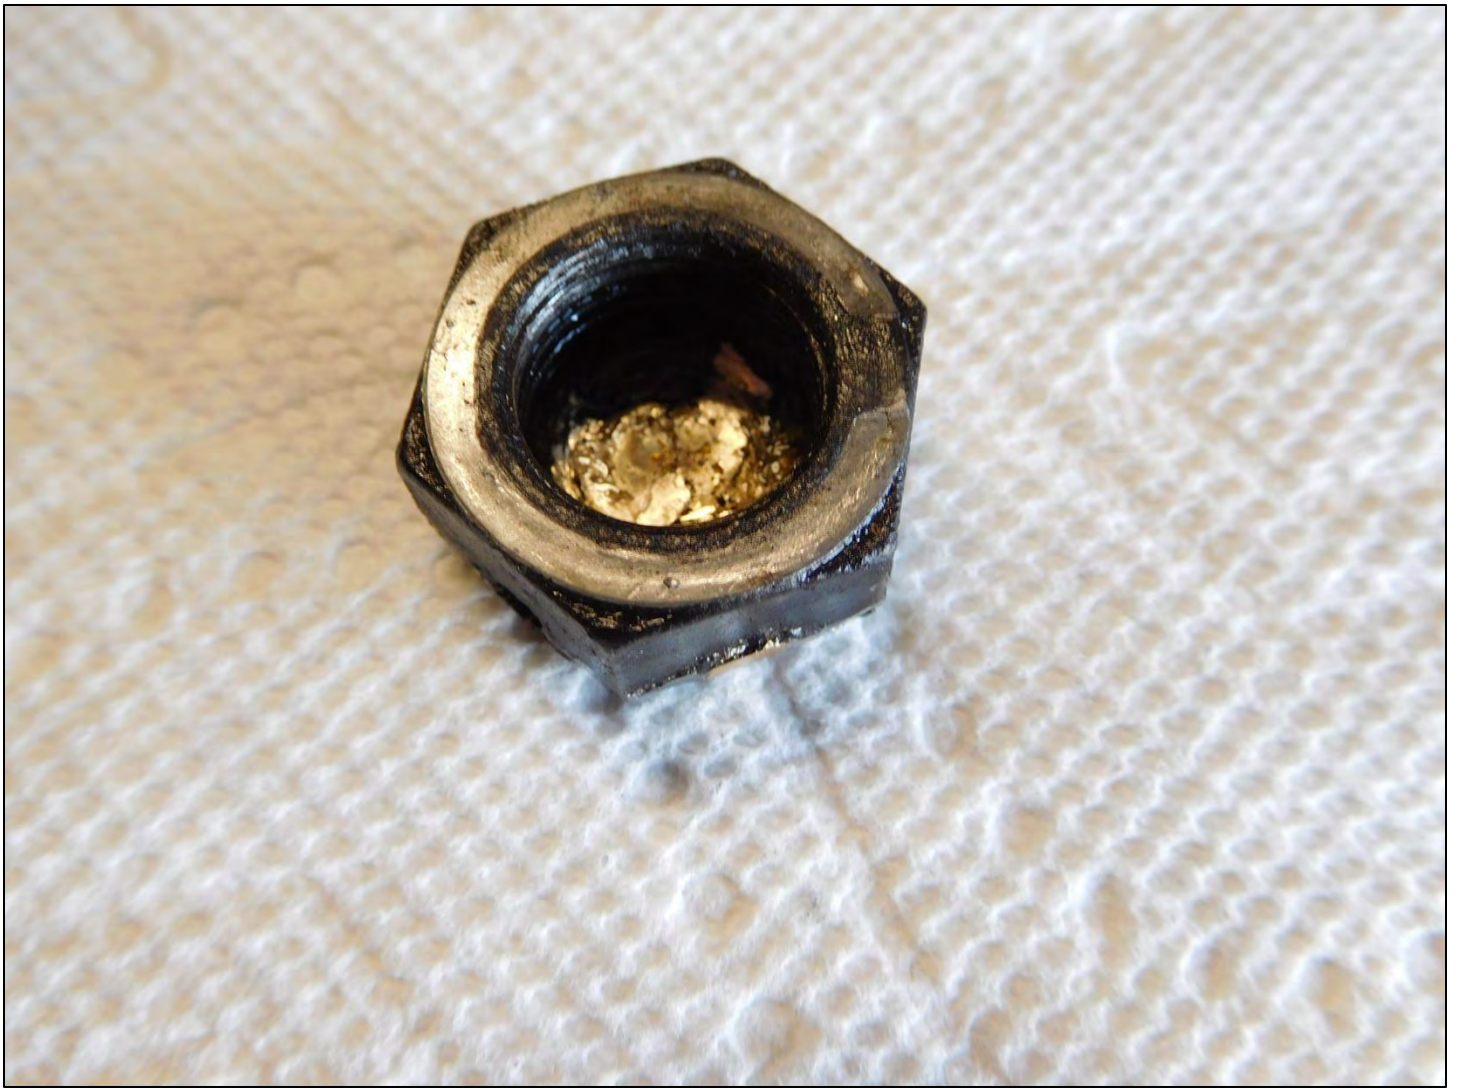
**The nut on the end of the drive shaft is seen here braised onto the end of the drive shaft.**

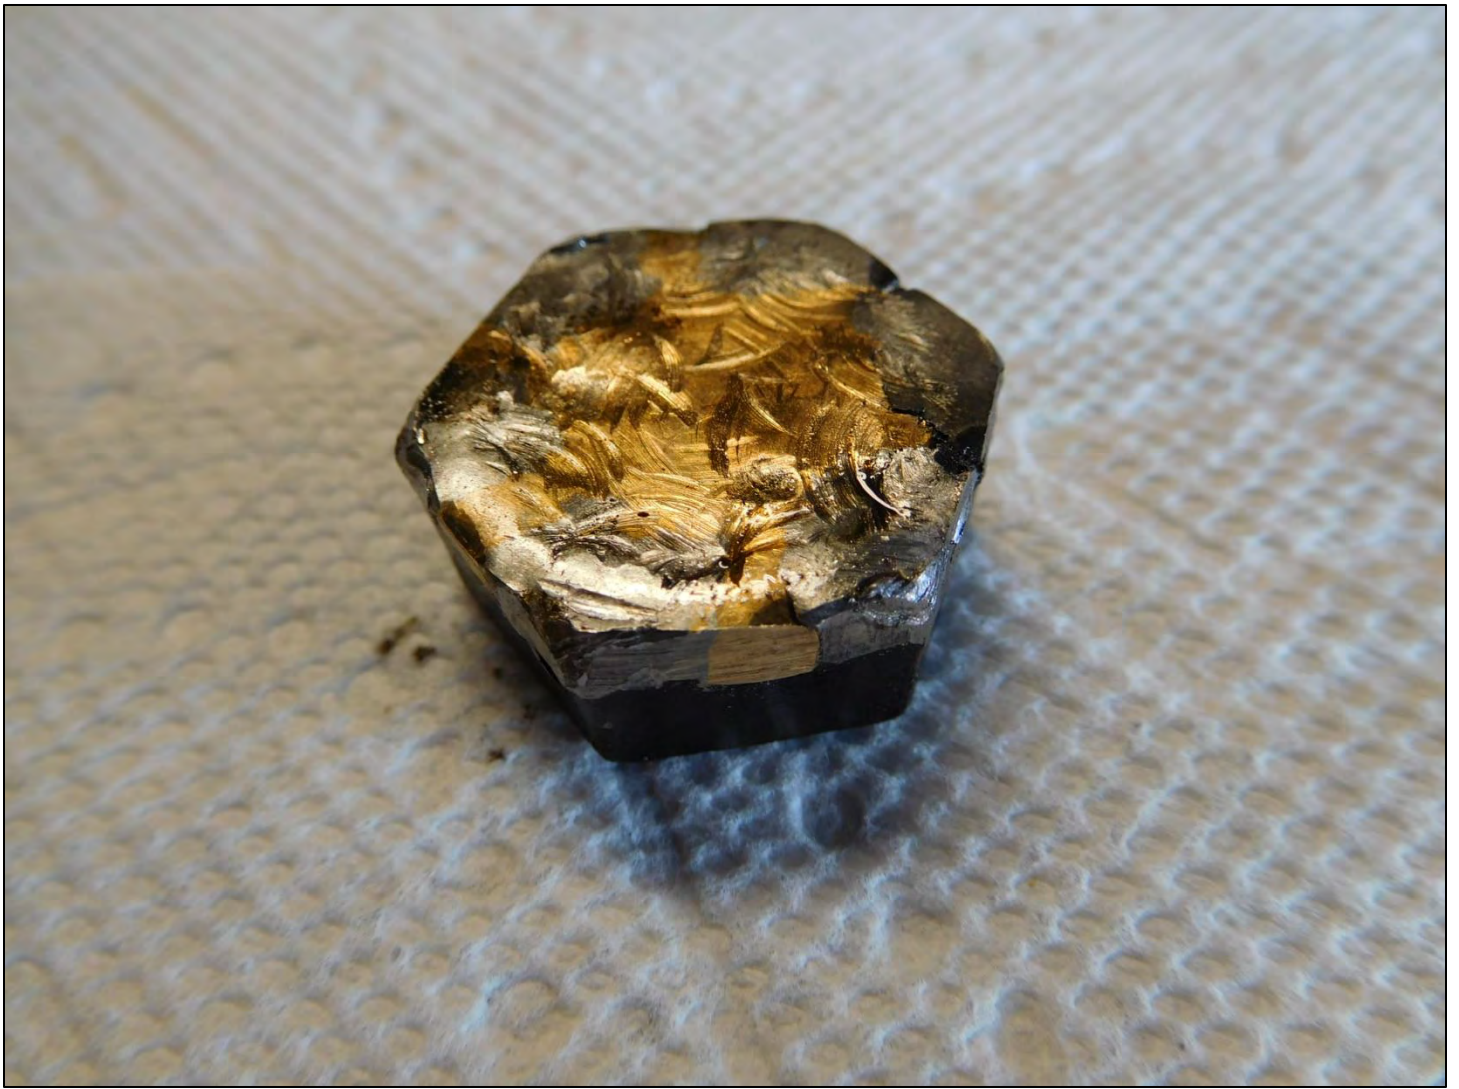
**Shown here is the inside of the nut after it was removed.**

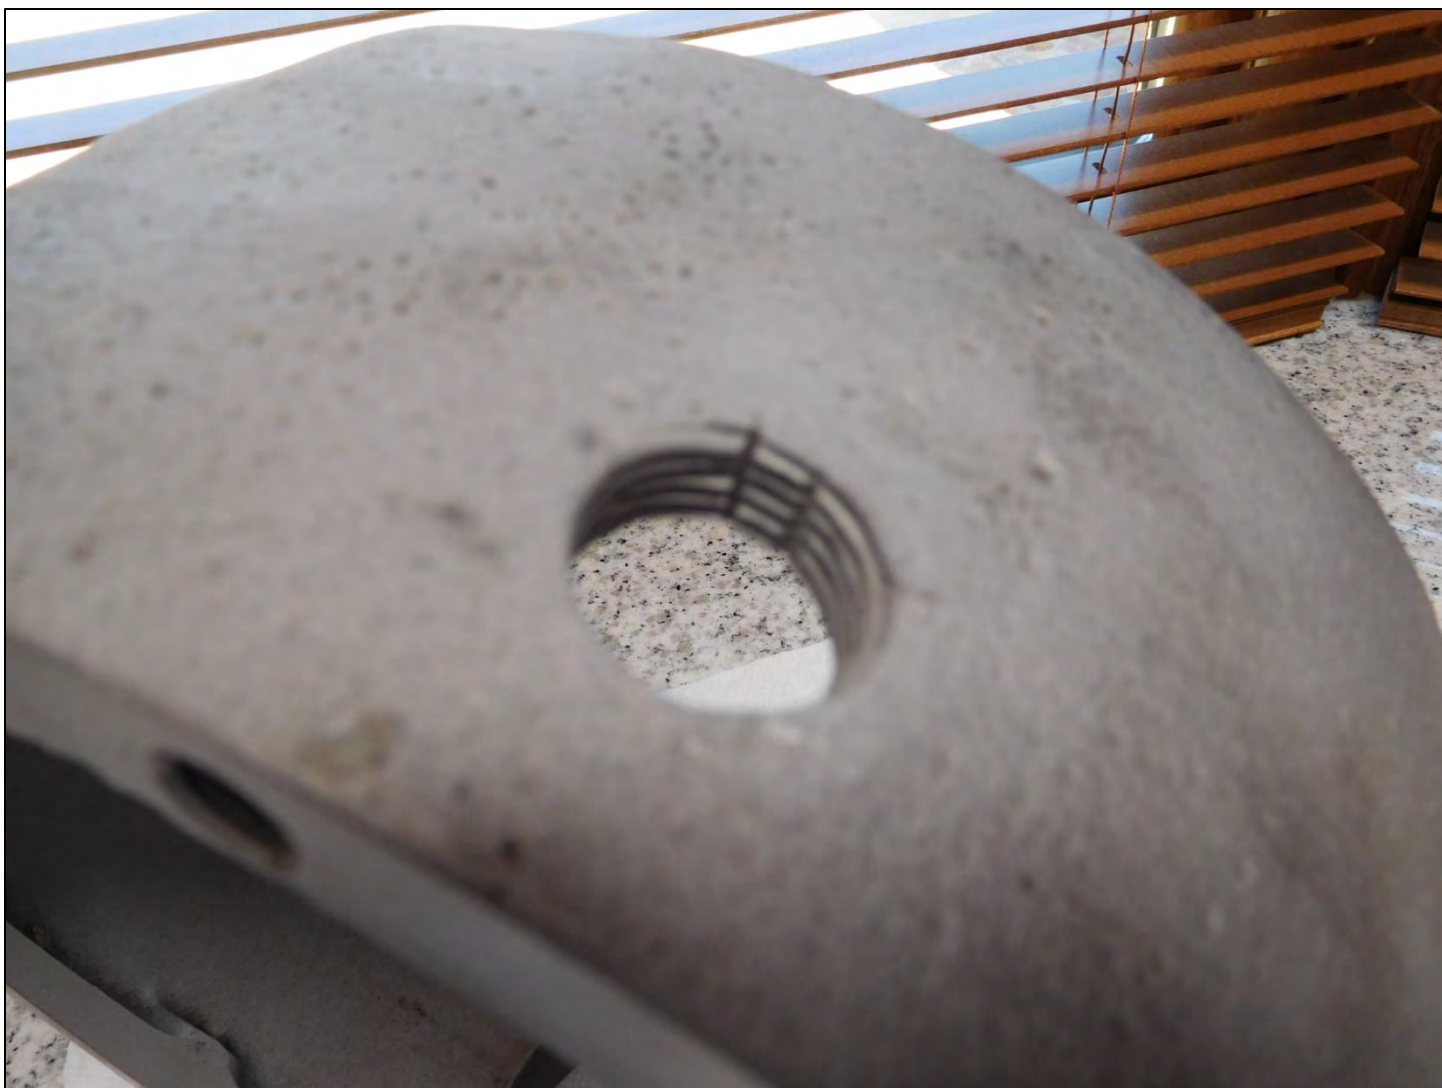
**This is a close-up photo of one of the banjo mounting bolt holes. A previous mechanic must have discovered the threads striped and as a repair drilled and inserted a Heli-coil. In the process the housing cracked. This mounting hole is located at the bottom of the banjo and the crack is an invitation to an oil leak. The banjo will be replaced.**

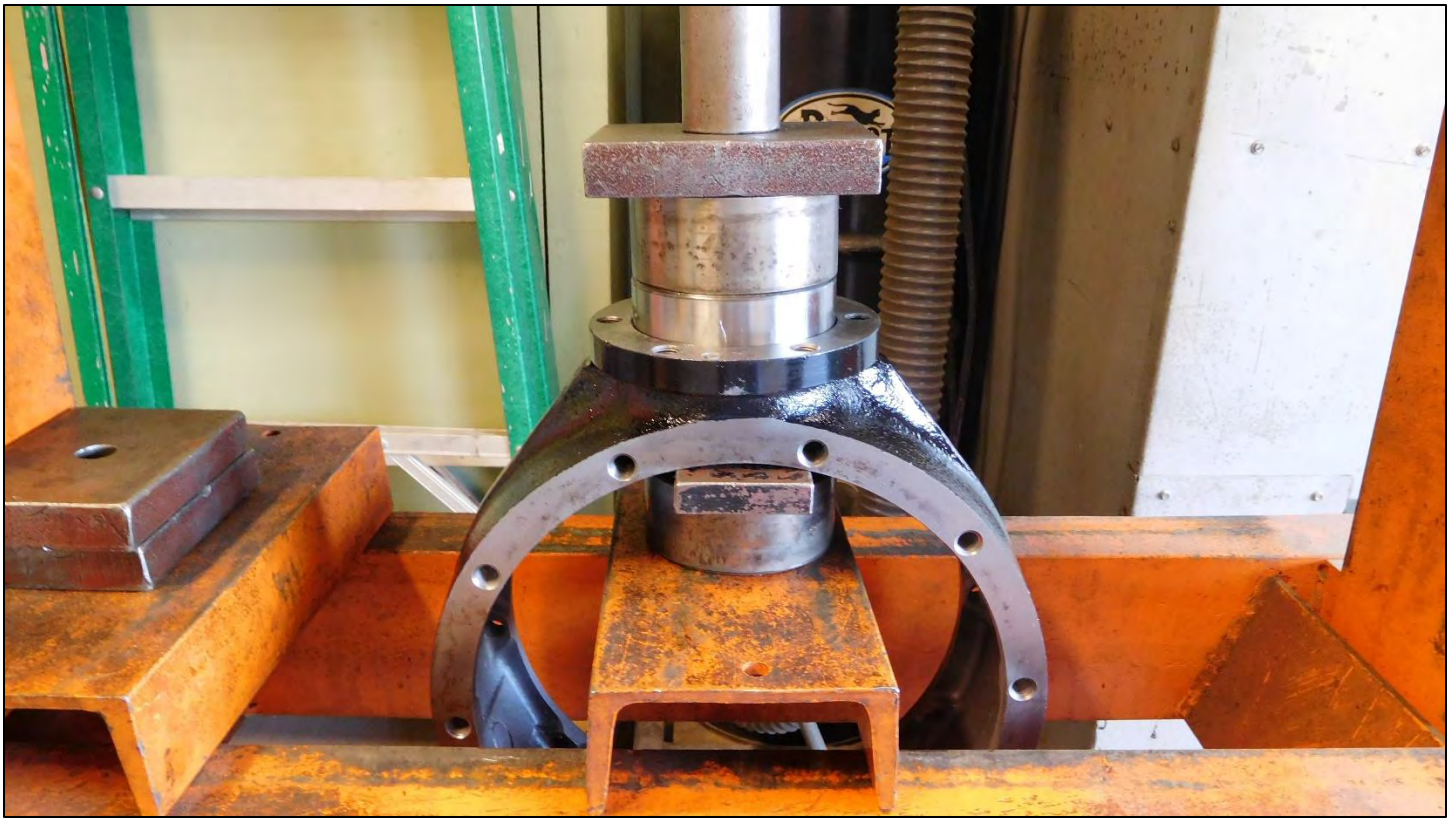
**Shown here is the first pinion bearing being pressed onto the sleeve. The sleeve had to be machined because the area for the second bearing was an incorrect diameter that would have been an interference fit that would have made setting the pinion bearing pre-load difficult.**

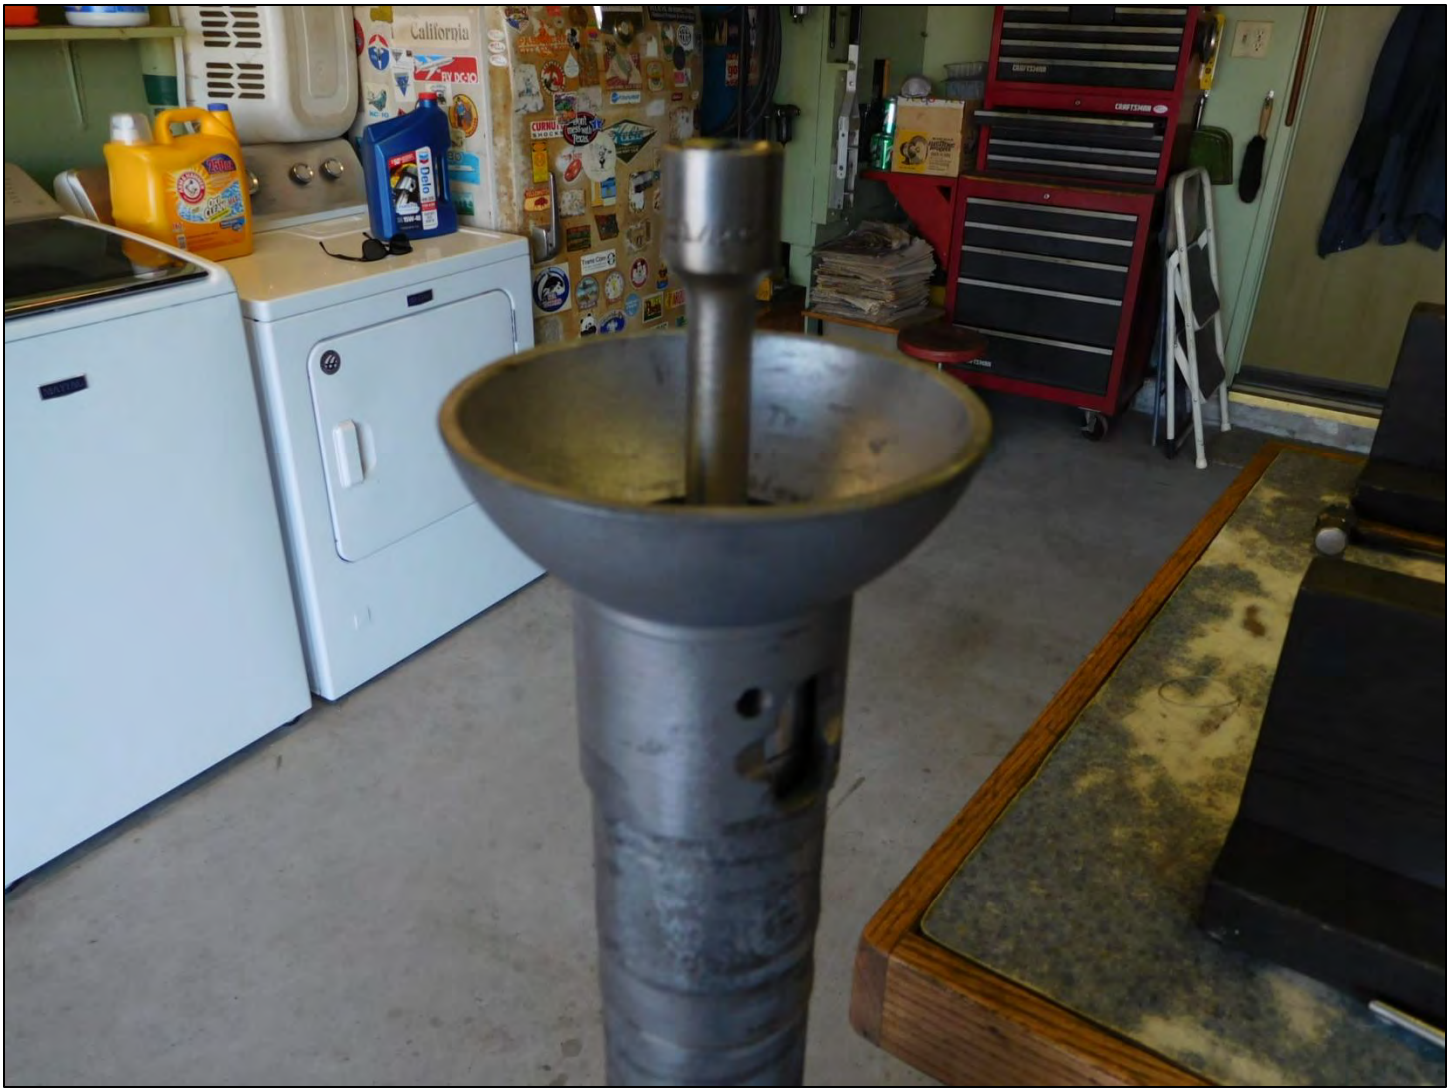
**The U-joint housing design on a 1932 rear axle assembly was not one of Henry's better ideas. The housing is one piece and was installed before the bell was welded on. It cannot be removed and makes it difficult to clean and restore. The bead blasting cleaned it up and it will be painted in place.**
