A Hidden Electrical Fault

By Tom Endy

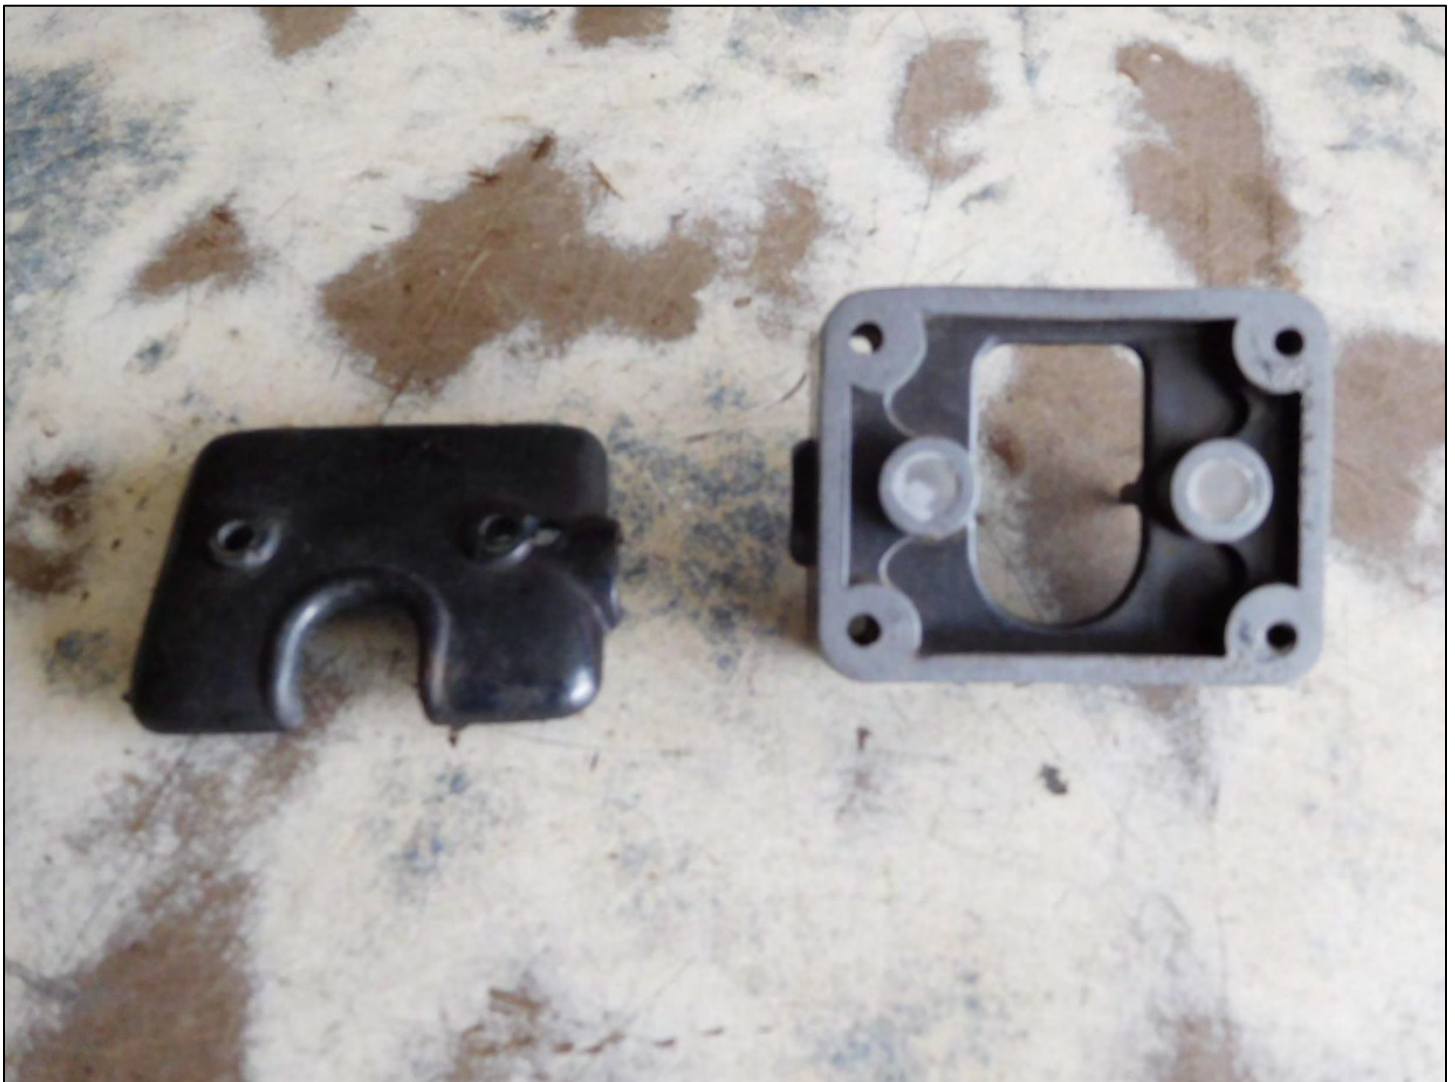
Reproduction Model A Ford firewall terminal blocks have been made in Hong Kong for at least the last 30 years that I am aware of and each has a potential hidden electrical fault that can be very difficult to locate and it could be disastrous, and actually cause a fire. The word Hong Kong is stamped on them, so there is no question where they come from.

In the photo, the back side of the terminal block seen on the right attaches directly to the fire wall with four screws. The originals were constructed such that the two terminal studs were molded into the structure during the manufacturing process and there is no way they could short out to the fire wall. The reproductions were manufactured by drilling two holes through the molding and inserting two screws into them from the back that form the two studs that are retained by a nut on each at the front. The two screws can easily back out and touch the fire wall. Both studs (screws) always have battery power on them, so there would be a direct electrical short circuit that is totally obscured.

It is prudent to do some modification to the Hong Kong terminal blocks before installing them. First, apply a little lock tight to the threads of the two screws where they screw into the nut at front and securely tighten. Next fill the hole behind each screw head with JB Weld. This will prevent the screw from backing out and shorting to the fire wall. JB Weld is non-conductive. The terminal block seen at right in the photo has had this done to it.
