# 1928 Transmission

by Tom Endy

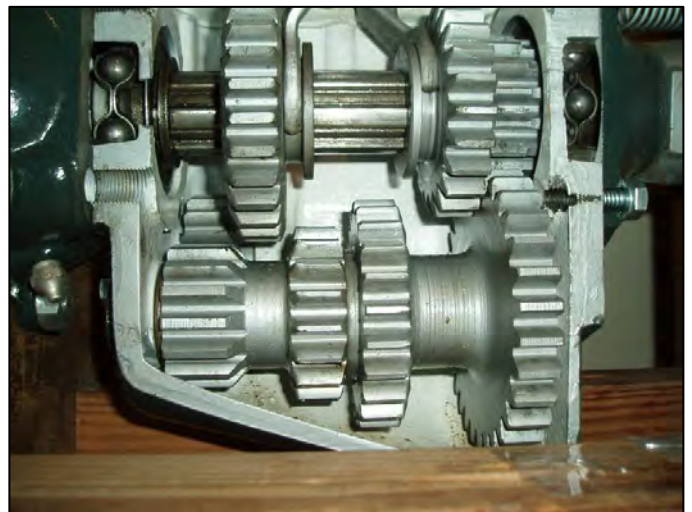
My observation has been that the boss at the rear of the housing seems to wear more than the front one. This would indicate there is some rearward pressure on the cluster gear as it rotates. I have been able to repair several transmission housings that had what I considered excessive cluster gear thrust clearance. What I did was use a small disk sander on a pneumatic tool and sand enough material off the rear boss to allow a 1928 bronze thrust washer to be installed. They are still available from some suppliers. Bratton's carry them under part number 10580, \$5.15 each.

**The photo at right is of a cut-away Model A transmission. The cluster gear is the gear at the bottom of the housing. The 1928 transmissions had a bronze thrust washer inserted between the case and at each end of the cluster gear. The rear of the transmission is to the left.**
