Differential Bust Up

by Tom Endy 2022

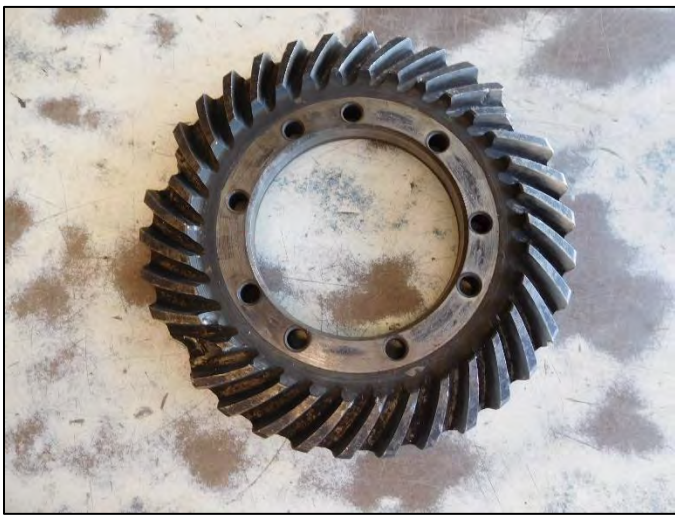
A recent overhaul of a Model A differential provided a unique challenge. The differential had suffered a ring & pinion failure with several teeth broken off the ring gear. A new ring & pinion gear set was procured and the rebuild was in process. While trying to set the carrier bearing pre-load we experience a lock up each time we tightened the banjo bolts. There was much frustration as we manipulated bearing shims and banjo gaskets to no avail.

Teeth broken off the ring gear

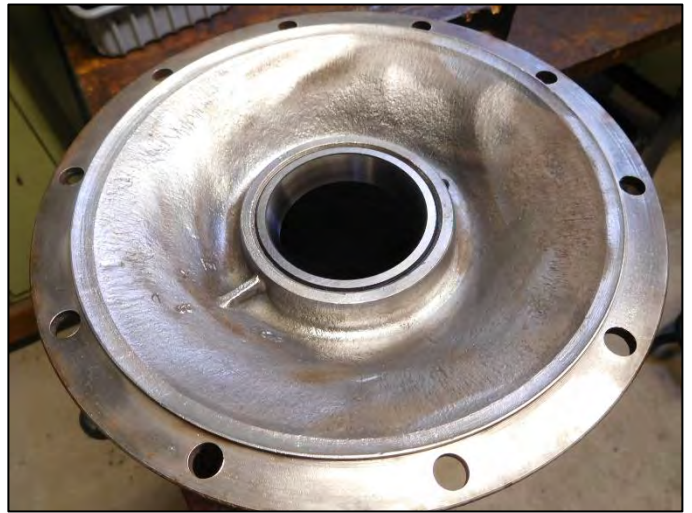
It was finally discovered there was a gouge on the inside of the left axle housing that would contact the back side of the new ring gear each time we bolted it down. An inspection of the old destroyed ring gear showed a witness mark on the back side. What apparently had happened was one of the broken off teeth from the ring gear had gotten between to the back side of the ring gear and the left axle housing and had caused a gouge that raise the metal enough to contact the new ring gear when bolted down. Using a grinder we ground off the protrusion and were then able to obtain the required carrier bearing pre-load.

The inside of the axle housing should be smooth

This something to look for when doing a differential overhaul. Make certain there are no gouges on the inside of the axle housings as a result of a bust up.
