Model A Banjo Cracking

by Tom Endy 2023

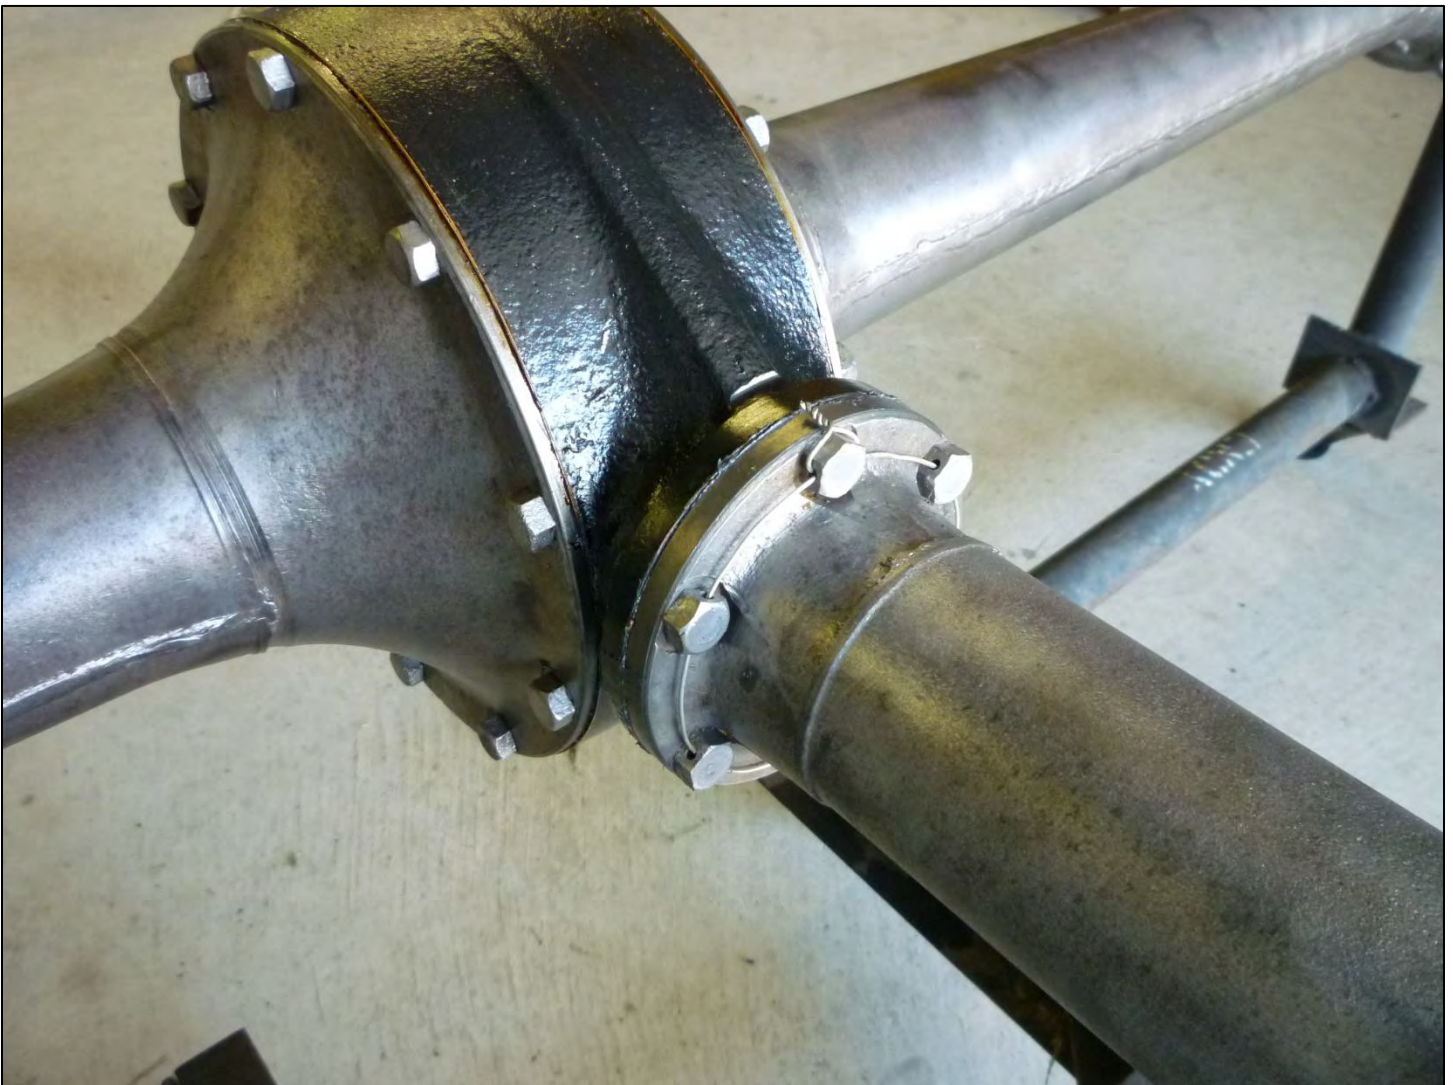
The top support gusset is seen directly above and to the left of where the safety wire terminates. There is an identical gusset on the bottom. The torque tube attaches to the banjo flange and is secured with six retaining bolts and is safety wired.

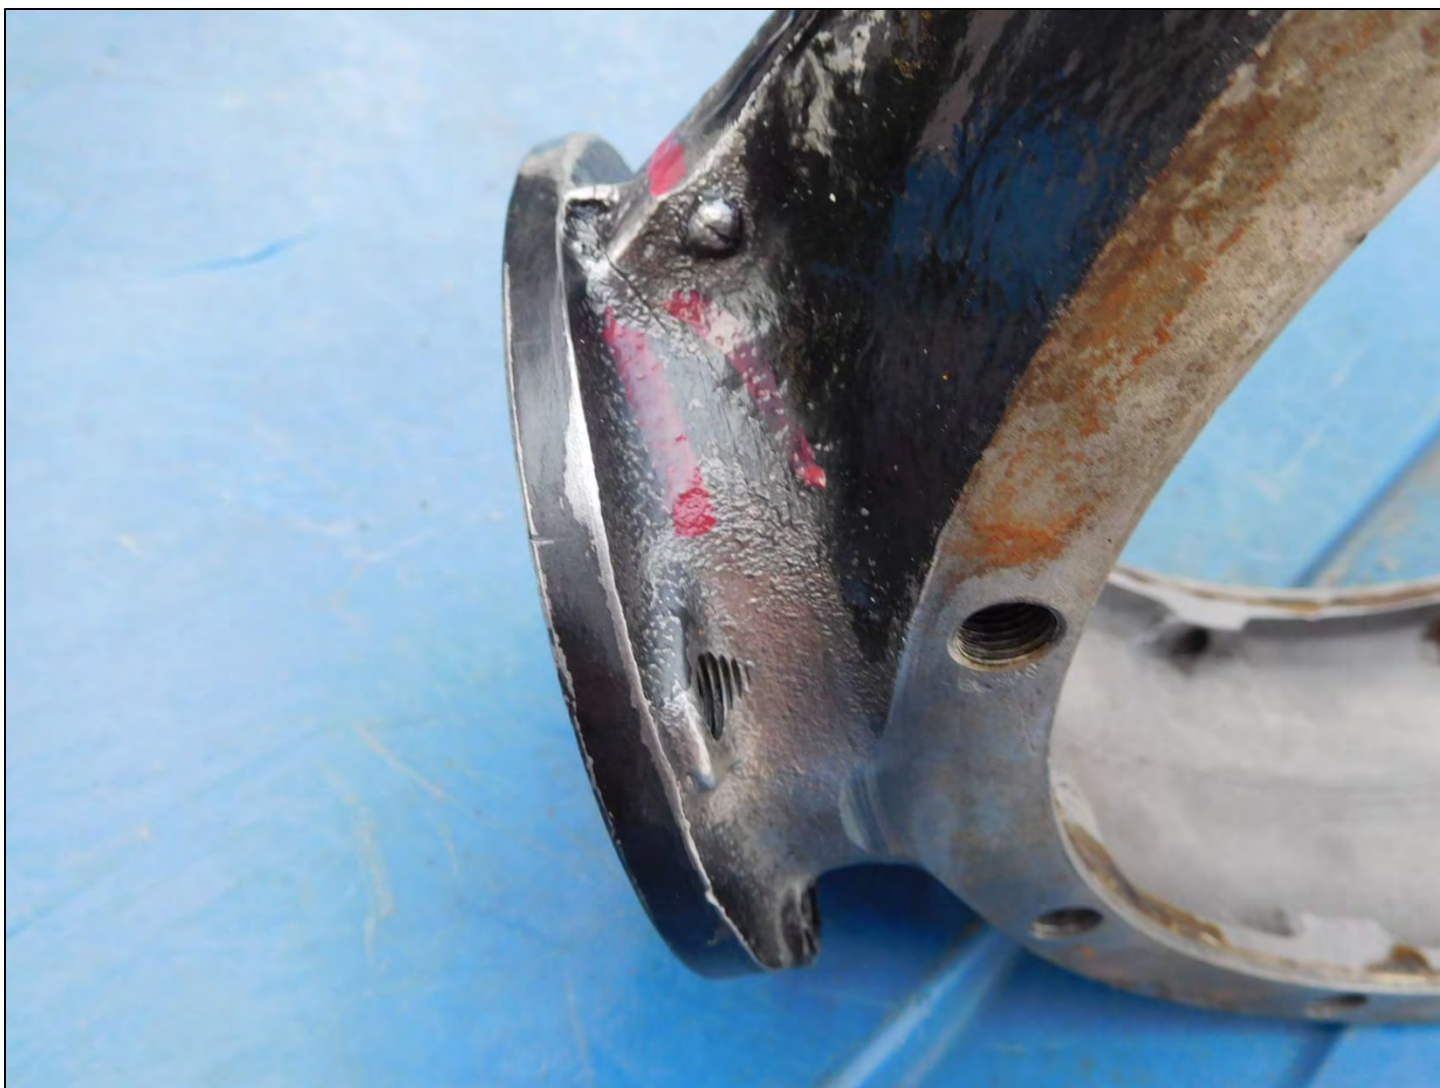
This photo shows a crack on the top left side of a 1930 banjo with support gussets that came out of my grandson's 1930 Tudor. The slot headed screw is a mystery and appears to have been included during the original casting of the banjo.

Early in the three year restoration of my grandson's 1930 Tudor the rear axle assembly was completely overhauled. The banjo used was an early 1930 with the support gussets and the fill and drain plugs in line. Soon after a slight oil spot was noticed under the banjo. It was thought to be coming from the drain plug, so pipe sealer was added to the threads. However the oil leak persisted. A closer inspection seemed to show the leak was at the joint of the banjo flange and the torque tube.

When we were installing the overdrive sometime later we investigated this problem. We ran a flat file over the banjo flange and inspected the banjo for cracks, no cracks were found. We applied sealer liberally to the flange gasket. After the overdrive was installed the oil leak became profuse. This time an inspection revealed a serious crack at the top of the banjo right behind the flange where the overdrive attached. The crack was apparently there when the differential was overhauled and went unseen. The weight of the overdrive must have opened the crack up more and the leak became extreme. The rear axle assembly had to be removed from the car and disassembled and the banjo replaced.

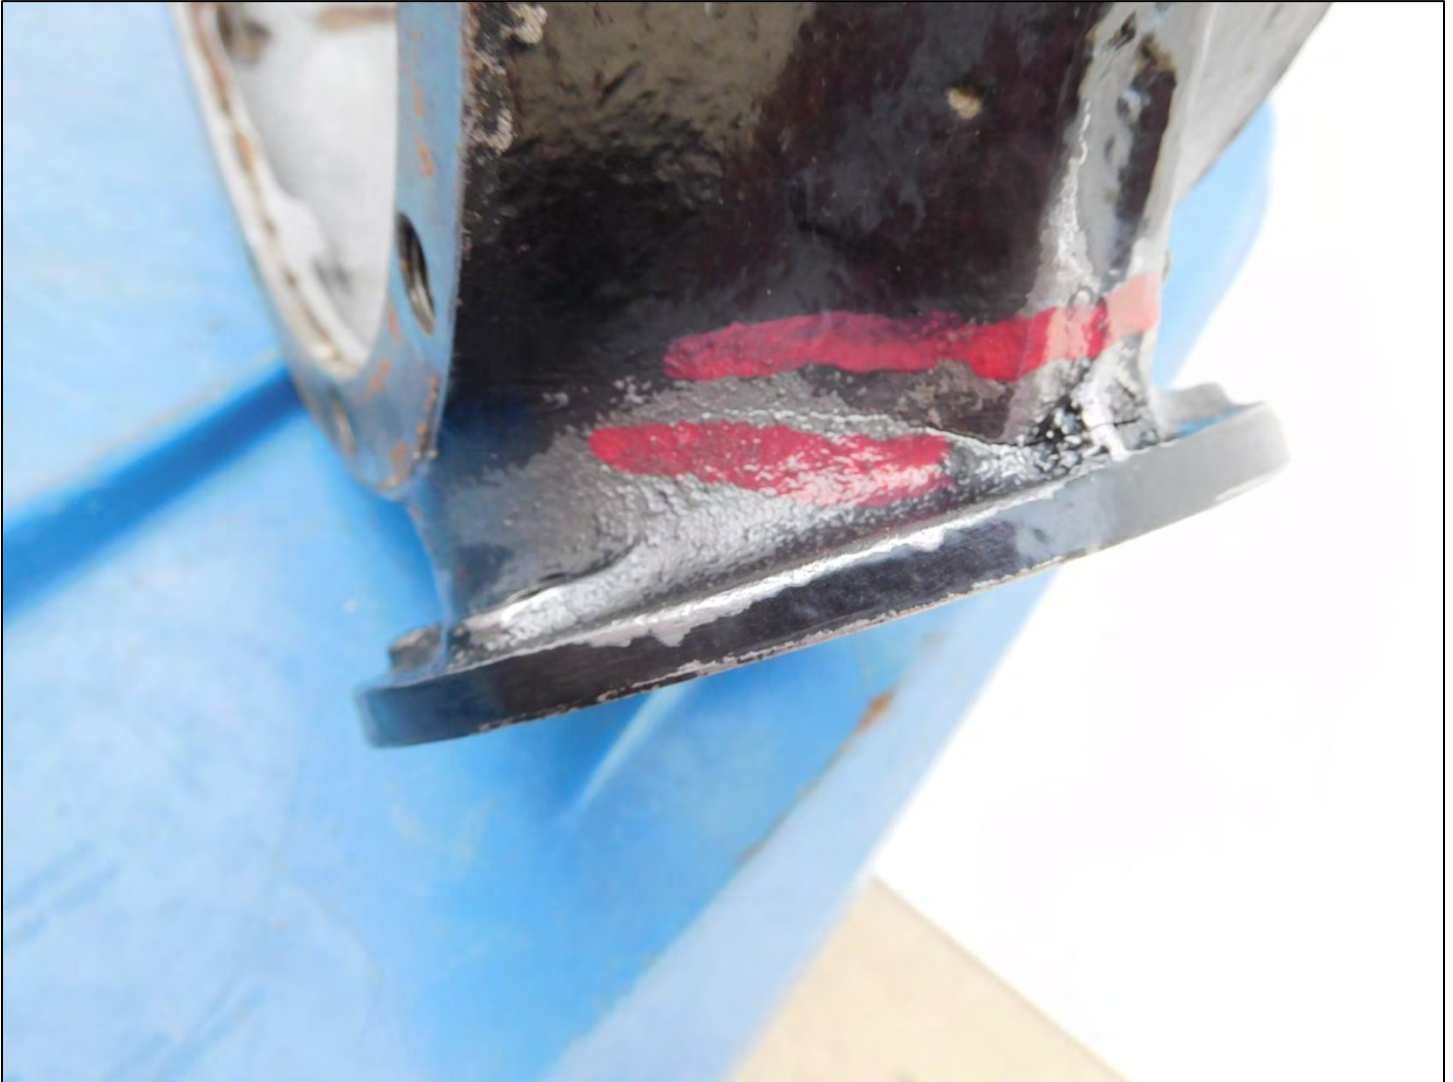
This photo shows the crack continuing on to the top right side of the banjo from the left side.

It is common for cracks to occur in the early banjos that do not have the support gussets, but is almost never seen with the later banjos with the support gussets. The occurrence of a banjo crack is usually associated with a bust-up of the ring and pinion gears.

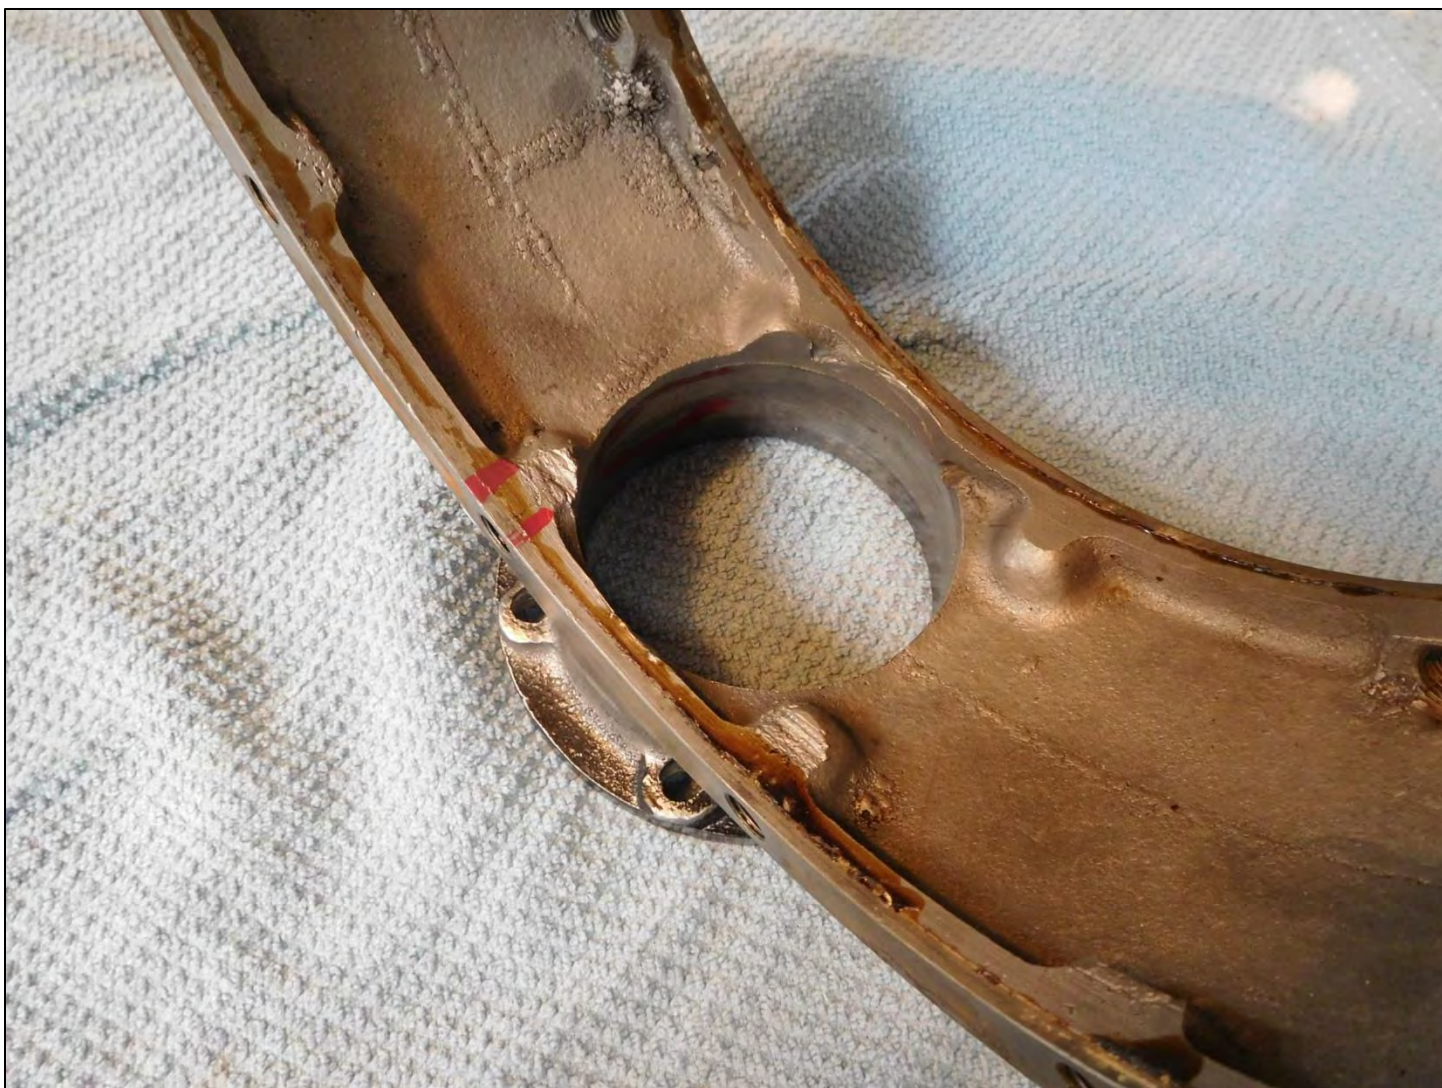
This photo show an additional crack in the banjo from the 1930 Tudor that is on the lip on the left side of the banjo flange where the left axle housing bolts on. There are also two witness marks on the left side where a ring and pinion bust-up must have occurred sometime in the past.

It is common to see a crack such as this at all four bolt holes nearest the torque tube flange on the early banjos without the support gussets.

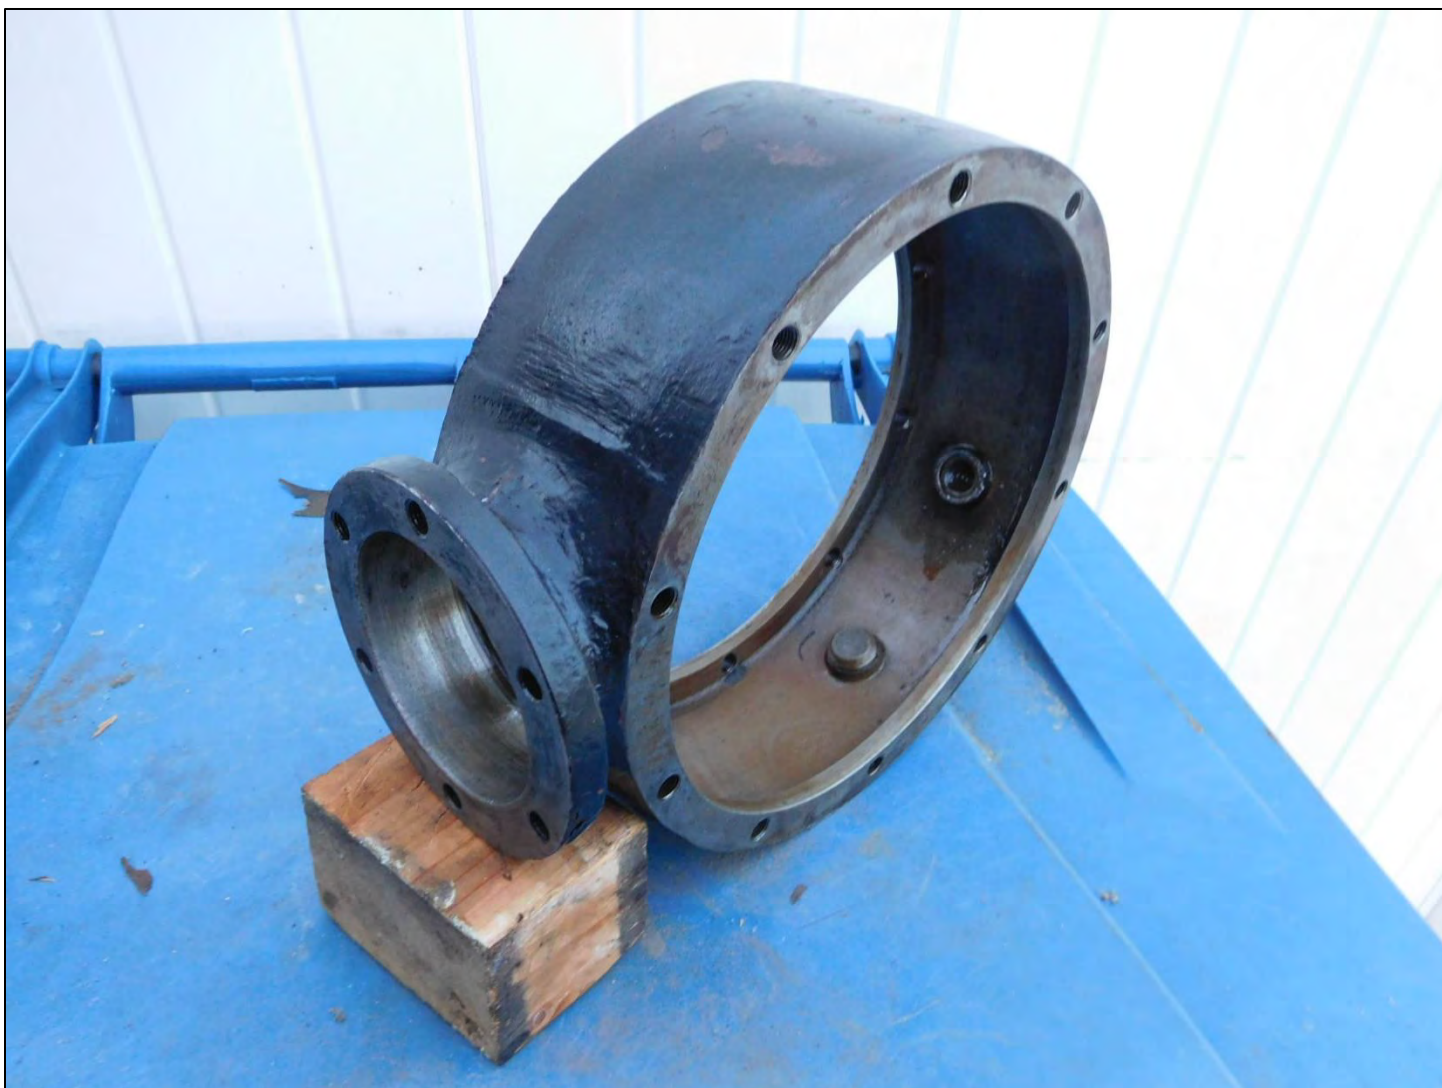
This is an early banjo without support gussets.

These early banjos were susceptible to cracking just behind the flange where the torque tube attaches. When rebuilding a Model A rear axle assembly that has an early banjo, it is prudent to replace it with a later one.

When rebuilding a rear axle assembly for a customer I have always advised them of the potential for cracks if the banjo is an early version without the support gussets. In most cases the customer opted to have the banjo replaced with a later one. Banjos have been found in abundance over the years at swap meets and I have been able to acquire an inventory.

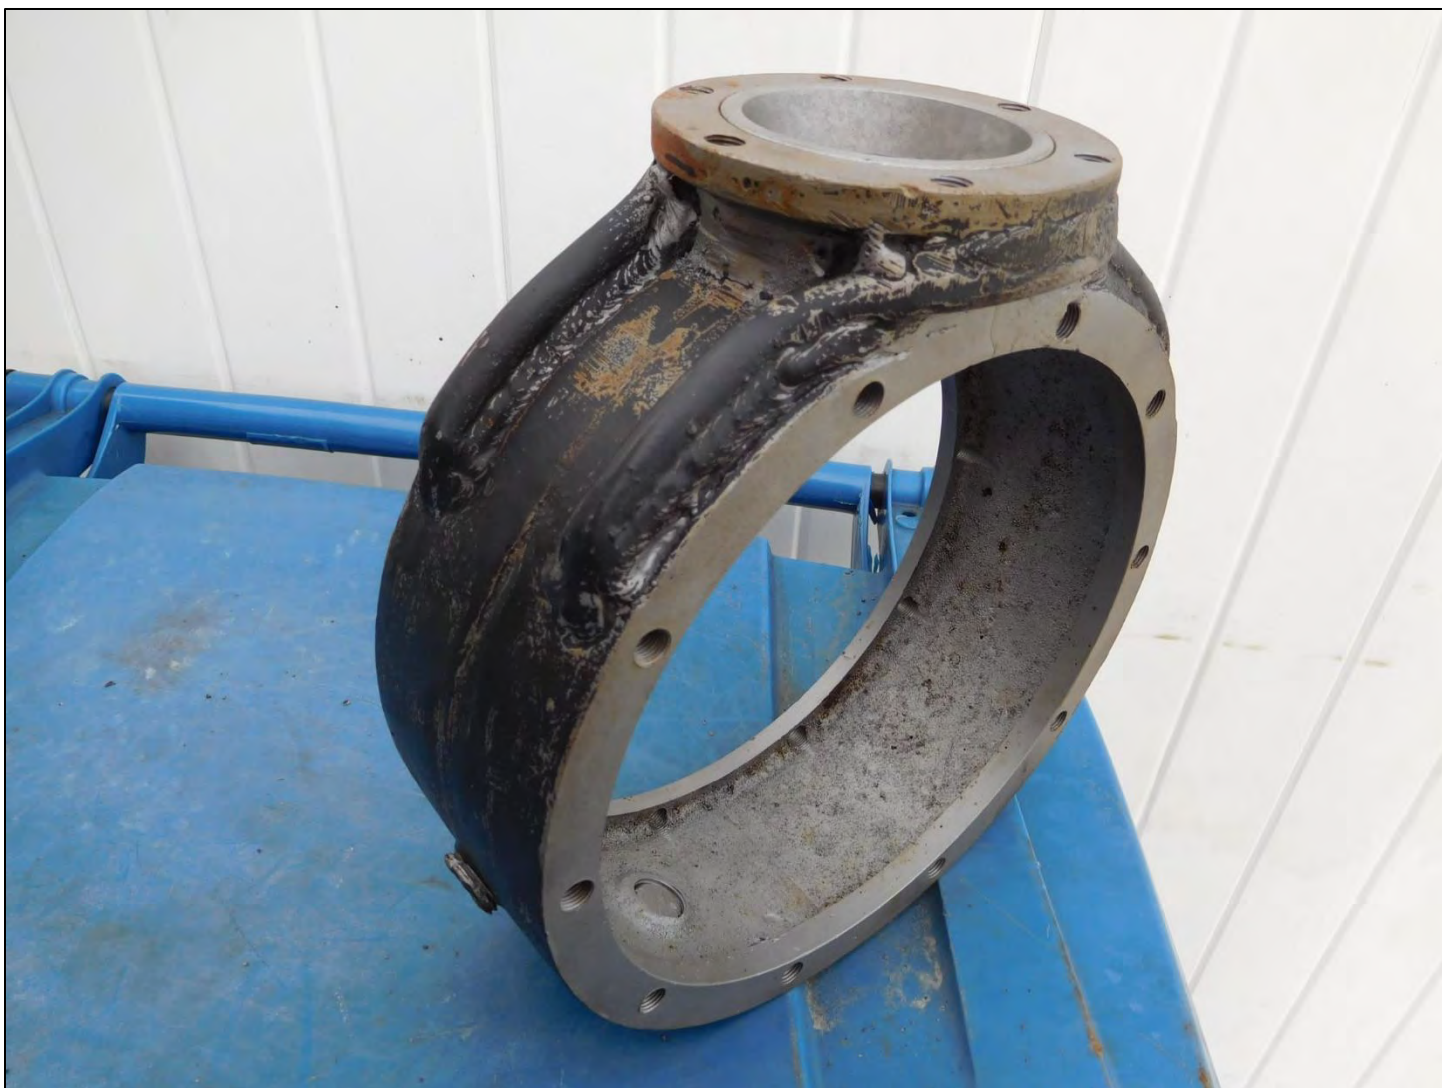
This is an early banjo without the support gussets. It came out of an early 1928 Phaeton that was brought up from Argentina a number of years ago.

I was asked to overhaul the rear axle assembly and I replaced the banjo with a later one. The banjo apparently experienced some cracking and some resourceful fellow was able to repair it by welding on re-bar supports.
