# LUG NUT WARNING!

by Bill Lancaster — Sunnyvale, California

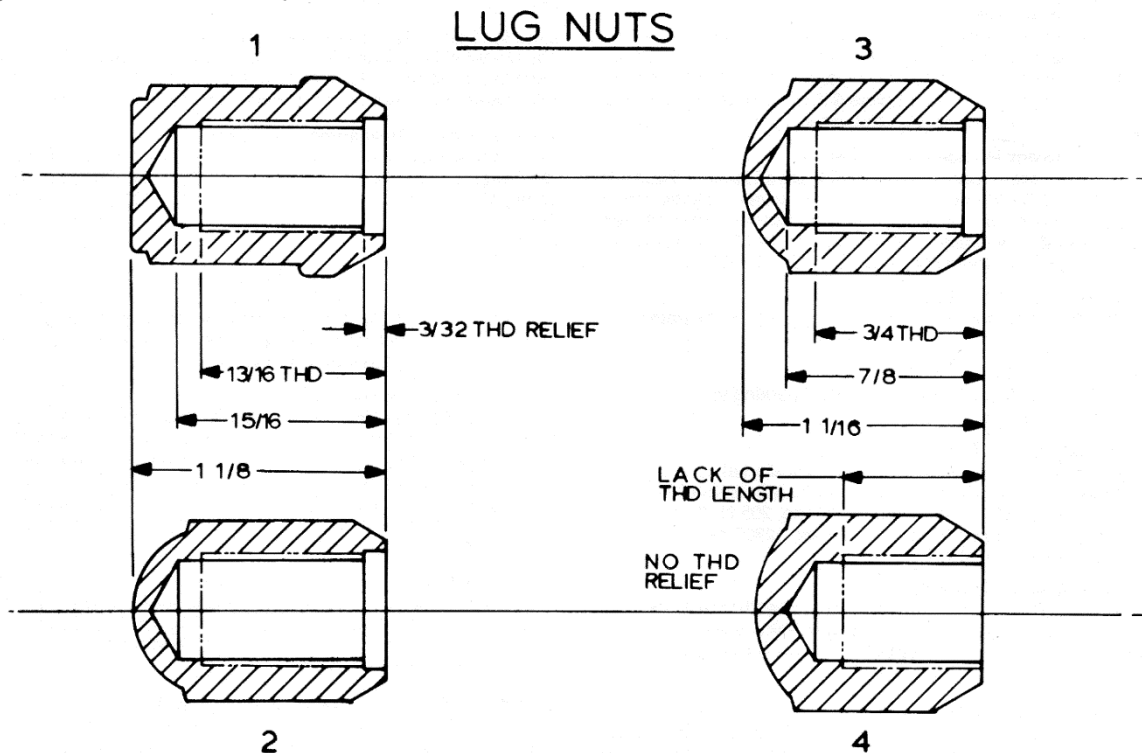
The two cases were unrelated and had somewhat different conditions leading to the determination that some reproduction lug nuts are not safe to use, and therefore are unacceptable. In both cases, there was no indication that a problem existed when these lug nuts were installed. They tightened up like acceptable lug nut. However, it was later determined that these new lug nuts were not fully seated.

very hard to remove. They were found to have damaged the threads on the hub stud. Prior to using them, all the lug nuts and studs were chased. The threads were again chased, and the lug nut thread length was verified to be correct. This included tap drilling deeper to provide .75 inches of full thread on these three lug nuts. After driving a couple hundred more miles, the lug nuts were again hard to remove. After much frustrating analysis, it was determined that a thread relief exists in a normal lug nut that did not exist in these defective lug nuts!

The enclosed sketch shows these conditions. The first cross-section is the "AR" lug nut. The second is our best estimate of the 11/16" hex size lug nut used for a short time after the "AR" nut was replaced. Lug nut number three is the most common Model A lug nut. The fourth cross-section is the unacceptable reproduction lug nut, which lacks adequate thread depth and lead-in thread relief.

If you have reproduction lug nuts of the common type, check to see that they have the following characteristics:

1. The overall length must be at least 1-1/16 inches.
2. At the entrance, there must be no threads for the first 3/32nds of an inch.
3. The tap drill depth must be at least 7/8 inch, and
4. The full thread length must be at least 3/4 inch (which can be checked with a 1/2-20 UNF x 3/4" long bolt).
