# Differential Vent

by Tom Endy 2023

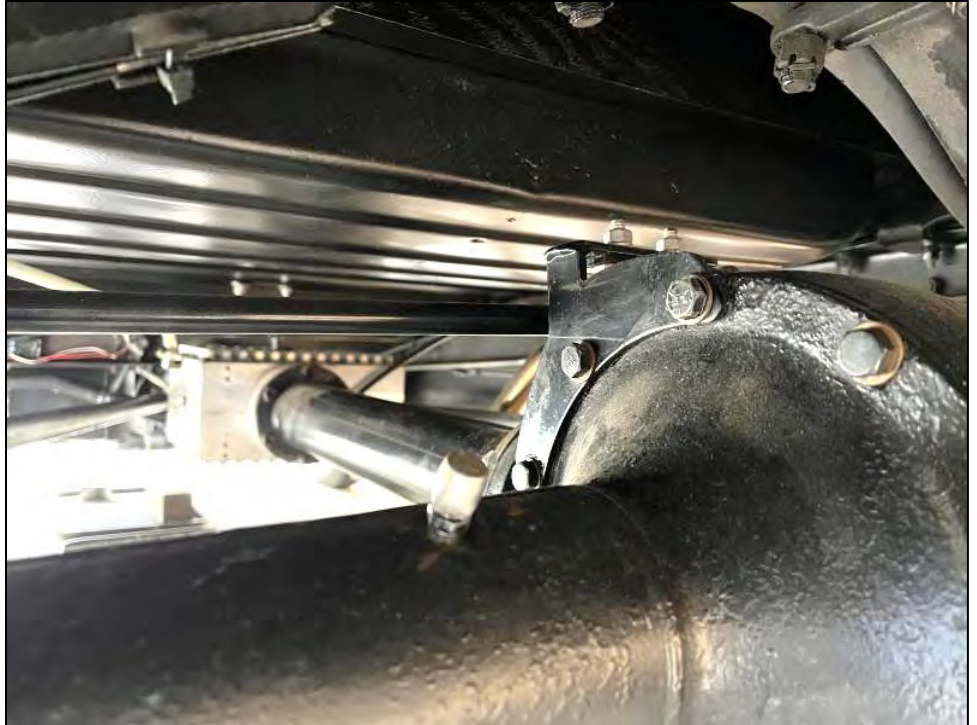
Some Model A owners have reported an oil leak from the differential section of the rear axle assembly after installing a Mitchell overdrive. The oil leak comes from around the banjo bolts. The Mitchell overdrive itself is vented by way of a vent valve supplied with the overdrive. It is believed that the installation of the overdrive removes the volume that was available in the original torque tube and allows pressure build up in the differential section. One Model A owner who experienced this installed a vent valve procured from Amazon.

**The vent valve was installed on the top of the left axle housing a few inches from the banjo flange. The owner coated the drill bit and tap with grease to minimize any metal chips falling into the axle housing. The photo at right shows the installation.**
