# Number Eight!

by Tom Endy

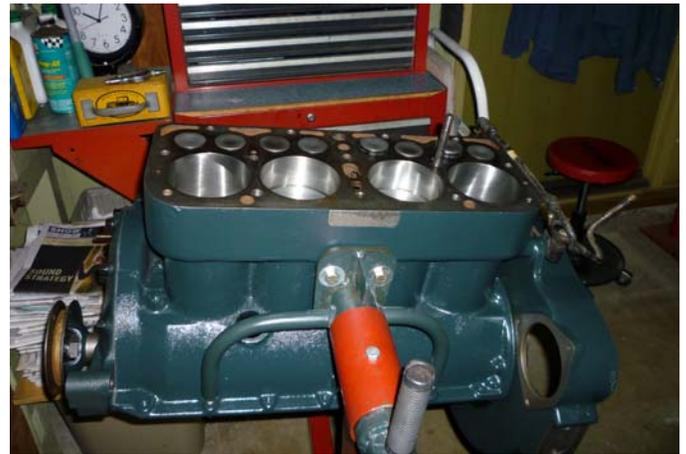
The #8 stud sits right next the narrow area between the #3 and #4 cylinders where the head gasket is very narrow and susceptible to blowing. The area between #3 and #4 cylinders is the most common area for a head gasket to blow even when there is proper torque on the stud. Removing the nut at #8, or running without the spacing of the clamp only adds to the possibility of blowing a head gasket and warping the head.

**The #8 stud sits right next to the narrow area between #3 and #4 cylinder.**

The best solution is to remove the clamp completely from the armored cable and install a spacer under the nut at the #8 stud to properly space it. Torque all the head bolts down to the proper specification in sequence, and don't fool with them when out on the road. The #8 stud can also be replaced with a standard length stud as used in the other stud positions.

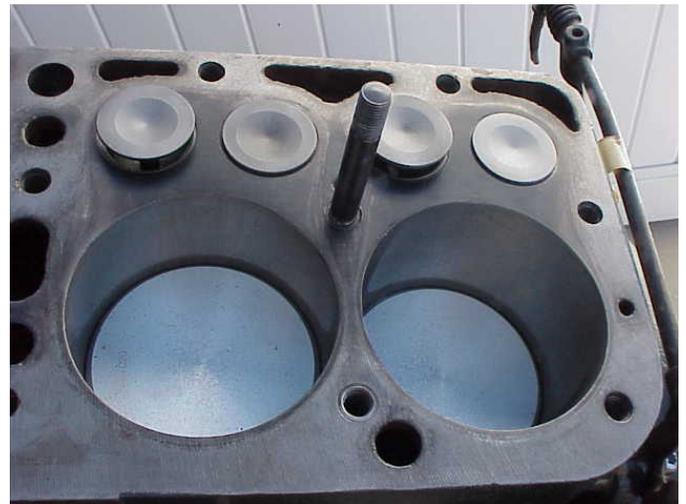
**The area between #3 and #4 cylinder is a common place for a blown head gasket. The #8 stud sits right next to the area.**
