Mitchell Overdrive One Day Installation

by Tom Endy 2019

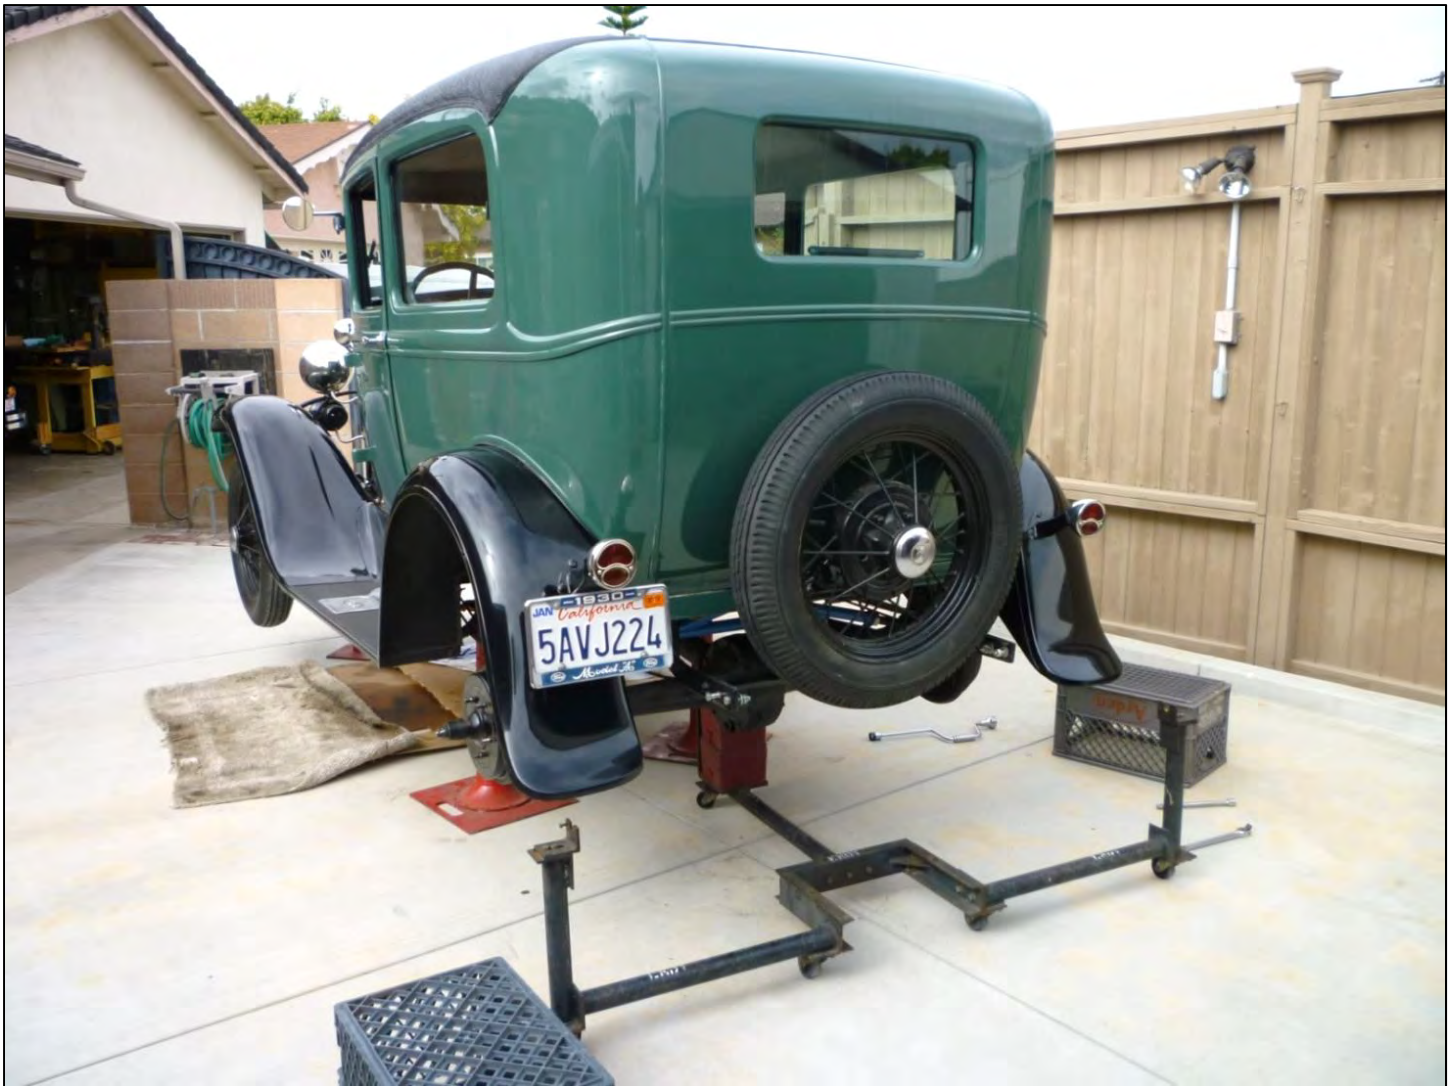
A Model A Ford has been positioned on the tall jack stands. The rear wheels have been removed. The rolling cradle has been positioned beneath the rear of the car and the spring spreader has been installed. The rear axle assembly is ready to come out. Once the cradle is fully under the car a floor jack will be placed under the banjo.

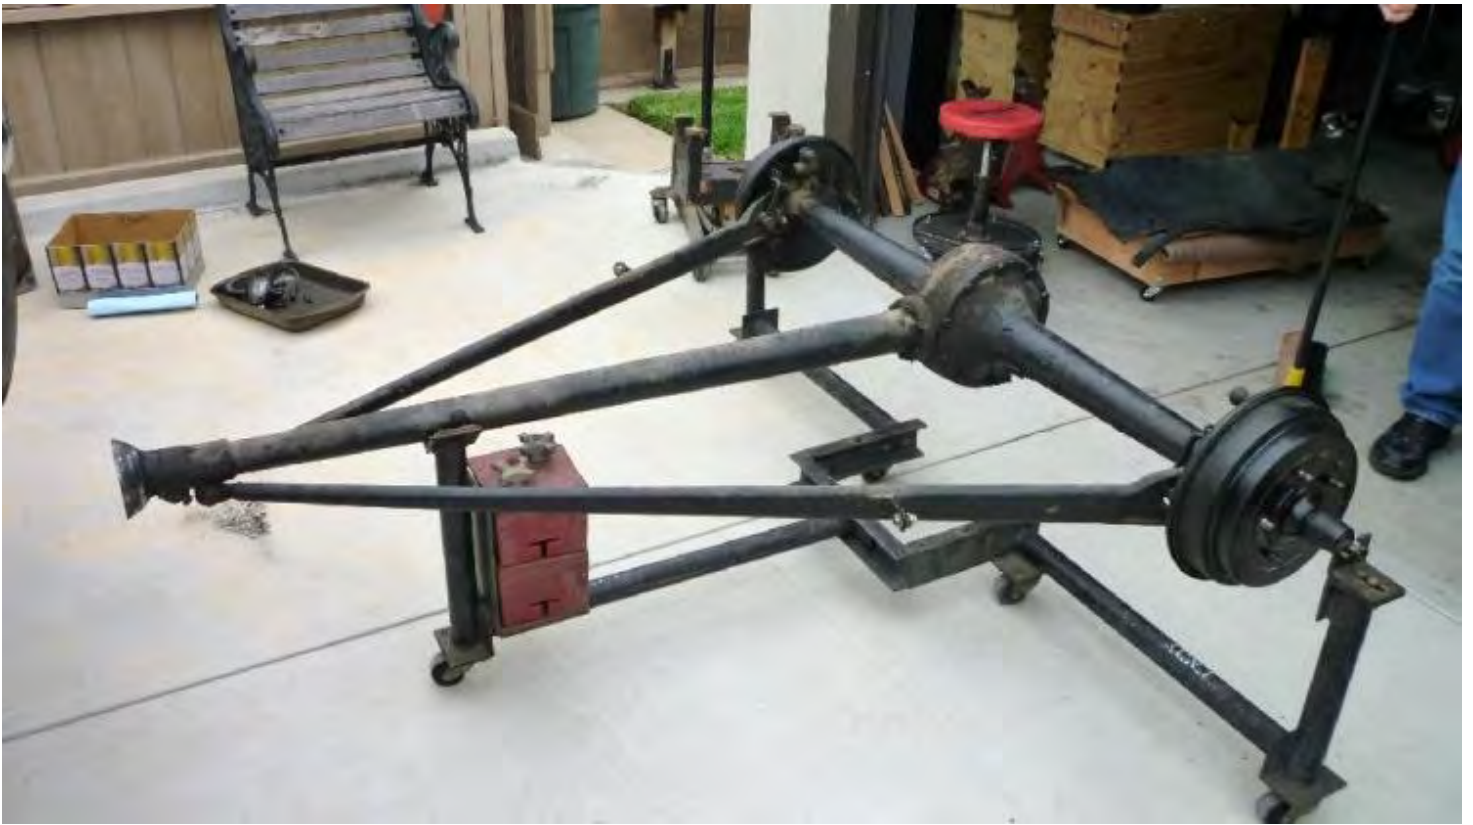
The rear axle assembly has been removed from the car. The torque tube is ready to come off. The rear spring is still attached to the frame of the car with the spring spreader still installed.

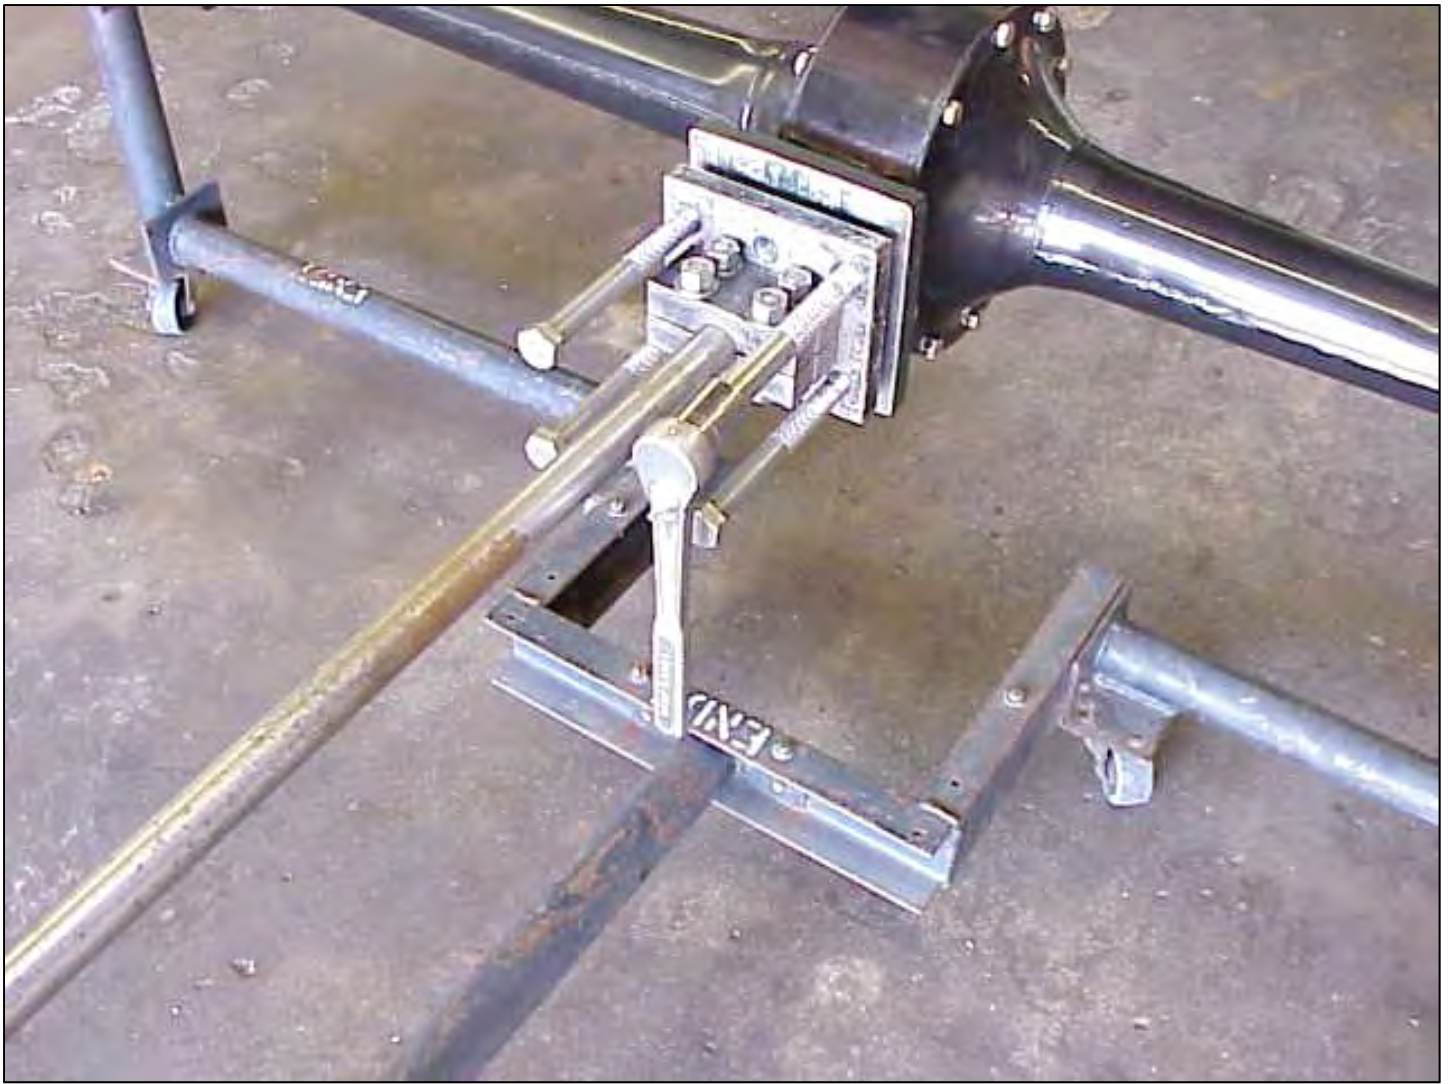
The torque tube has been removed and discarded. The pinion assembly and drive shaft are being removed from the banjo with the pinion gear assembly puller.

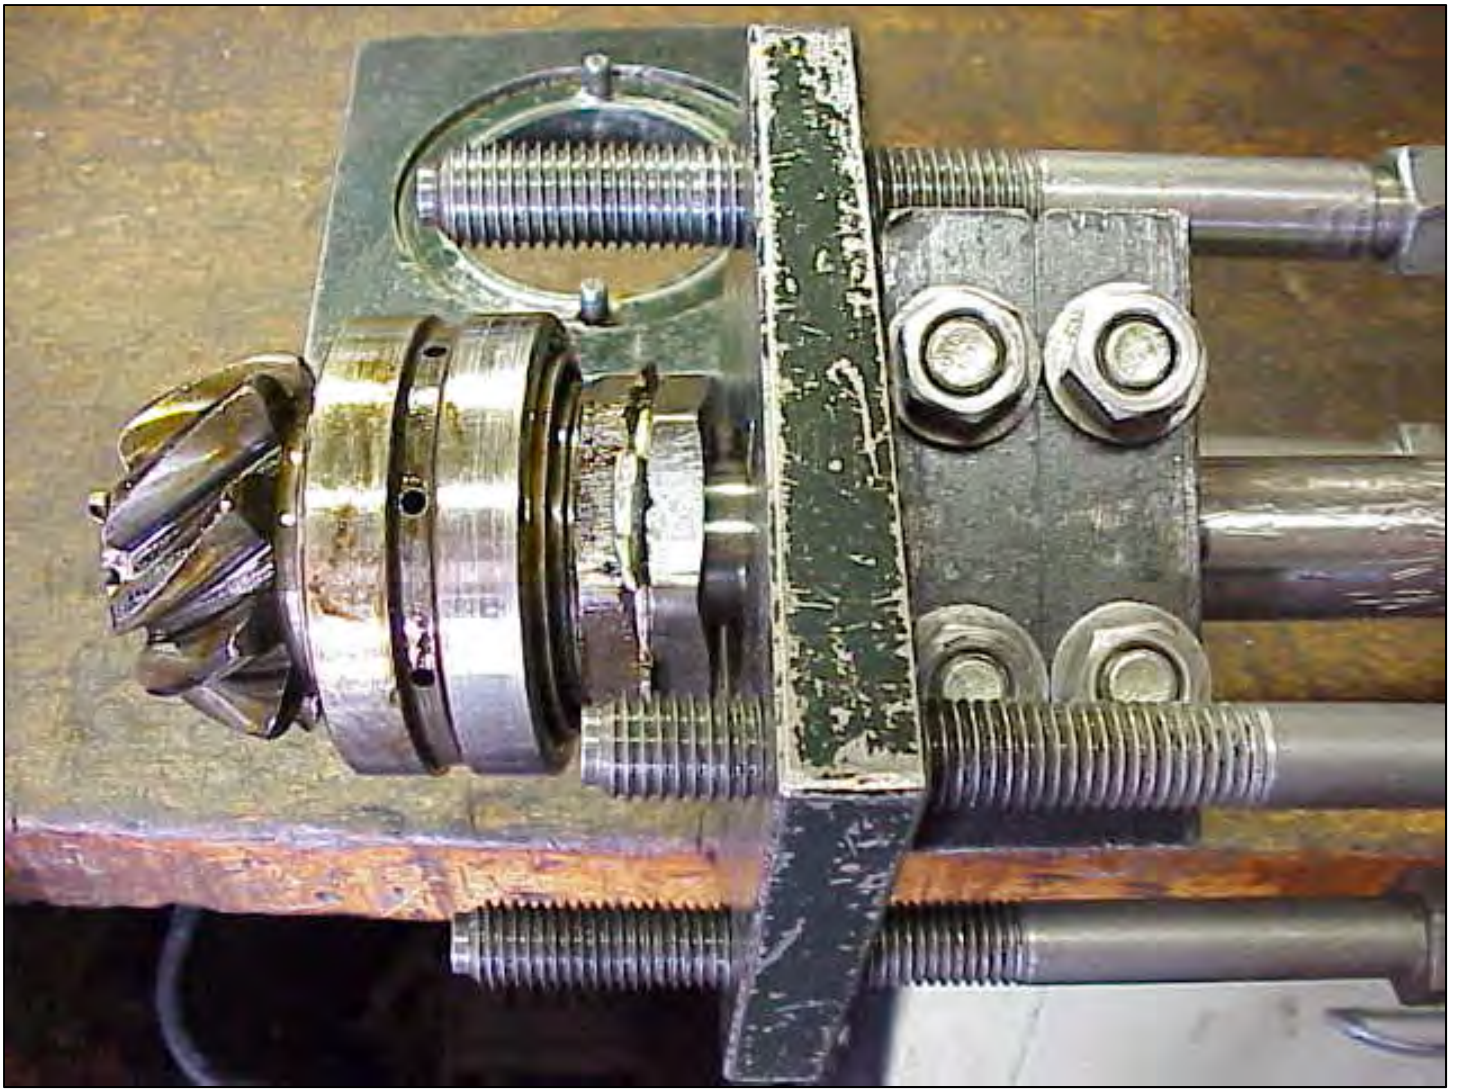
The pinion gear assembly has been pulled from the banjo without disturbing the preload on the two pinion bearings.

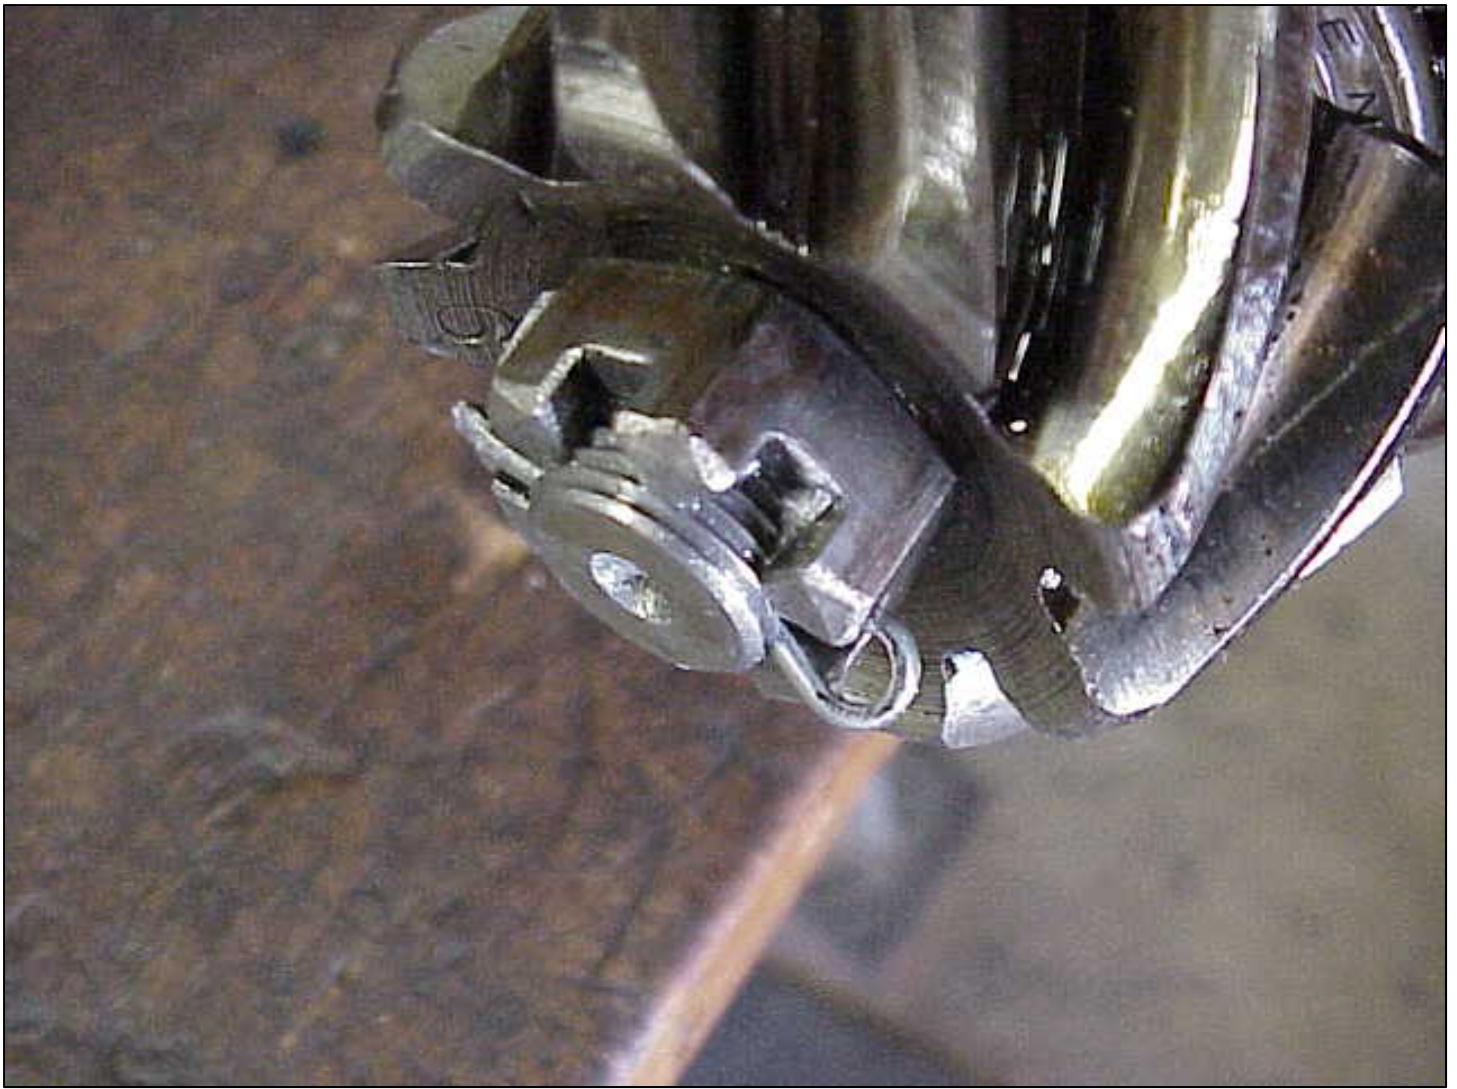
The cotter pin will be removed from the end of the drive shaft and the nut loosened and backed off about 1/8".

It is important that during an installation the cotter pin legs be bent down along the side of the nut and not over the end of the drive shaft. The reason being, there is not a lot of clearance between the end of the nut and the rotating carrier. This is especially true with after-market ring & pinion gears and overdrive stub shafts.

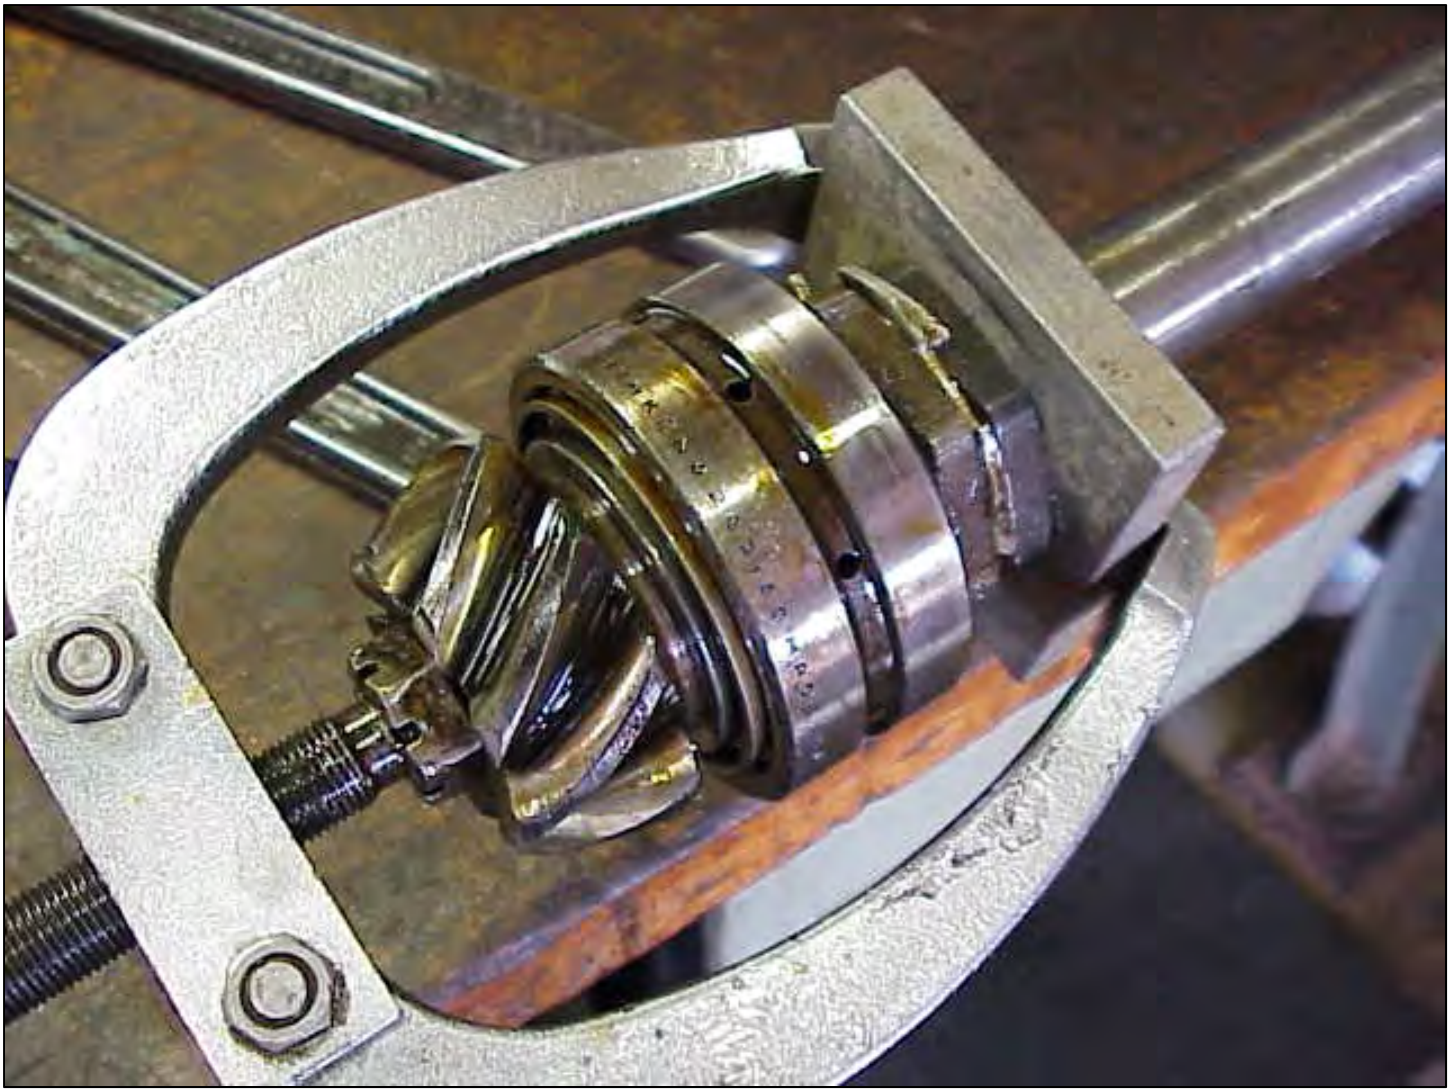
The pinion assembly is removed from the drive shaft with a puller tool without disturbing the pre-load on the pinion bearings. The puller is tightened against the block of steel that has a hole in it to allow it to slide over the drive shaft and up against the pinion assembly. The end of the puller is hit with a hammer to dislodge the pinion assembly from the tapered shaft.

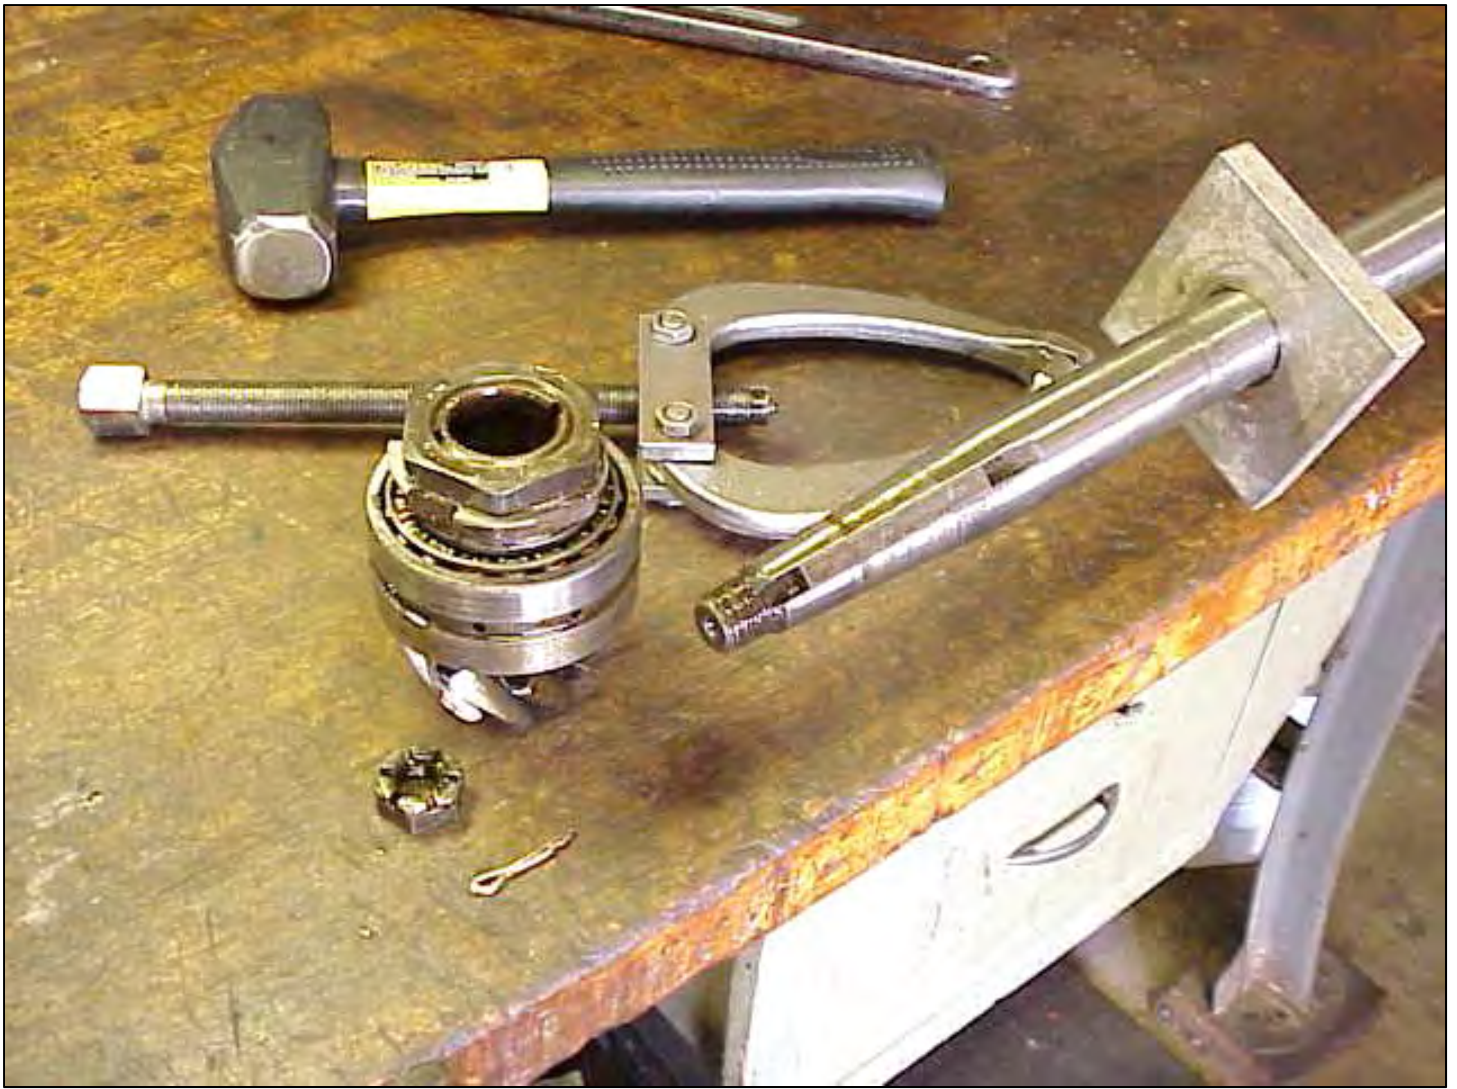
The pinion assembly has been removed from the drive shaft without disturbing the bearing pre-load.

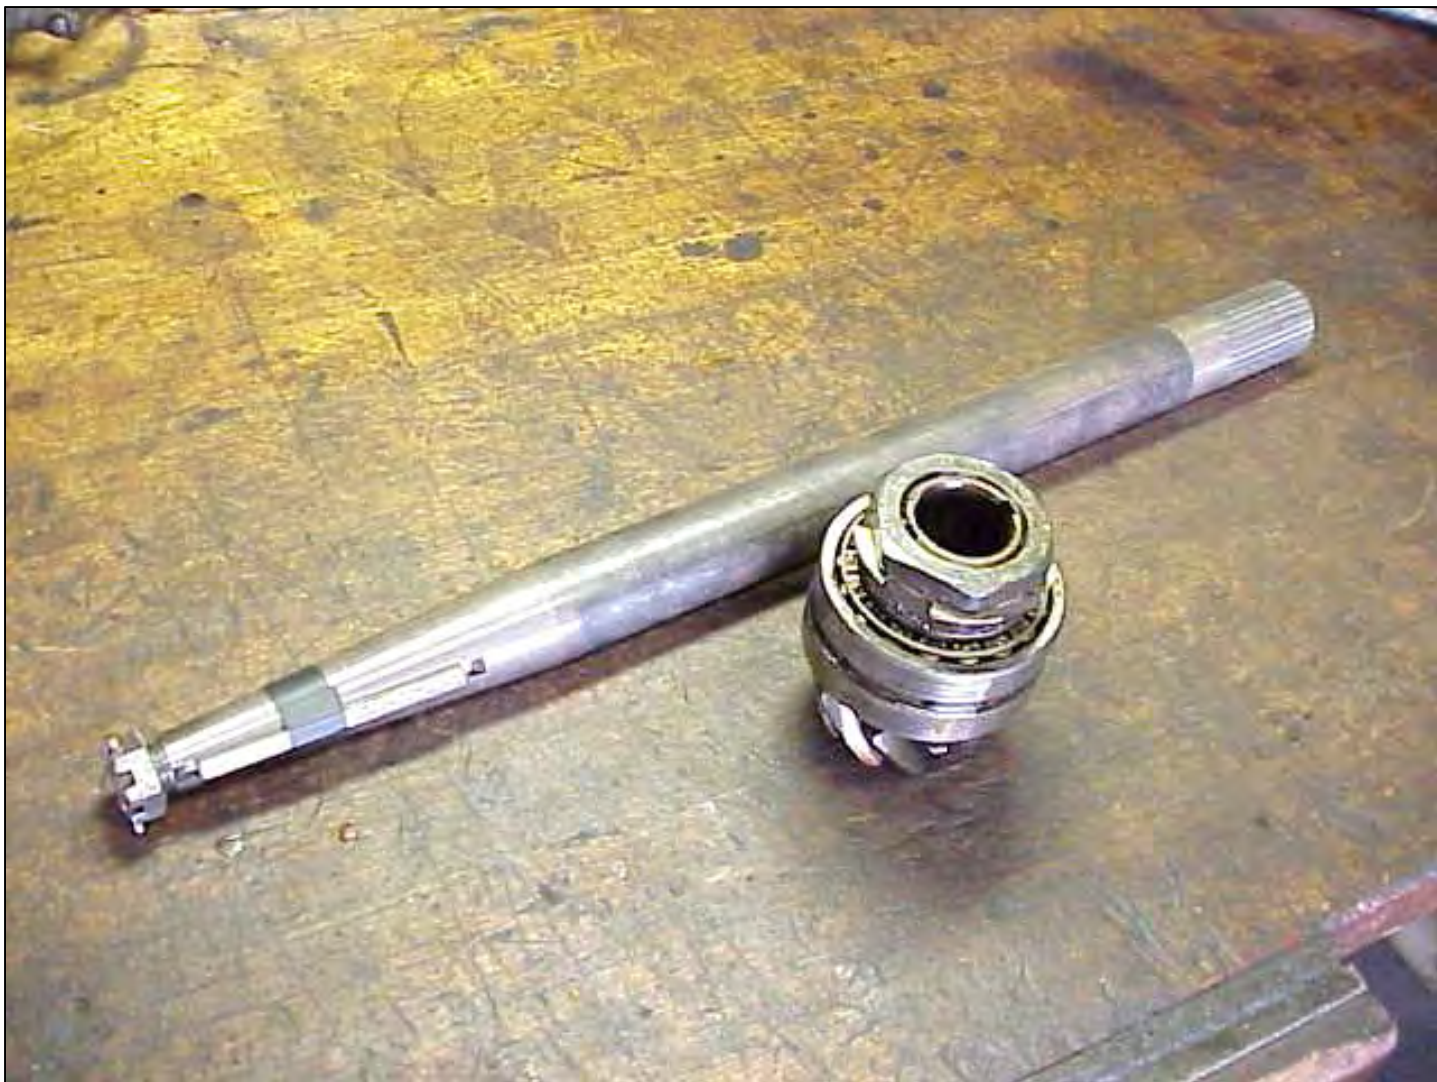
The Mitchell stub shaft is ready to be installed into the removed pinion gear assembly. The nut will be torqued to 100 ft. lbs.

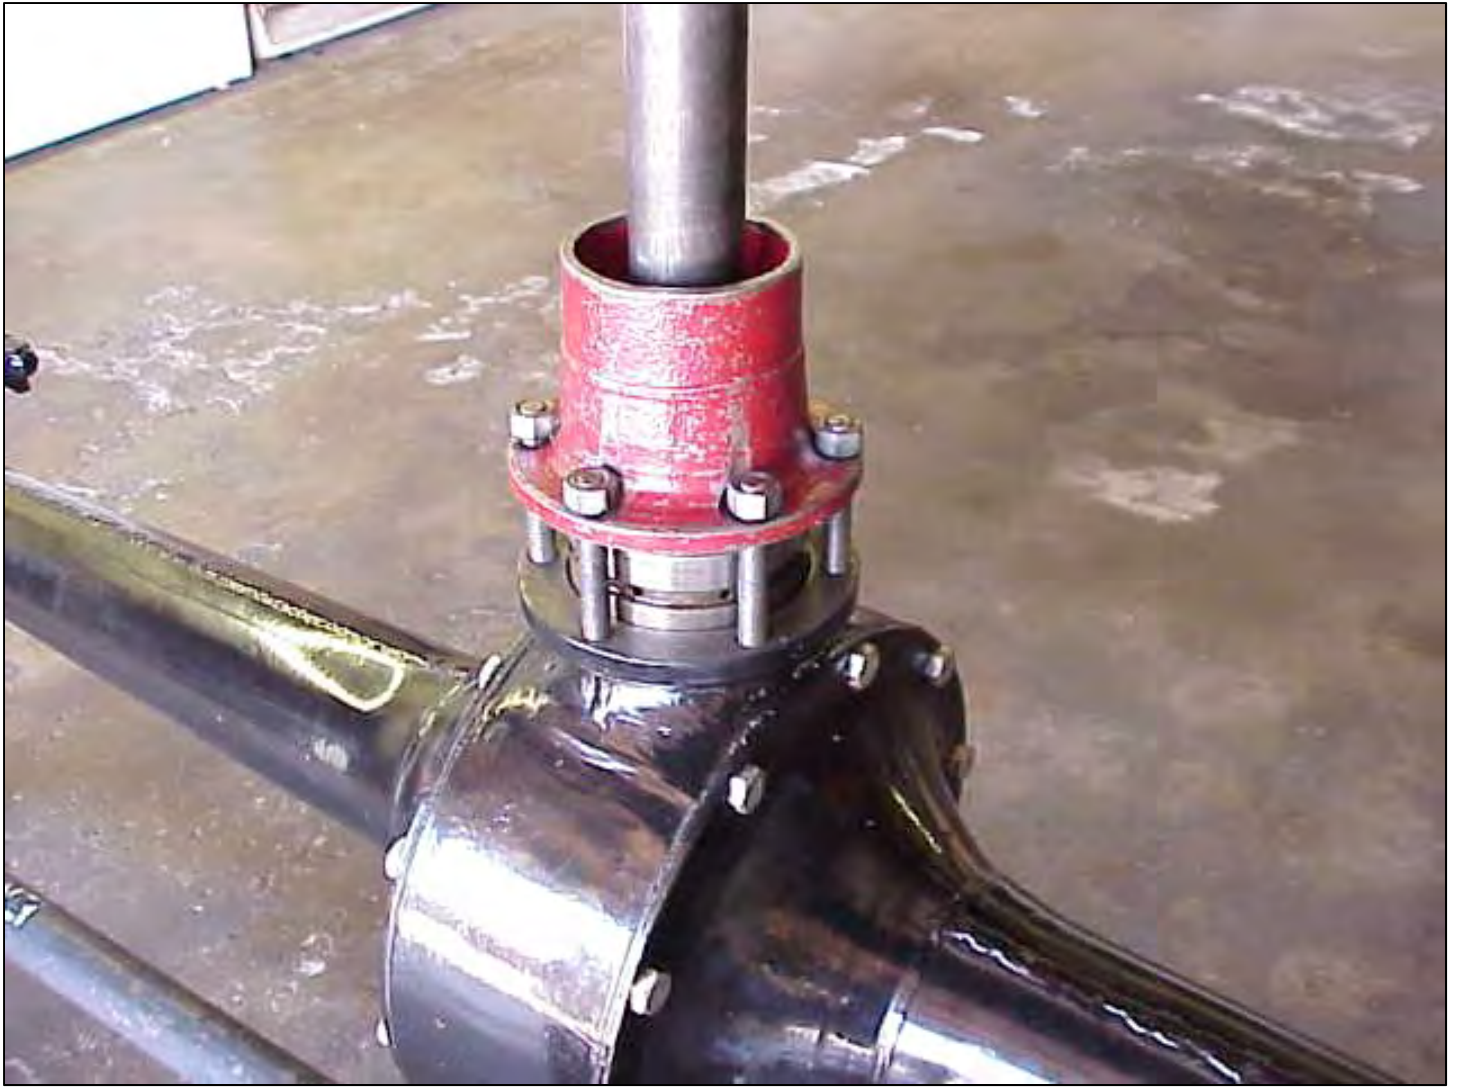
The pinion gear assembly attached to the Mitchell stub shaft is being reinstalled into the banjo using a puller-in tool. By tightening the nuts on the threaded studs evenly it will seat the pinion assembly into the banjo.

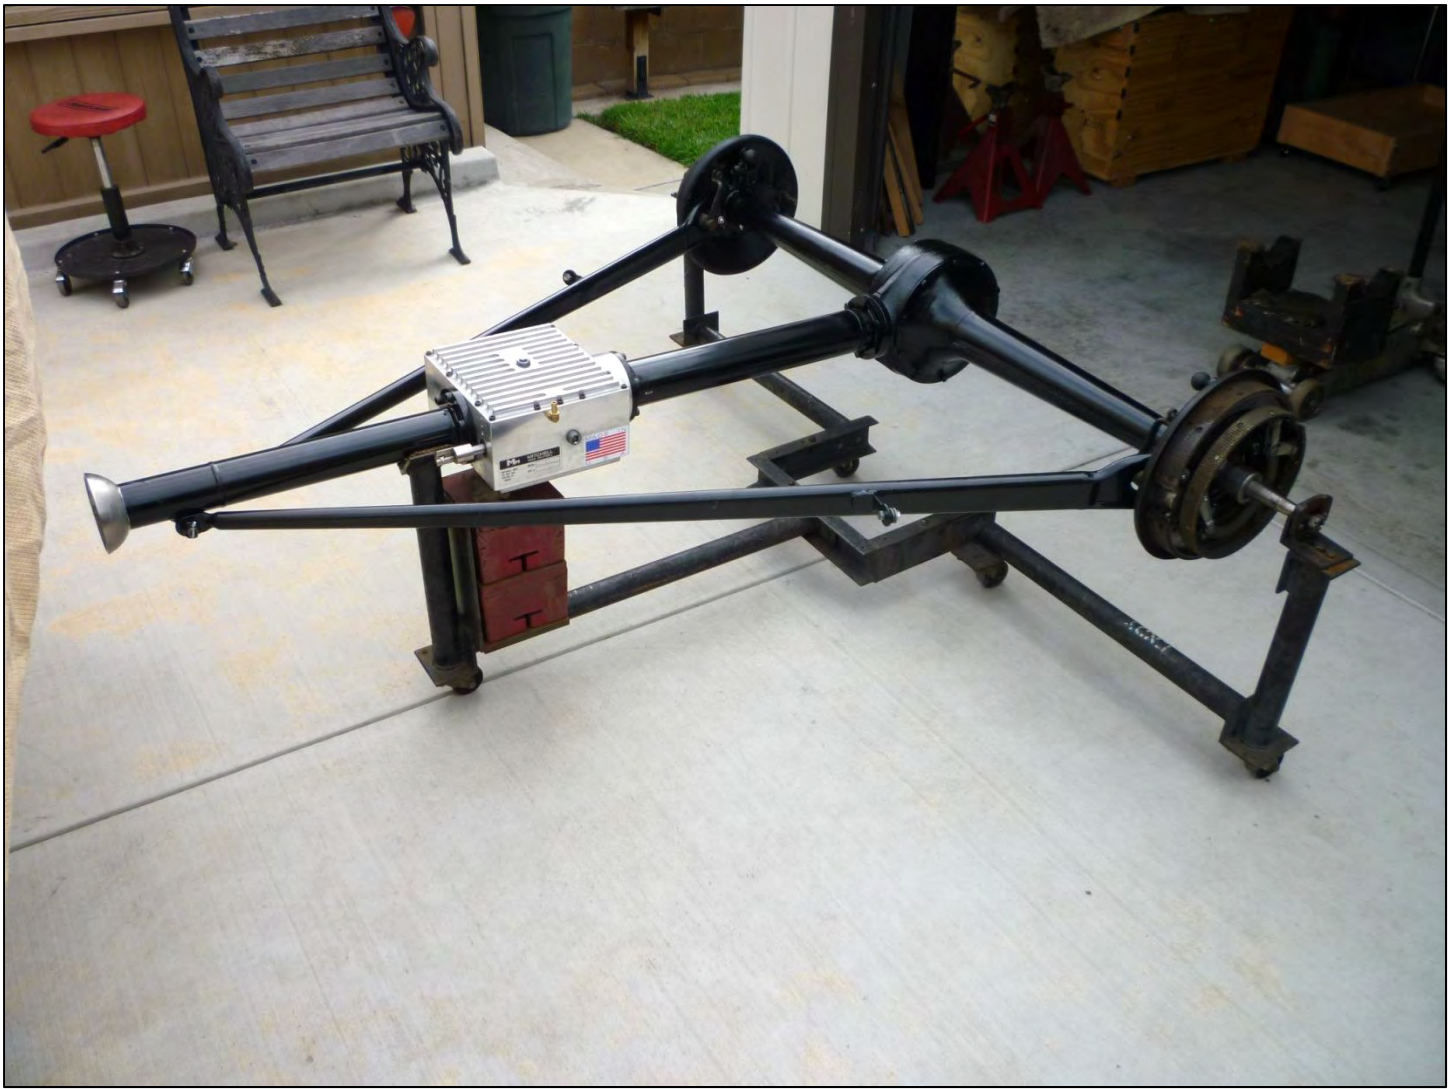
The Mitchell overdrive has been installed onto the rear axle assembly and it is ready to go back into the car. A floor jack can be seen behind the rear axle assembly. It has a fixture on it that fits directly under the banjo and captures both axle housings. The U-shape structure on the rolling cradle allows the jack to be positioned directly under the banjo.

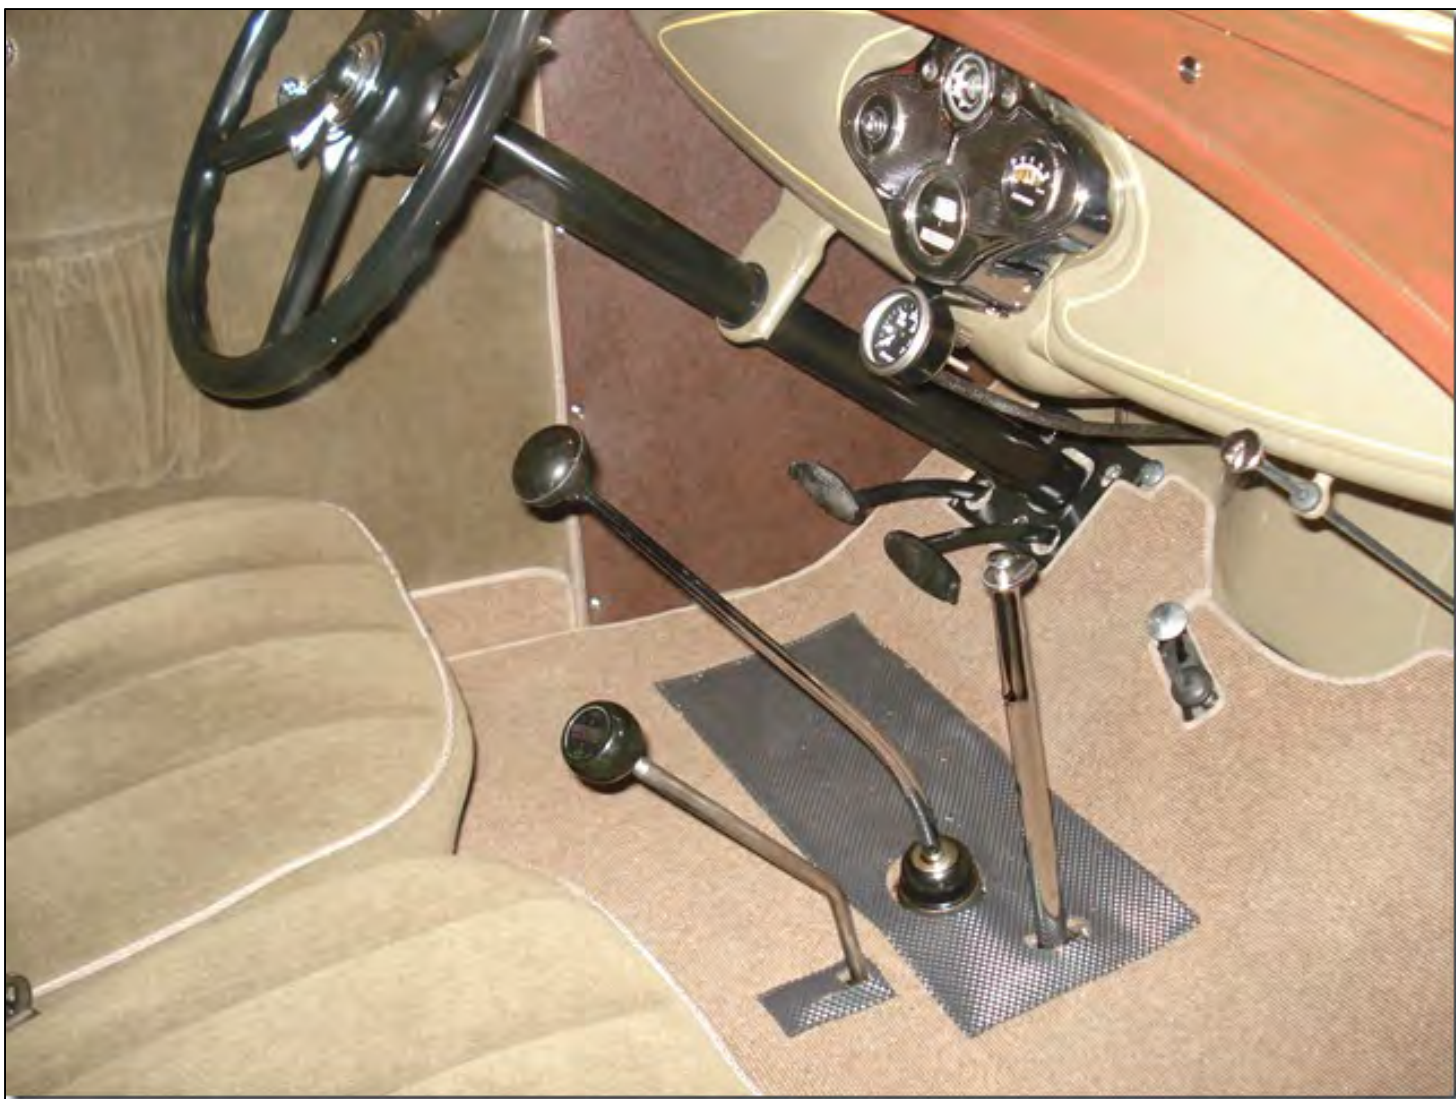
A template was used to locate the slot in the floor board for the overdrive shift lever to protrude through. The shifting mechanism can be adjusted to provide desired fore and aft positioning of the shift lever.
