## Does Your Model A Engine Suffer from Cam Slap?

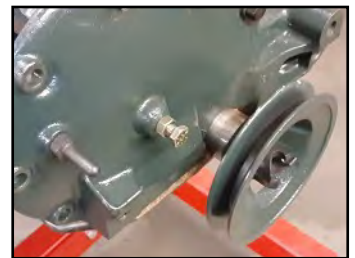
A better solution would be to use is a combination of the two, an original softer spring and a means of limiting the movement of the plunger. This consists of a pin that is installed thru the center of the spring with a bolt that pushes only on the end of the pin. The original spring will keep the plunger against the end of the cam at all times but at very low engine speed when the spring does not have enough force to keep the cam in place, the pin will limit the travel of the plunger and keep the cam slap noise in check. The advantage of this design is an overall quieter running engine without increasing the load on the plunger.

*Finished Installation*

Install the front cover as you normally would with the plunger and spring in place. Insert the pin thru the tapped hole followed by the bolt and lock nut. Screw the bolt in until it just comes into contact with the pin. At this point, the pin should be bottomed out in the bottom of the plunger. Back off the bolt ever so slightly and lock the bolt in place with the nut. Do not over tighten the lock nut as you do not want to strip the threads in the cast iron cover. A little gasket sealer on the bolt threads may help prevent any oil from seeping out around the bolt.

When properly adjusted, there will be just a few thousands clearance in the end of the pin and bottom of the plunger. You do not want to add any pre-load to the plunger. The idea is to limit how far the camshaft could move away from the block by limiting the travel of the plunger.
