Transmission Vent

by Tom Endy December 2023

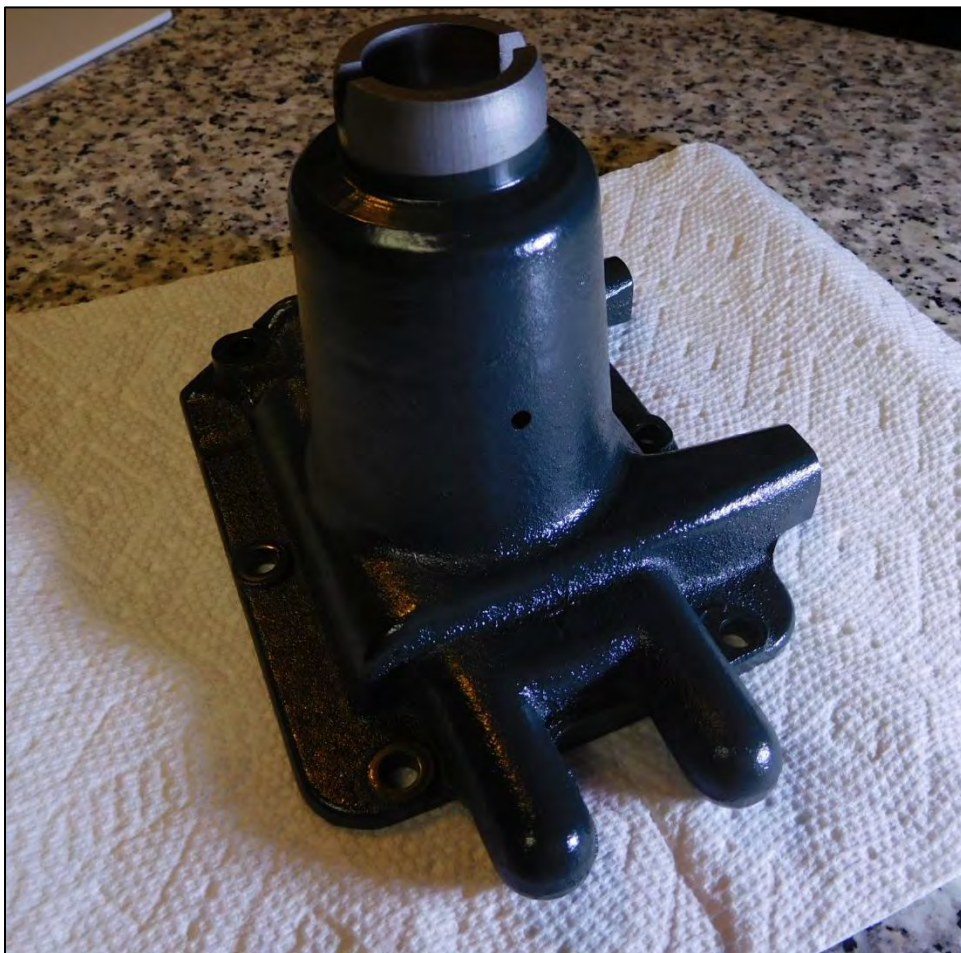
The Model A Ford transmission does have a vent, it is located in the tower. Many in the Model A kingdom may not be aware of it. There is a 1/8" hole drilled into the backside of the tower located just above the floor level. It is very common for this hole to become plugged off from dust and debris collected on the floor. When this occurs pressure will build up inside the transmission and force oil out through the end of the cluster and idler shafts that are probably already leaking oil. It is prudent to periodically check this hole and run a wire, paper clip, cotter pin, or even a drill bit through it to make sure it is open.

The vent hole in the backside of the transmission tower

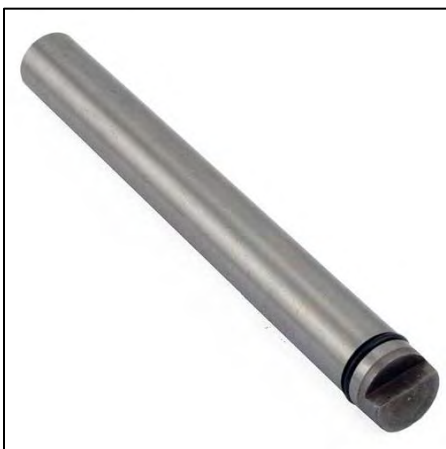
The O-ring modification for the cluster shaft is seen in the photo above. The idler shaft has the same modification.

In recent years an O-ring modification for the two shafts has become available and most suppliers carry the modified shafts. When overhauling a transmission it is prudent to install them as it will eliminate the oil leak. Another option is a device that fits over the ends of the two shafts in the form of a small casting that bolts on and essentially dams up any oil trying to exit around the two shaft. Most suppliers carry them.

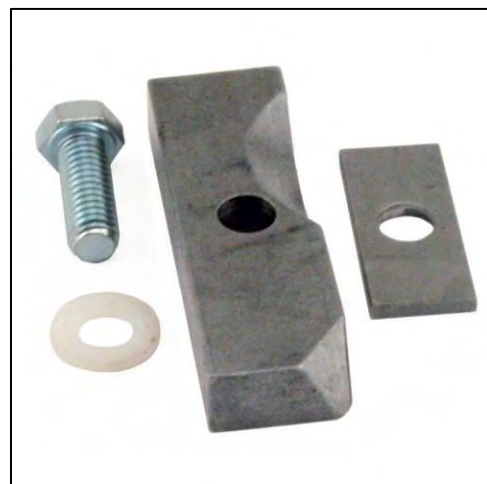
The device that fits over the ends of the two shafts in the form of a small casting that bolts on and essentially dams up any oil trying to exit around the two shaft is seen in the photo at right.
