# Distributor Cracks

By Tom Endy, Westminster, California

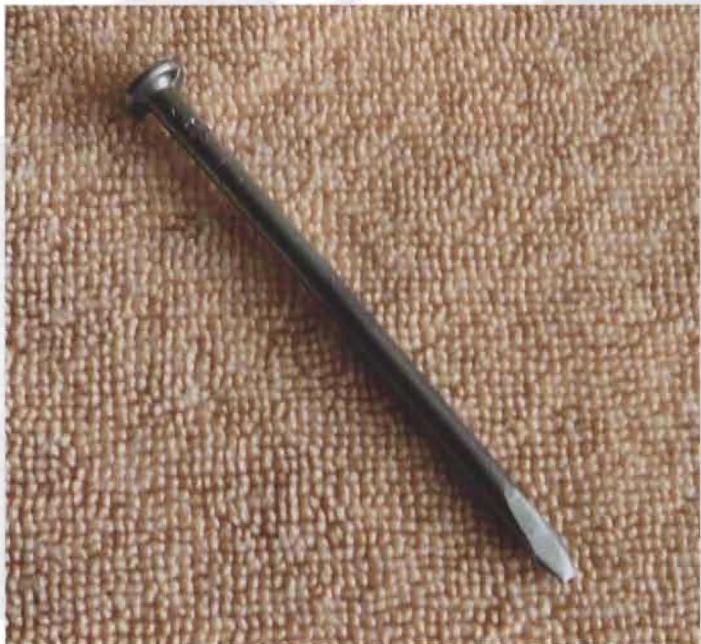
Common nail shaped to a chisel point.

Using a bushing insertion tool and a shop press is the quick and easy way to remove both bushings. However, if cracking is to be avoided, it is best to not use this method. Though it is more time consuming, a better method is to split the bushings using a hacksaw blade. Once the bushing is split, take a common nail and flatten the end with a hammer and grind it to a chisel point. Insert the nail down along the split in the bushing and gently tap it with a hammer to force it away from the shaft tunnel.

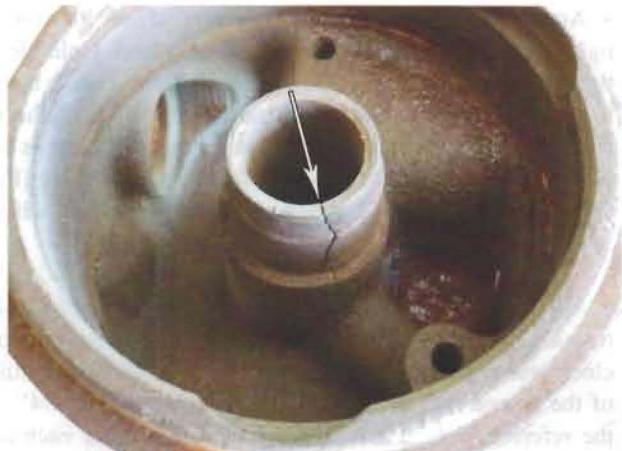
Typical crack found near the top bushing.

The Model A Ford distributor is often found to have a crack in the cast housing. The crack is usually discovered at the top of the shaft tunnel where the upper bushing resides. However, they are also prone to cracking at the lower bushing. It is my opinion that the cracks do not occur during normal service. I believe someone attempting to remove and replace the bushings causes the housing to crack.

During normal service, "crud", comprised of wear particles and hardened lubricant, forms around the inner diameter of the shaft tunnel between the upper and lower bushings. When an attempt is made to remove the bushings using a bushing insertion tool and a shop press, the crud compacts and cracks the housing. The area around the top bushing is the most likely to crack since the housing is very thin in this area. Severely worn bushings can also allow the insertion tool to slip past the bushing and cause the housing to crack.

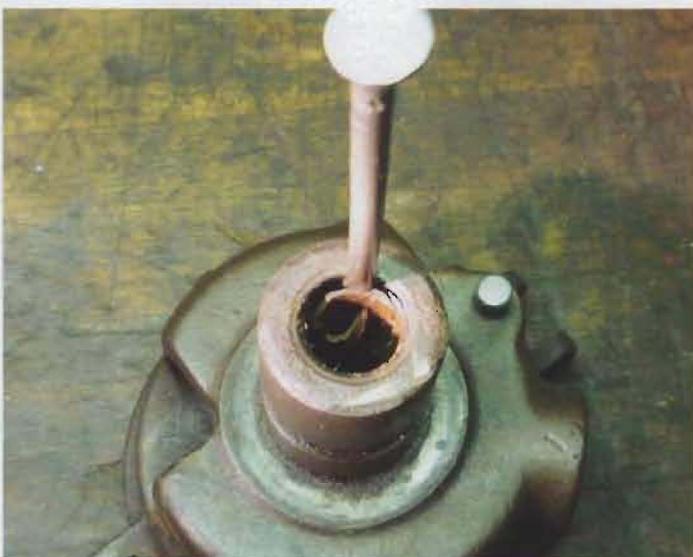
Both bushings in the distributor housing have been split with a hacksaw blade and the modified nail is gently tapped down along the split.

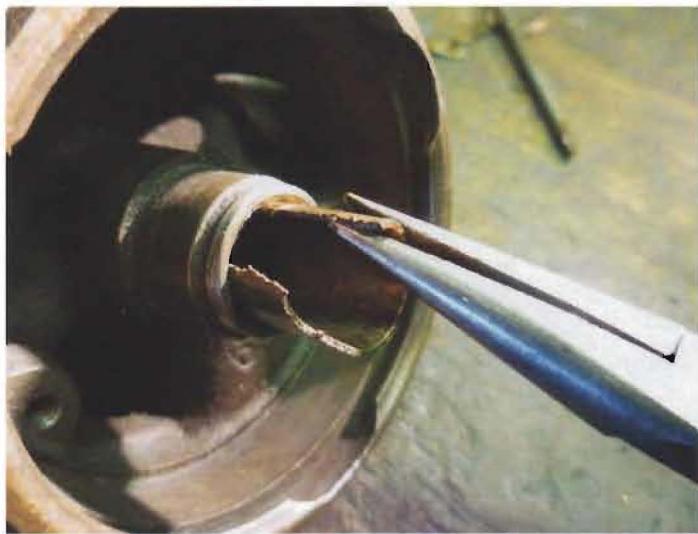
The top bushing is curled out with long nose pliers.

Grab the protruding area of the bushing with a pair of long nose pliers and curl the bushing out.

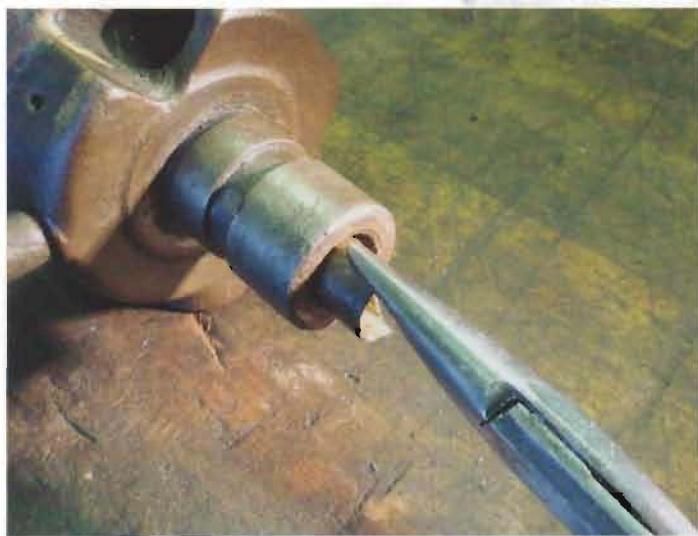
The bottom bushing is curled out with long nose pliers.

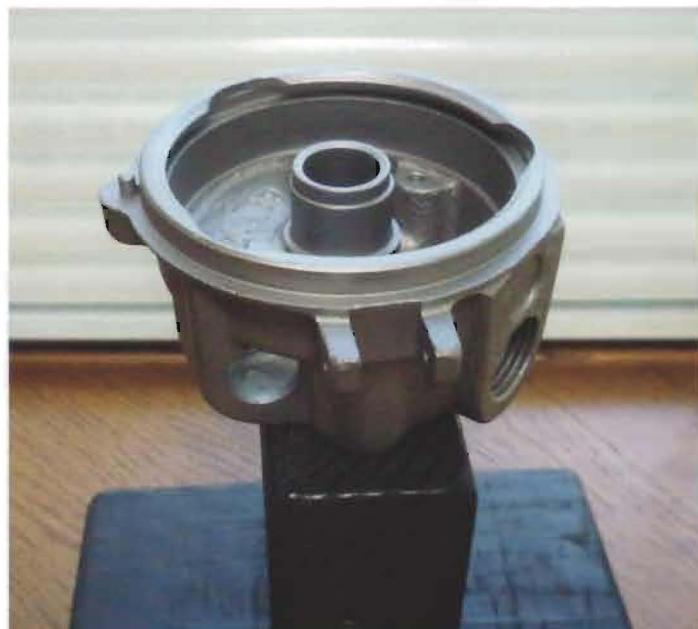
Bushings have been removed, the housing has been de-greased and bead blasted and is ready for the installation of two new bushings.

Once both bushings have been removed, the housing should be thoroughly cleaned. Bead blasting is the best method. The shaft tunnel should be free of any debris. Run a 1/4" drill bit though the oil reservoir hole to clean out any "crud" residing there. Often the hole is found completely blocked.

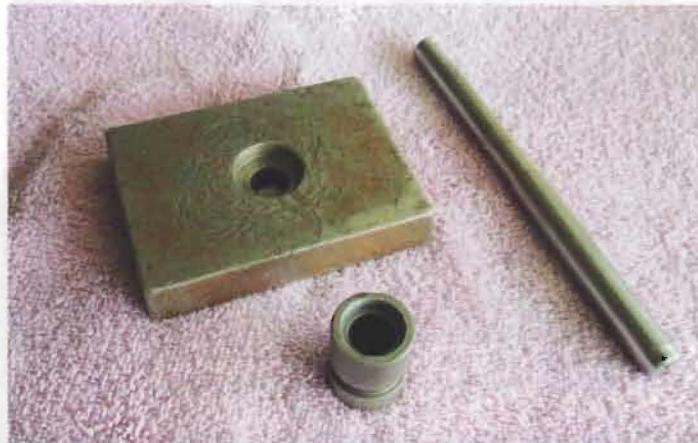
The three tools used to press in the new bushings. The plate is at the upper left, the collar is at the lower center, and the insertion tool is on the right.

Several tools have been developed to aid in the pressing in process. The insertion tool is a shaft with a step machined in it that the bushing is slid onto. Another tool is a collar made from the bottom section of a discarded unserviceable distributor housing machined to support the top of the shaft tunnel when the housing is placed upside down on a press platform. This is needed because the top of the tunnel for the shaft is below the level of the outside diameter of the distributor housing. A third tool is a plate to place the collar in for support. The plate must have a hole drilled through it to allow the insertion tool to pass through it.

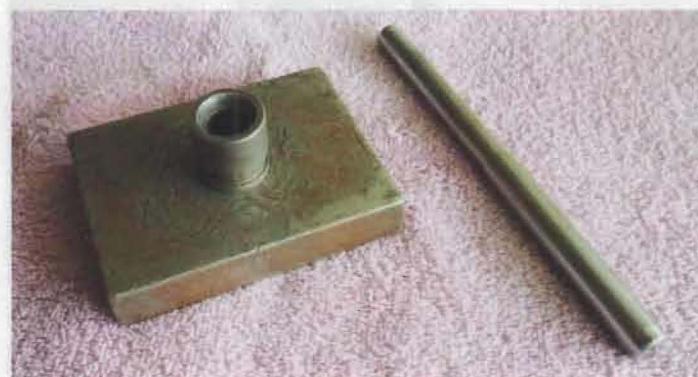
The collar is placed inside the recess in the plate.

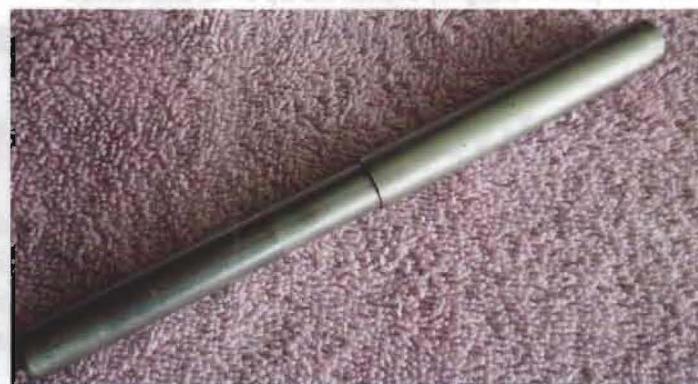
The insertion tool has a step machined into it.

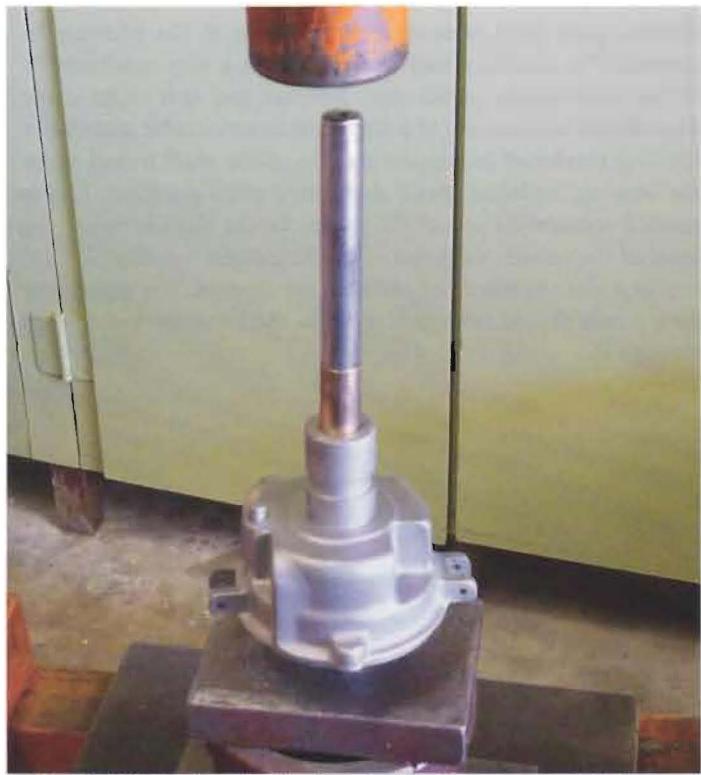
The distributor housing is placed under the press upside-down on the collar and on the plate. The top bushing is inserted from the bottom.

The housing can also become cracked if care is not taken during the pressing-in process. Both bushings should be pressed in from the bottom. In this manner, the top bushing will be correctly lined up as it approaches the top of the shaft tunnel where cracking is more likely.

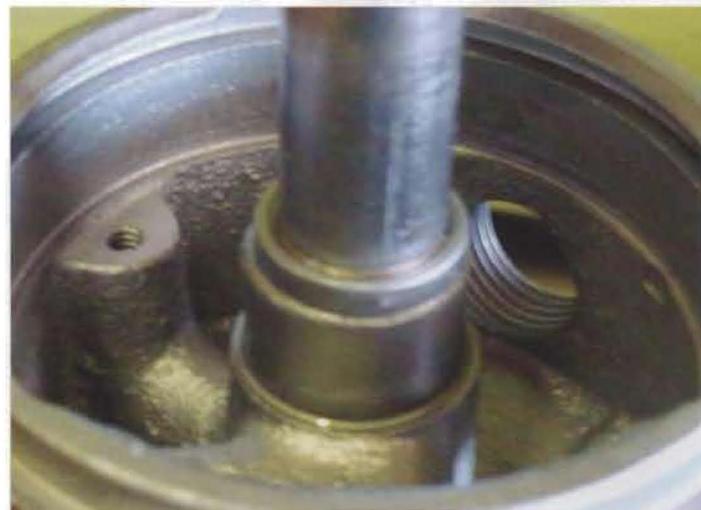
The distributor housing is turned over under the press and the insertion tool is inserted from the top and the bushing is pressed back into place if it slightly overran the top of the shaft tunnel.

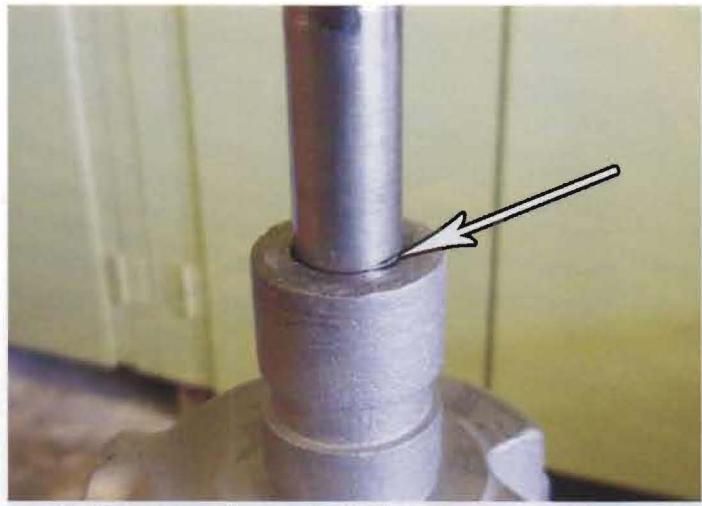
A marker on the insertion tool indicates when the top of the bushing has reached the approximate top of the shaft tunnel.

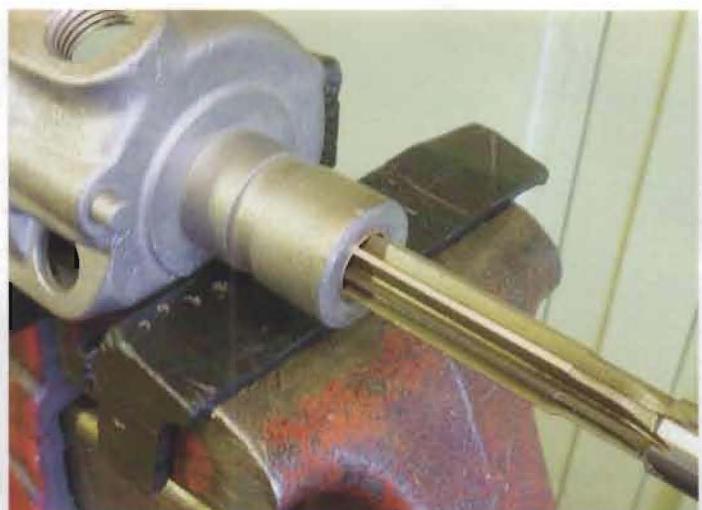
With both bushings installed, and with no cracks in the housing, the two bushings are reamed to accept the new shaft.

Once the new bushings have been reamed and the new shaft fitted, the distributor can be fully assembled and put into service with the assurance that there are no cracks in the housing.
