Clutch Failure

by Tom Endy

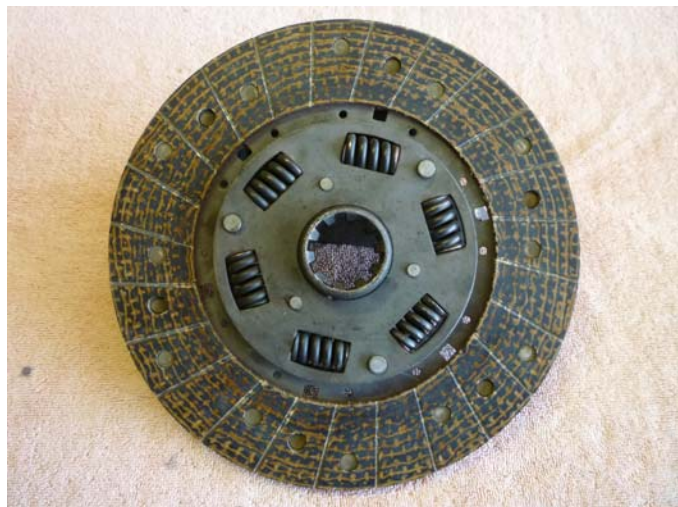
The six springs are not well secured. They can easily become dislodged.

Clutch failures in a Model A have become more prevalent in recent years due to the construction style of the clutch disks being marketed by most Model A suppliers. If you recently purchased a clutch disk take notice that the six springs in the center of the hub are not secured very well. Each spring appears to be held in place only by its own spring tension. Quite often a spring will dislodge from its window and jam the clutch.

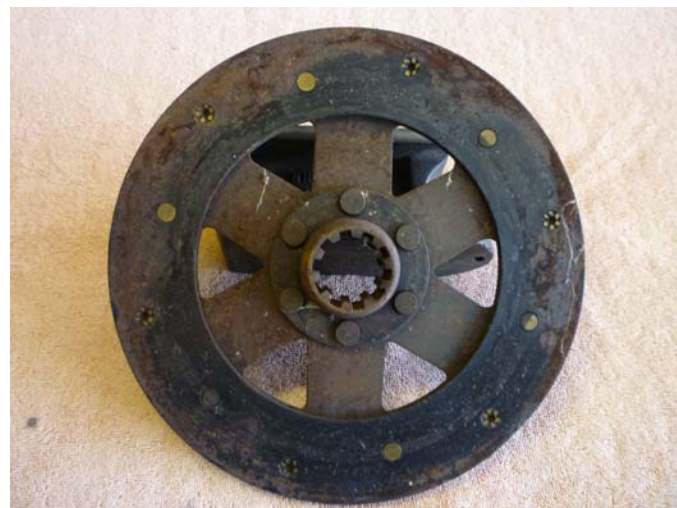
The original Model A clutch disk did not have springs.

The original Model A clutch disk did not incorporate springs at the center of the hub. The addition of springs in a clutch disk was incorporated in later years to reduce the possibility of the clutch chattering.
