Henry's Way

by Tom Endy

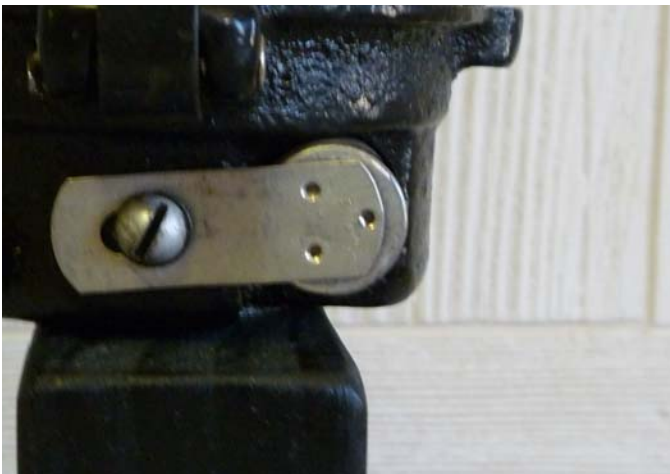
There are some poor quality condensers on the market. The condenser itself is not at fault; it is the way the ground strap is attached. Those that are merely soldered onto the body of the condenser will come loose when the solder melts because of an overheated engine. The good quality condensers have a stake weld holding the ground strap on. They can be identified by the three "dots" on the strap.

Quality condenser with the three "dots"

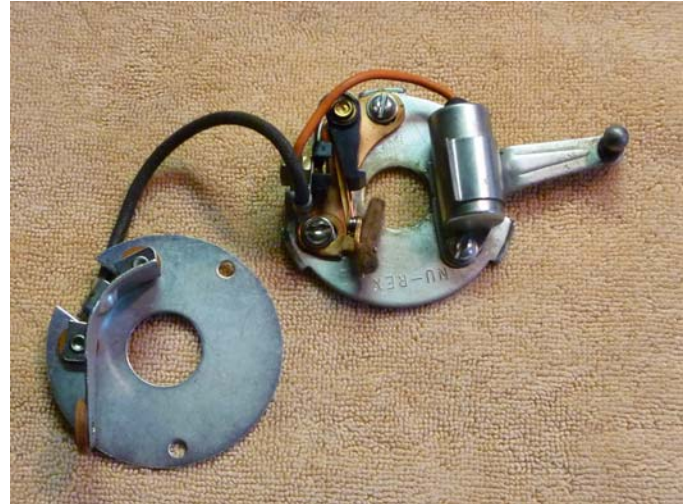
The modern upper plates have the condenser mounted directly onto it. The problem here is that the absence of the original condenser in place allows the attachment tab on the lower plate to be unsupported and it can easily short out against the distributor housing. The longer wires on top of the modern plate can also hang up when the spark handle is moved.

Modern upper plate with longer wires

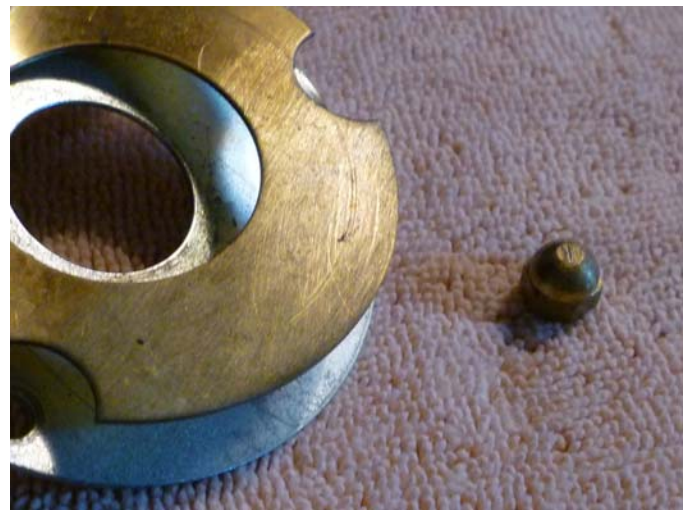
The modern lower plate does not have the wire that connects from the lower plate to the upper plate. Instead it has a slider arrangement. This is not a positive connection and each time the spark handle is moved the slider connection moves and causes sparks and eventually creates a burn trail and in time it will lose the connection.

The modern lower plate. Note the witness marks on the plate and on the end of the acorn nut. This arrangement was cleaned up after it actually failed.

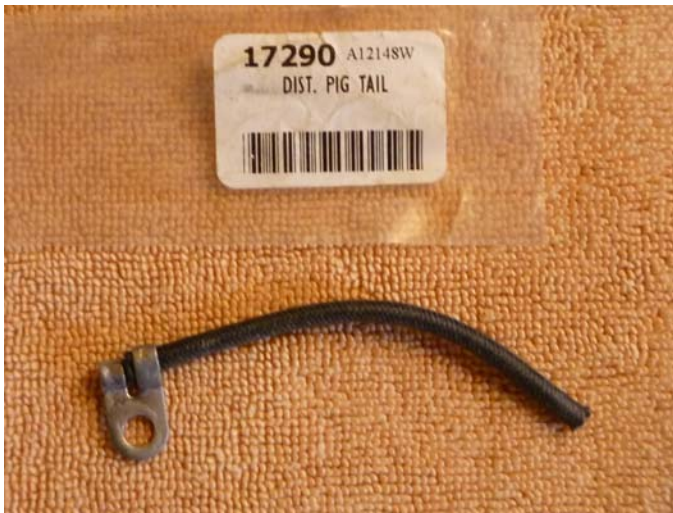
Henry's original wire was multi-stranded and very flexible. Too often this wire has been replaced by an incorrect type of wire. The correct flexible multi-stranded wire is available from Bratton's Antique Auto. If installed correctly it will serve you well.

Correct flexible multi-stranded distributor wire

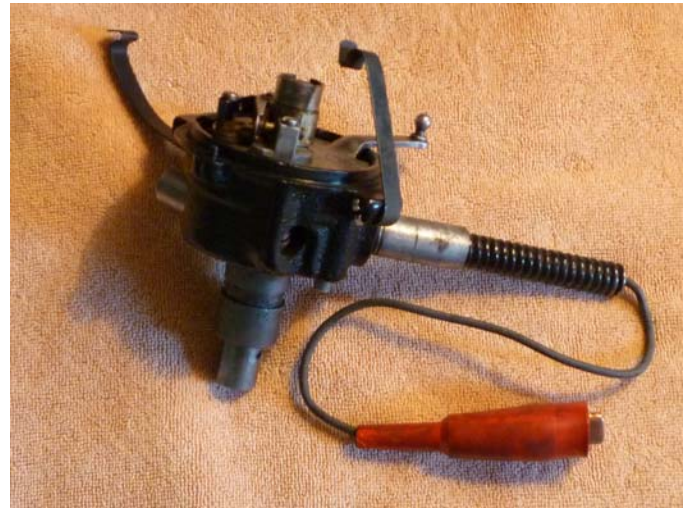
A spare distributor with a by-pass cable attached

The by pass cable screws into the distributor in place of the pop-out cable. The clip on the end of the cable is attached to the primary terminal of the coil where a red wire is normally attached. The red wire must first be removed before the clip is attached. In order to stop the engine once it is running, the clip has to be removed, as the ignition key has been by-passed.

Along with the spare distributor carry a by-pass cable with you that is used to by-pass a possible open or shorted pop-out cable. With both a spare distributor and a by-pass cable you can easily swap out the distributor with the spare and install the by-pass cable as well. Within a short time you should be able to have the car running again with this

A spare distributor that has had the timing set for a particular car does not have to be re-timed, as long as the large screw holding the point cam in place is not disturbed.
