Potential Transmission Leak

by Tom Endy

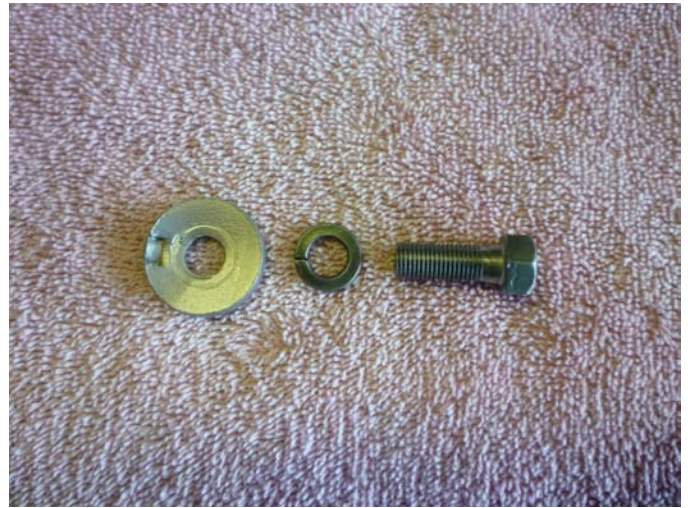
The special flat washer with the notch is used in conjunction with the bolt and lock washer that attaches the U-joint to the rear of the main shaft.

It is common to find this washer either missing or being substituted with a flat washer that is smaller in diameter. This will allow oil to escape into the U-joint housing and possibly down the torque tube to the banjo if the seal behind the torque tube roller bearing is shot.

It is prudent to apply some sealer to the front flange of the U-joint and to the front of the notched washer when installing the U-joint.

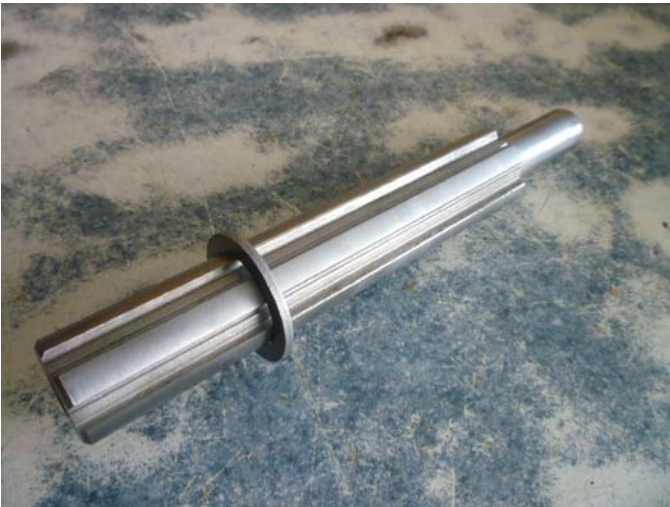
Note the spaces under the bearing stop on the main shaft. There is a space under each flute for the two sliding gears.

The reason for the leak is that oil can pass under the front bearing stop on the main shaft. It then passes under the bearing and continues on until it is stopped by the special washer that fastens to the end of the main shaft in conjunction with the bolt that holds the U-joint to the end of the main shaft.

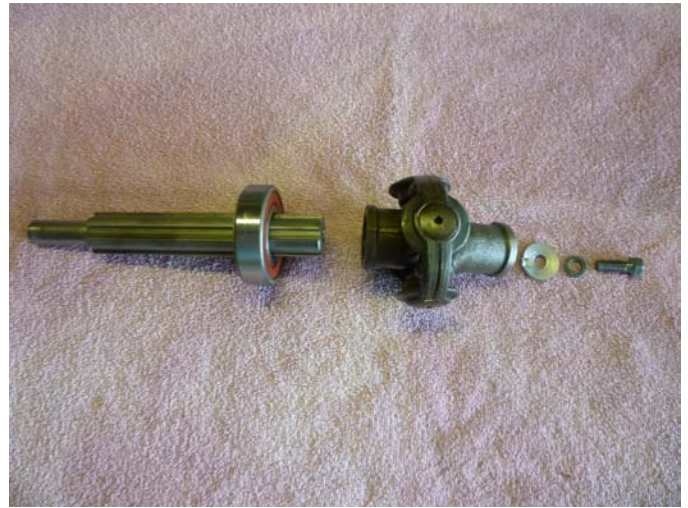
The U-joint is attached to the end of the main shaft and acts as the rear bearing stop. The notched washer fits around the fluted end of the main shaft and is what prevents oil from escaping from the transmission.

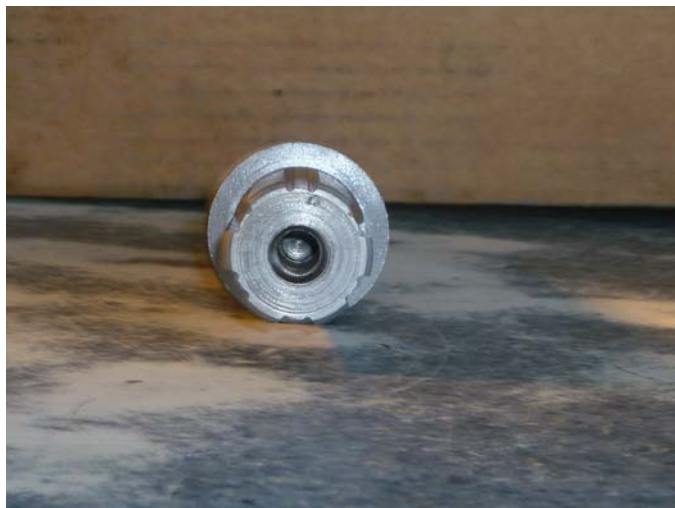
End view of the main shaft showing the spaces under the bearing stop.
