Potential Transmission Leak

by Tom Endy

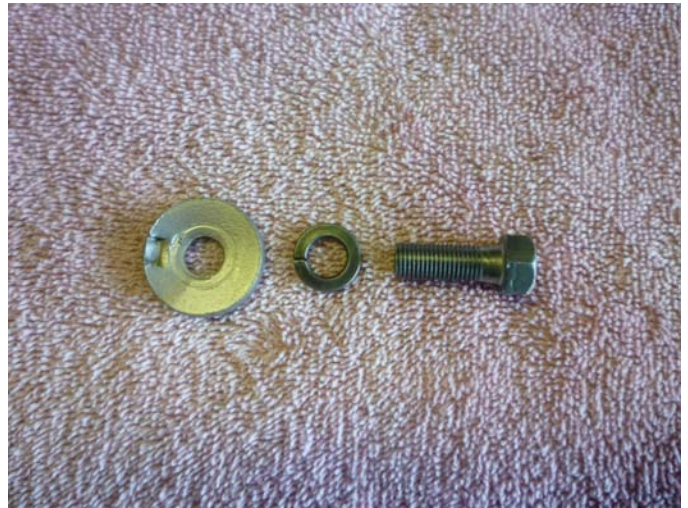
The special flat washer with the notch is used in conjunction with the bolt and lock washer that attaches the U-joint to the rear of the main shaft.

It is prudent to apply some sealer to the front flange of the U-joint and to the front of the notched washer when installing the U-joint.

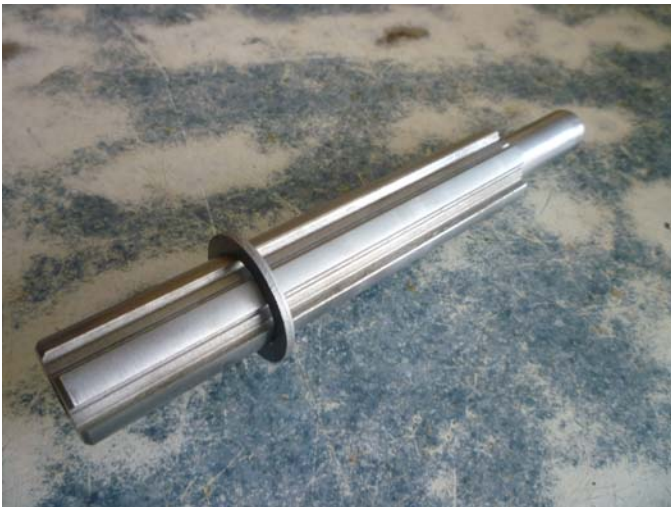
Note the spaces under the bearing stop on the main shaft. There is a space under each flute for the two sliding gears.

The reason for the leak is that oil can pass under the front bearing stop on the main shaft. It then passes under the bearing and continues on until it is stopped by the special washer that fastens to the end of the main shaft in conjunction with the bolt that holds the U-joint to the end of the main shaft.

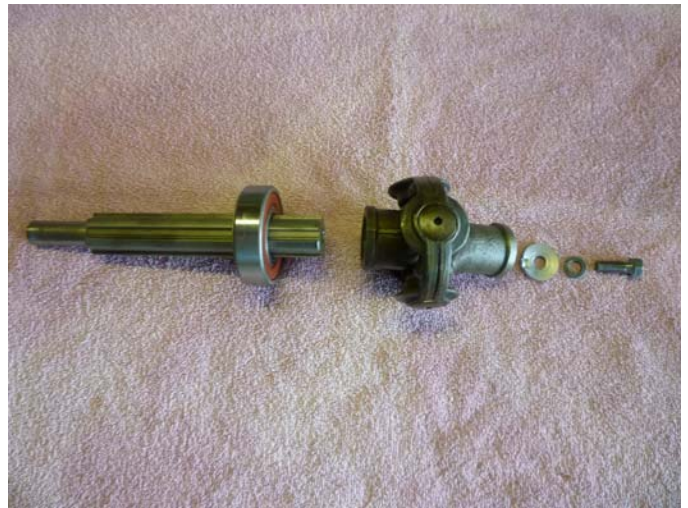
The U-joint is attached to the end of the main shaft and acts as the rear bearing stop. The notched washer fits around the fluted end of the main shaft and is what prevents oil from escaping from the transmission.

It is common to find this washer either missing or being substituted with a flat washer that is smaller in diameter. This will allow oil to escape into the U-joint housing and possibly down the torque tube to the banjo if the seal behind the torque tube roller bearing is shot.

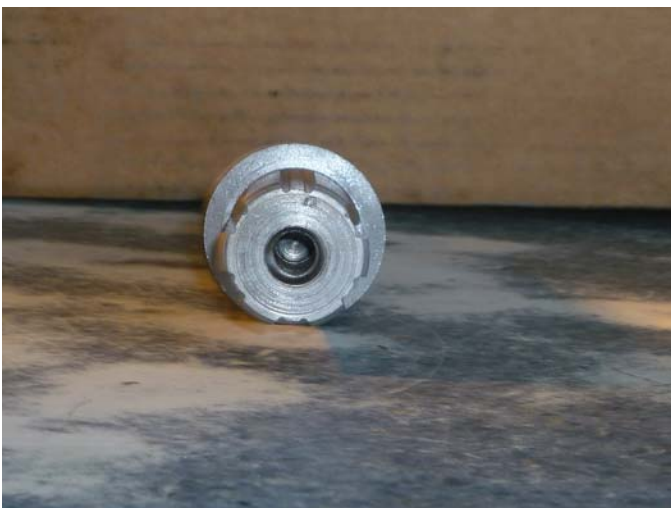
End view of the main shaft showing the spaces under the bearing stop.
