# Rear Spring Testimony

by Tom Endy

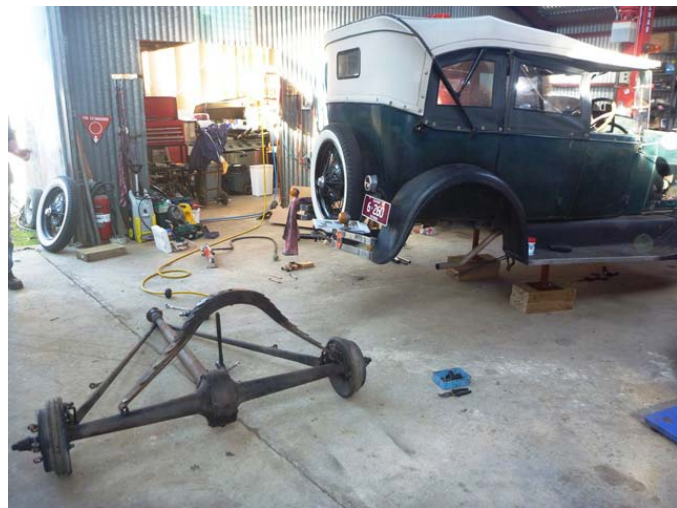
The folks down under attempted to remove the axle assembly without a proper spring spreader and a shackle broke in the process. Fortunately no one was hurt.

**Note how far the end of the spring is sitting from the broken shackle.**

Whenever it becomes necessary to remove the rear axle assembly from a Model A Ford the safe and prudent thing to do is to obtain a proper spring spreader. Install the spreader to take the tension off the spring. Remove the shackles from each end of the spring and lower the rear axle assembly and pull it out from under the car.

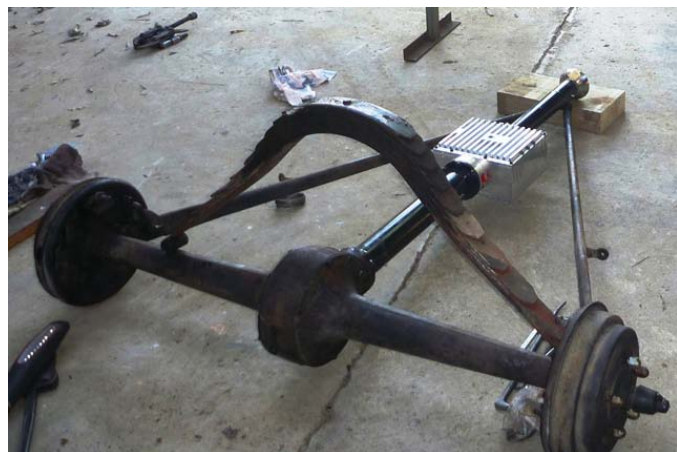
**Fortunately the spring was still attached to the frame of the car when the shackle broke.**

This series of photos demonstrates the hazard of dealing with the rear spring on a Model A. Had the shackle broken when the rear axle assembly was out from under the car with the spring still attached it would have pirouetted and likely broke the other shackle and propelled the spring into the air.

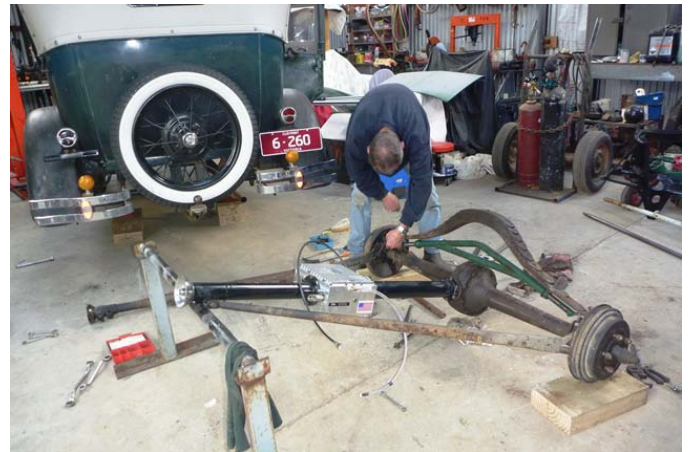
**A proper spring spreader was obtained to reinstall the spring. The hazard here is the 86-year-old 3/8" rusted center bolt may be ready for the head to pop off. If it were to do so the top leafs will fly 20 feet in the air and possibly injure the fellow working over the spring. If he escaped injury he needs to run like the devil, because they will be coming back down.**

The other hazard is the 3/8" center bolt that even when new was not meant to contain the energy packed into a Model A rear spring when spread to be attached to the axle assembly. A rusted center bolt head can easily pop off allowing the top leafs to fly 20 feet into the air.

The spring spreader can be left in place under the car indefinitely until the rear axle assembly is ready to go back into the car.
