A Thermostat Theory

by Tom Endy

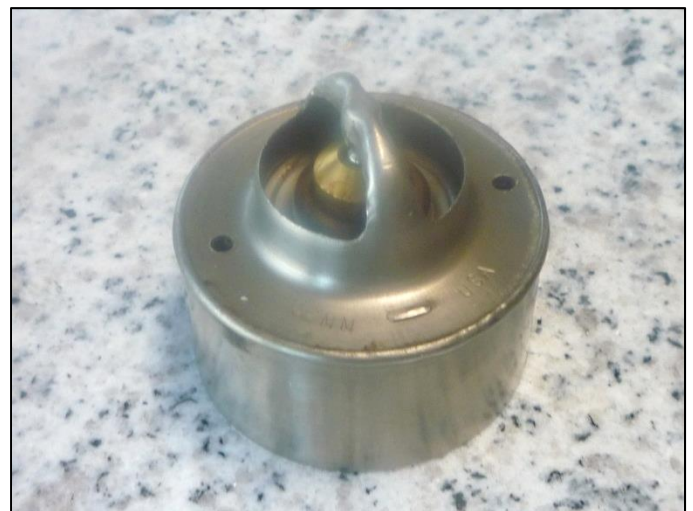
An automotive thermostat modified for use with a Model A. Note the skirt welded to the base to prevent it from tumbling in the water outlet hose. Two small holes are drilled into the base for a small amount of water flow when the thermostat is closed.

Rick's theory is that under these circumstances with the thermostat closed water is not circulating through the block normally. With the thermostat closed only a small amount of water is getting past the thermostat through the two small holes drilled into the mounting flange of the thermostat. The water pump is not causing water to flow through the block normally as when no thermostat is installed.

It may be just a theory, but it may have some merit. After experiencing a costly engine failure I decided to remove the thermostat from my Victoria. I can't see where it can do any harm, after all Henry produced over five million Model A's that roamed the planet for decades without a thermostat.
