A Walk Off!

by Tom Endy

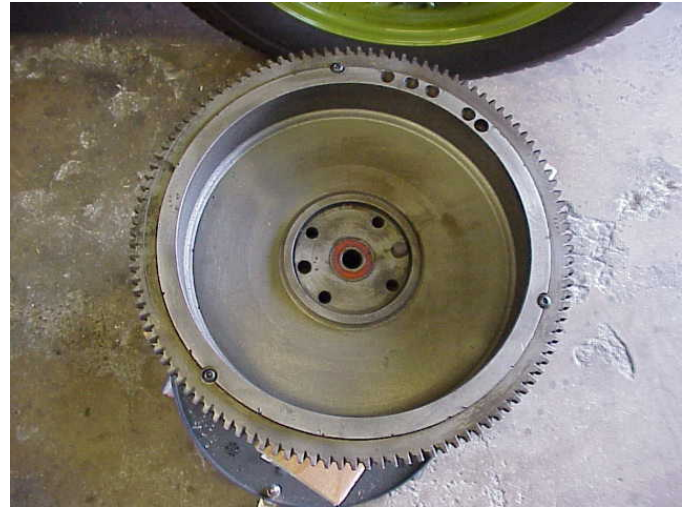
Three setscrews are installed at 120 degrees distance from each other.

There is a permanent fix. A machine shop can press the ring gear back into place then pin it with setscrews. Holes are drilled and tapped through the surface of the ring gear and into the flywheel in three equally distant places and seated with lock tight. This would be a prudent thing to have done anytime you are having a new repo ring gear installed. ☺

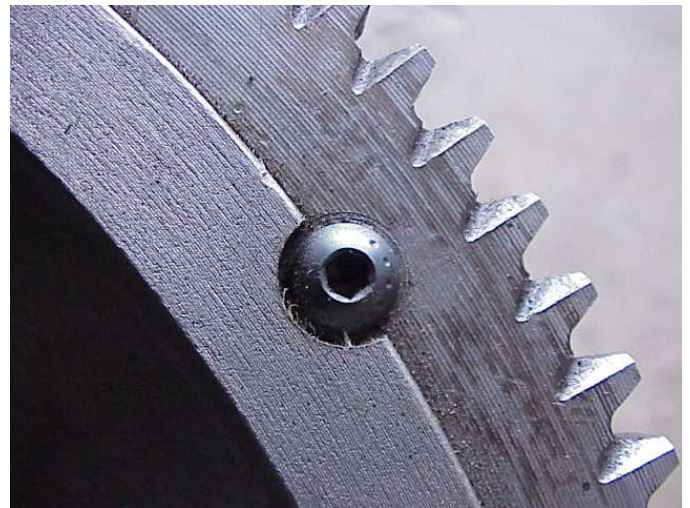
The setscrews lock the ring gear to the flywheel.
