A Cracked Engine Block

By Tom Endy, Westminster, California

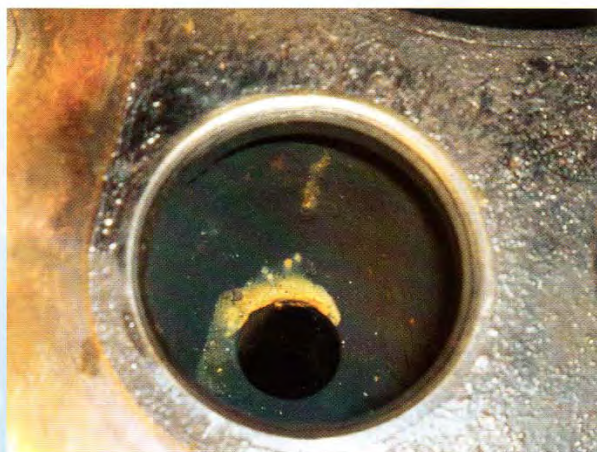
The first visible sign of a crack. This is the exhaust valve seat for the number two cylinder. Note the line of rust at the top of the port where the suspect crack is, and the puddle of rust where it is suspected water congregated before it leaked down the valve guide into the valve chamber. Both rust areas were not visible with the valve installed.

A closer inspection of the engine after it was disassembled revealed a suspect rust spot in the valve port of the exhaust valve of the number two cylinder. There appeared to be a hairline crack in the port just under the valve seat. It was impossible to see it with the valve installed. Not too bad, this could probably be repaired.

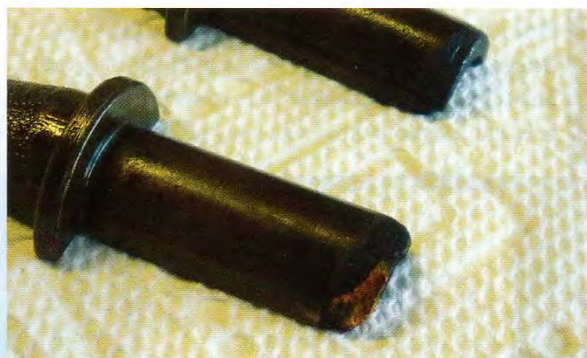
The rusted tip of the valve guide from the exhaust port of the number two cylinder.

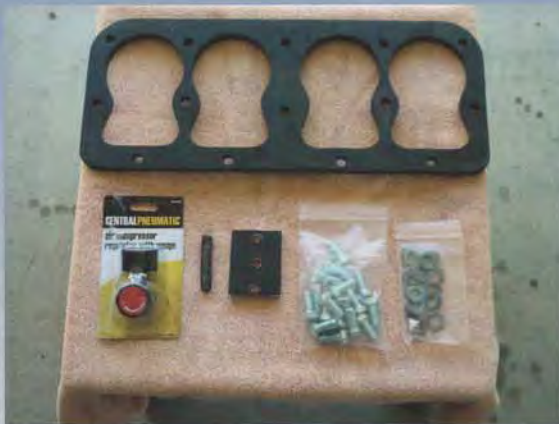
The Snyder engine block leak testing kit is shown with the rubber gasket side up on both the head plate and the water inlet plate. The kit does not include the air connection fitting. Since there are a variety of fittings, they must be purchased locally to match the shop air system to be used. It is an inexpensive item.

However, to be on the safe side, I ordered an engine block testing kit from Snyder's. The kit has a half-inch steel plate that bolts to the top of the head. The plate has a 1/8" rubber gasket glued to the

bottom surface. When bolted to the head with the bolts supplied, it covers up the water jacket ports and leaves the cylinders and valve seat areas exposed. A smaller steel plate also supplied bolts to the water inlet port on the side of the block. It also has a 1/8" rubber gasket glued to it and has an inlet port for shop air. An air pressure regulator is also supplied with the kit.

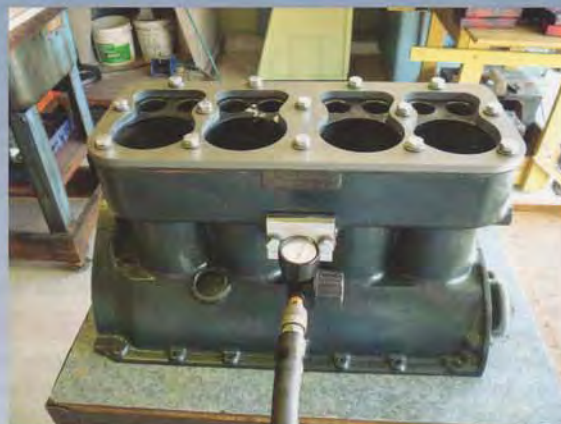
The Snyder kit is shown attached to the engine block under test. There is an excellent YouTube video demonstrating this kit on the Internet. Go to: "John Karal Engine block leak detection".

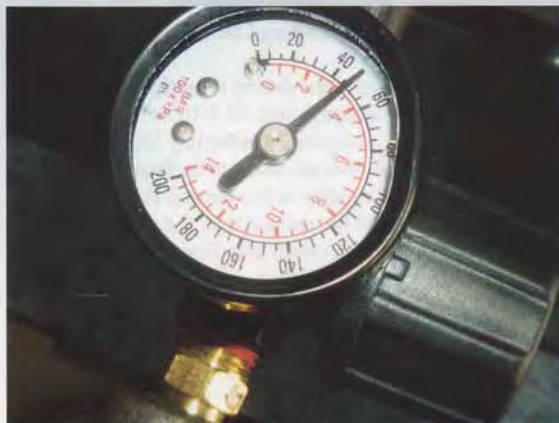
Shop air is applied and adjusted with the regulator to a nominal 40-50 pounds. The brass fitting screwed into the regulator was purchased to match up with my shop air system.

The scheme is to pressurize the block water passages with 40-50 pounds of shop air and then using a paintbrush and soapy water go looking for bubbles. The first place I soaped was the suspect rust spot and sure enough there was a crack. This would have allowed water to run down the valve guide into the valve chamber and on into the pan. While I was at it, I soaped the whole block. Much to my surprise, I found bubbles coming out of a crack between the cylinder and the valve seat and another in the valve chamber. There were so many cracks around the number two cylinder exhaust valve that I do not think this block is repairable.

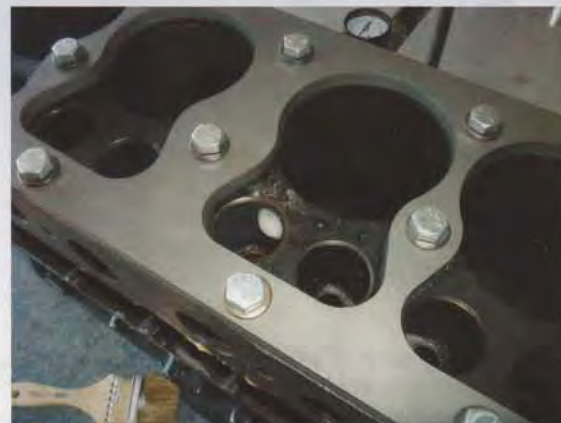
The first area soaped was at the suspect exhaust port of the number two cylinder. Sure enough, there was a crack leak there. Note bubbles forming just under the valve seat. There were also bubbles coming out of an almost invisible crack between the valve seat and the cylinder.

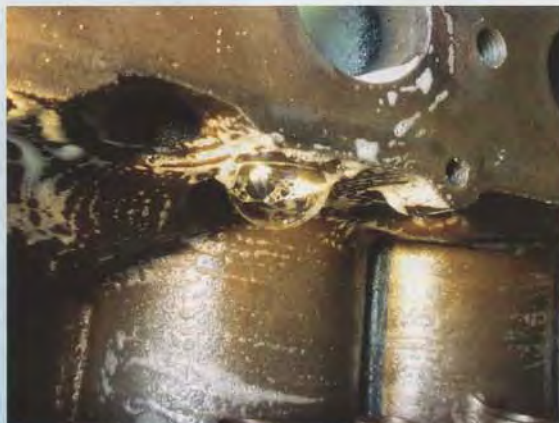
A bigger surprise were the large bubbles coming out of the valve chamber in the area of the number two cylinder and exhaust valve seat. This pretty well renders this block as scrap, and it was the smoothest running engine in the stable.
