Outer Space

by Tom Endy

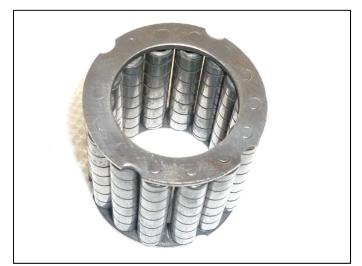
It should be noted that the thrust washer has a series of holes drilled through it around the circumference. The purpose is to allow grease pumped in through the grease fitting that lubes the U-joint to also travel to the roller bearing. If an additional washer is placed in this area it will block the flow of grease to the roller bearing.

The thrust washer with holes around the circumference

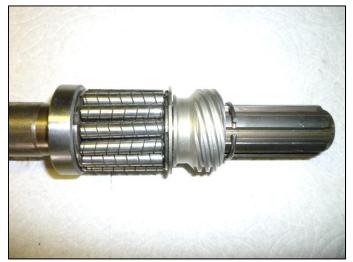
The end cap of an original roller bearing is also notched to allow grease to migrate in.

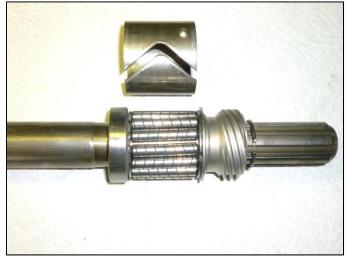
This photo shows the sequence of installed parts. From left to right the grease seal, the roller bearing, the thrust washer, the speedo drive gear, and the snap ring retainer.

Inside the torque tube there is a machined stop where the seal comes to rest when it is driven in. The bearing sleeve is inserted next and it comes to rest near the top outer structure of the seal and is also positioned inside the torque tube by the dimple in the sleeve that locks into a recess inside the torque tube. The roller bearing is then installed inside the sleeve. The thrust washer is installed next and it comes to rest against the front edge of the sleeve. The speedo drive gear is then slid on and the snap ring retainer installed. There is always a space between the gear and the snap ring.

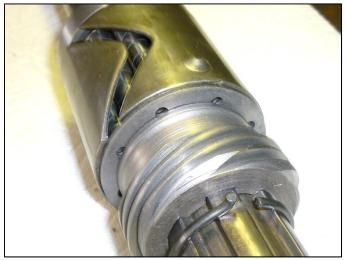
The sleeve is shown positioned around the roller bearing. Note the dimple in the sleeve.

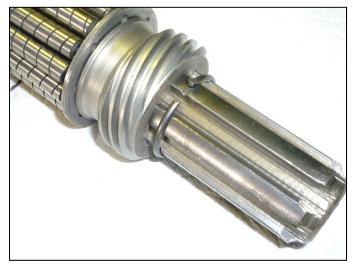
This photo shows the positioning of the thrust washer behind the speedo drive gear. The holes around the circumference allow grease pumped in the grease fitting to lube the U-joint to allow it to also flow to the roller bearing.
