Mitchell Overdrive One Day Installation

by Tom Endy 2019

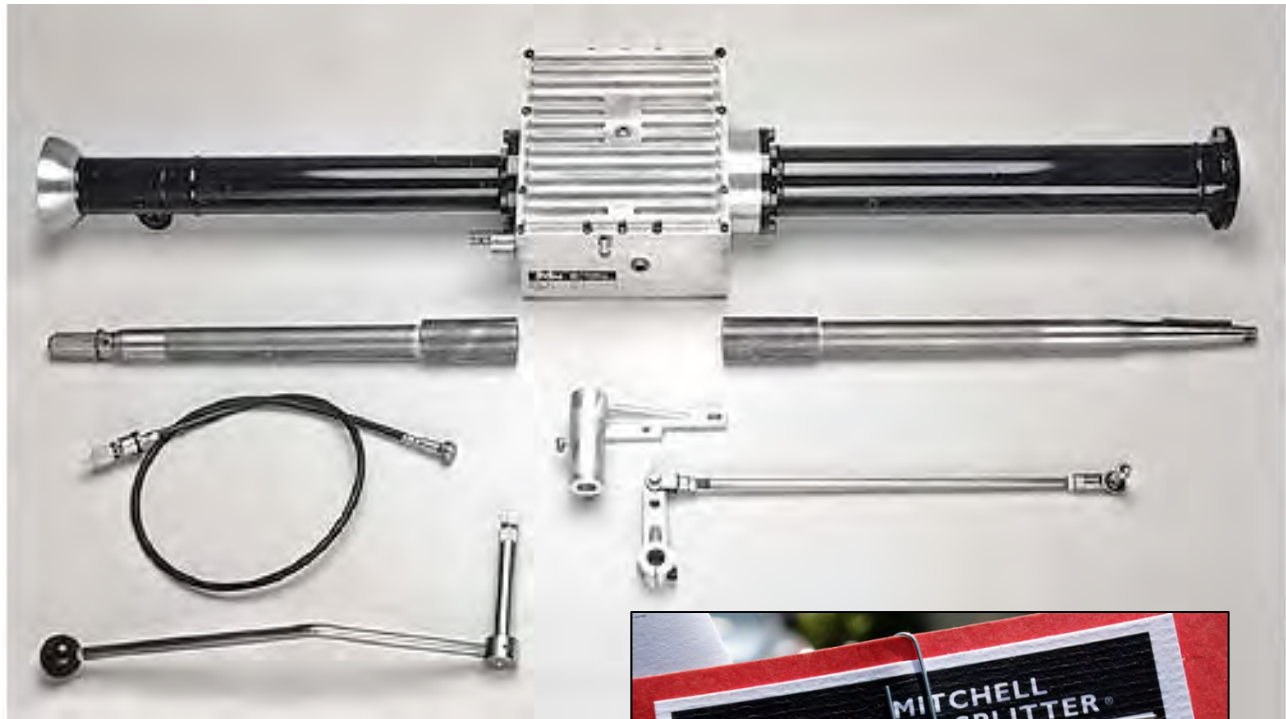
The Mitchell overdrive

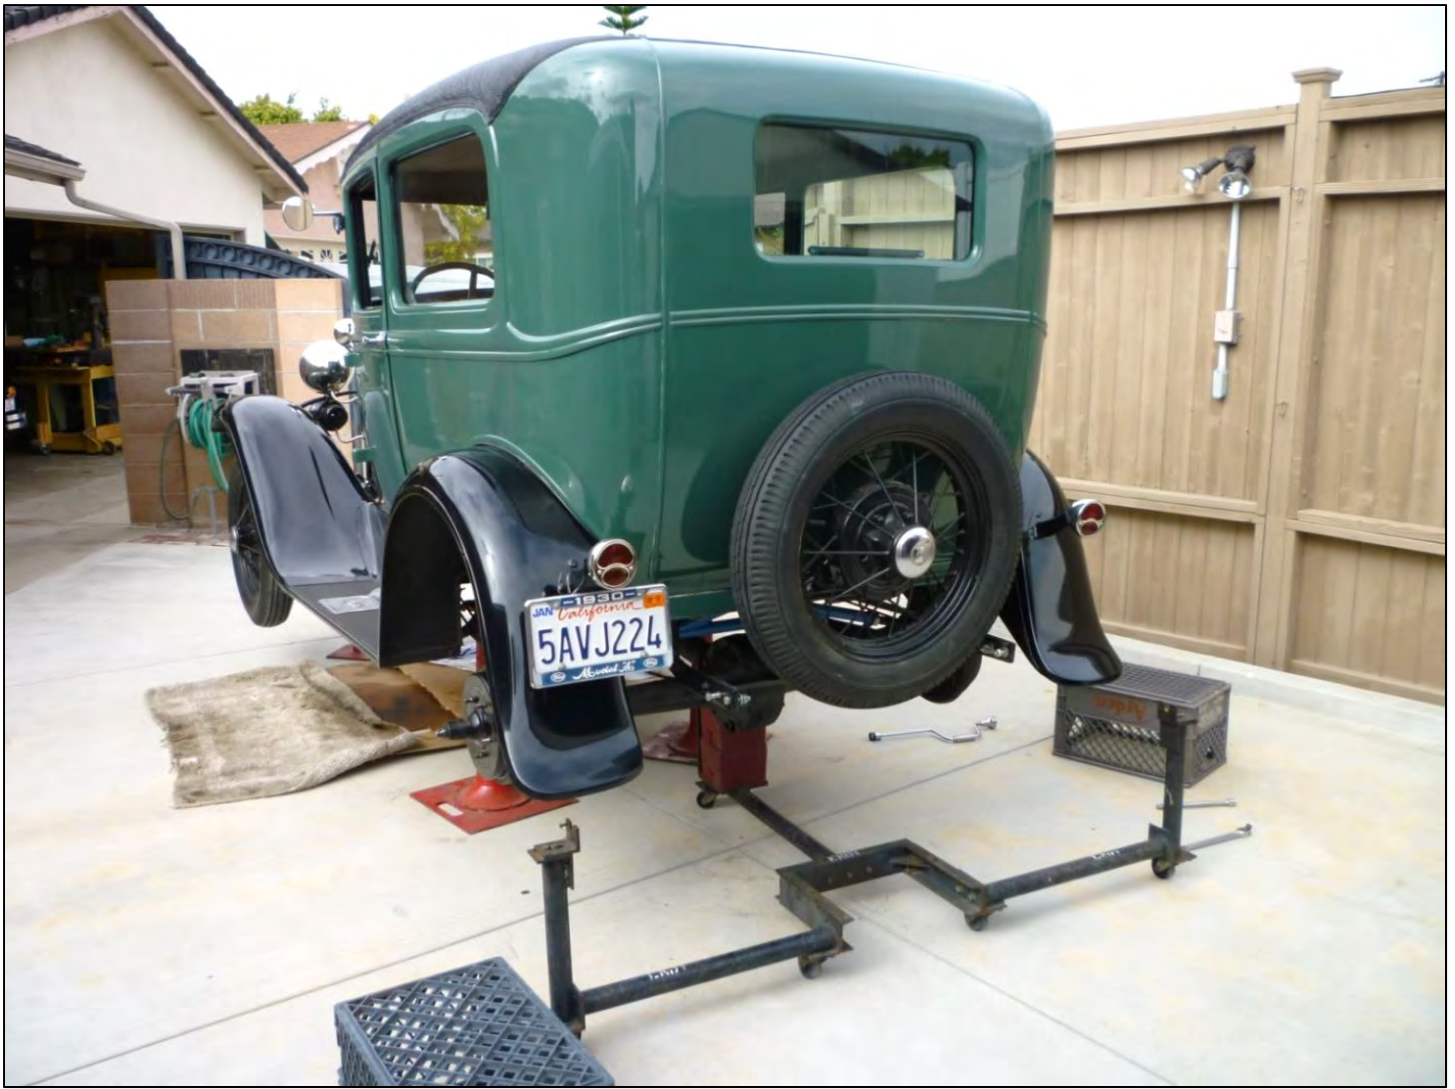
A Model A Ford has been positioned on the tall jack stands. The rear wheels have been removed. The rolling cradle has been positioned beneath the rear of the car and the spring spreader has been installed. The rear axle assembly is ready to come out. Once the cradle is fully under the car a floor jack will be placed under the banjo.

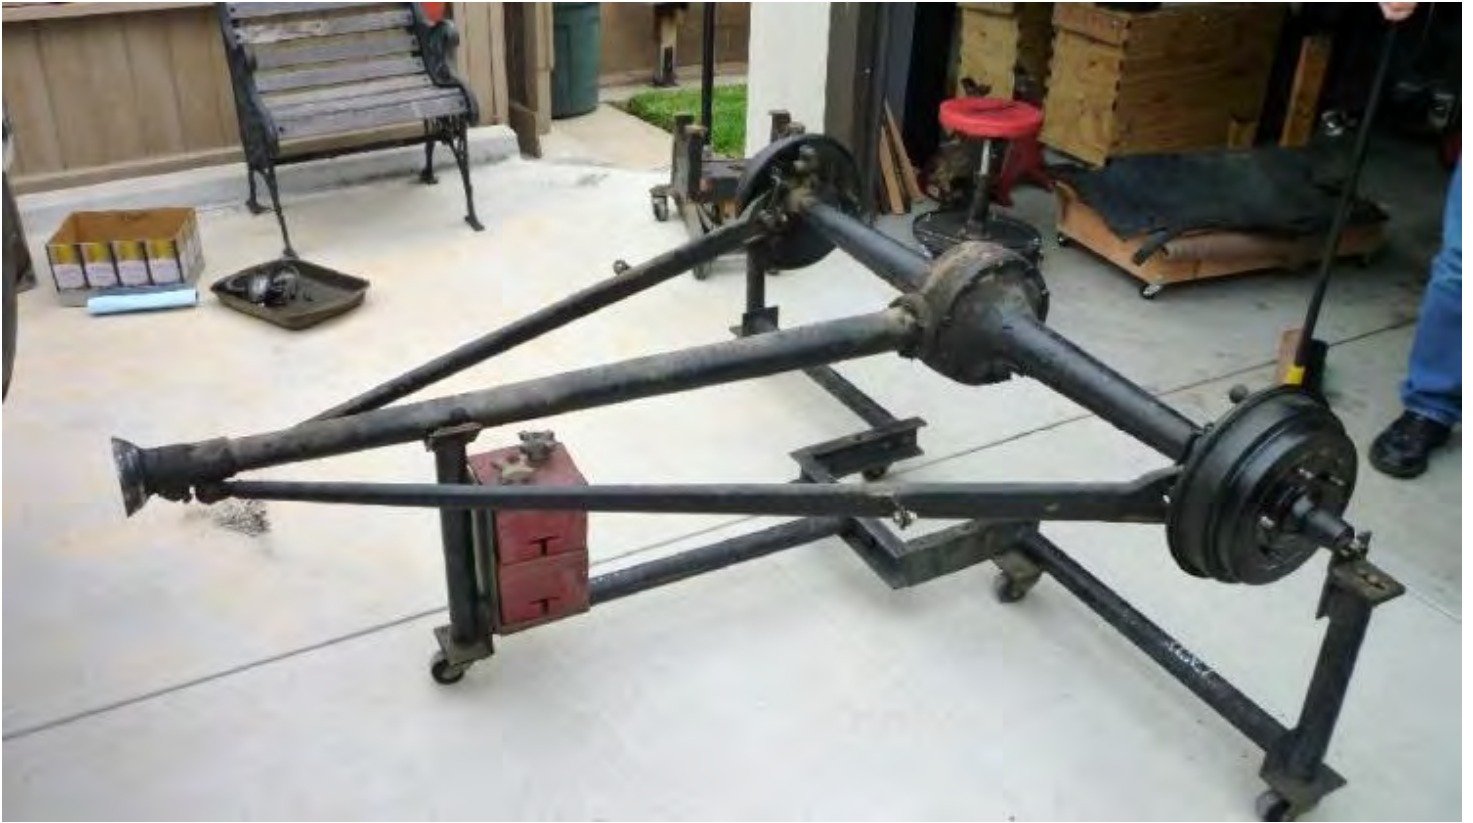
The rear axle assembly has been removed from the car. The torque tube is ready to come off. The rear spring is still attached to the frame of the car with the spring spreader still installed.

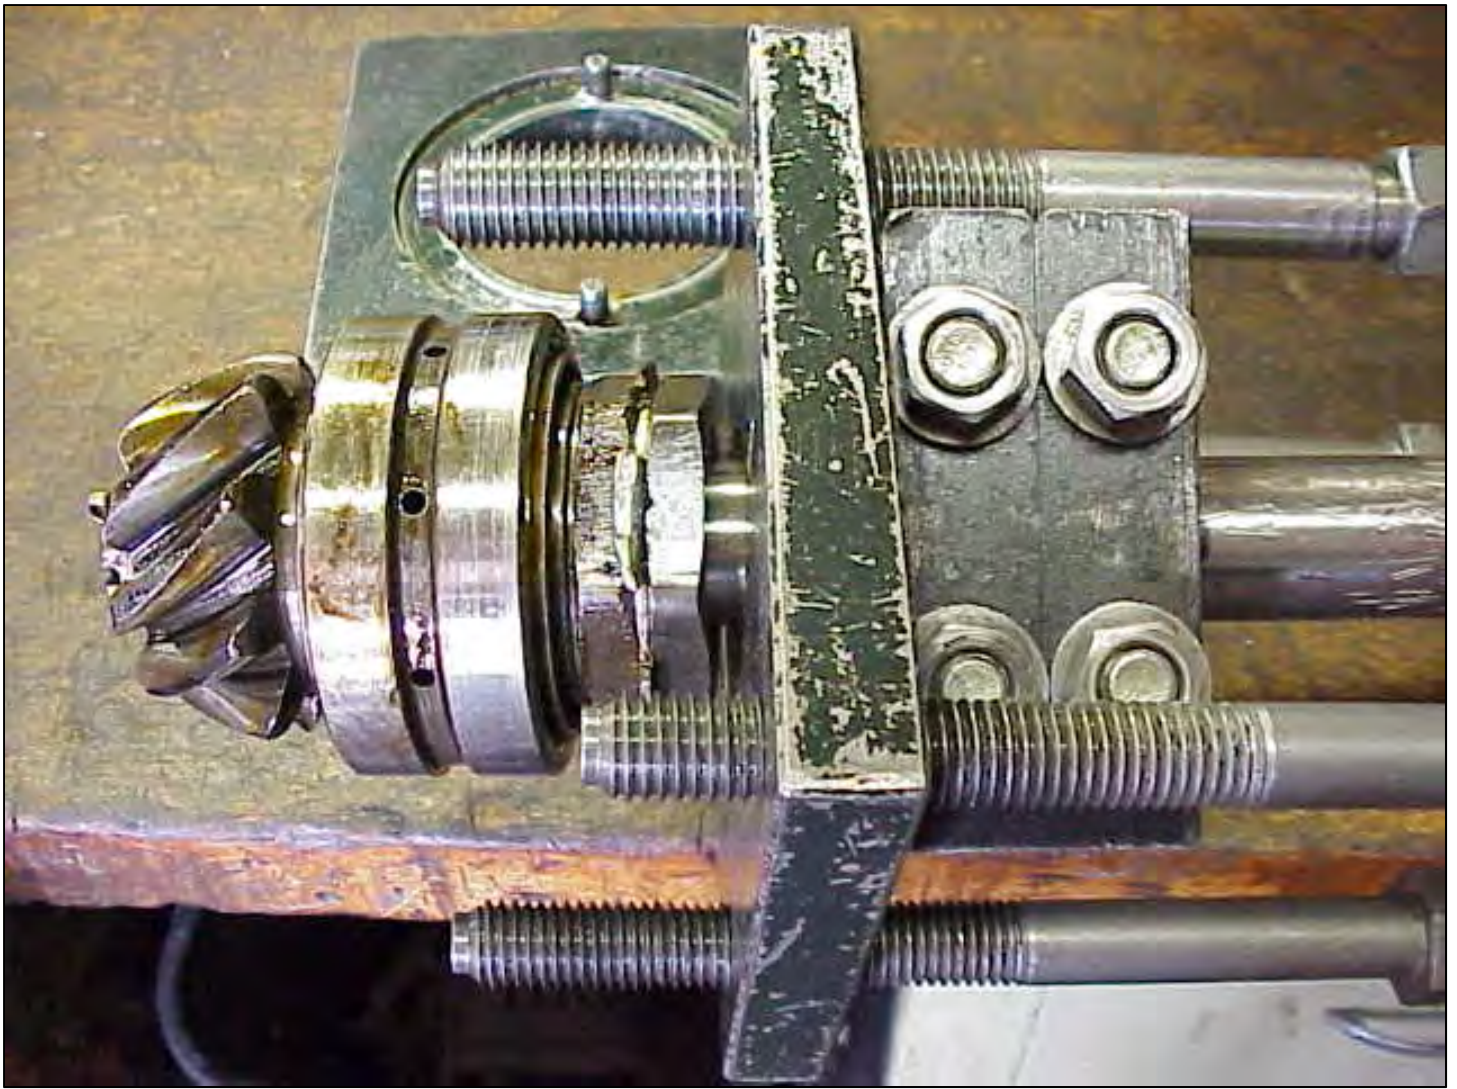
The pinion gear assembly has been pulled from the banjo without disturbing the preload on the two pinion bearings.

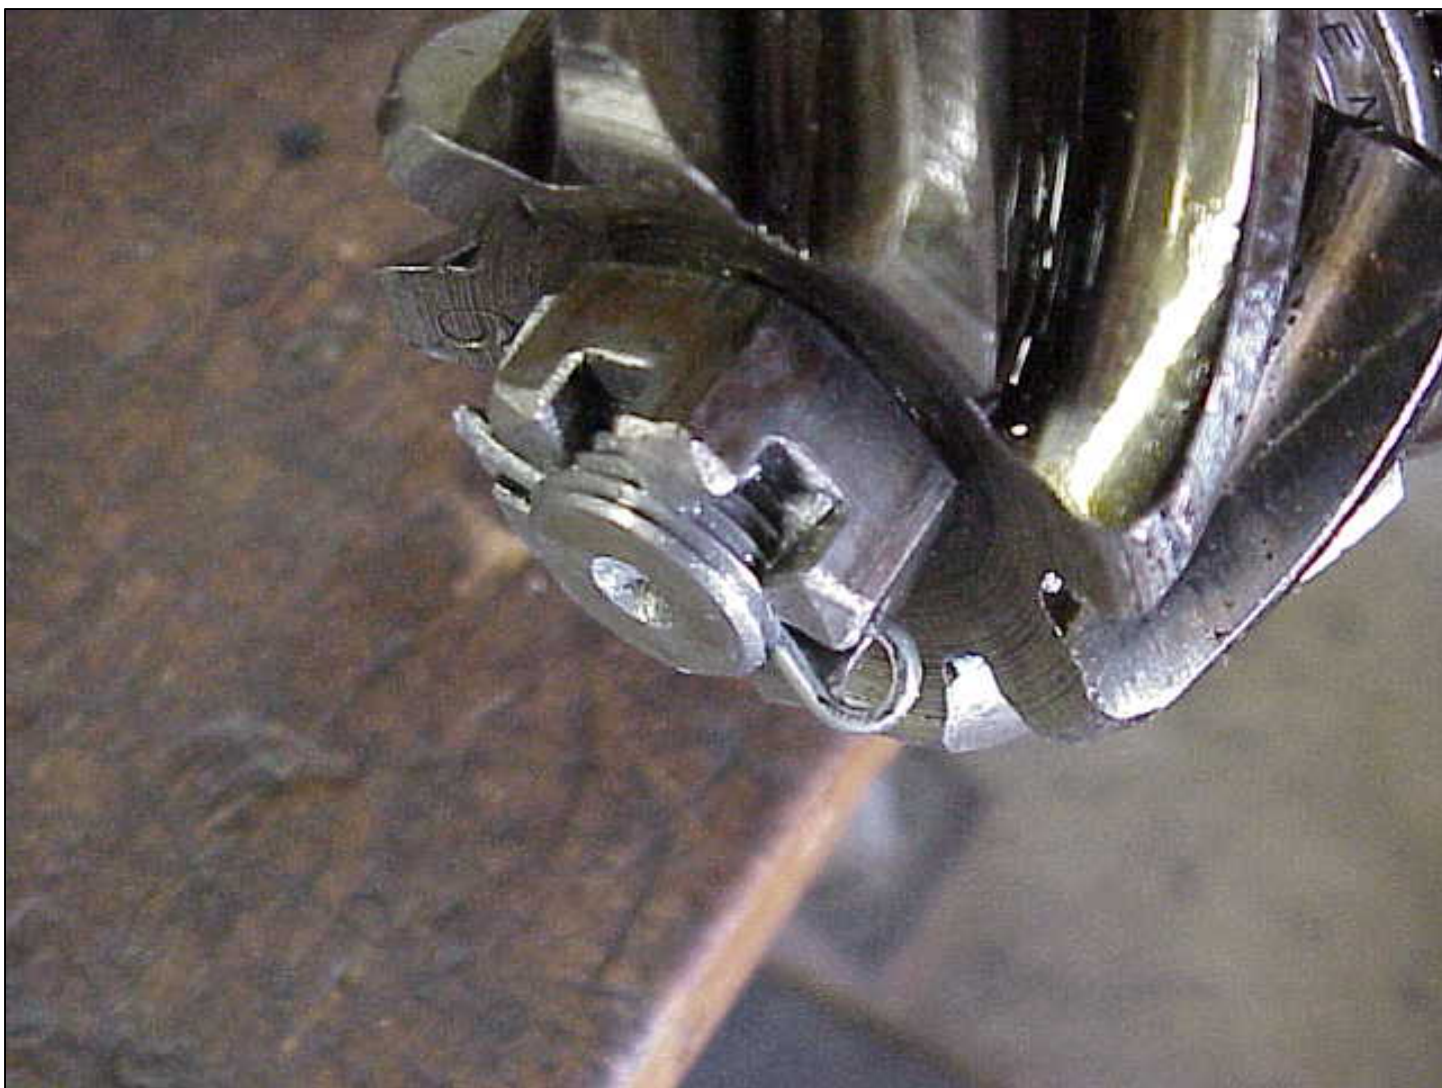
The cotter pin will be removed from the end of the drive shaft and the nut loosened and backed off about 1/8".

It is important that during an installation the cotter pin legs be bent down along the side of the nut and not over the end of the drive shaft. The reason being, there is not a lot of clearance between the end of the nut and the rotating carrier. This is especially true with after-market ring & pinion gears and overdrive stub shafts.

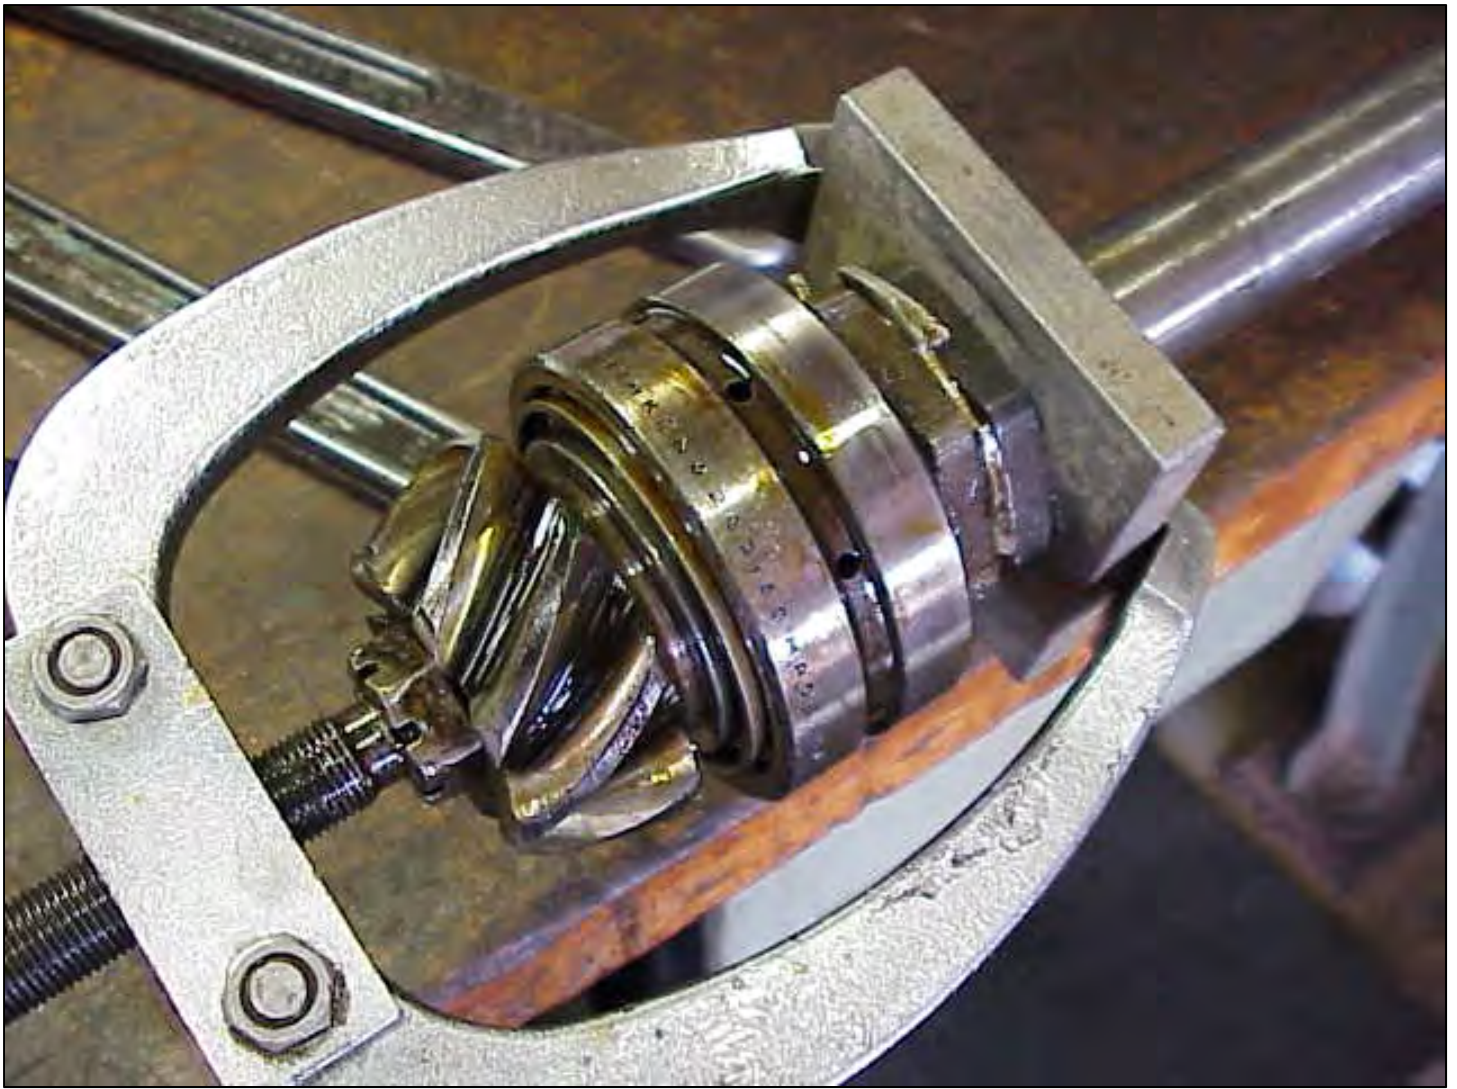
The pinion assembly is removed from the drive shaft with a puller tool without disturbing the pre-load on the pinion bearings. The puller is tightened against the block of steel that has a hole in it to allow it to slide over the drive shaft and up against the pinion assembly. The end of the puller is hit with a hammer to dislodge the pinion assembly from the tapered shaft.

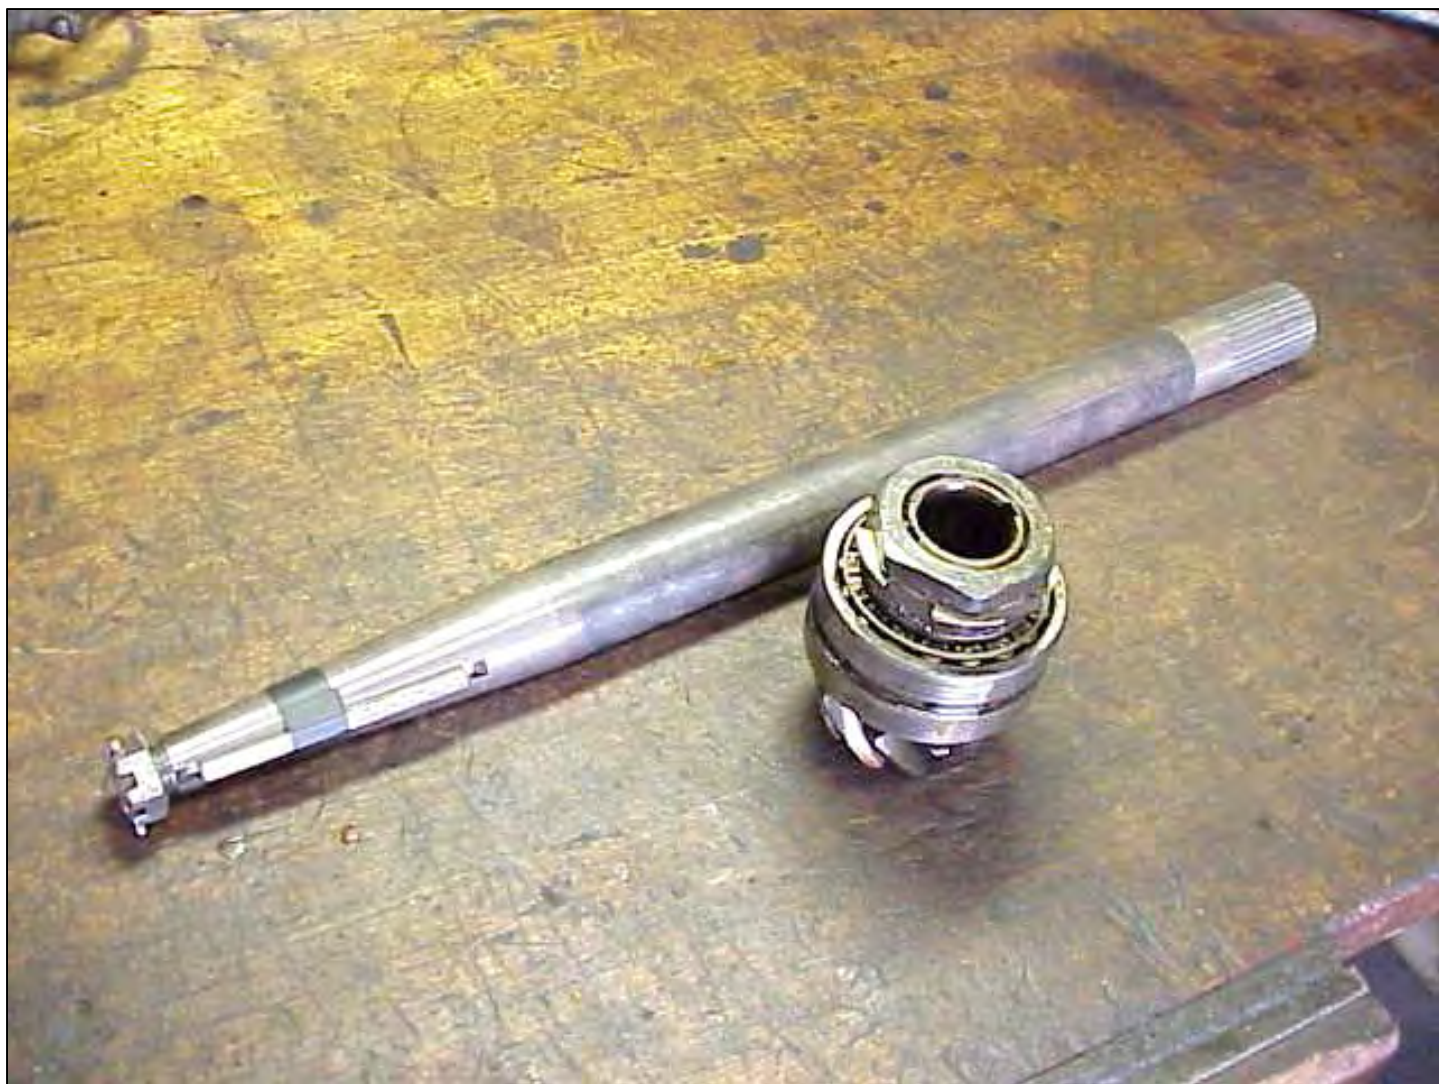
The Mitchell stub shaft is ready to be installed into the removed pinion gear assembly. The nut will be torqued to 100 ft. lbs.

There are three different Mitchell stub shafts produced for the Model A Ford. The standard length fits most Model A's. The Victoria and A-400 require a stub shaft that is 4.5 inches longer in order to position the overdrive further forward to clear the dropped rear floor pan. The 1931 slant window town sedans have a floor pan under the front seat for tool storage. The stub shaft for this car is several inches shorter to position the overdrive further back to clear the floor pan.

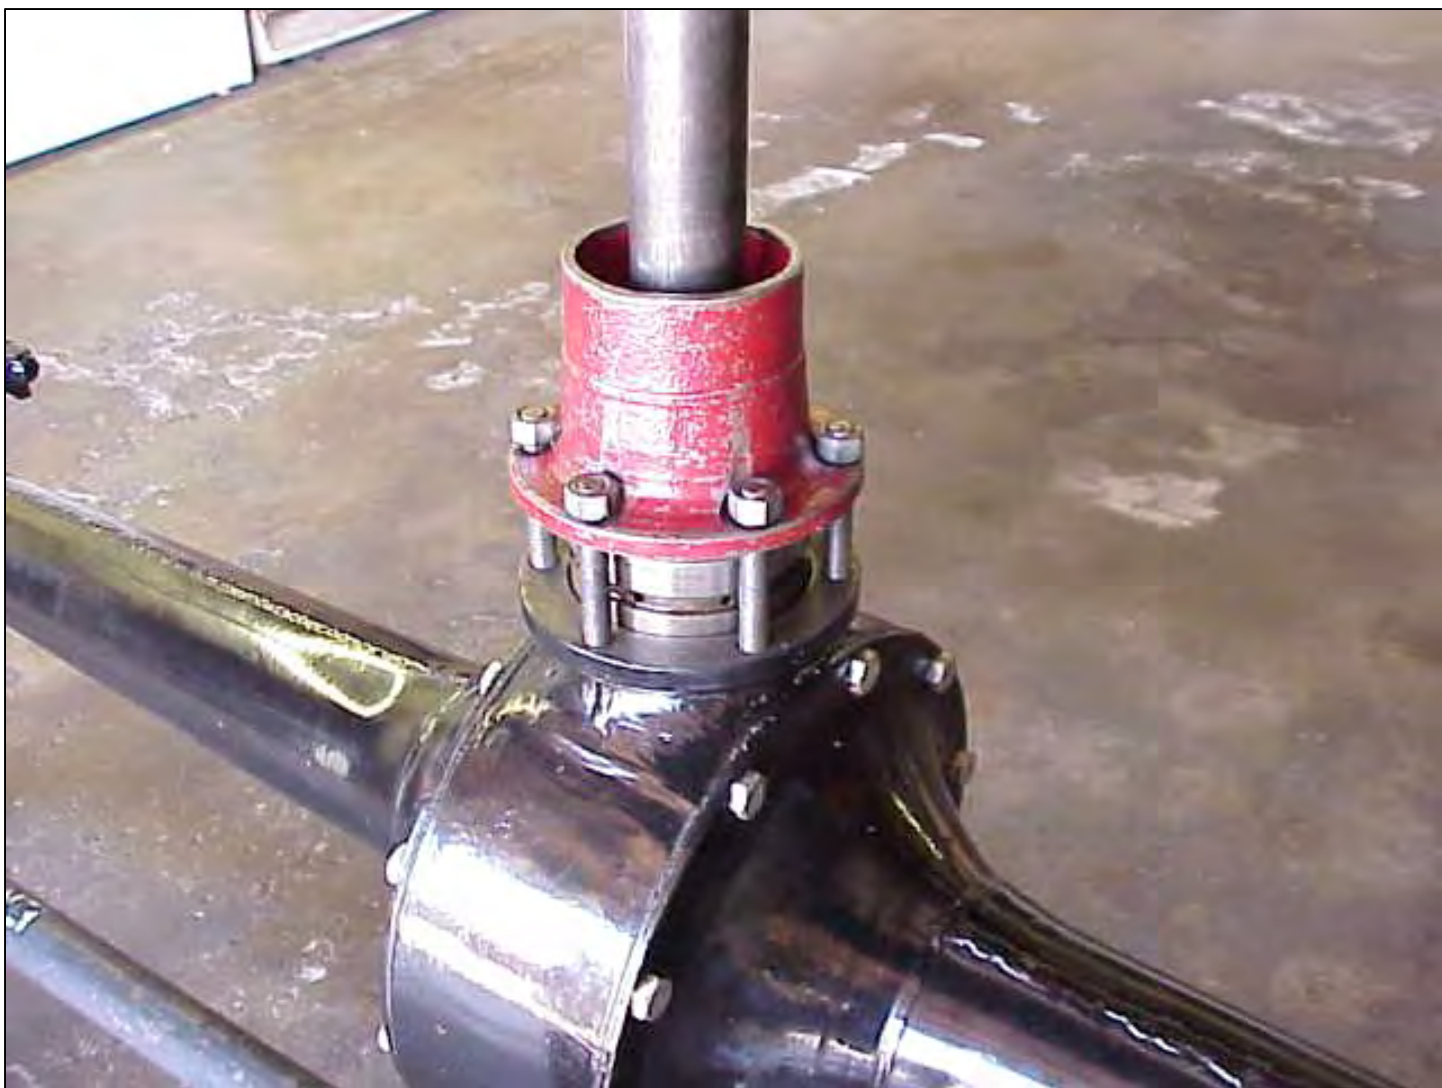
The pinion gear assembly attached to the Mitchell stub shaft is being reinstalled into the banjo using a puller-in tool. By tightening the nuts on the threaded studs evenly it will seat the pinion assembly into the banjo.

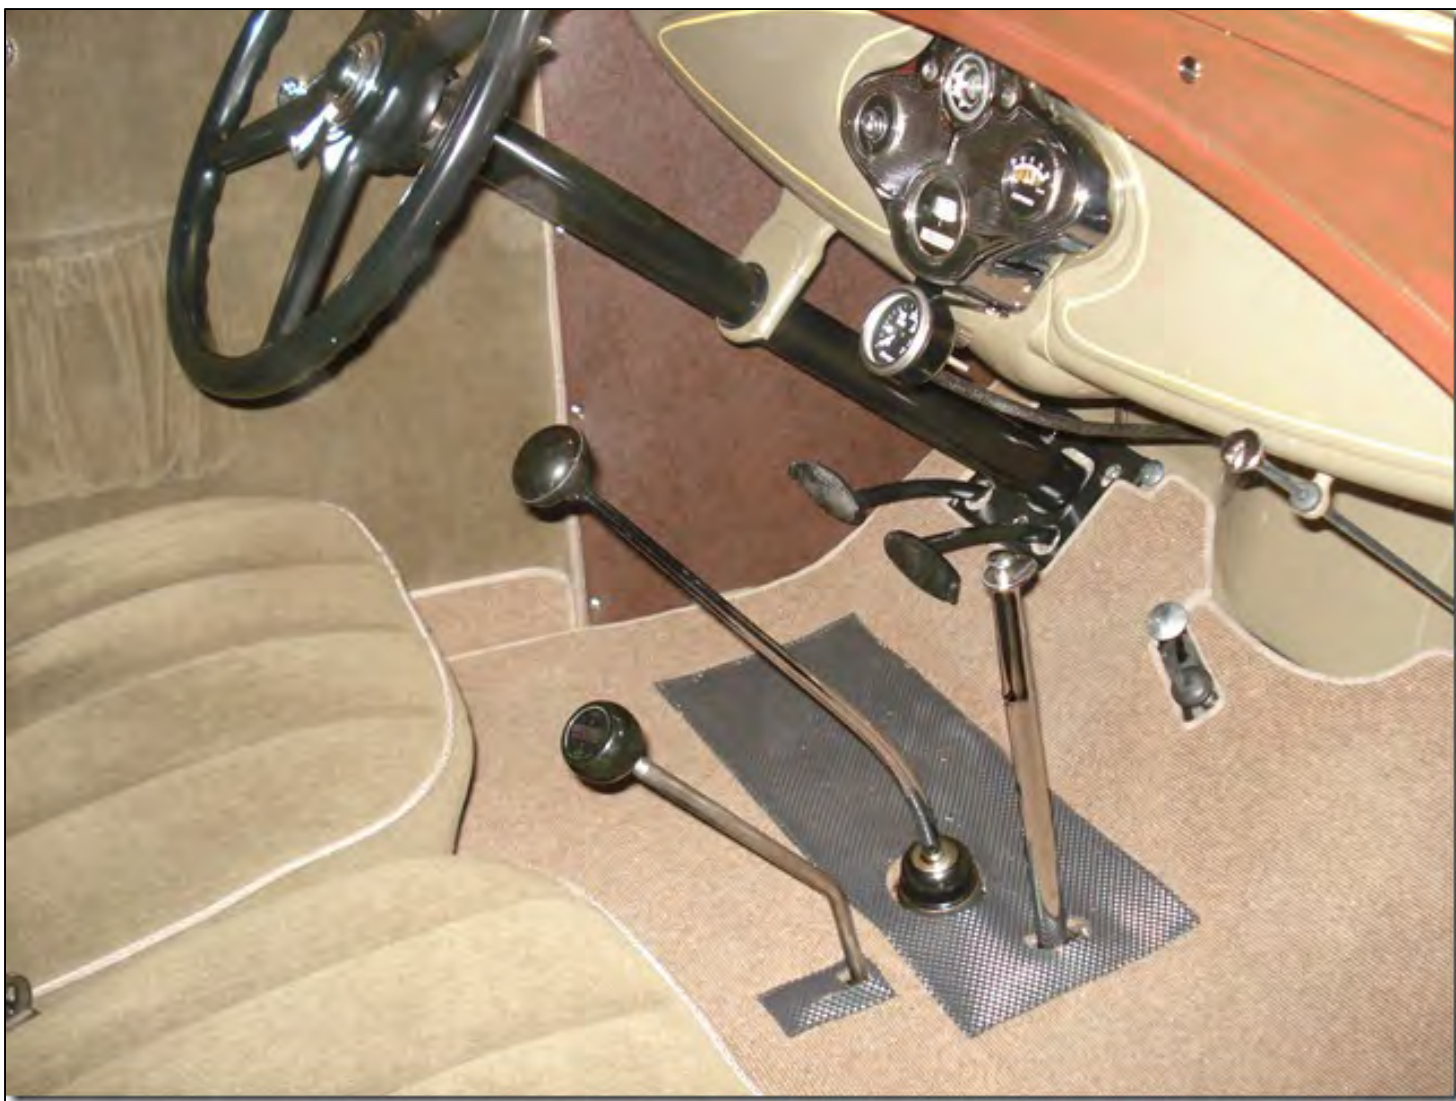
A template was used to locate the slot in the floor board for the overdrive shift lever to protrude through. The shifting mechanism can be adjusted to provide desired fore and aft positioning of the shift lever.
