Modifying the Ford Factory 4 Blade Fan

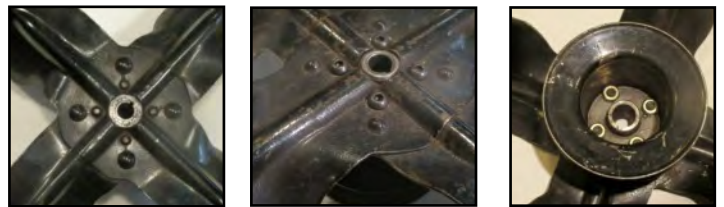
Recently I have discovered that there is a weakness in the design of the factory 4 blade fan. If you carefully look at one of these fans, you will see 4 large rivets that attach the fan blades to the pulley assembly and 4 small rivets that attach the fan blade and pulley assembly to an inner hub with a tapered hole for the water pump shaft. When these fans have been in use for a long period of time, the heads of the small rivets tend to loosen. If this is allowed to continue, the fan and pulley assembly could eventually separate from the inner hub. This condition develops over a period of time and accompanied by a rattling noise in the area of the water pump. It is easy to check for any looseness of the fan by grabbing one blade and moving side to side. If looseness is detected, either the hub itself is not tight on the shaft or the small rivets are starting to loosen up.

There is a very easy repair to fix this problem. Replace the 4 small rivets with larger $\frac{1}{4}$ inch screws. First remove only one rivet and then drill thru both the fan and hub assembly with a $\frac{1}{4}$ inch drill. Install a $\frac{1}{4}$ -28 (fine thread), 1 inch long,

button head, socket head screw with a grade 8 nylon inserted self locking nut. Then remove the other 3 rivets, drill out those holes and install the other three screws and nuts. Enlarging the holes in this manner will keep the holes in good alignment with a tight fit of the screws. A drop of Loctite on the threads is also a good idea. The button head screws are slightly larger and much stronger than the original rivets and the heads of the screws are much larger than the original rivet heads which will keep the fan assembly from loosening on the hub. Do not use ordinary slotted round head screws as they are not nearly as strong as socket head screws. An extra bonus is with the fan installed you can check the screws for tightness with an allen wrench. The nuts on the inside will not turn because of their close fit to the inside of the pulley assembly. Just be sure to include an allen wrench with the tools you carry in your car.
