Differential Carrier

by Tom Endy 2021

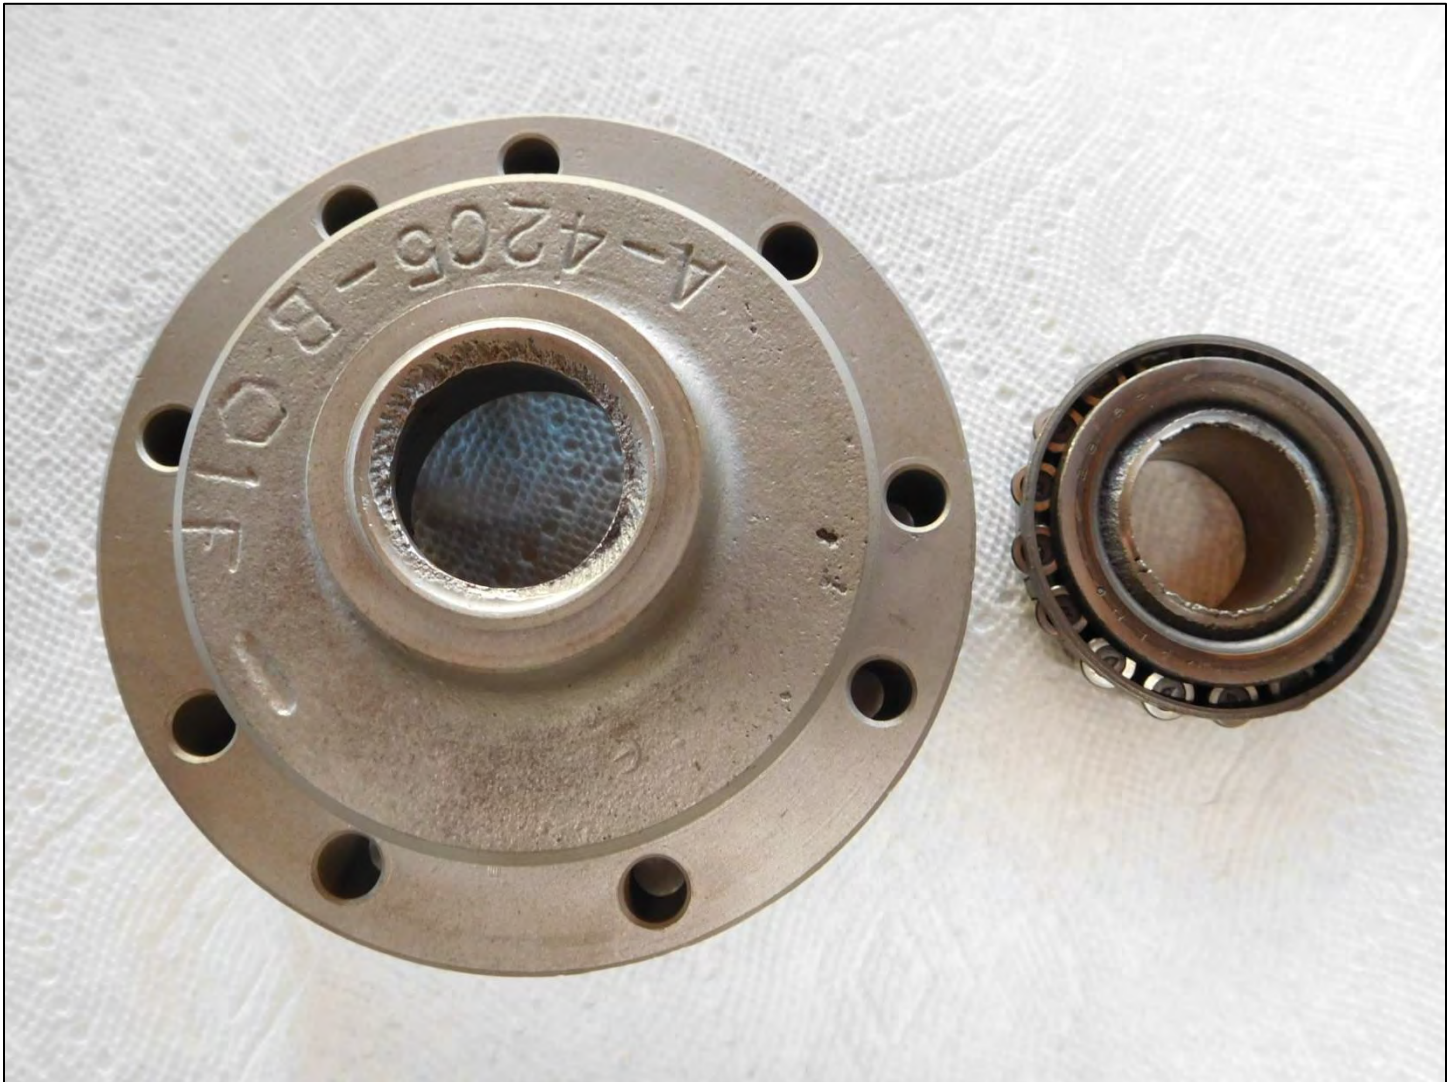
The photo below shows the ring gear side of a carrier that had been put together so tight that Henry's forty horses actually sheared the hub off the carrier. What is interesting is that this carrier came out of a running Model A that did not exhibit a problem with the differential. The bearing was captured in place because it could not go anywhere, however, the carrier was not rotating on the bearing. When I disassemble the differential the bearing and the sheared hub fell out. Certainly a testimony to the ruggedness of the Model A Ford.

Quite often Model A differentials are rebuilt by people who do not have an understanding of how the pre-load on the two carrier bearings is established. They are not aware it is done by the selection of the number and thickness of the banjo gaskets. All too often differentials are assembled by merely putting a single gasket on each side of the banjo without any thought given to bearing pre-load. The result is that the bearings are usually locked up. Once the car is back on the road Henry's forty horses will break them loose. This causes the bearings to spin on the mounting hubs. From then on the carrier is rotating mostly on the hubs instead of on the bearing roller elements. Nine out of ten differentials I overhaul I find one or both bearings spun on the mounting hubs. The repair is to have the carrier mounting hubs knurled, so that the new bearings will press tightly on the hubs.
