The last Word About Fluid Leaks.

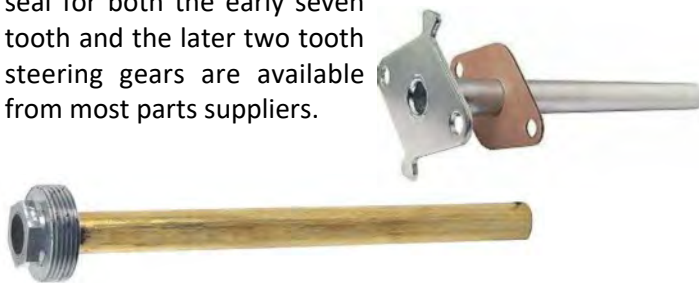
Originally, there was a cork seal that fitted around the horn rod and prevented oil from leaking from the steering gear and into the switch but eventually, the cork would fail and the oil would leak into the switch housing. Ford continued the same head light switch design well into the late thirties but designed a tube that fit around the horn rod that prevented oil from leaking into the head light switch. Tube assemblies that will replace the original cork seal for both the early seven tooth and the later two tooth steering gears are available from most parts suppliers.

First, let us consider the steering gear. It is not uncommon for the steering gear to leak oil around the horn rod and into the head light switch assembly. This not only makes a mess but often the headlight switch will not work because the switch contacts are all coated with oil.

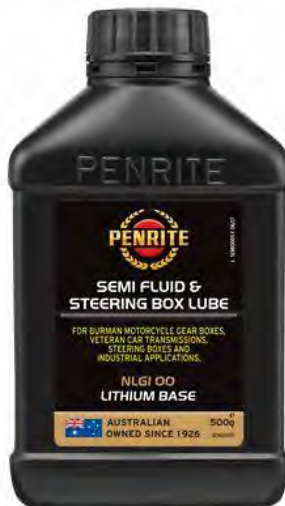
Another place the steering gear may be leaking is around the sector shaft. O rings and seals are available that may help this situation. If the sector bushings are tight and the proper 600W oil is used, most steering gears will not leak. For the steering gears that do leak, you may try using a semi fluid grease such as Penrite 1500W. This semi fluid grease will still flow and allow adequate lubrication of the internal components but will not drip or leak.

It is not advised to use chassis grease in the steering gear of a Model A. This thick grease will "channel" and move away from the components as the steering gear is used and will not flow back and keep everything well lubricated. Use 600W oil or a semi fluid grease.
