The New Burtz Model A Engine (Part 2)

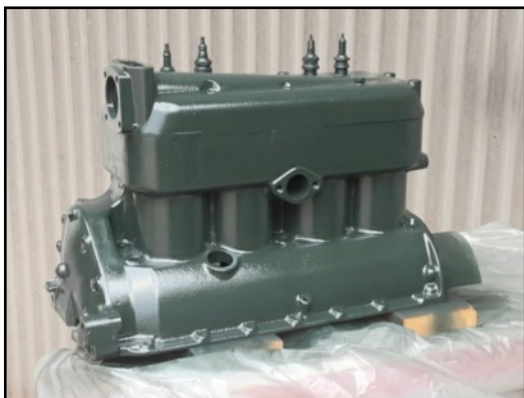
The head, block and front cover are temporarily installed for painting.

The block is now ready for paint. When painting a Model A engine, I have found the easiest way to keep paint off the surfaces you do not want to get painted is to set the block on a table and temporarily bolt on the head, side and front covers. I use only a few bolts, just enough to hold the parts in place. A little masking on the rear machined surfaces and some old spark plugs to keep paint out of the cylinders and you are ready to paint.

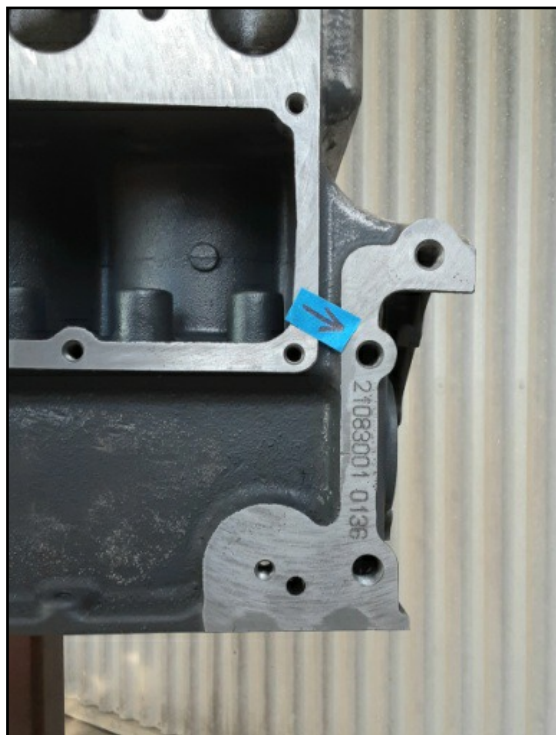
The arrow points to an oil passage hole that must be plugged and sealed by a 7/16-14 “set screw”.

There is one place where a 7/16-14 “set screw” is used to plug a short oil galley at the front of the engine. This set screw was intended to only be screwed in until it was flush with the outside machined surface of the casting but the threads were tapped so deep that the set screw could be screwed in so far in that it would block off an intersecting oil galley. If the engine was not being used with an external oil filter this would not be a problem but these passages are used to supply filtered oil to the main oil galley when using an oil filter.

I sent an email to Terry Burtz and he very quickly responded and said this plug was intended to only be installed flush with the machined surface and not screwed all the way in. Terry proceeded to communicate my finding to his quality assurance team and also made an addition to the "Builders Guide" to point out this issue.

To insure this plug and all the other galley plugs would stay in place, all but one were installed using epoxy as a sealer. The exception was the plug for the main galley at the rear of the block. A half inch long, 1/2-13 socket head cap screw (Allen screw) with an aluminum sealing washer was substituted for the 1/2-13 "set screw" type plug supplied in the kit. I had heard from others that there were a few instances where an oil leak had developed when the "set screw" did not seal properly. Using a cap screw with a sealing washer will provide a positive seal.

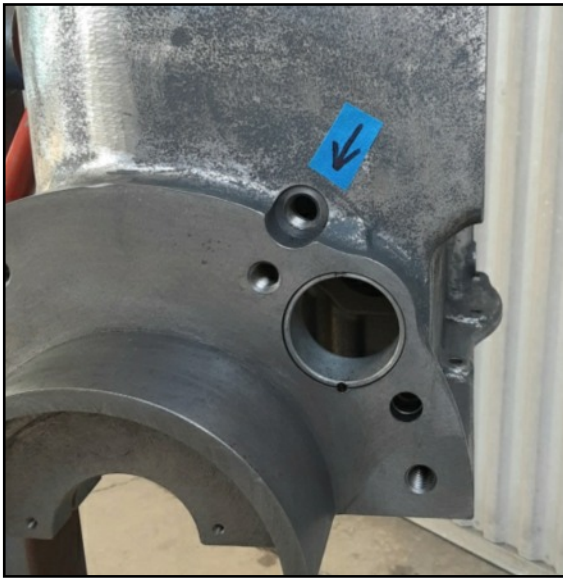
The arrow shows where a 1/2 inch long, 1/2-13 socket head cap screw (Allen screw) with an aluminum sealing washer was installed.

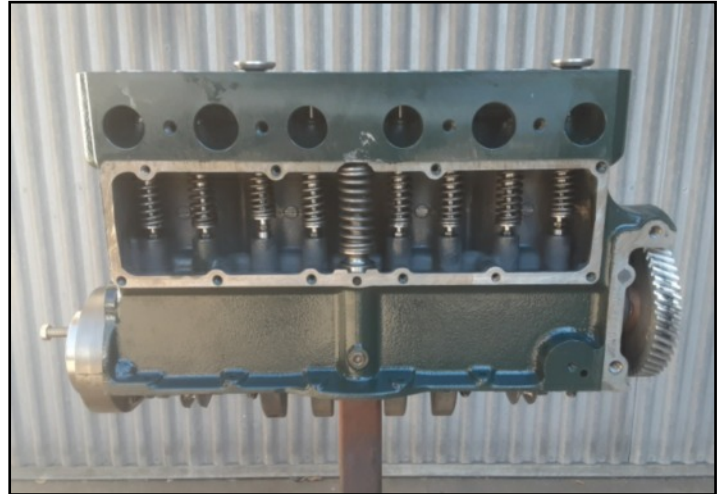
Block assembled with crankshaft, pistons, rods, cam and valves.

Now, on to the valve train: The tappets were placed in the block. The crank and cam gears were installed and the cam was placed in the block. A liberal amount of assembly lube was used on the foot of each tappet and on each cam lobe and journal as well as the cam thrust surface at the front cam bearing. The valves, springs and keepers were then installed and the valve clearances adjusted. When adjusting the valves, I find it a lot easier to rotate the crank without having the pistons and rods in place.
