# Bell Housing Restoration

by Tom Endy

Model A Ford bell housings are often found with a worn out pedal shaft, clutch release shaft, housing bushings, and with worn out bushings in the pedals. Bell housings are also usually covered with grease, crud, and rust. There are people who claim they can replace a pedal shaft while the bell housing is still installed in the car. That may be true, but I would never attempt it. The many I have done have all been on the work bench. Before beginning a restoration examine the bell housing for obvious damage. If damage is found discard it and find another. There are still many around and they are very inexpensive at swap meets.

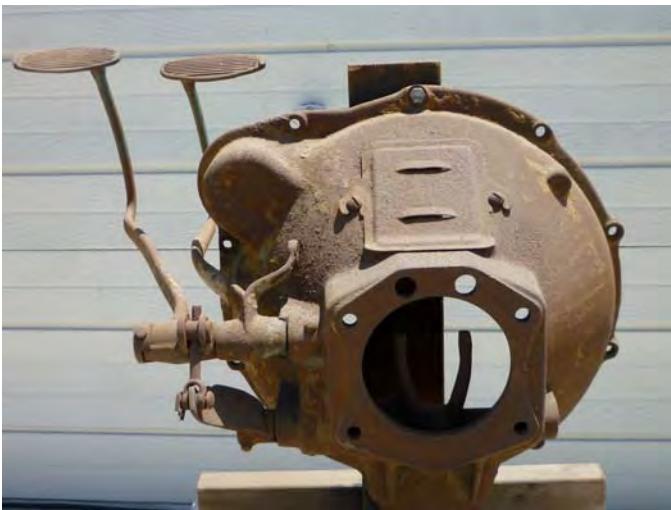
**A complete bell housing ready for disassembly.**

The first effort after the bell housing is on the work bench with pedals removed and separated from the transmission is to completely disassemble it. Depending on the condition of the bell housing the task can be easy or very difficult.

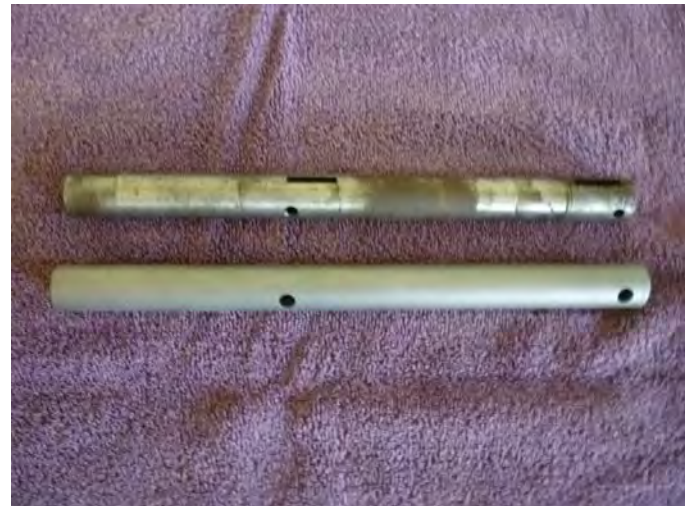
**Clutch release shafts. The shaft at the top of the photo is the early type using woodruff keys to lock the lever arm and yoke into place and using  $\frac{3}{16}$ " locking pins. Note the wear on the left end of the shaft and about an inch in from the right end. The shaft at the bottom of the photo is the later type using  $\frac{5}{16}$ " locking pins. This shaft has only a slight amount of wear on it.**

Beware, there is an early and late version of the clutch release shaft, operating lever, and yoke. The early ones use a  $\frac{3}{16}$ " locking pin and have a woodruff key in both the operating lever and the yoke that corresponds to slots cut into both places on the release shaft. The later ones did not use the woodruff key method and had a  $\frac{5}{16}$ " locking pin. Reproduction shafts and locking pins of both versions are available from Bratton's. There is a Ford service bulletin that addresses the change.

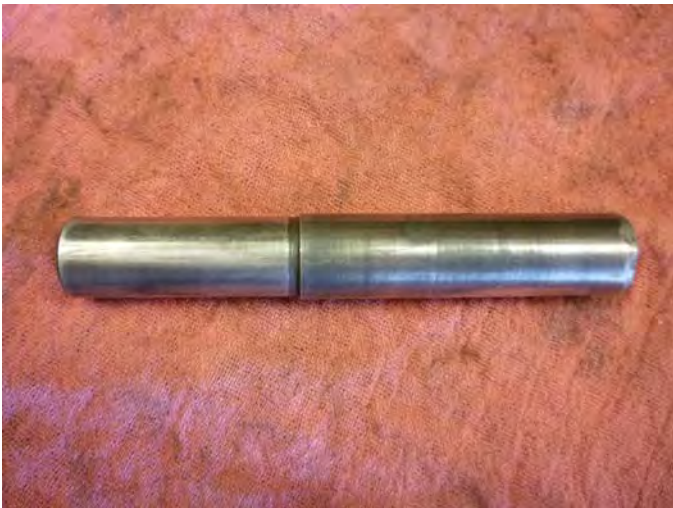
**Bushing removal and installation tool. The tool can be used for removal and installation of bushings in both the bell housing and the two pedals**

Once the clutch release shaft assembly has been removed from the bell housing remove the two bushings. A stepped tool for removing and inserting bushings is the most desirable method. The tool is inserted into the bushing and driven out with a hammer. If one is not available an alternate method is to split each bushing with a hack saw blade. Hammer or grind a common nail to a chisel point and tap it down along side the split. Grip the protruding bushing with a pair of long nose pliers and curl it out. The pedal bushings in the two pedals are the same part number as the two in the bell housing and can be removed in the same manner.

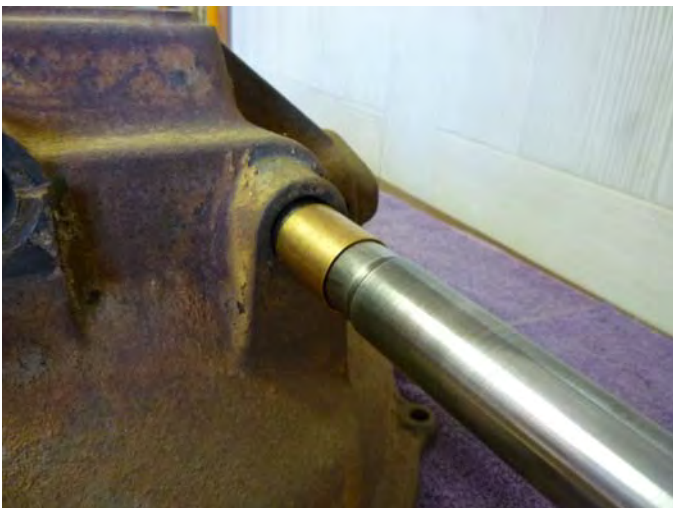
**The bushing tool can be used to drive the old bushings out and to drive the new bushings into place.**

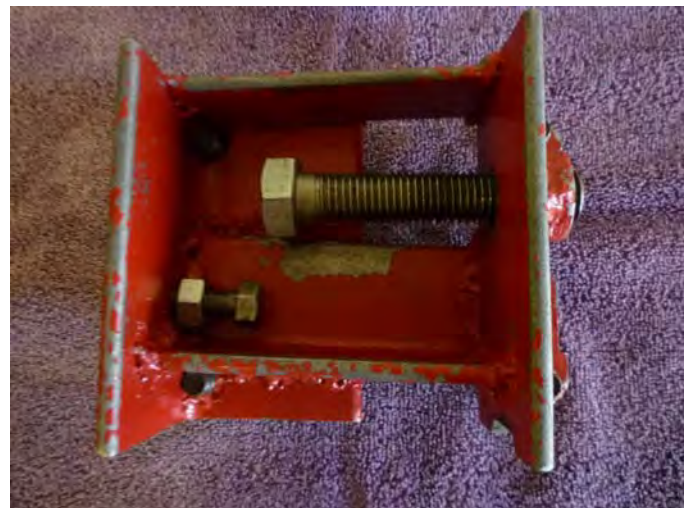
**Crude but effective tool used to push out a stubborn pedal shaft. The tool is bolted at the bottom to the four transmission mounting holes in the bell housing. The large bolt is turned with a wrench to push the shaft out.**

When the pin has been removed the pedal shaft can be driven out from the inside with a long punch held at an angle, Sometimes! Some pedal shafts are in there very tight and are difficult to get out. For the difficult ones I use a tool I made up that bolts to the transmission mounting holes. A large bolt is then turned and it forces the shaft out. An alternate method is to saw the shaft off close to the outside of the bell housing and drive out the remaining length toward the inside with a punch.

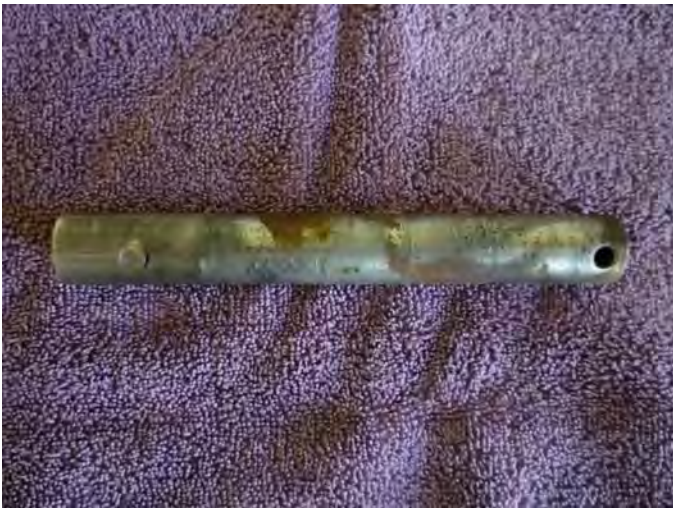
**Worn pedal shaft after removal from a bell housing. Note the locking pin hole on the left end still has a portion of the pin in place. This stubborn pin had to be drilled out from each end, then sheared by driving out the pedal shaft.**

The last task in the disassembly process is to remove the pedal shaft, and this is not always easy. The pin that locks the shaft into place in the bell housing also comes in two versions. The earlier ones have a domed head, were driven in from the top, and had the end inside the bell housing mushroomed over. The later version had a soft tapered pin also driven in from the top. The tapered pins are fairly easy to get out. Both have to be driven out from the inside with a suitable punch. Before you can drive out the early ones with the dome shaped head you have to grind the mushroom off the end of the pin inside the bell housing. I use a small pneumatic grinder to do the job

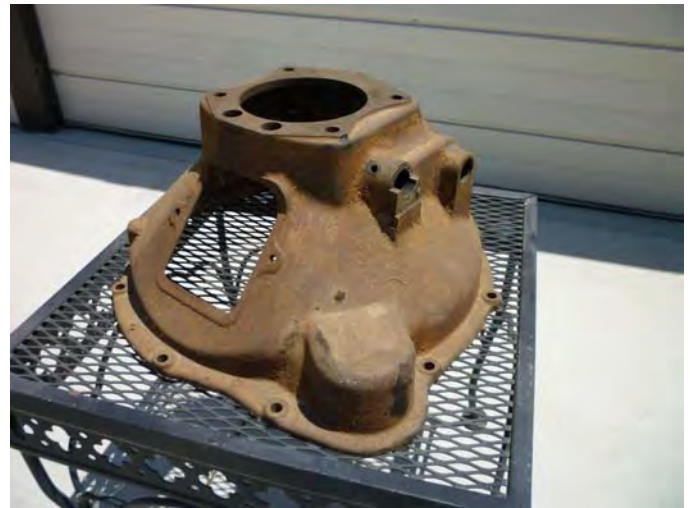
**Disassembled bell housing ready for bead blasting and painting.**

With the bell housing completely disassembled a massive clean up project is the next task. After de-greasing, I bead blast them inside and out and paint the exterior with Ford green paint.

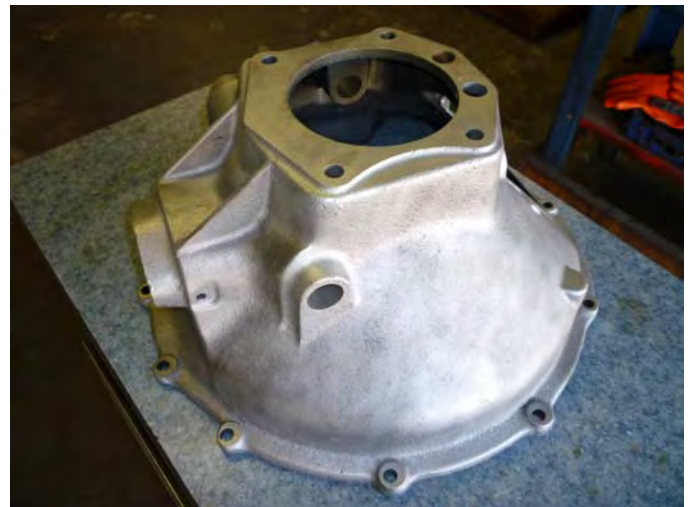
**The outside of the bell housing after it was de-greased and bead blasted.**

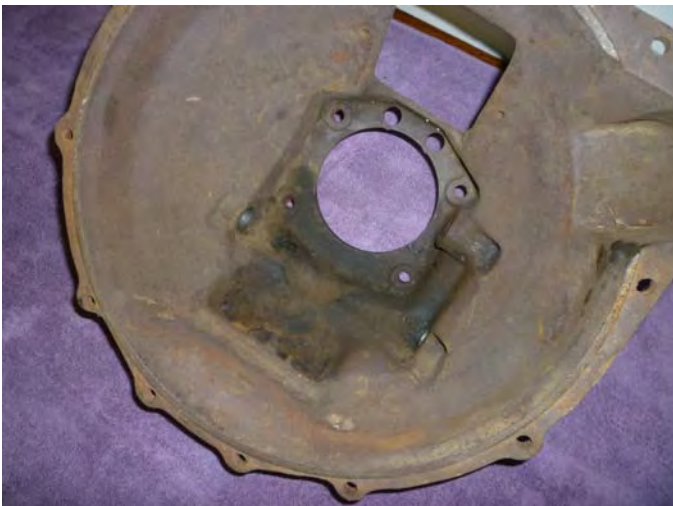
**The inside of a bell housing can be extremely cruddy. This one will have to be de-greased before it can be bead blasted.**

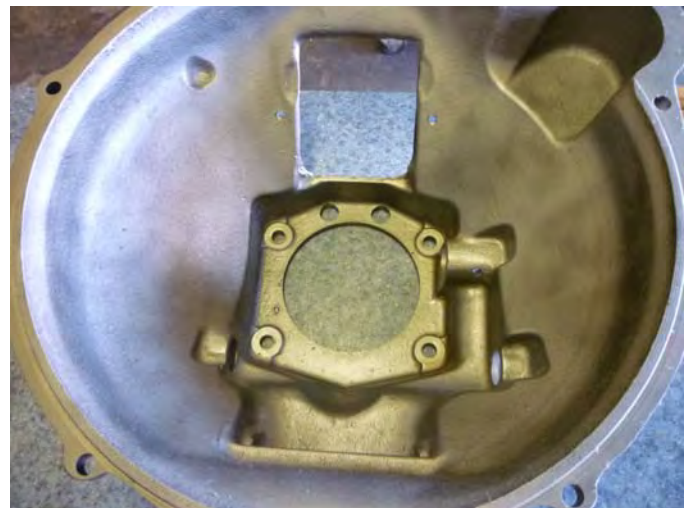
**The inside of the bell housing after it was de-greased and bead blasted.**

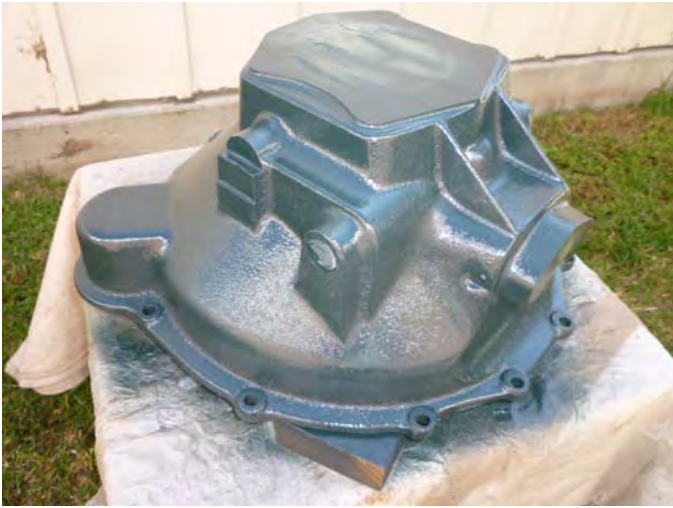
**The machined surfaces are masked off and the outside of the bell housing is painted Ford green. The inside of the bell housing is left unpainted and sprayed with WD-40 to prevent rusting. The unpainted machined surfaces are also coated with WD-40.**

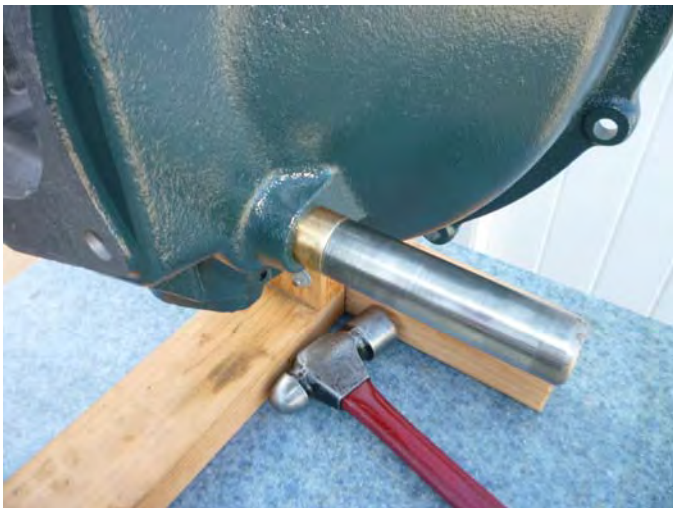
**New bushings are driven in with a bushing tool.**

Once the bell housing has been cleaned and painted the re-assembly procedure is begun by installing the two bushings in the bell housing. This is where you will need some type of insertion tool. One can be made on a lathe from some round stock. The tool should have a small collar on it that grips the edge of the bushing so it can be driven in without mushrooming the end.

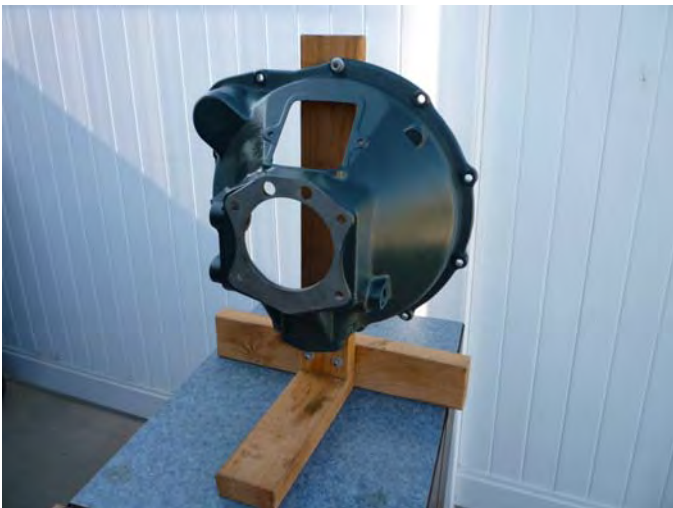
**A simple wooden stand makes the assembly process easy. It can also be used for disassembly.**

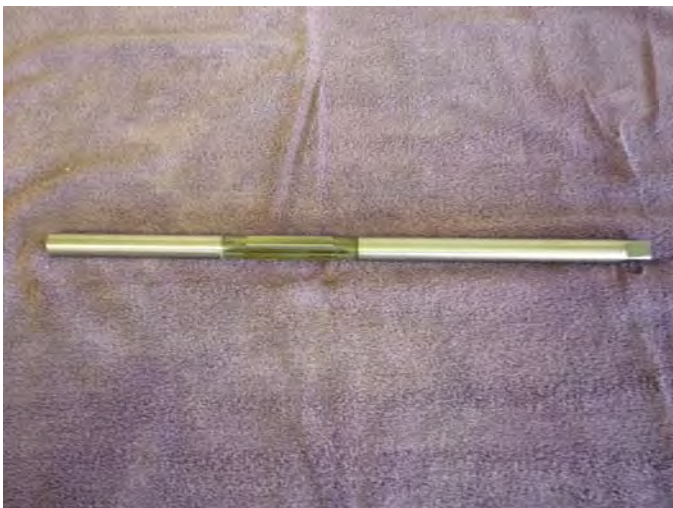
**Bushing reamer. This tool is long enough to ream both bell housing bushings in line. It is also used to ream the pedal bushings.**

The two bushing may need to be reamed to fit the new clutch release shaft. You will need a reamer long enough to be able to ream the two bushings so they will line up with each other. Honing is not a good idea in this case as you may be able to fit the shaft from either end, but they may not line up with each other and you will not be able to get the shaft through both bushings.

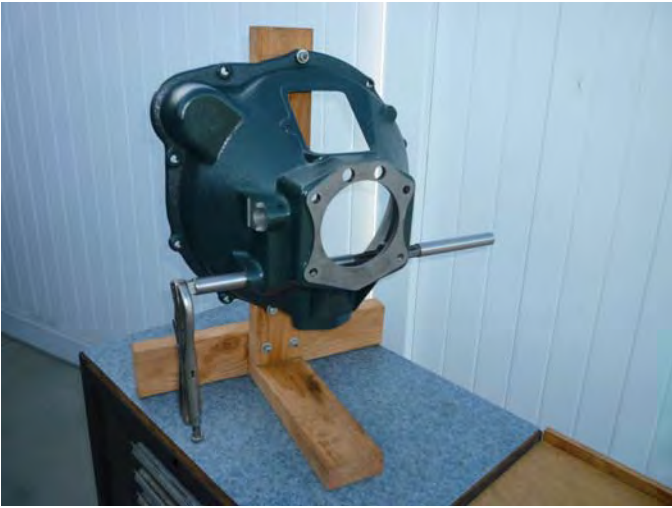
**This bushing reamer is long enough to fit through both bushings at the same time to ensure they will line up with each other.**

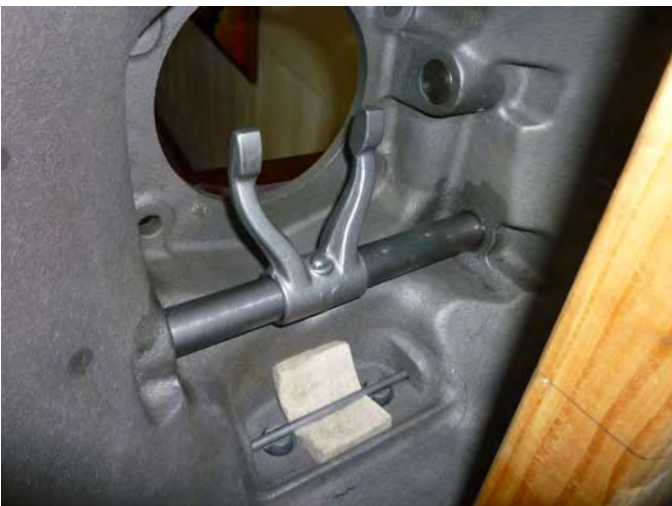
**Yoke oriented correctly on new clutch release shaft. Radius rod bolt heads and felt installed correctly and retained by the long pin.**

The yoke is then installed onto the release shaft as it is slid into the bell housing. Be certain to orient the yoke in the correct position to properly engage the throw-out bearing. With yoke in a vertical position the operating lever should be pointing to the rear. The yoke locking pin is driven in from the top.

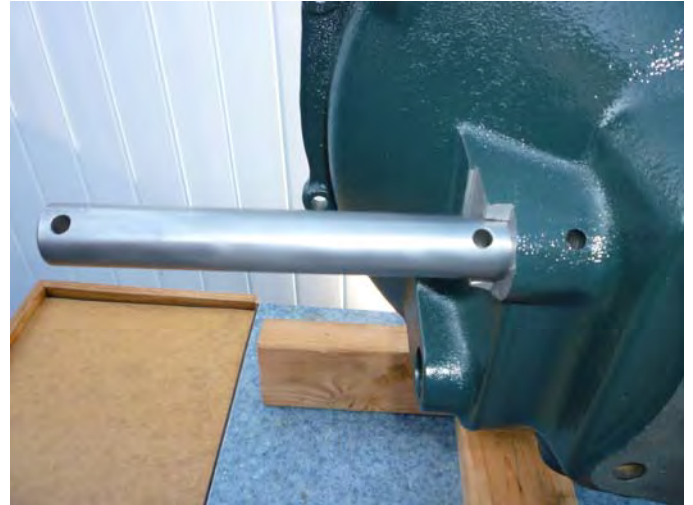
**The end of the pedal shaft with the pin hole about an inch from the end of the shaft goes into the bell housing. The other end of the shaft has the hole close to the end of the shaft. Accurately line up the hole in the shaft with the hole in the bell housing before driving it in.**

When installing the new pedal shaft there are three things to take into consideration. (1) Be certain to install the correct end of the shaft into the bell housing. The end with the locking pin hole about an inch from the end of the shaft goes into the bell housing. (2) Be certain to line up the hole in the shaft accurately with the hole in the bell housing. (3) Do not pound on the end of the pedal shaft with a hammer as it will mushroom the shaft. Use a block of wood against the end of the shaft. Drive the shaft in until the two holes line up.

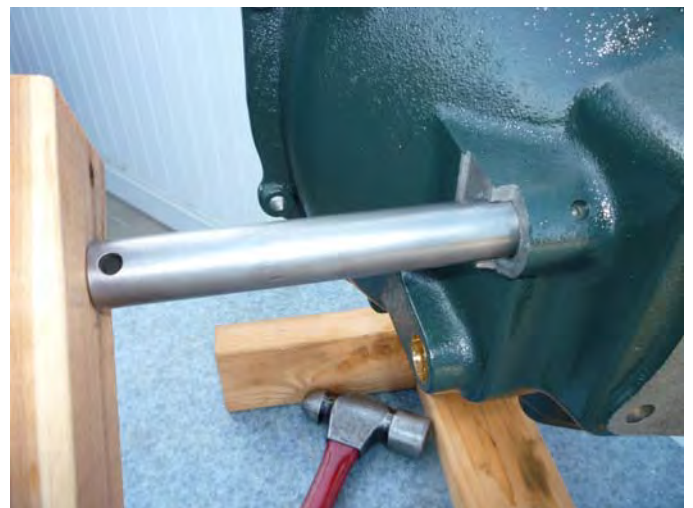
**Use a block of wood so as not to mushroom the end of the shaft with the hammer.**

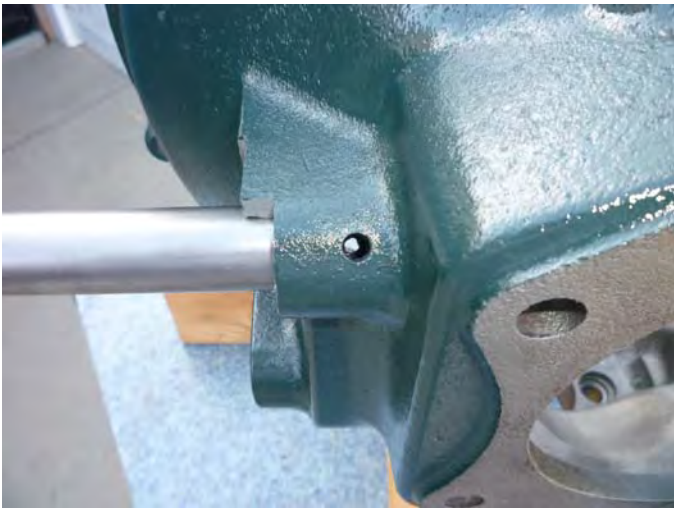
**Drive the pedal shaft in until the two holes line up.**

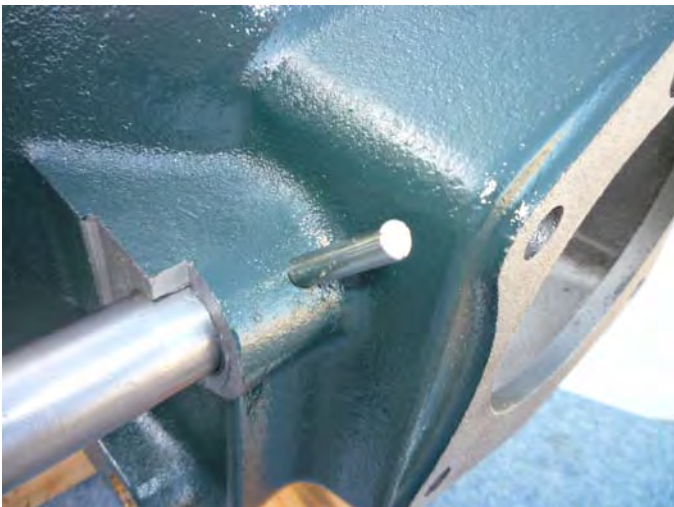
**A tapered pin is driven into the bell housing hole to lock the pedal shaft in place.**

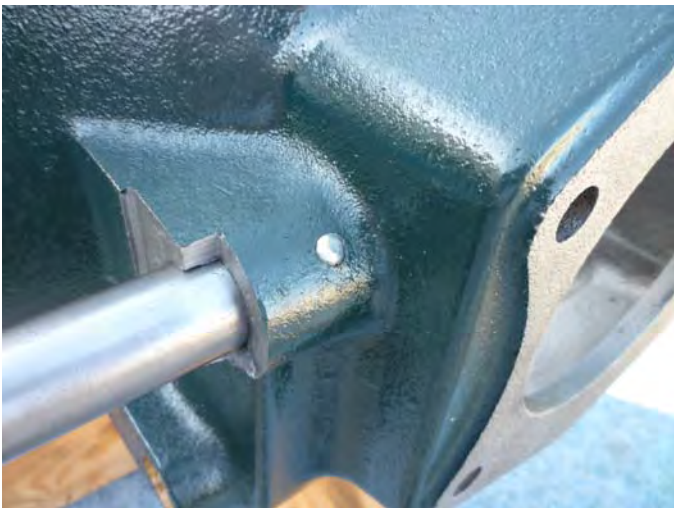
**Drive the pin in until it is flush with the housing.**

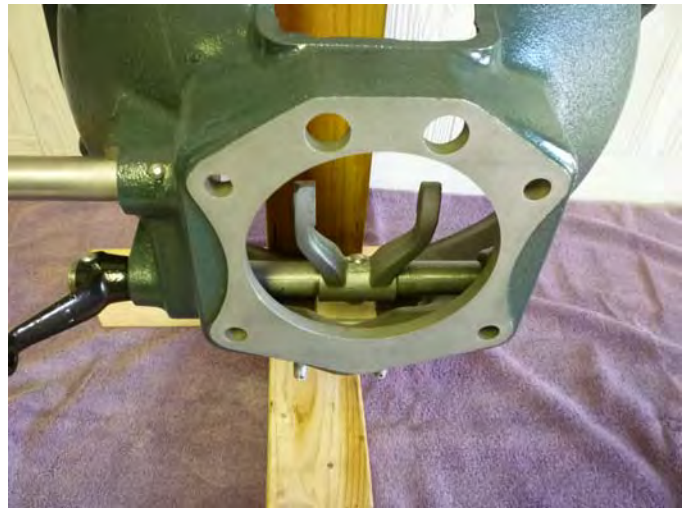
**New pedal and clutch release shafts installed. Note operating lever points to the rear when the yoke is standing vertical.**

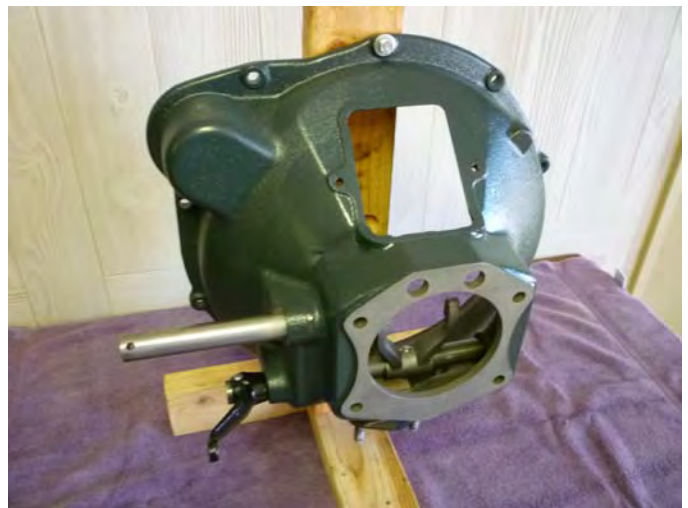
**Complete restored bell housing bead blasted and painted Ford green. New clutch release shaft, bushings, and pedal shaft have been installed. The bell housing is ready for installation in the car once the transmission has been attached.**

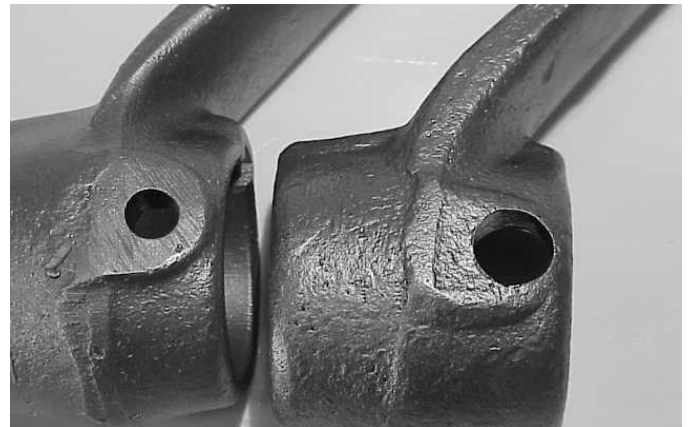
However, there is not ample material to allow the arm to be drilled out to accommodate the larger pin.

If the pin hole in the arm is enlarged the outer circumference of the new hole is almost to the edge of the arm and would certainly be prone to a crack at that point.

**The above photo shows two A7511-B arms. The arm on the left has the original 3/16" hole. The arm on the right has been drilled out to 5/16". Note how close to the edge the new hole is.**

I certainly would never drill out an old A7511-B release arm to accommodate a 5/16" locking pin, as it would be an invitation to failure of the arm.

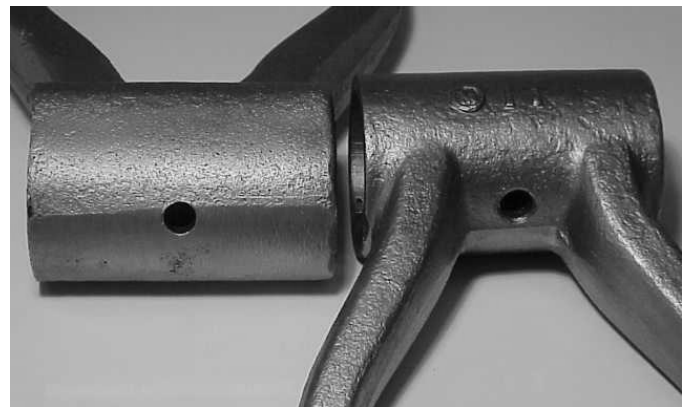
If you examine the old fork you will notice that there is ample material to accommodate a larger hole to allow use of the larger diameter pin.

**The above photo shows two A7515-B forks with the original 3/16" holes. Note there is ample material to drill the holes out to 5/16".**
