Stop Light Switch Anatomy

by Tom Endy 2023

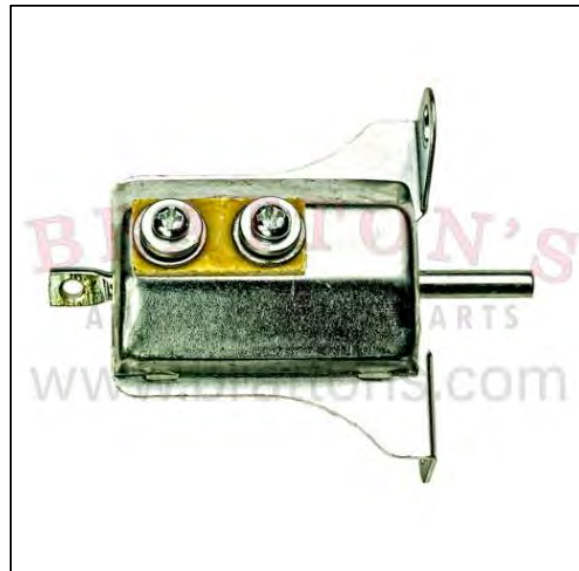
The Chinese product p/n 19410 \$10.95

Years ago the only reproductions available were made in China, and they were very poorly made and did not have bushings and could easily and did short out. If it did not take out the fuse, when one was installed, it could easily burn the car down. About 20 years ago A&L Parts Specialties located in Canton, CT began manufacturing 30-31 stop light switches per the original design. The price then was \$35 and they were originally introduced at a MAFCA meet. Al Lepore, the owner of A&L passed away in 2010, he was known as the maker of quality Model A parts. Al's son still runs the business but now only sells wholesale to the Model A suppliers.

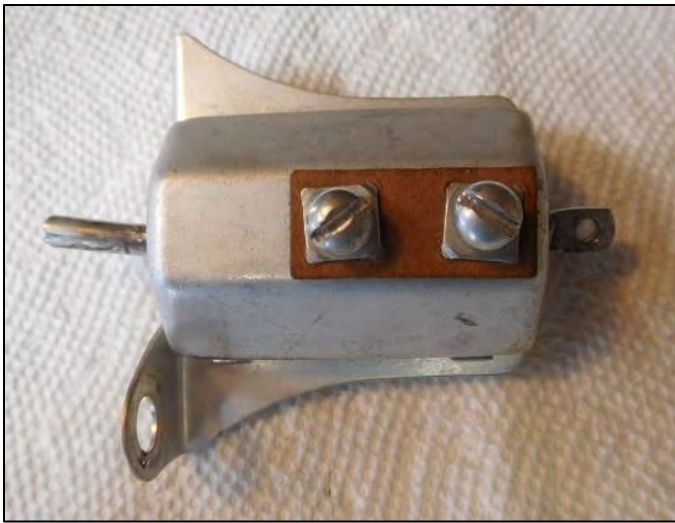
When we obtained my grandson's 1930 Tudor, it had the Chinese stop light switch installed. I took it off and threw it away and purchased the A&L stop light switch from Bratton's. During the recent removal of the transmission, "someone" was not careful and the shaft got bent. The bent shaft later jammed and there were no stop lights, not a good thing. We removed the switch and were able to straighten the shaft and restore the switch to a serviceable condition.

The bent shaft

The photo on the left shows the bent shaft. On the opposite end of the shaft there is a hole for the purpose of hooking a length of bailing wire through it and pulling the shaft to extend it and then tying it off out of the way when the transmission is removed. This will ensure the shaft does not become bent when the transmission is reinstalled.

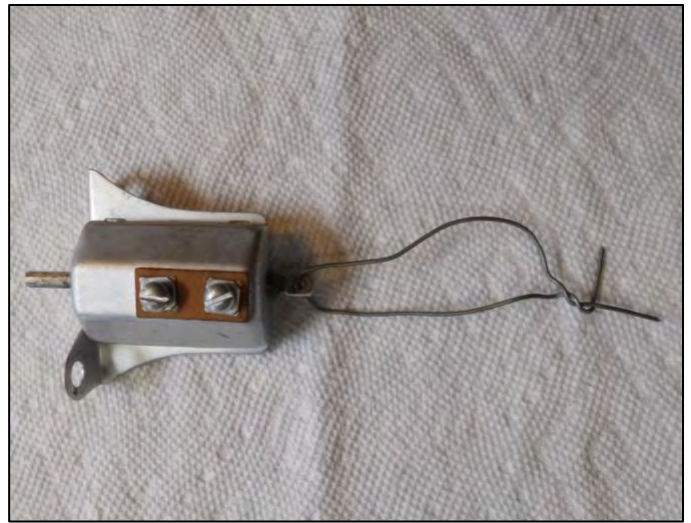
The shaft has been straightened

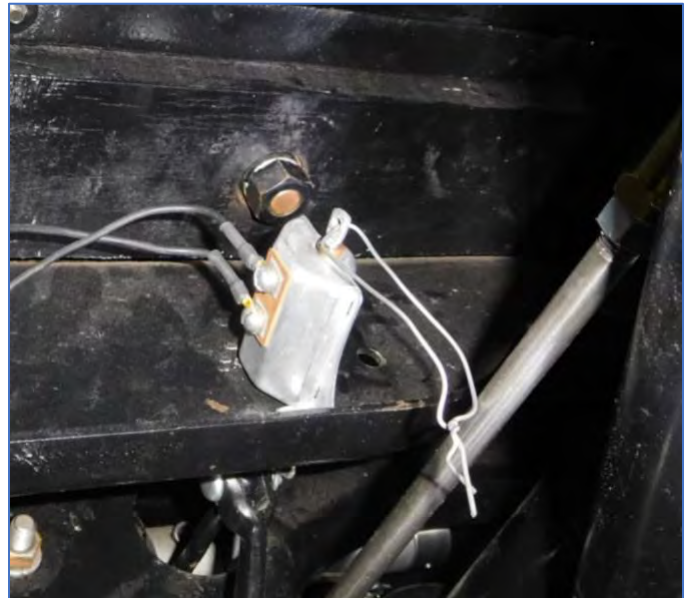
The photo on the left shows the installation of the 30-31 stop light switch. The switch is bolted to a cross member with the actuator shaft protruding through a hole in the crossmember. On the front side of the crossmember is a rod that is attached to the brake pedal that pushes on the actuator shaft. The bailing wire on the rear of the stop light switch can be temporarily connected to the E-brake cross shaft to pull the actuator shaft away from the hole in the cross member and tie it off out of the way.
