Frozen Speedo Drive Gear

by Tom Endy December 2023

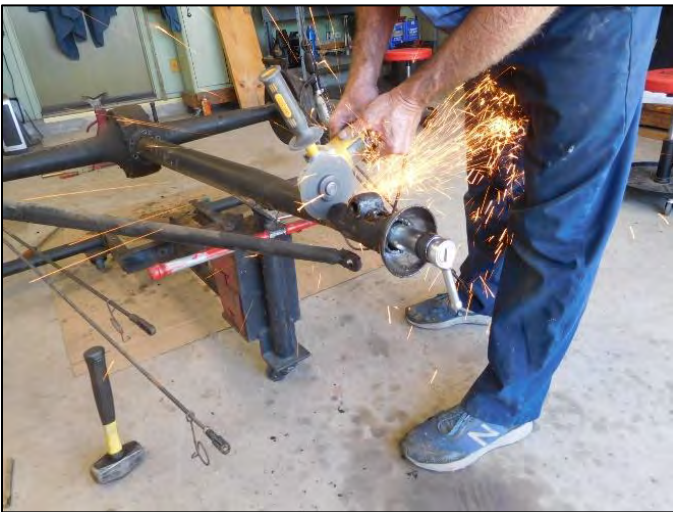
The front of the torque tube was sawed off

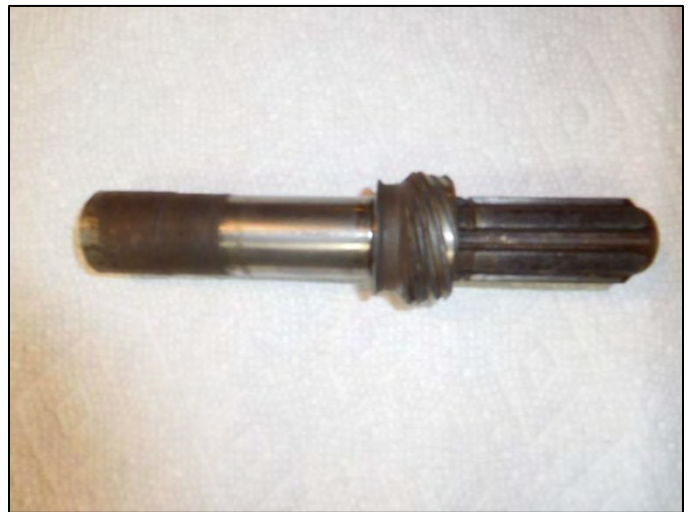
The speedo gear frozen solid to the drive shaft

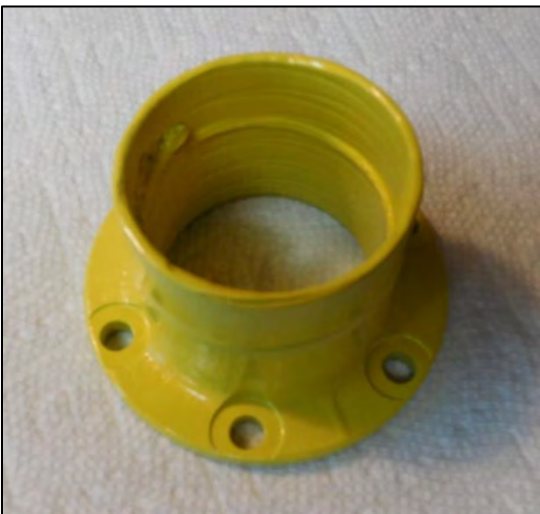
The speedo drive gear is the second item from the right (item #6) in the drawing, it should easily slide off the end of the drive shaft once the snap ring is removed and the speedo cup (#8) blow the torque tube is removed.
