Difficult Bell Housing Restoration

By Tom Endy 2025

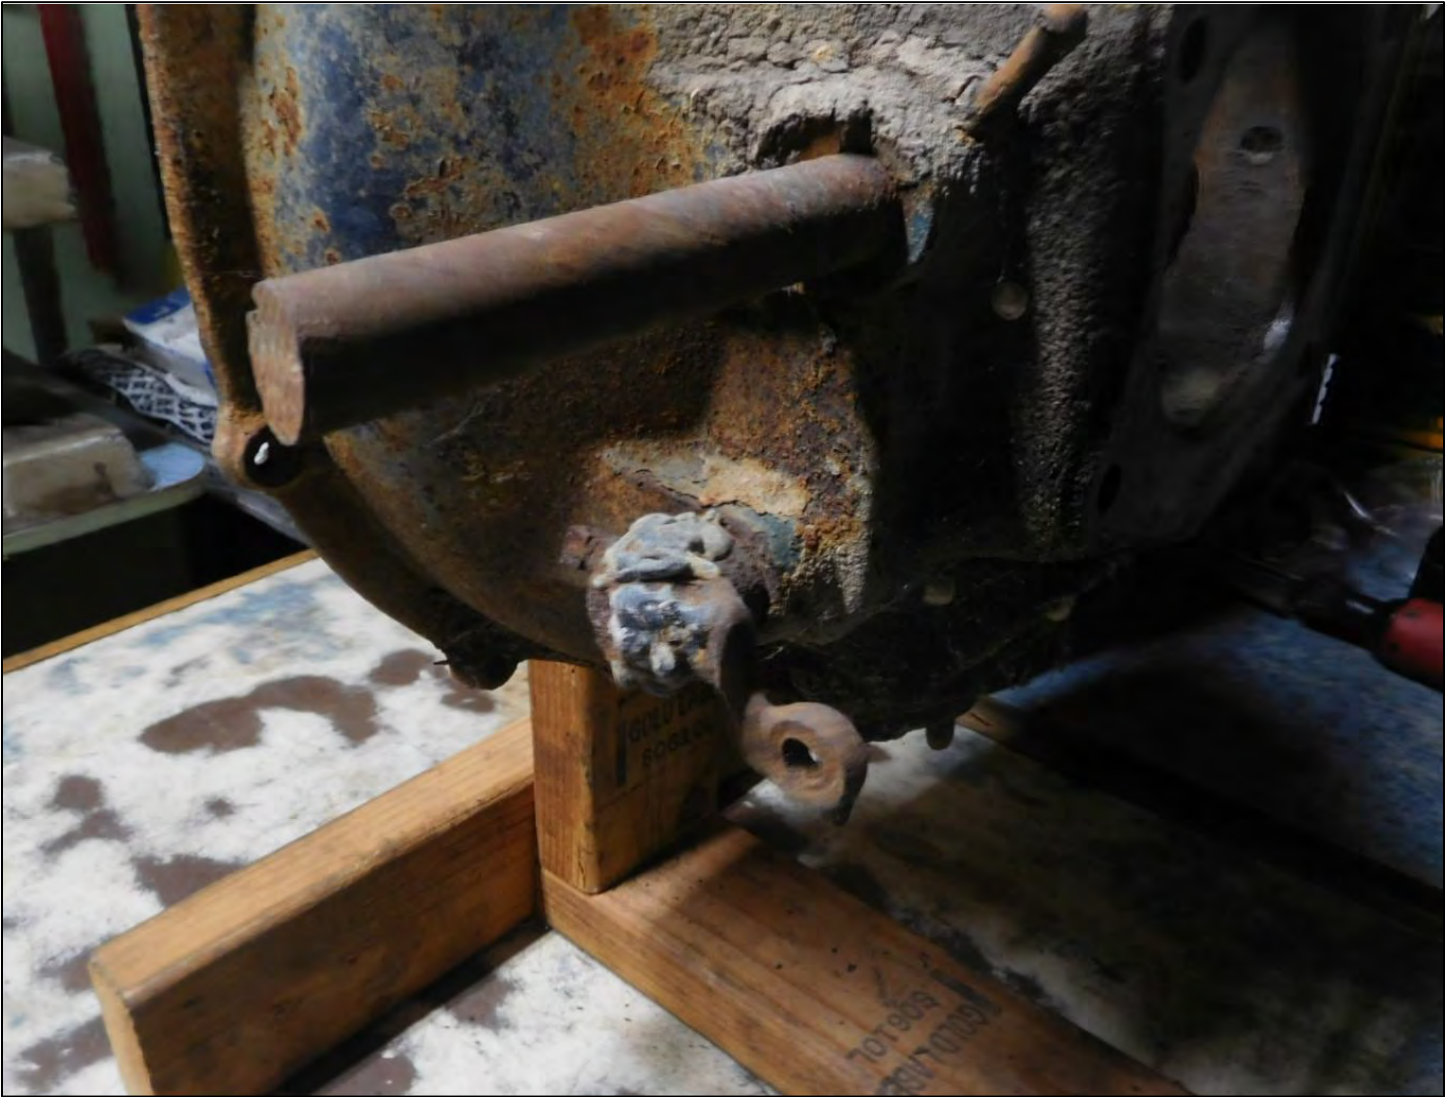
The beginning of a restoration of a very rough looking bell housing salvaged from the trash heap. Note the professional certified weld repair to the clutch release lever. Also note the locking pin on the pedal shaft. The bell housing showed signs of considerable service. The housing bushing on the clutch release lever side was worn clear through. It also showed signs of having been overhauled at some time in the past..

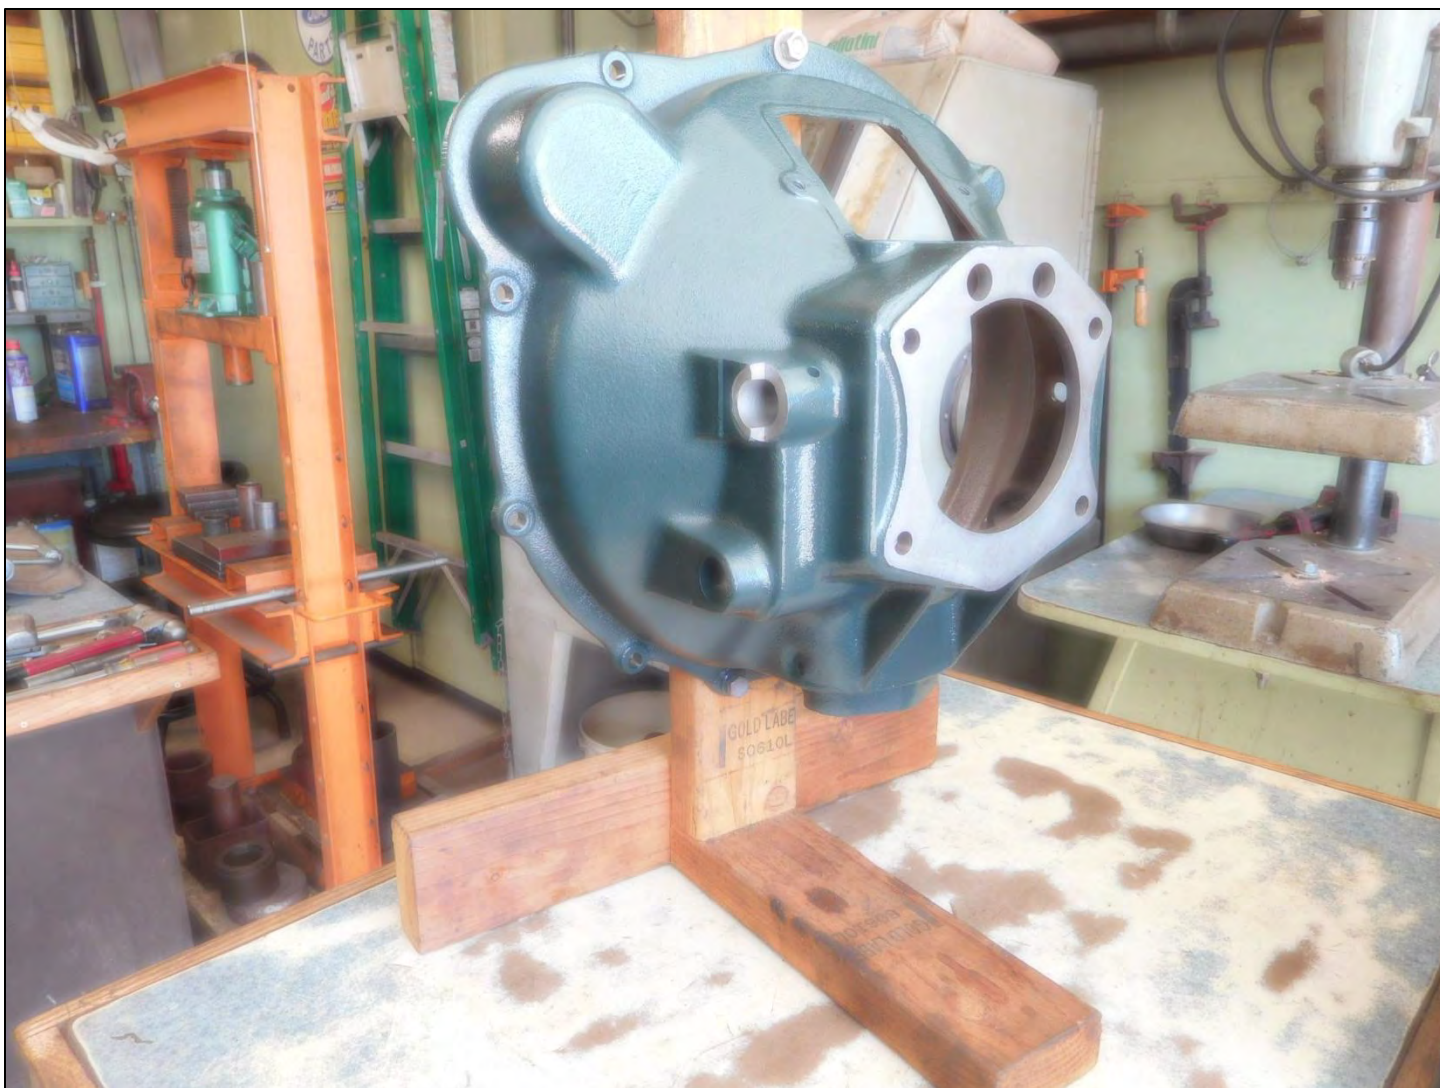
The bell housing has been bead blasted inside and out to bare metal and looks like it did in Henry's Model A plant back in the era before it was painted. The next step is to paint it ford green.

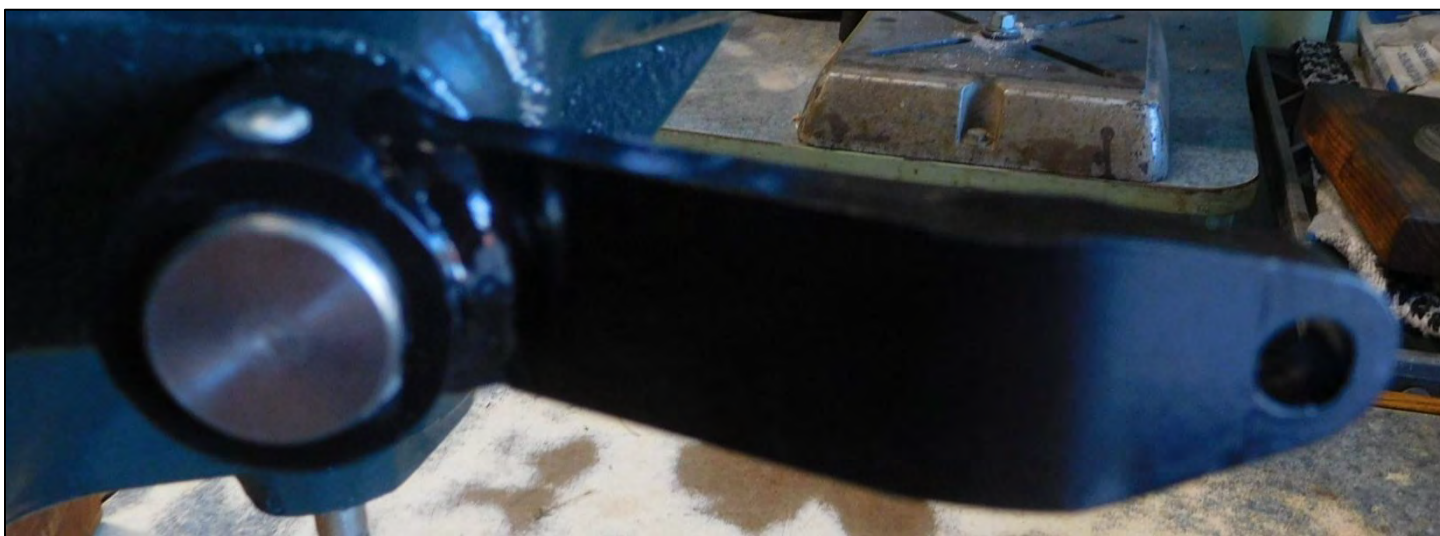
The bell housing has been painted, the outside Ford green and the inside with a clear coat. It is now ready to have all the required parts installed. The parts will all come from Bratton's Antique Auto.

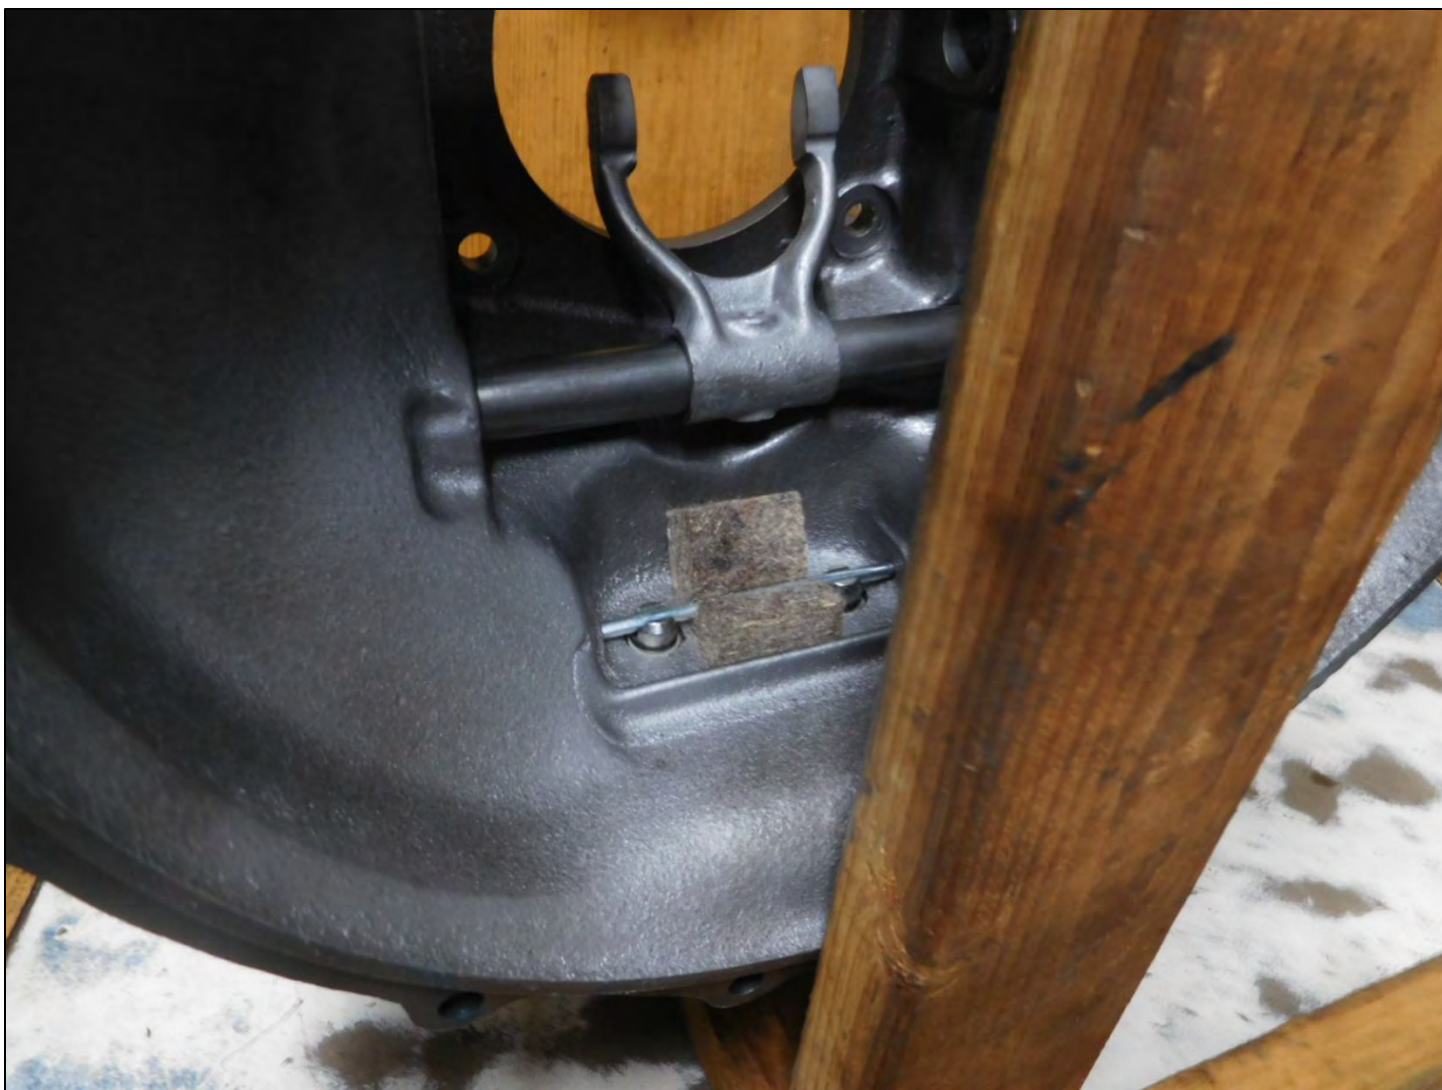
New front wishbone bolts, felt, and pin installed along with a new clutch release shaft and housing bushings.

The three radius rod parts are actually part of the front wishbone assembly. It is a good idea to install them in the bell housing while it is on a work bench rather than when it is installed in a car. I include them in all bell housing rebuilds.

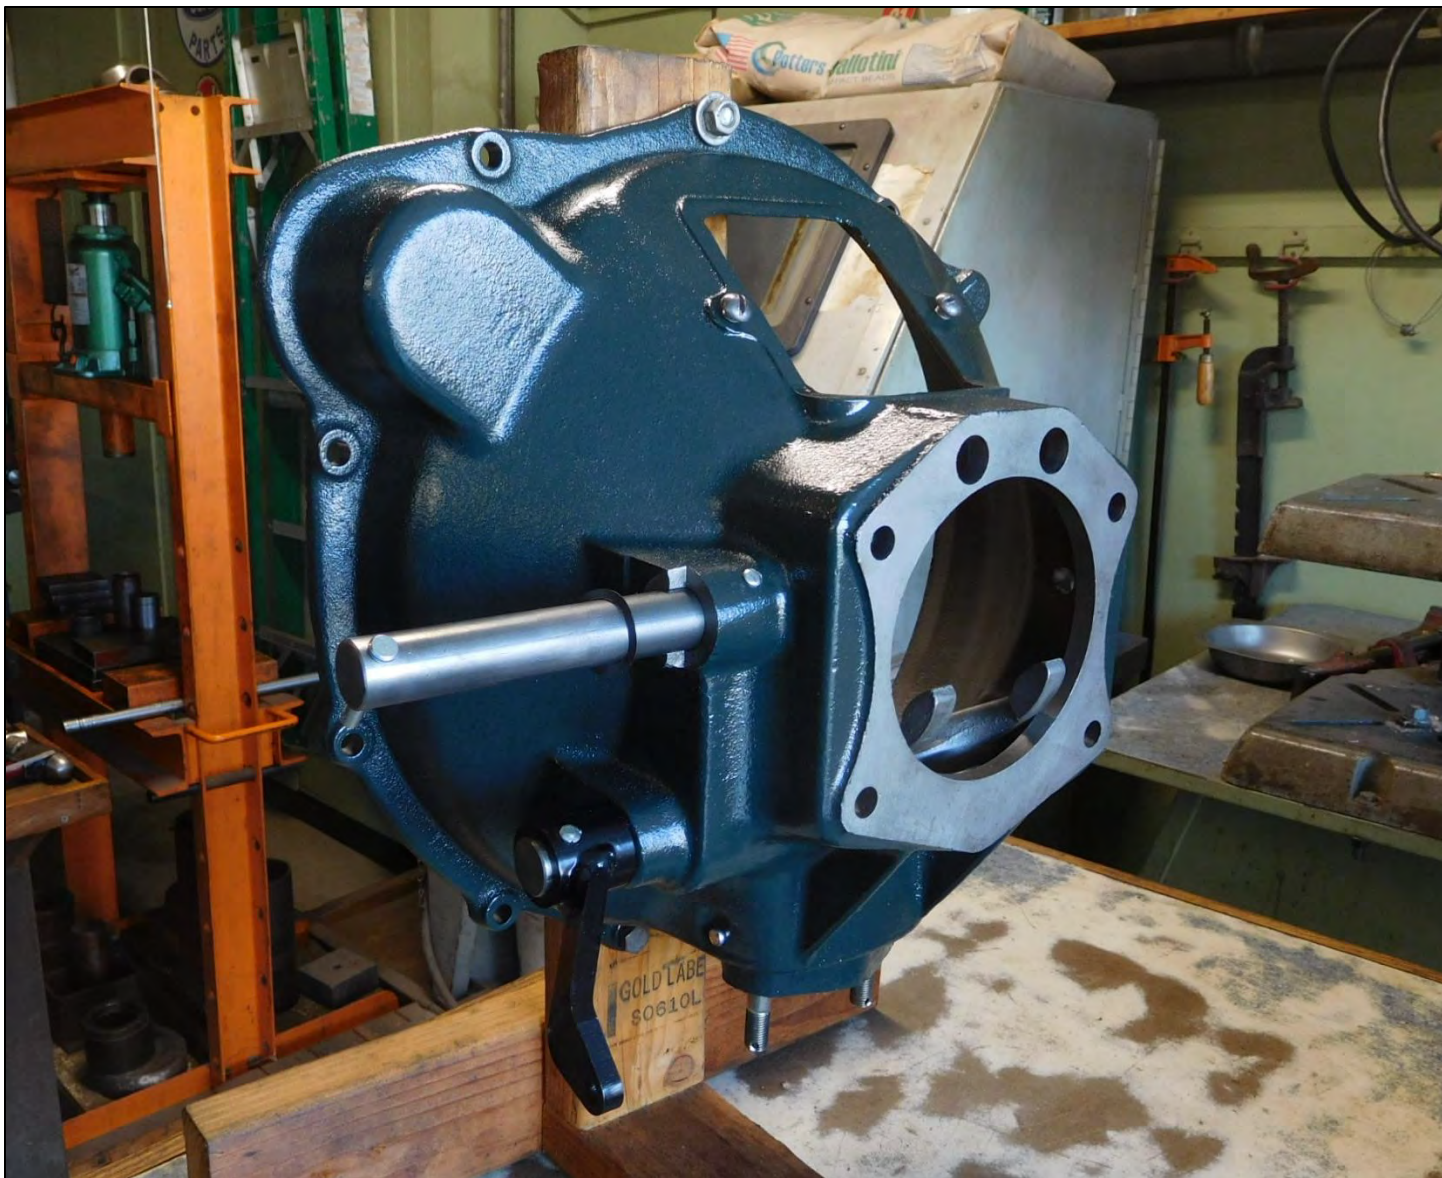
The pedal shaft has been installed.
