1928 Differential Rebuild, May 2016

by Tom Endy

This 1928 rear axle assembly was removed from a 1929 roadster pick up for rebuild; the owner is a member of the Santa Anita A's. A complete disassembly took place while the owner was present.

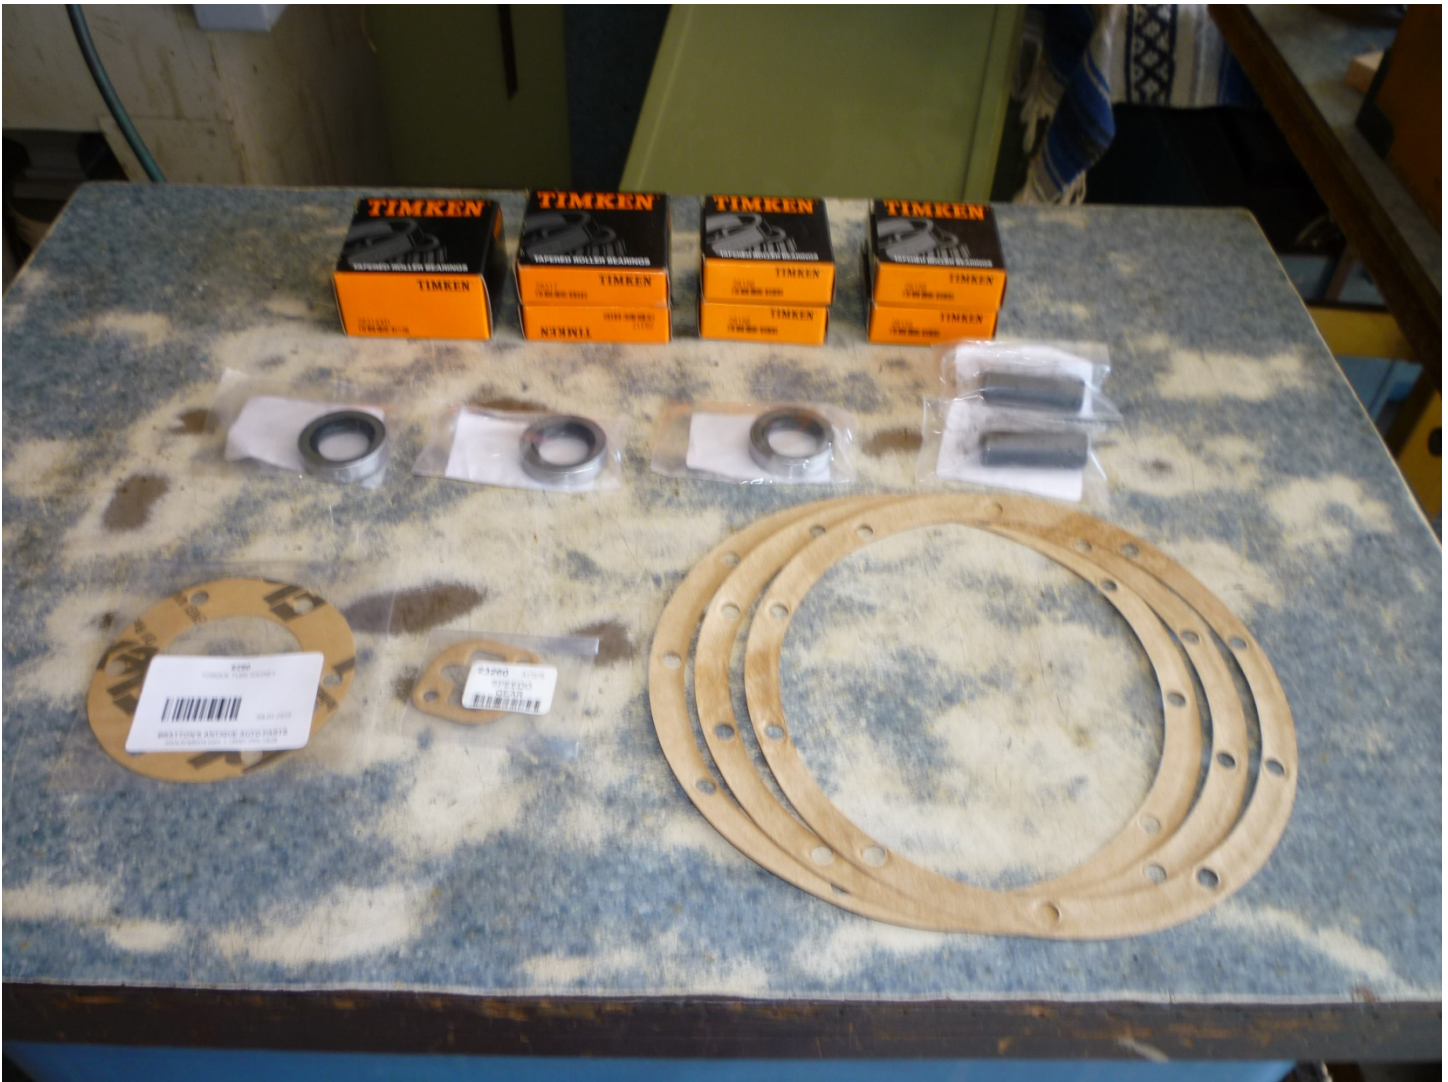
Internal parts have been cleaned up and bead blasted: Ring & Pinion, both carrier halves, spider gear assembly, nine carrier bolts & nuts, 20 banjo bolts, 6 torque tube bolts, pinion nut assembly, drive shaft nut, speedo drive gear, with thrust washer, front roller bearing race, banjo drain & Fill plugs. Snap ring and thrust washer were missing. Four new bearings, two new axle housing races, and one double banjo race will be installed during the rebuild process, all made by Timken. Three new axle and drive shaft seals will be installed. New shackle bushings will be installed in both axle housings.

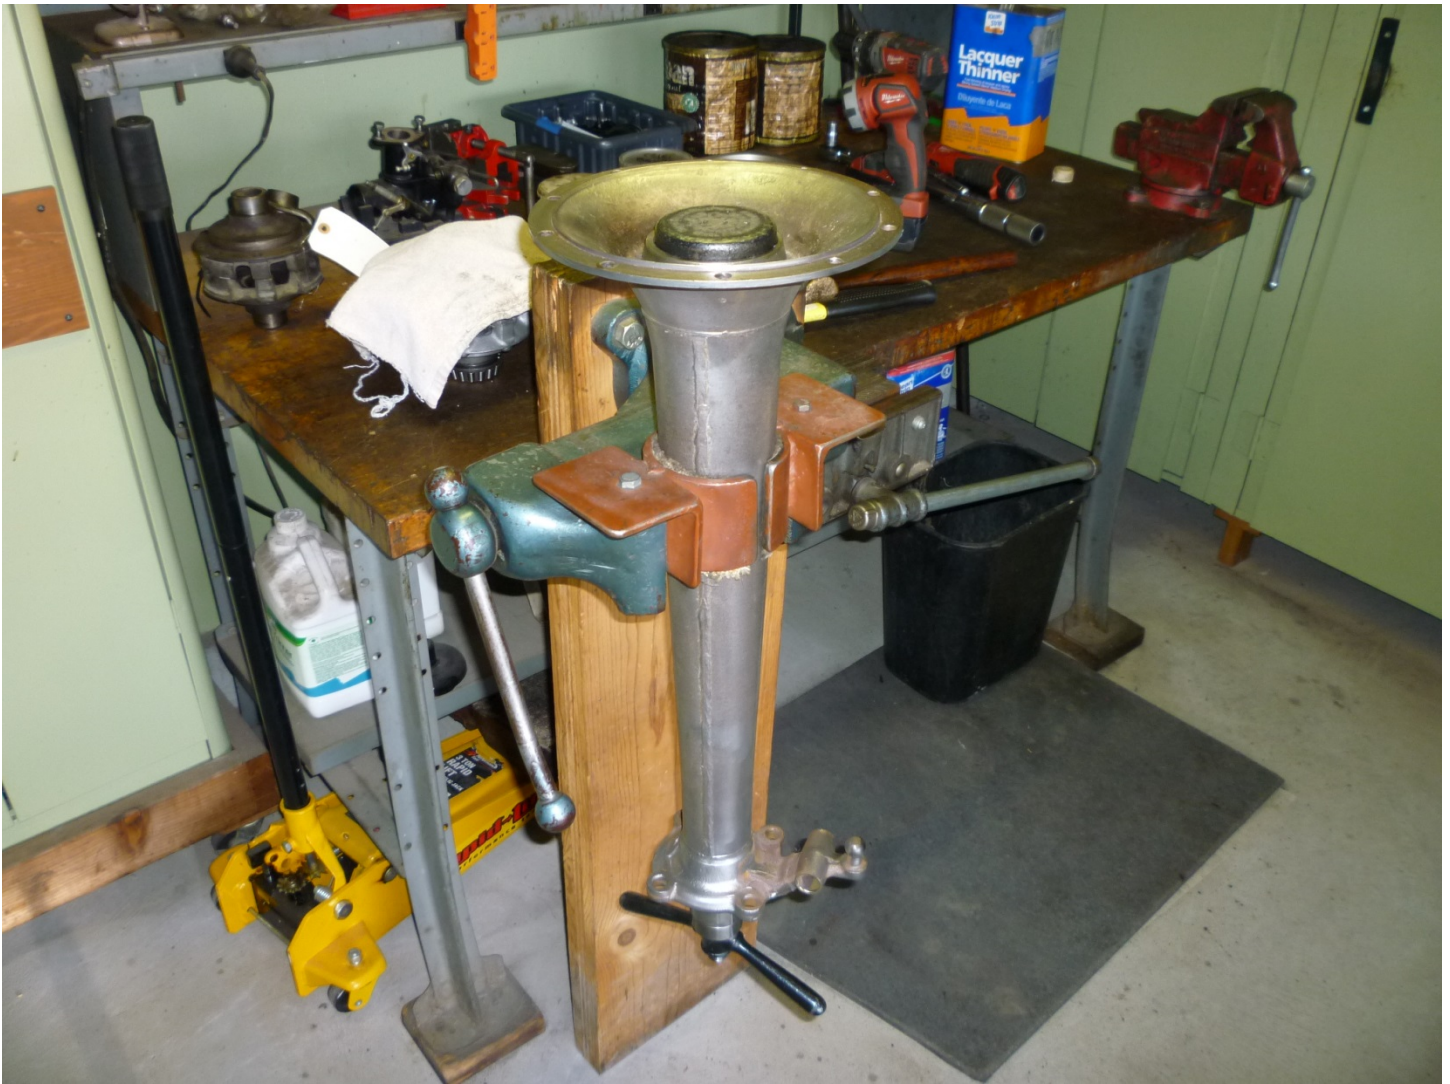
An axle housing bearing race is installed using a vintage K. R. Wilson press-in tool

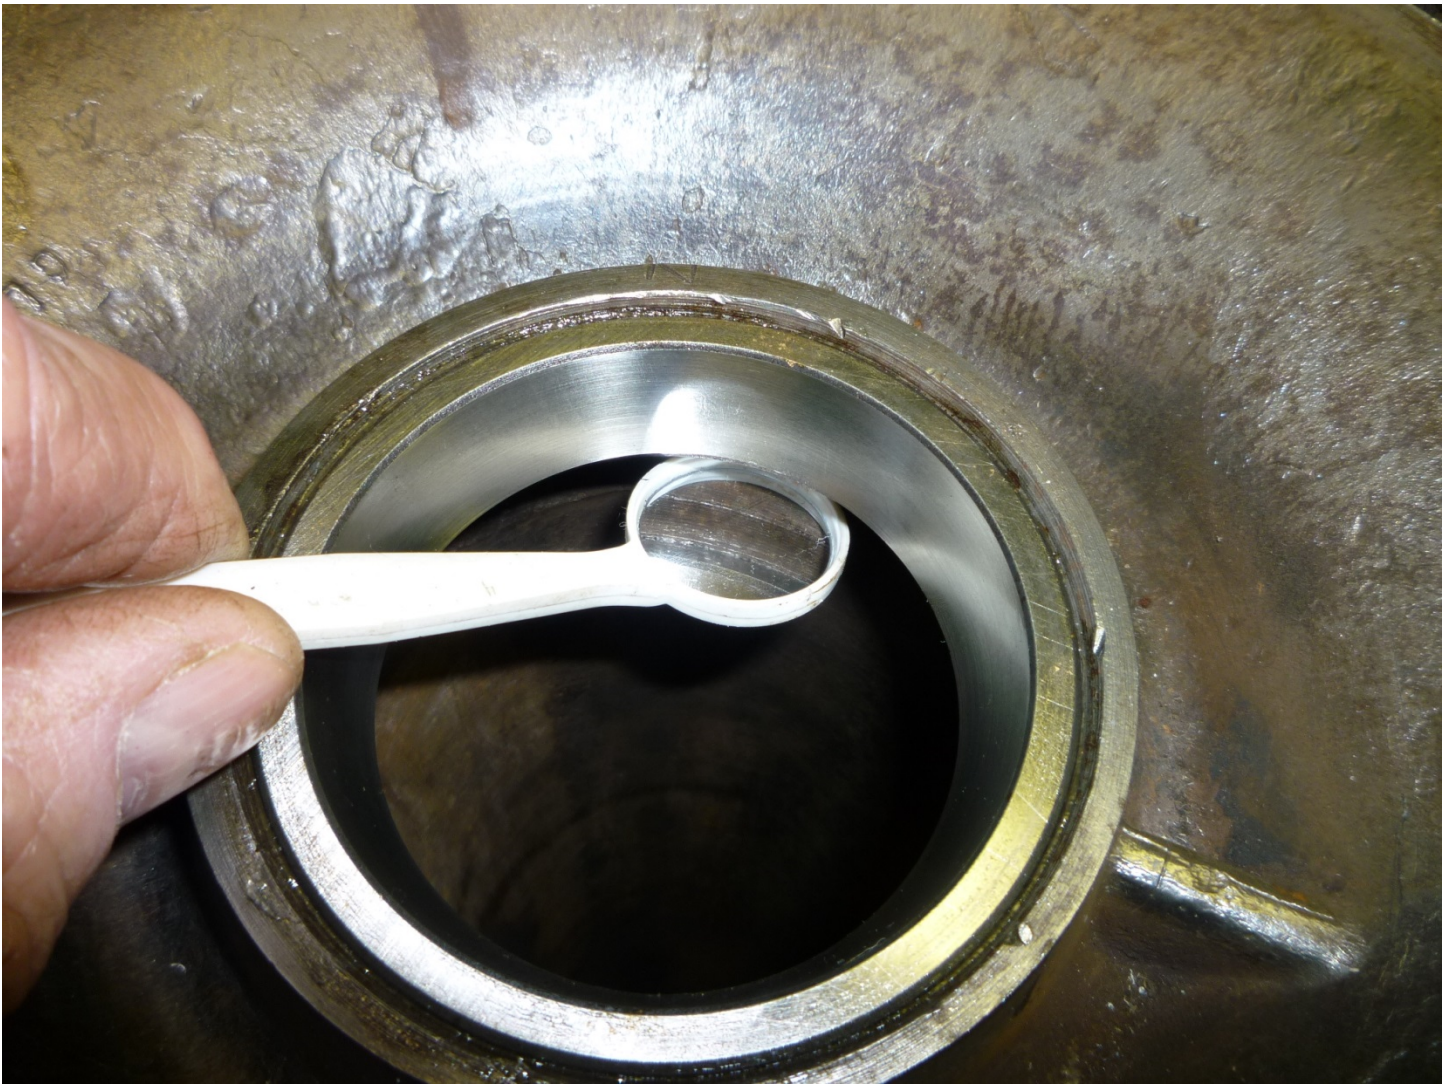
A dental mirror is used to make sure the bearing race is fully seated against the stop in the axle housing all the way around.

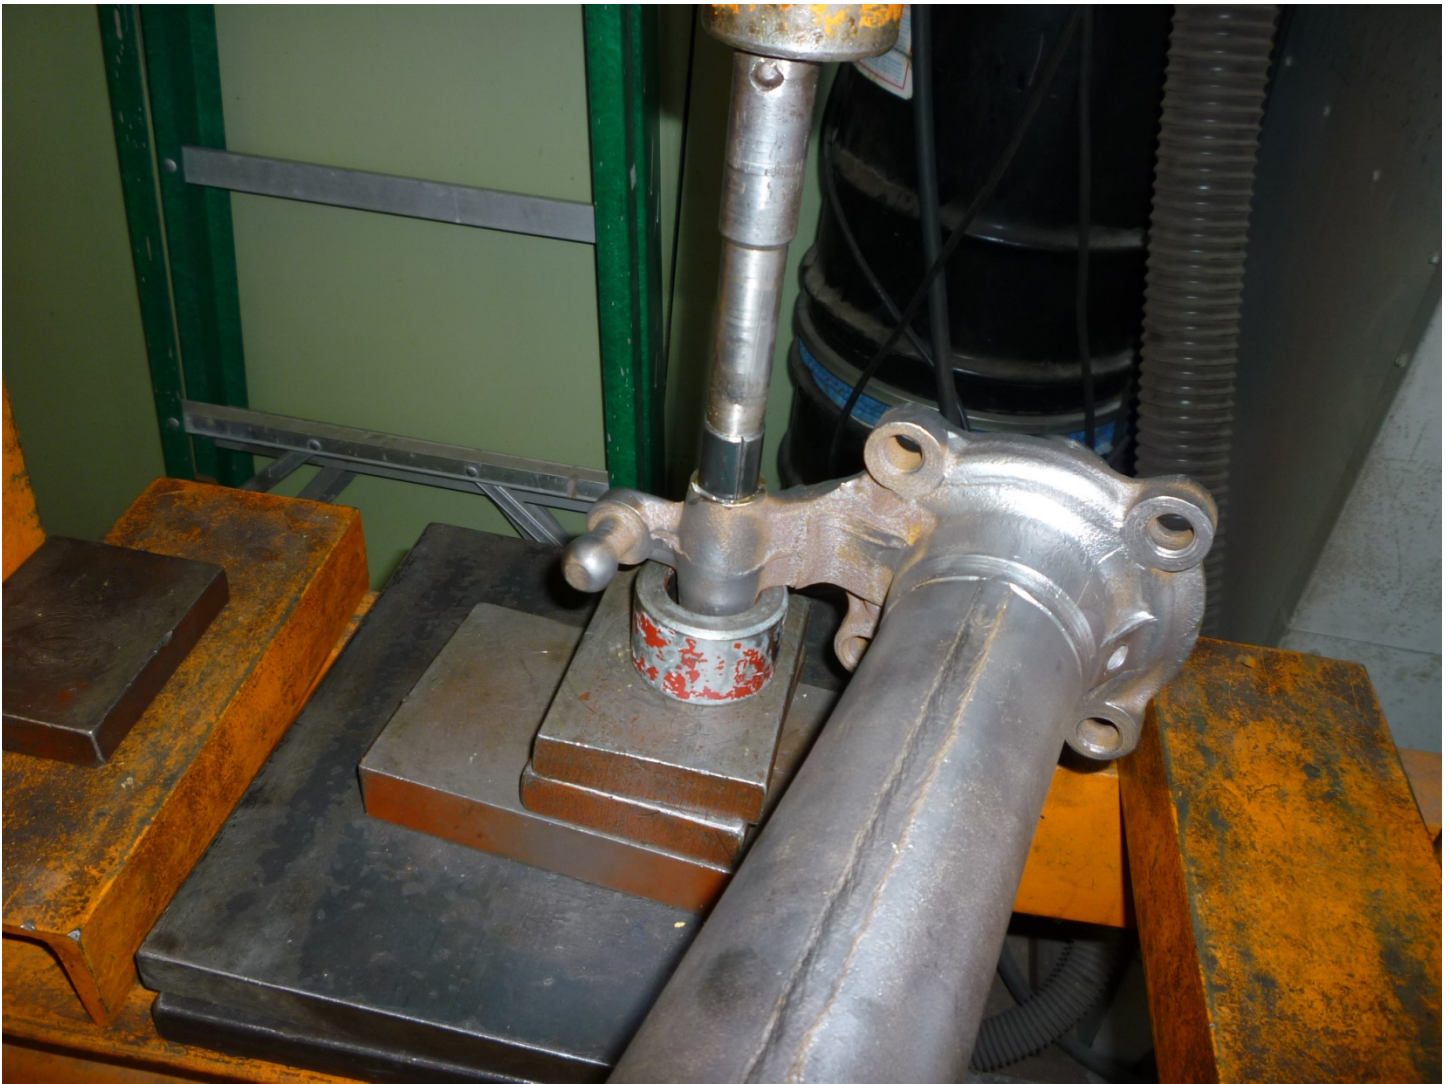
A new axle housing shackle bushing is pressed into place using a shop press and an insertion tool.

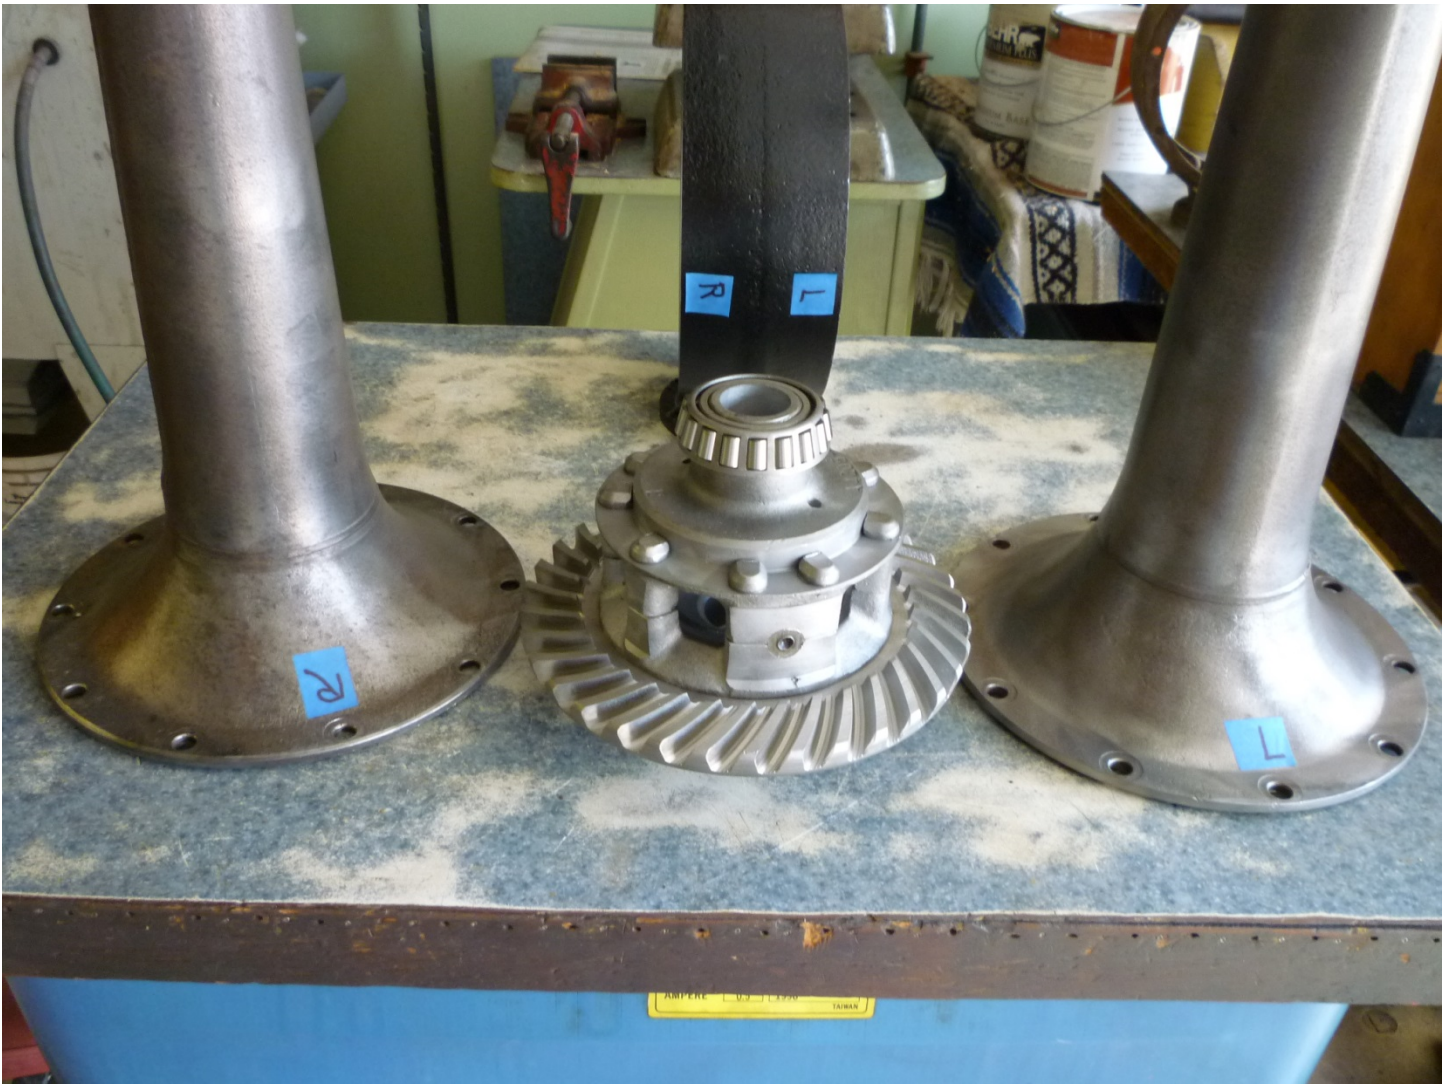
The two axle housings have been de-greased, and wire wheeled to remove surface rust. Axle housing bearing races and grease seals have been installed in both axle housings. The ring gear has been installed on the carrier along with both bearings. The pre-load tool has been placed inside the two carrier halves. A new double bearing race has been installed in a 29-30 banjo. The housing pieces have been marked left and right for easy reference when doing the carrier pre-load adjustment, which will require numerous trial and error assembly efforts.

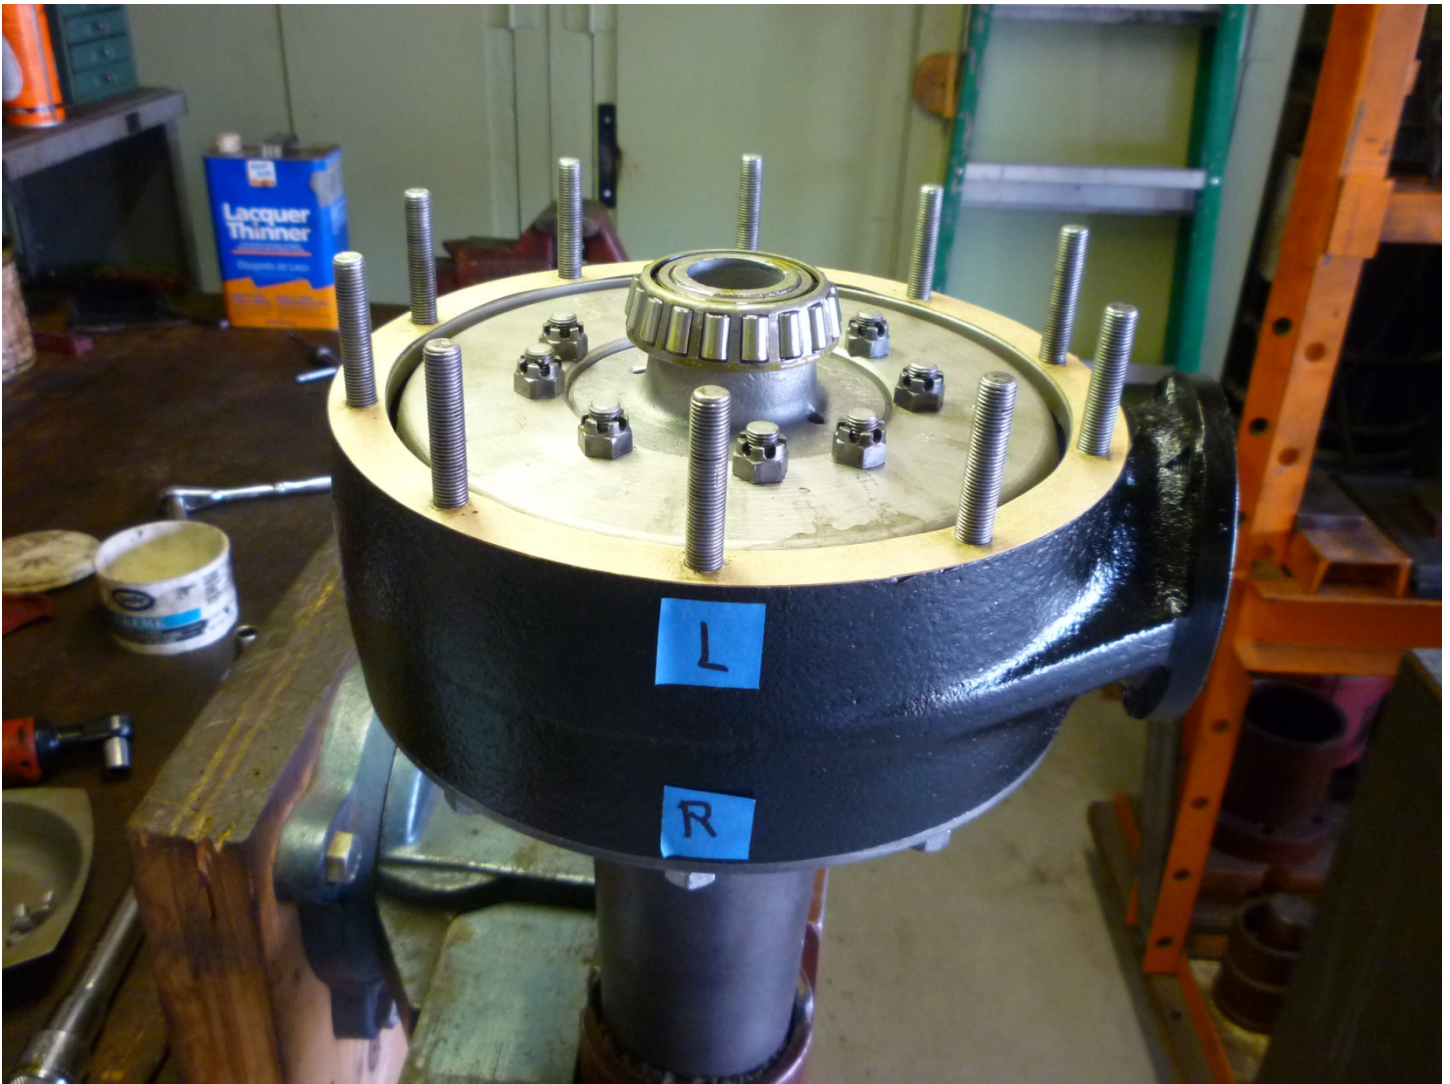
The banjo has been attached to the right axle housing and torqued to 35 ft. lbs. The carrier assembly is set in place in the banjo and several banjo gaskets are placed on the left side of the banjo and secured with 3/8-18 positioning studs. The left axle housing will be placed down over the studs and replaced with banjo bolts and torqued to 35 ft. lbs. This will be the first trial and error attempt to determine how many gaskets will be required to establish the proper pre-load.

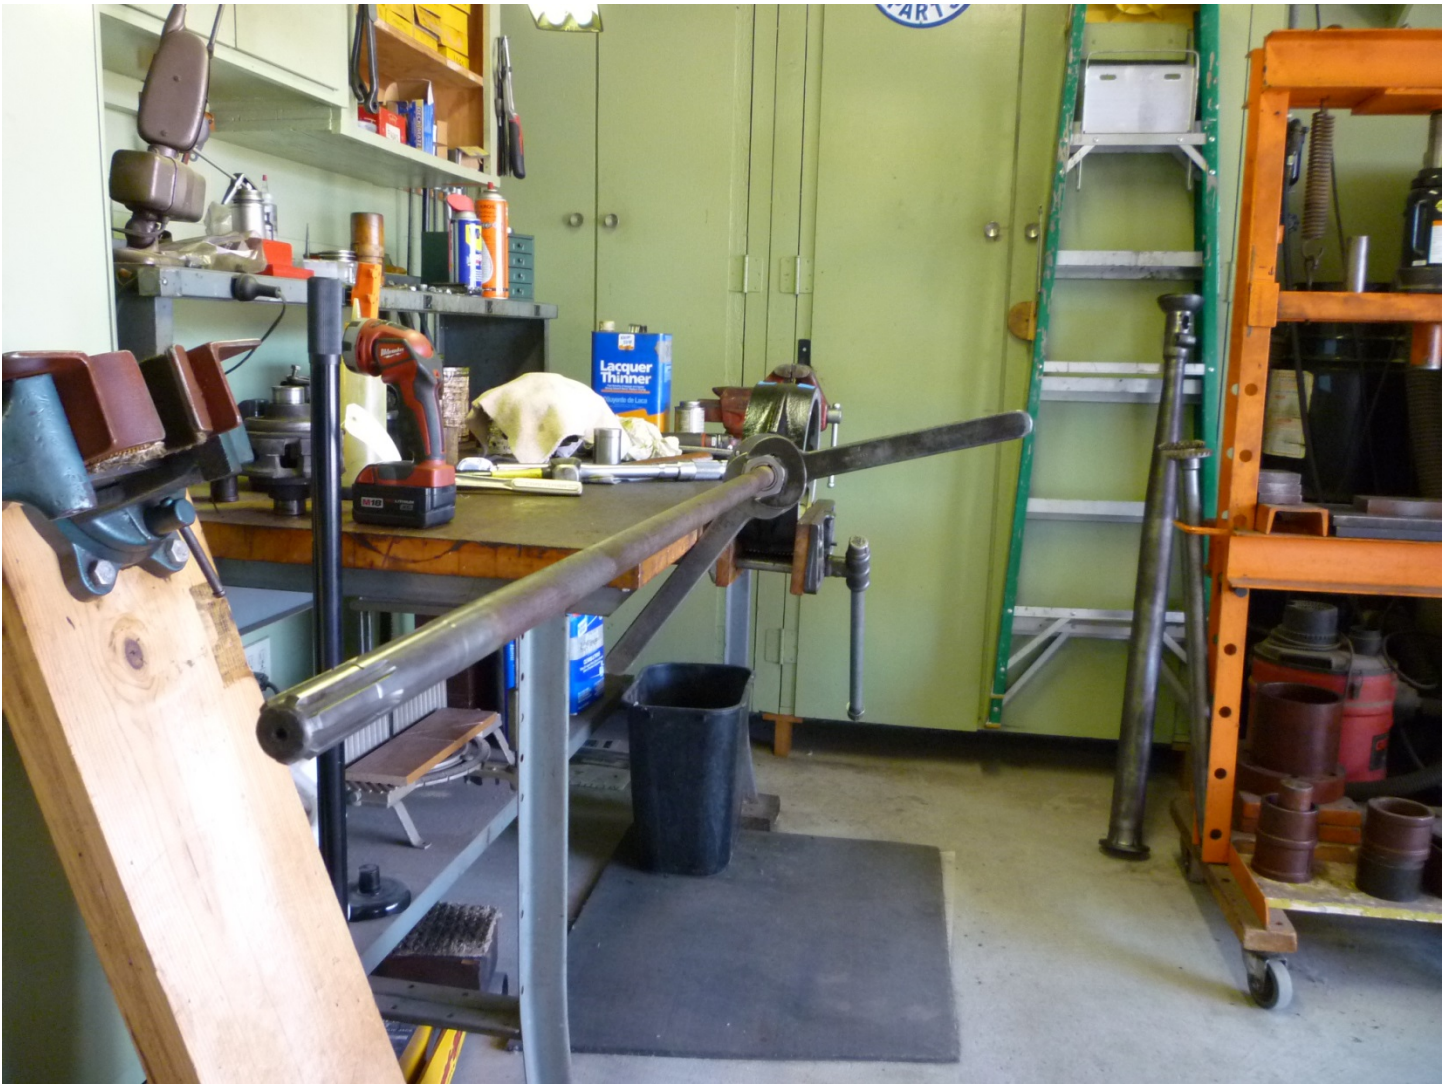
The pinion assembly has been installed along with the drive shaft. The drive shaft is torqued to nominal 100 ft. lbs. The pre-load on the pinion bearings is established by adjusting the two large nuts on the pinion gear sleeve.

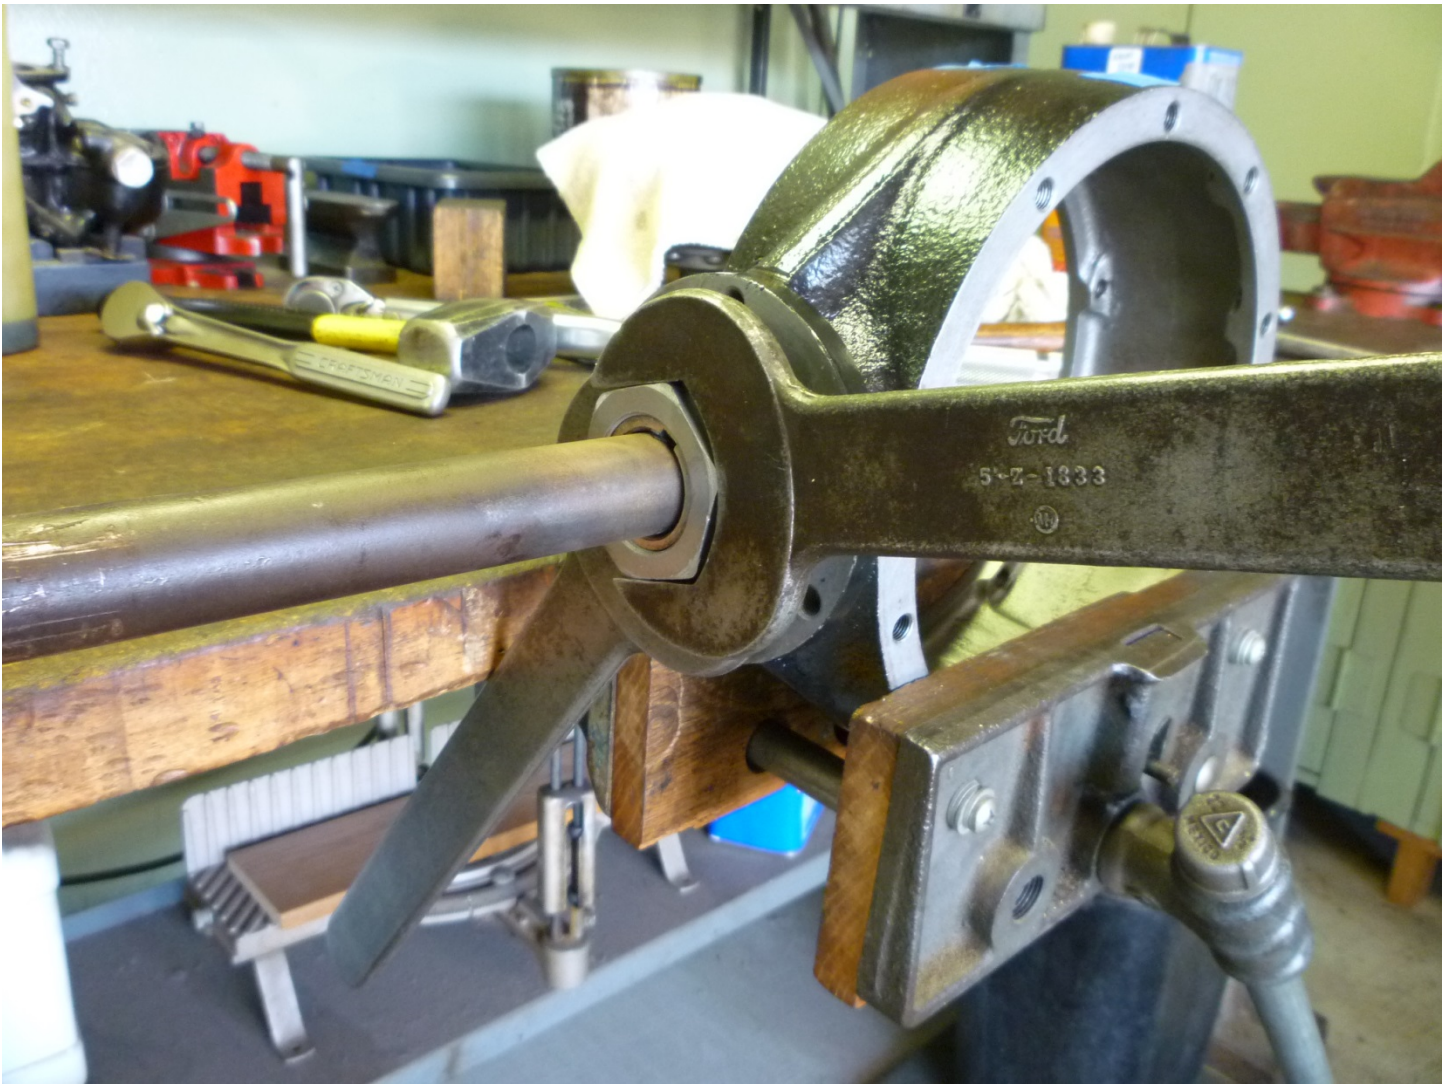
Ford factory wrenches are used on the two large nuts. The rear nut is tightened to establish pre-load, the front nut locks the first nut. The pre-load on this unit was set at 15 in. lbs.

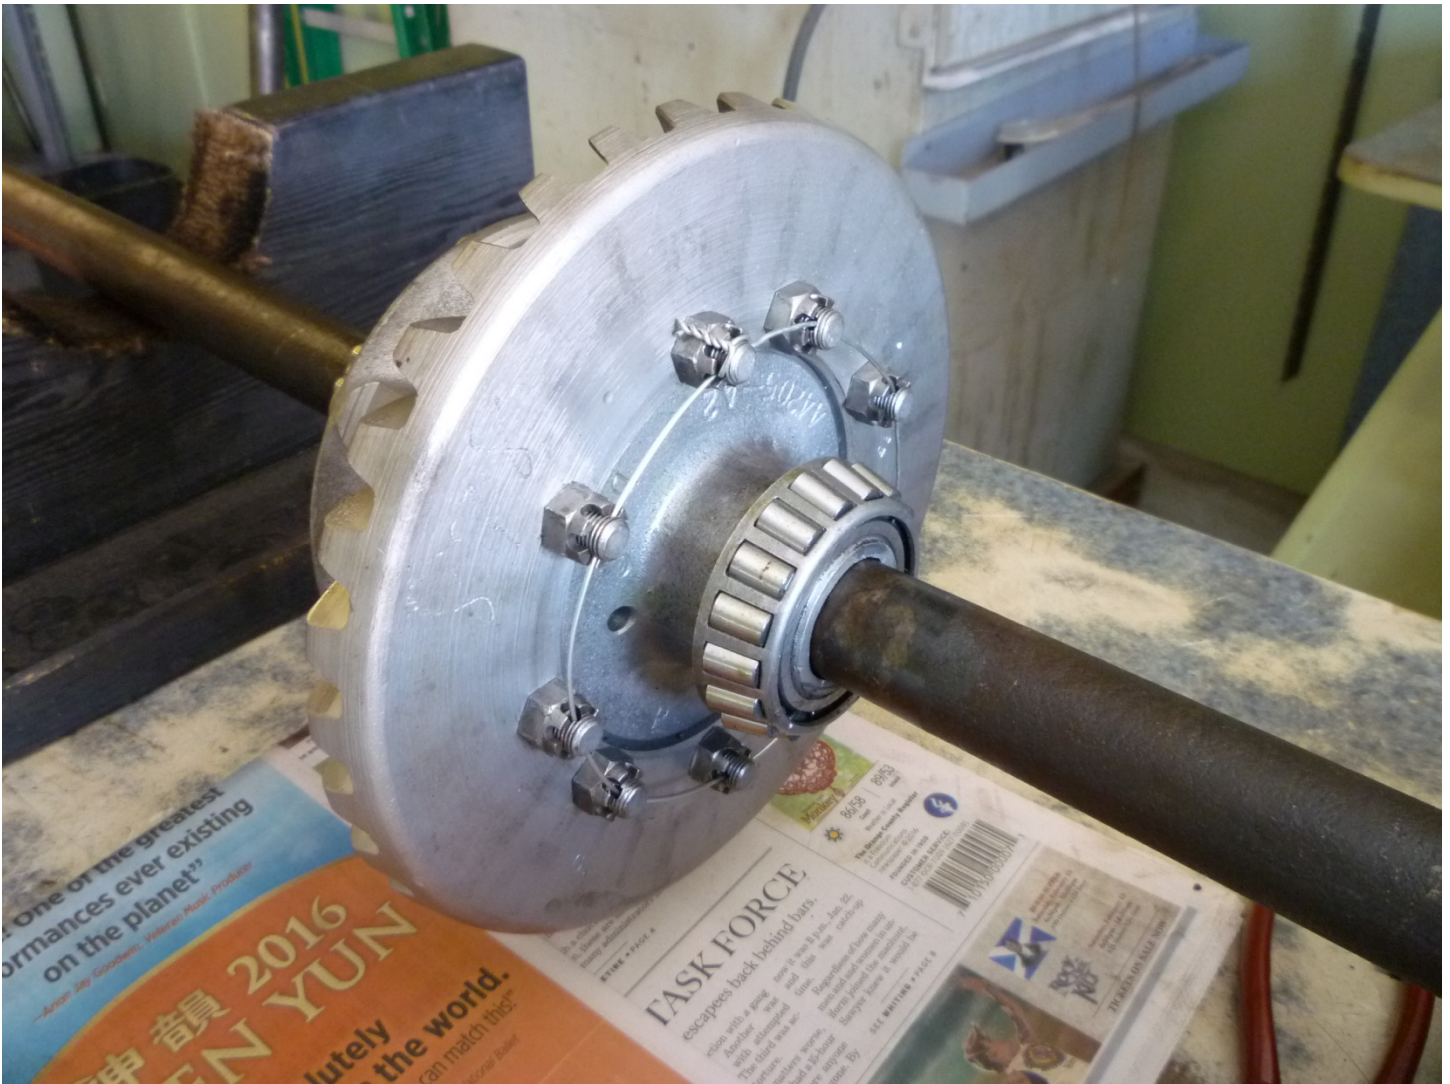
The carrier has the spider gears and both axles installed. The nine bolts and nuts are torqued to 35 ft. lbs. and safety wired. This carrier is an early one with the nuts on the ring gear side and dome headed bolts locking in place on the other side. The later carriers are different with the rectangular head of the bolts resting on the ring gear.

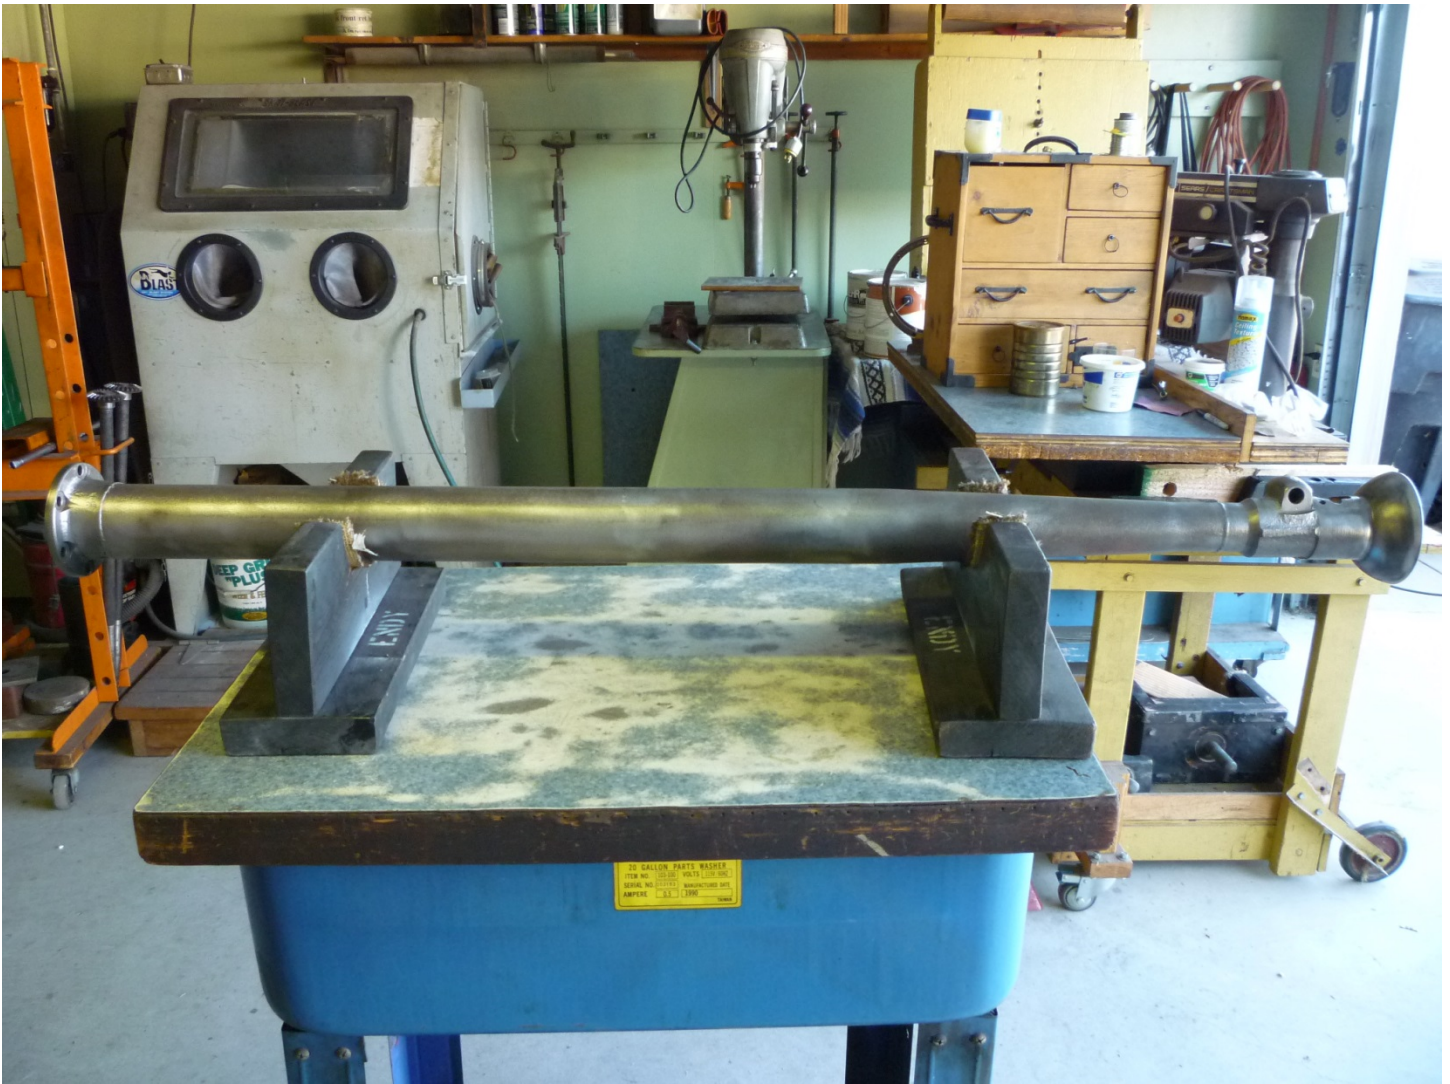
The torque tube has been cleaned up and wire wheeled to remove surface rust. The roller bearing race sleeve and the old grease seal have been removed.

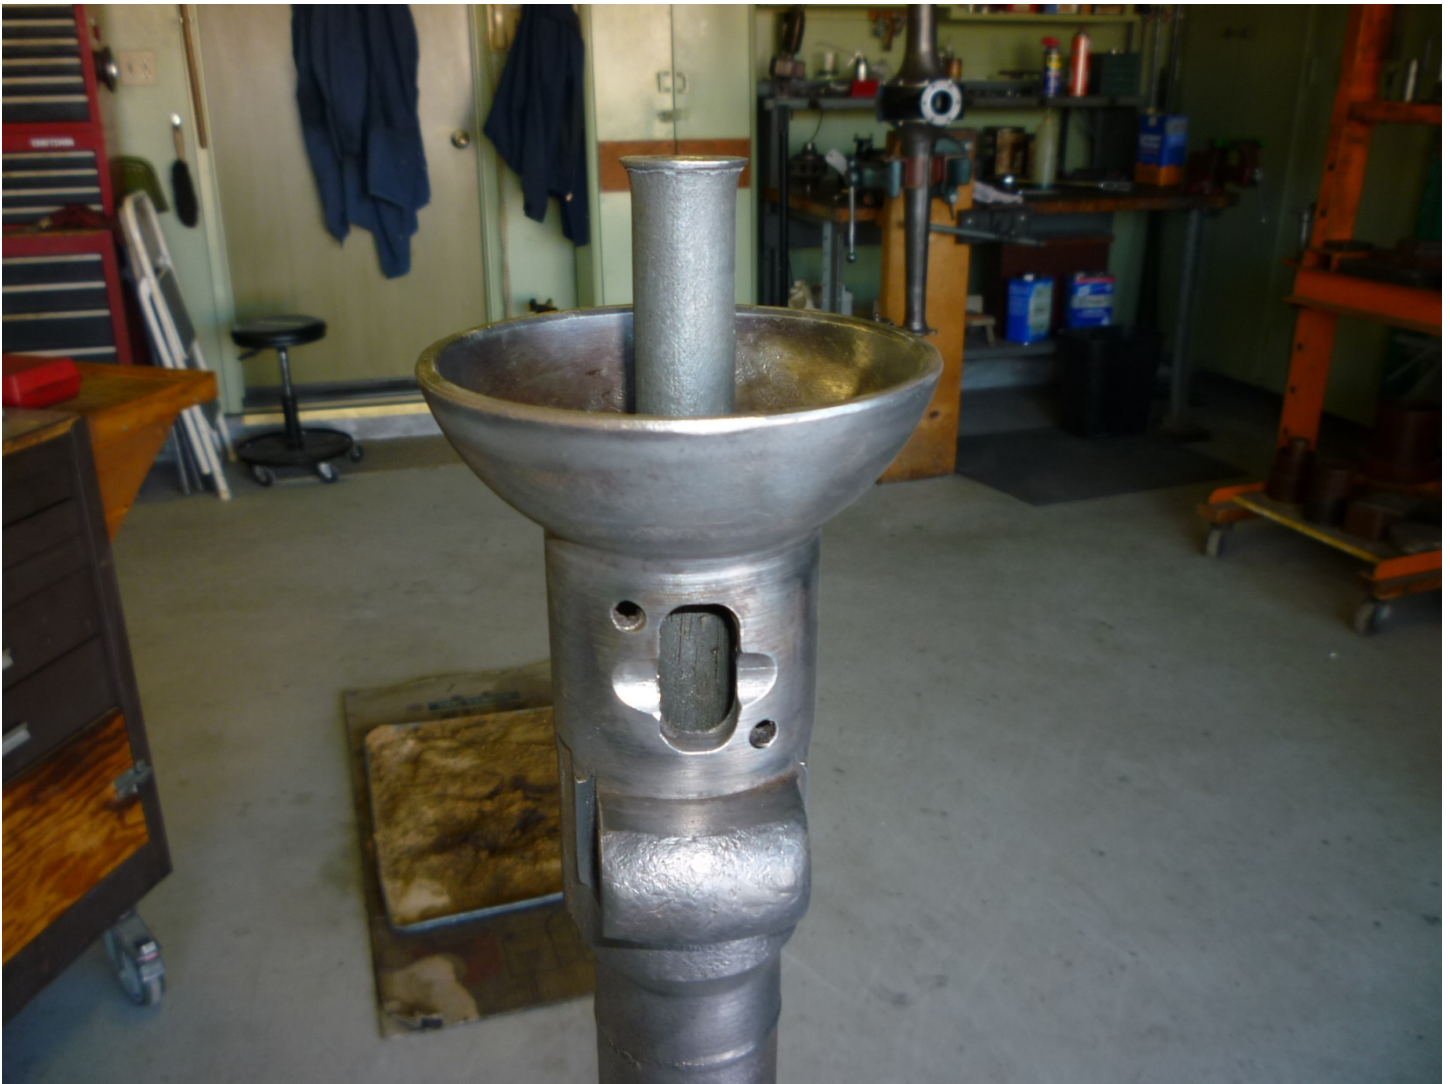
A new grease seal is driven into place with an insertion tool. The seal must be installed first before the bearing race sleeve is installed.

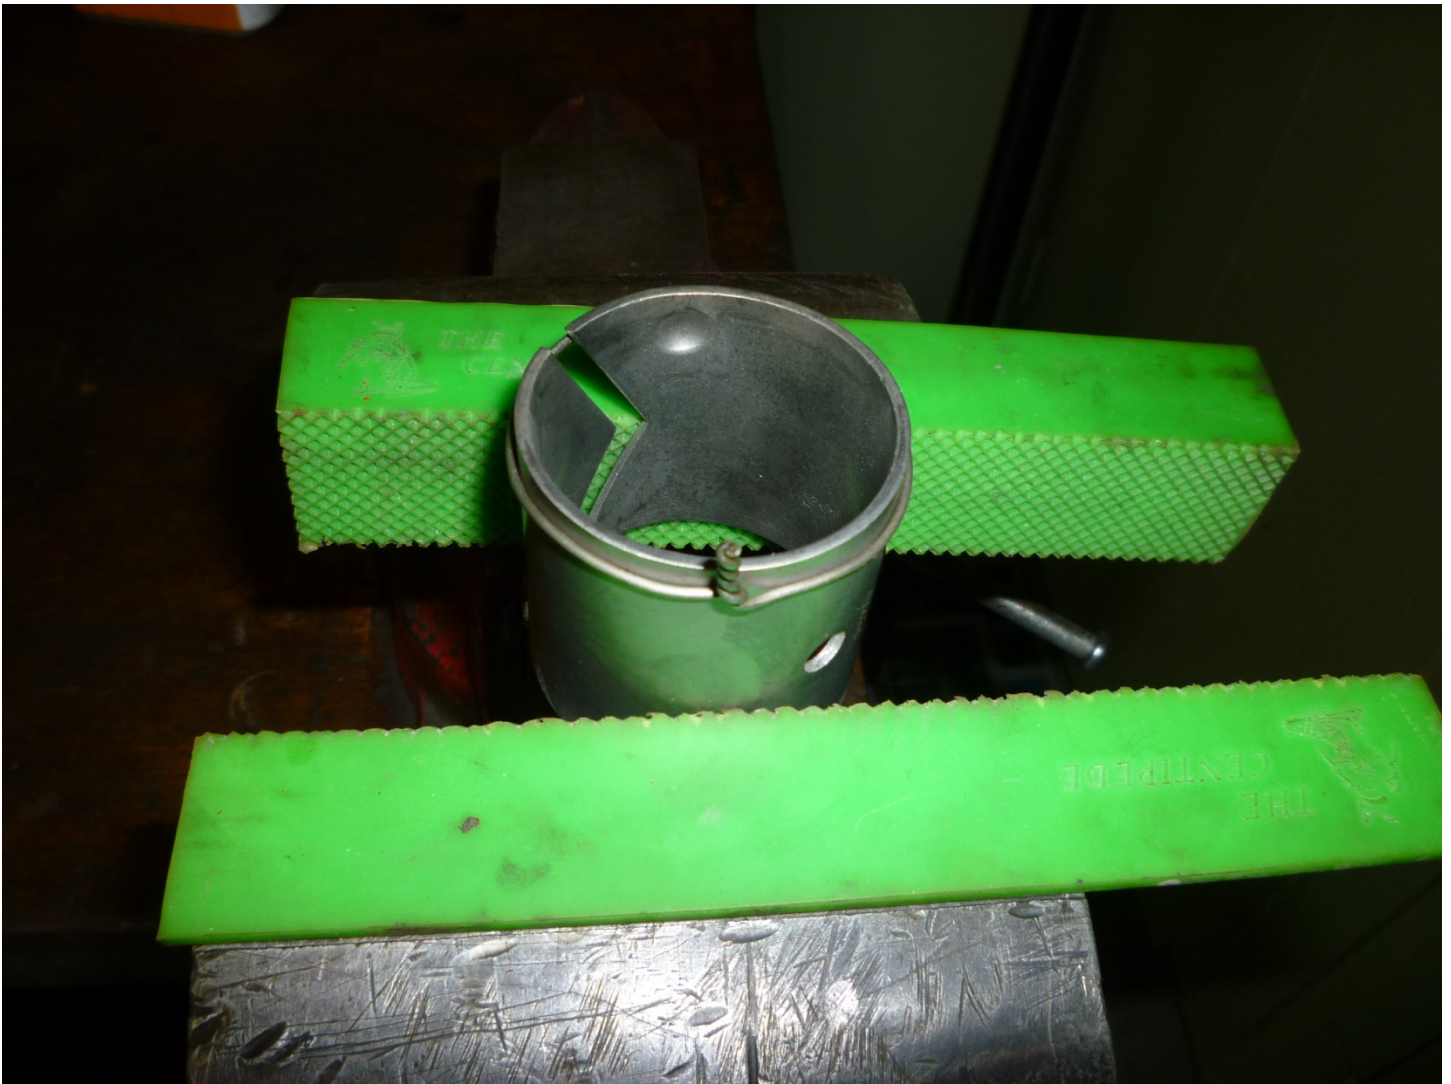
The roller bearing race sleeve is prepared for installation by squeezing it in a vice and wrapping it with safety wire to slightly reduce the circumference.

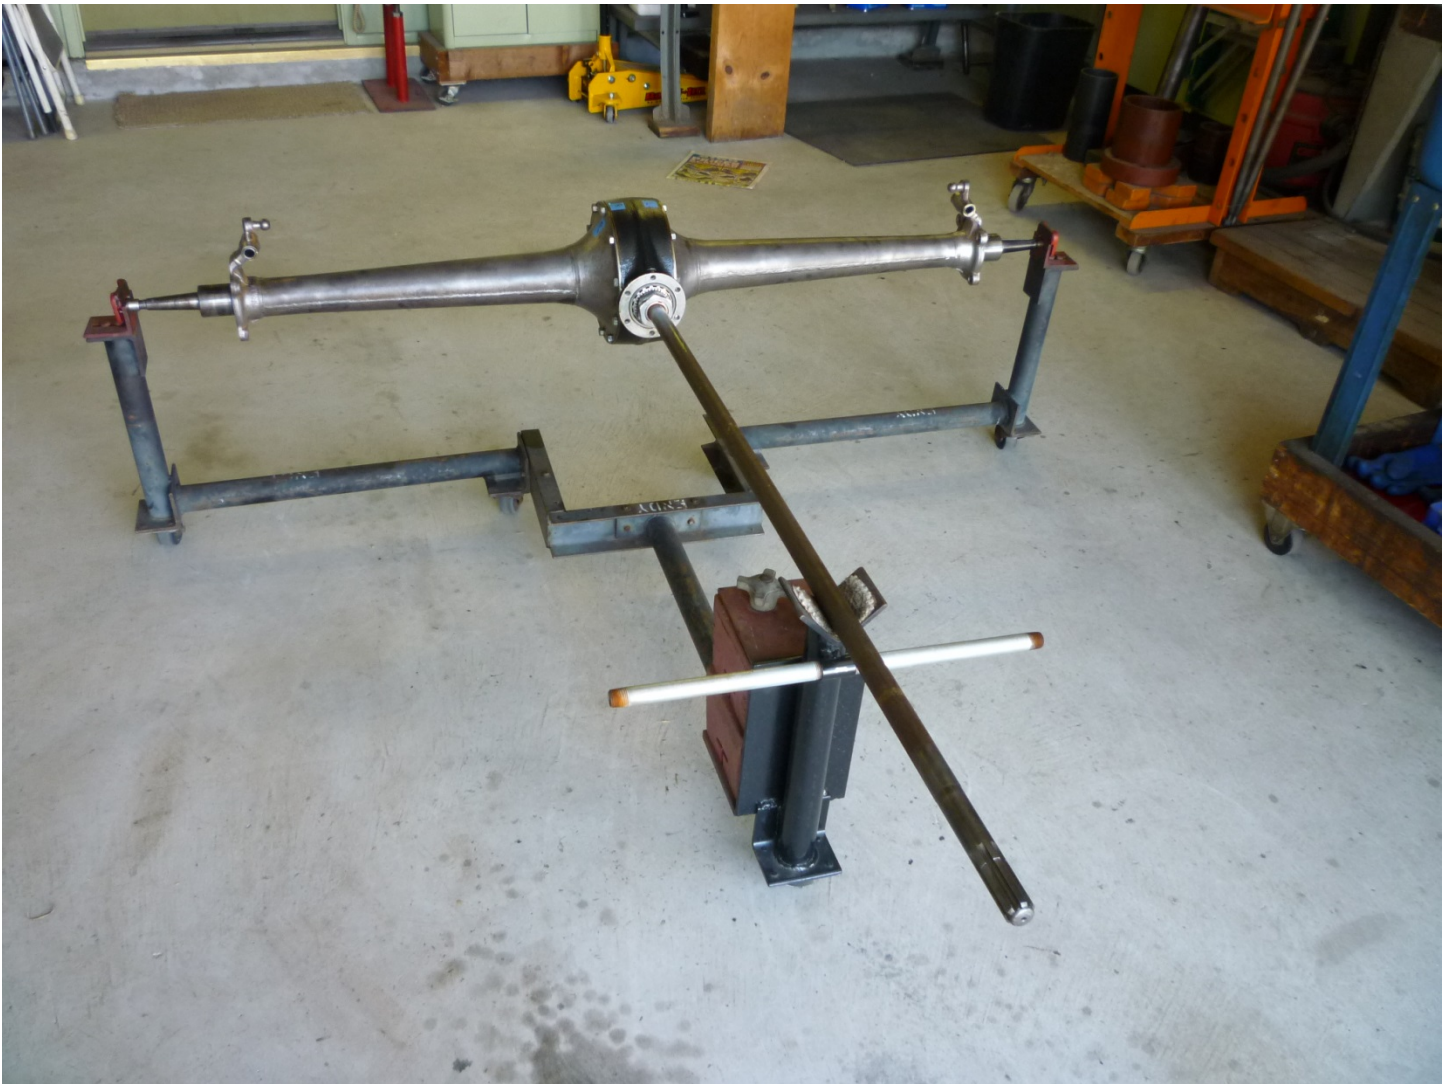
The rear axle assembly has been removed from the vertical jig and placed in the roll around cradle and is ready to have the torque tube installed.

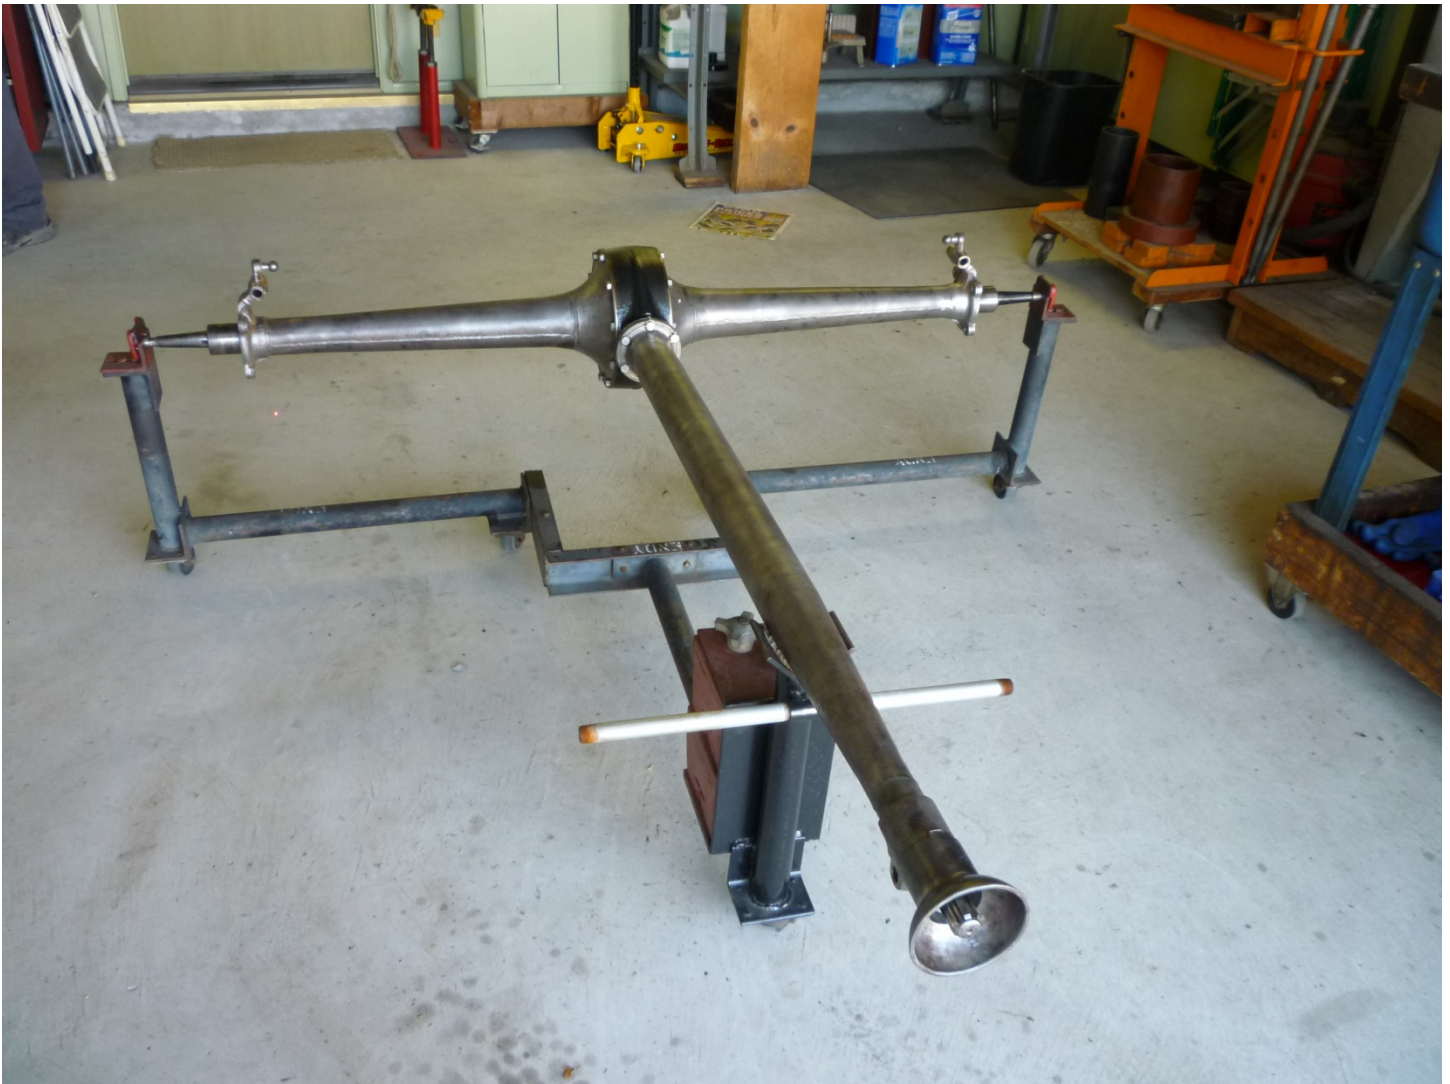
The assembly is complete and has been removed from the vertical assembly jig and placed in the roll around jig where the torque tube was installed. It will next be masked off and painted.
